Rotorua Lakes Council  
1061 Haupapa Street  
Rotorua 3046

**Re: Prince's Gate Arches Structural Inspection Report**

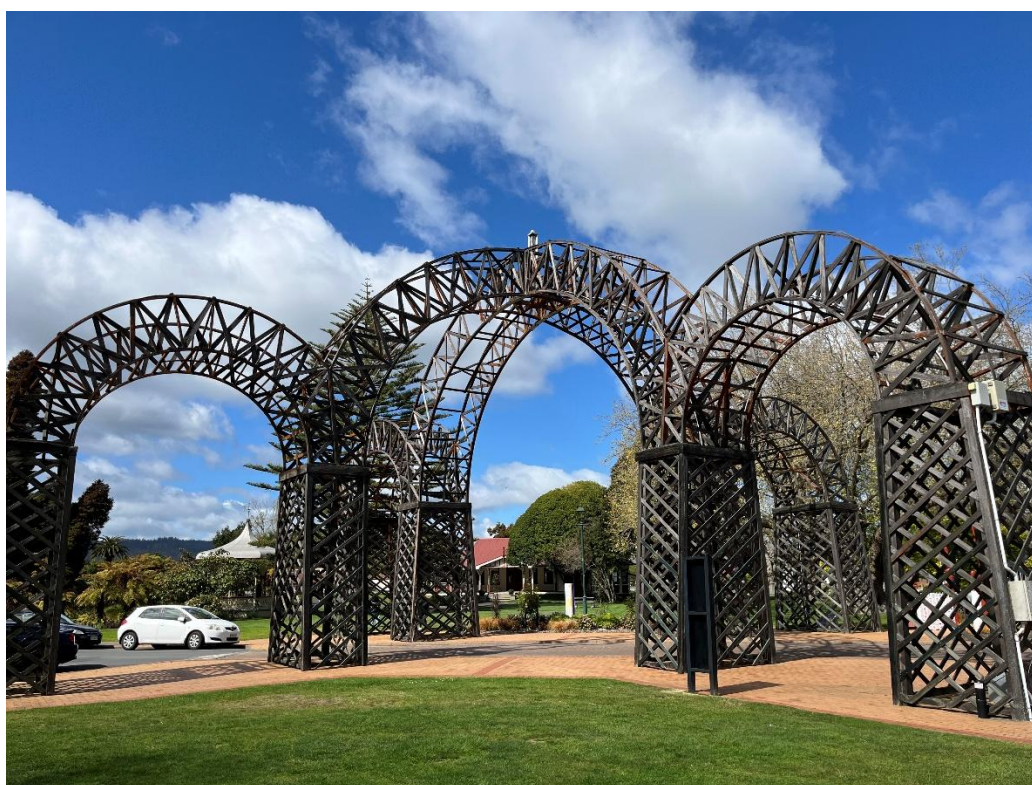
Figure 2: View of overall Structure (Looking to the South)

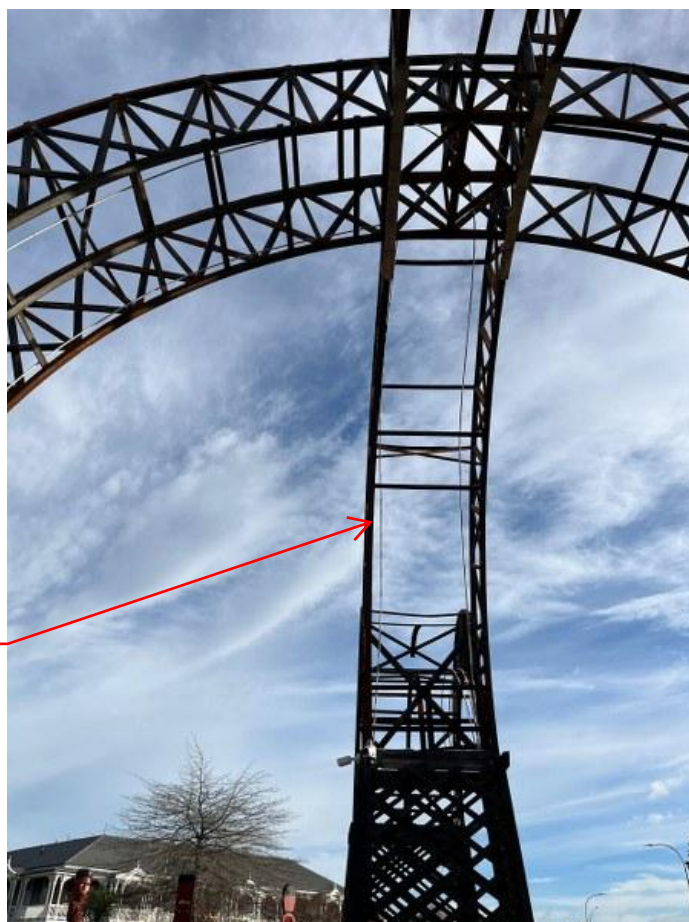
Our site inspection found that a significant number of lateral ties between the primary trusses orientated in the North-West and South-East direction are missing. The cross members which link between the two vertical trusses provide lateral restraint to the trusses under gravity loading. They also provide a load path to transfer horizontal wind and seismic loads to the supporting towers similar to a Vierendeel truss configuration. One bay of the vertical diagonal tension/compression members is missing from one side of the South-Eastern Truss. The removal of these members will increase the demands to the top and bottom chords and surrounding members as the loads redistribute to the supports. As the two orthogonal lattice box trusses rely on each other for lateral stability failure of one section of the structure may initiate collapse of the other sections.

North-West Arch with  
missing lateral ties  
top & bottom

Figure 3: North-West Primary Arch Span showing missing members between top & bottom chords  
Adjacent spans shown the original density of framing

The programme to address the arches should be expedited as a matter of urgency. Temporary intervention measures should be carried out as soon as practicable to mitigate the risk of collapse should the structure be subjected to high winds or a seismic event. Until such time, measures to isolate the existing structure from the public shall be implemented, particularly during times of increased wind conditions. Temporary intervention measures may involve either removal of the existing arches from the towers or remediation of the existing arches in their current placement.

In concept, remediation works may involve reinstating the members which are missing using SG8 timber and screw fixings, however the cost and time to achieve adequate structural performance are considered impractical. Alternatively, removal of the arches from the supporting towers would be a pragmatic approach (noting this would require temporary bracing of the towers to maintain structural integrity).

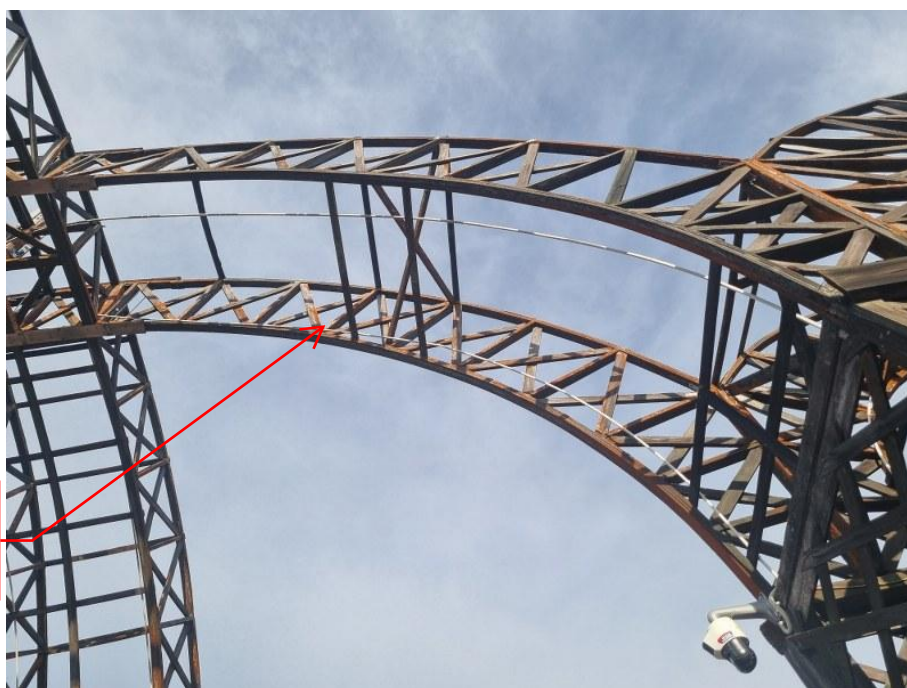
North-West Arch with  
missing lateral ties  
top & bottom

Figure 4: North-West Primary Arch Span showing missing members between top and bottom chords  
Adjacent spans shown the original density of framing

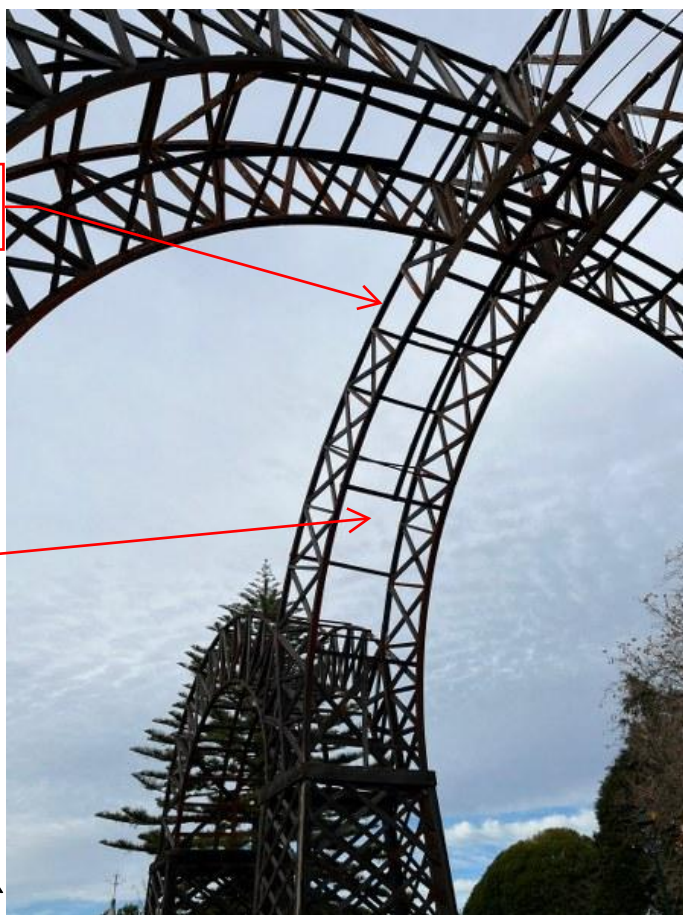
South -East Arch with missing  
tension/compression members

South -East Arch with  
missing lateral ties  
top & bottom

*Figure 5: South-East Primary Arch Span showing missing members between top and bottom chords  
Adjacent spans shown the original density of framing, Diagonal Bracing missing second bay from apex.*

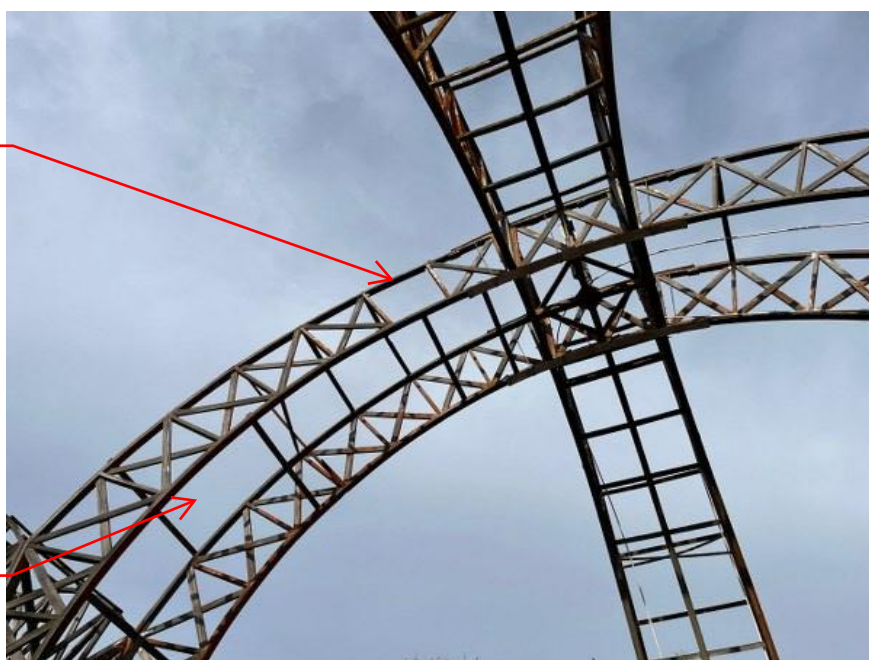
South -East Arch  
with missing  
tension/compression  
members

South -East Arch with  
missing lateral ties  
top & bottom

*Figure 6: South-East Primary Arch Span showing missing members between top & bottom chords  
Adjacent spans shown the original density of framing, Diagonal Bracing missing second bay from apex*

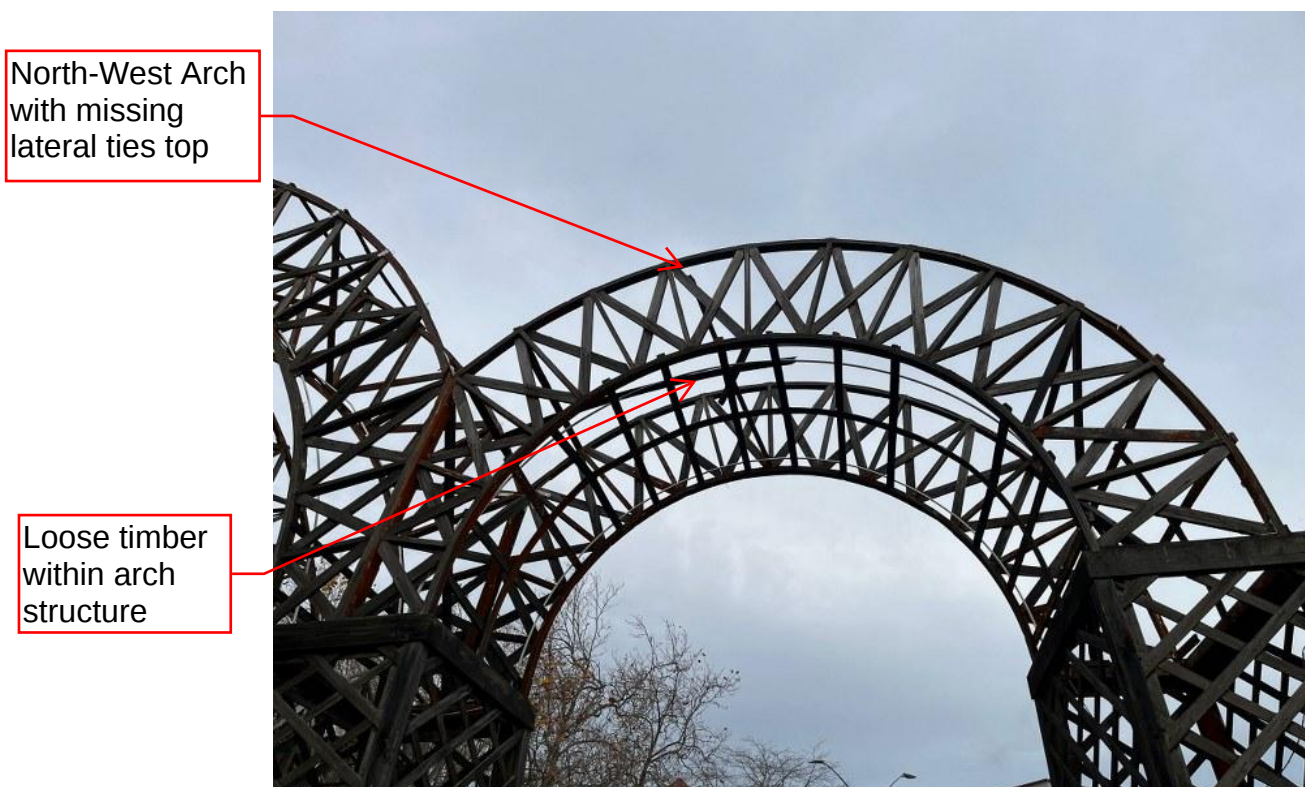
Figure 7: North-West Secondary Arch Span showing missing members to top chord, note timber laying within arch

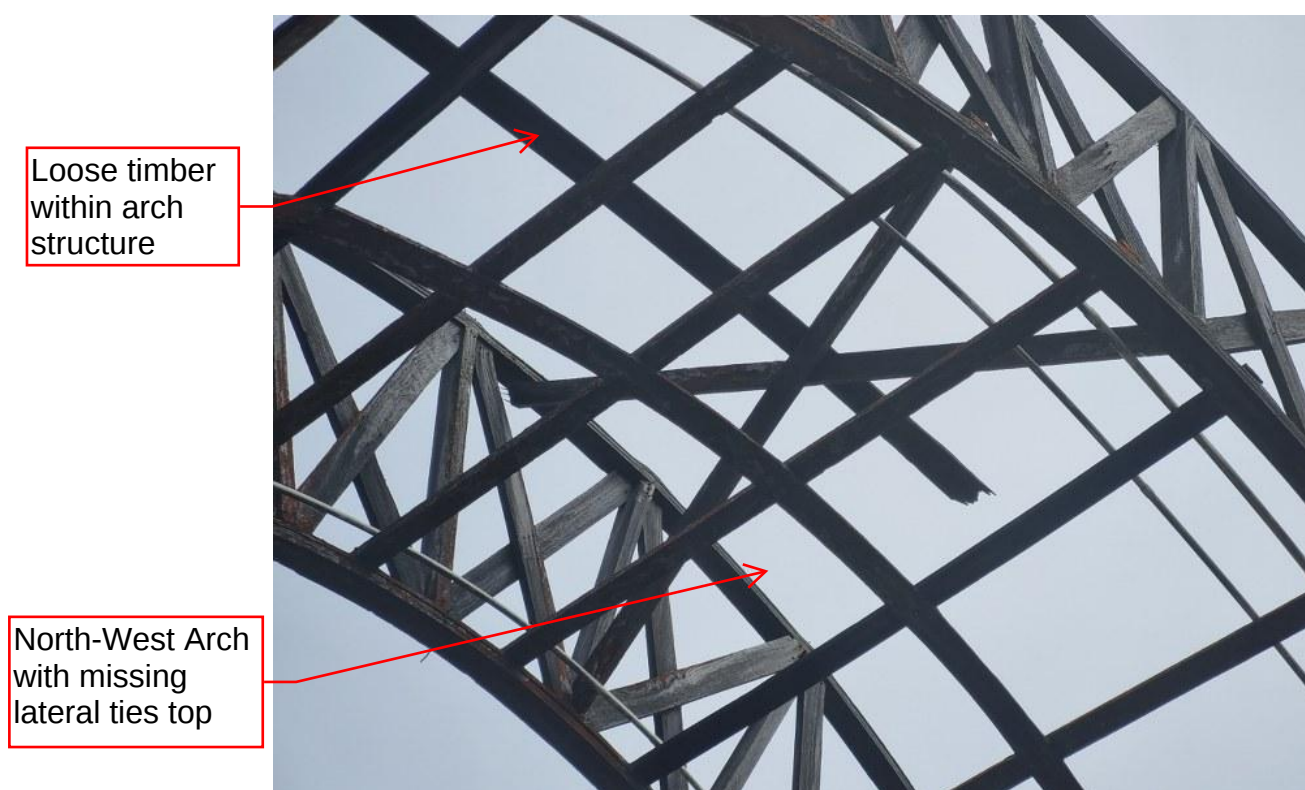
Figure 8: North-West Secondary Arch Span showing missing members to top chord, note timber laying within arch
