**CAPTION SHEET AND SUMMARY OF FACTS**

**CRI-2017-063-3196**

**Bay of Plenty  
Regional Council**

**Rotorua District Council  
1061 Haupapa Street  
Rotorua**

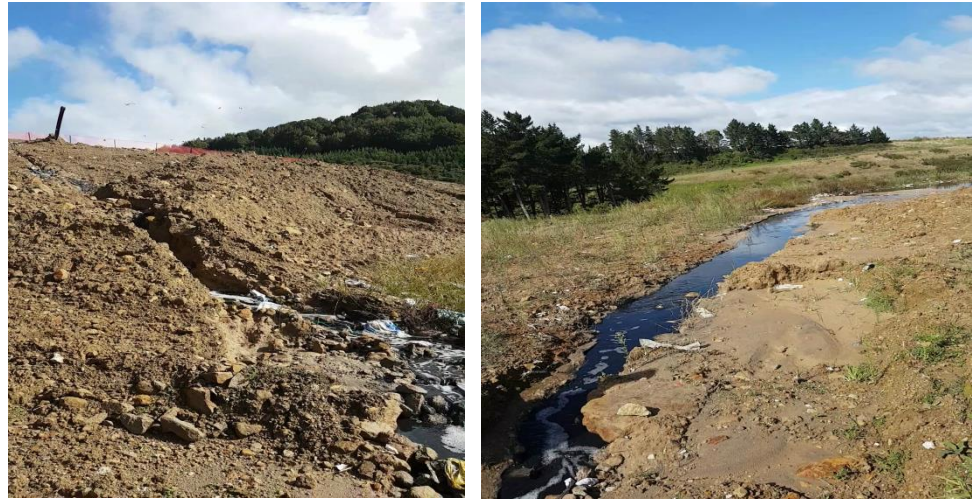
30. At 10am on 6 April 2017 a Regional Council officer carried out an inspection of the landfill site. When she arrived, the officer found that leachate had breached the bund of leachate pond 1 in two places and was flowing down

the tip face and into leachate pond 2 (**pond 2**). The following photographs show leachate flowing from pond 1 to pond 2.

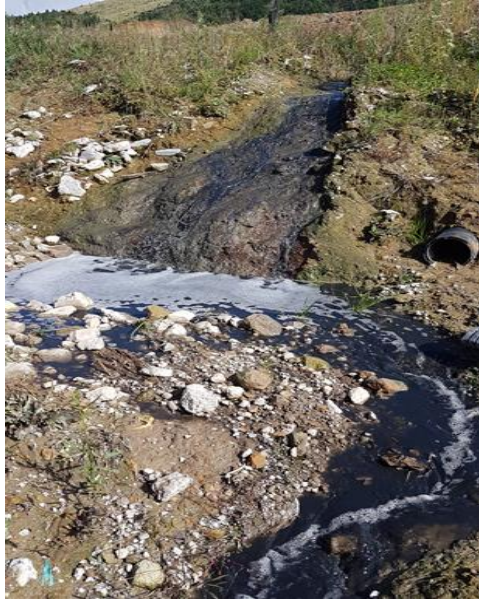
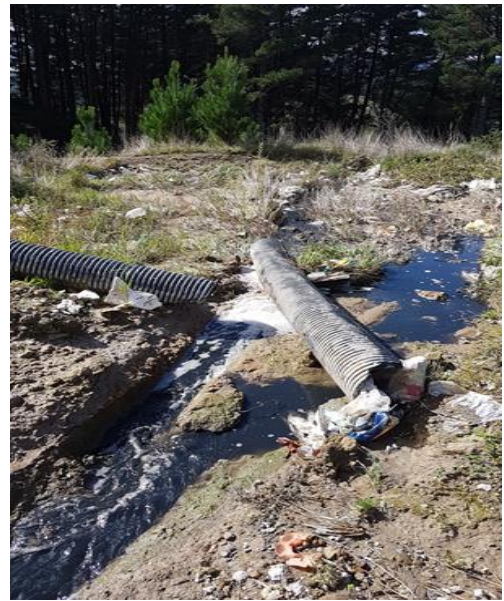
31. The bund of pond 2 (which is in the north-eastern corner of Stage 6b) had also been breached and leachate from pond 2 was overflowing at a high rate into an open stormwater drain. At the time, the officer thought that this open drain led to the leachate system but later that day she was advised that the drain actually flowed to stormwater pond B.

32. The following photographs show the leachate overflowing from pond 2 and into the stormwater drain on the morning of 6 April.

35. No one working at the landfill site appeared to be aware that leachate was overflowing from pond 2. When the officer pointed out to the staff at the landfill site that leachate had broken through the leachate pond's bund and was overflowing into a drain, staff at the landfill immediately arranged for the breach of the bund to be blocked. This stopped leachate from discharging from that pond into the stormwater drain.

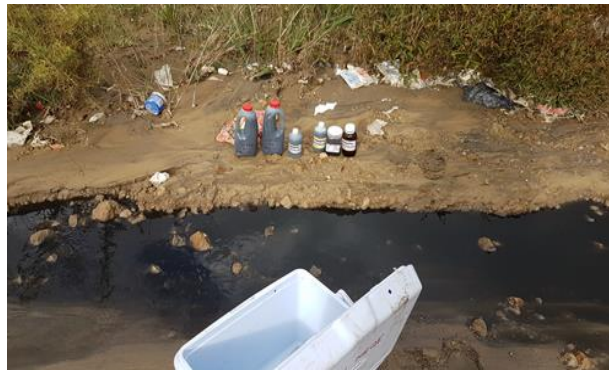
37. After receiving this email two Regional Council officers immediately went to the landfill site. The officers inspected the area where the leachate had overflowed from pond 2 and into the stormwater drain. Leachate was not discharging into the stormwater drain at this time because the breach in pond 2's bund had been repaired.
38. One of the Council officers took a sample of the leachate that remained in the flowpath from pond 2 to the stormwater drain at the location shown in the following photograph.

39. When that sample was analysed it was found to have faecal coliform levels of 21 million cfu/100mL. An aerial photograph showing where this sample was taken is attached at **Tab 8**.

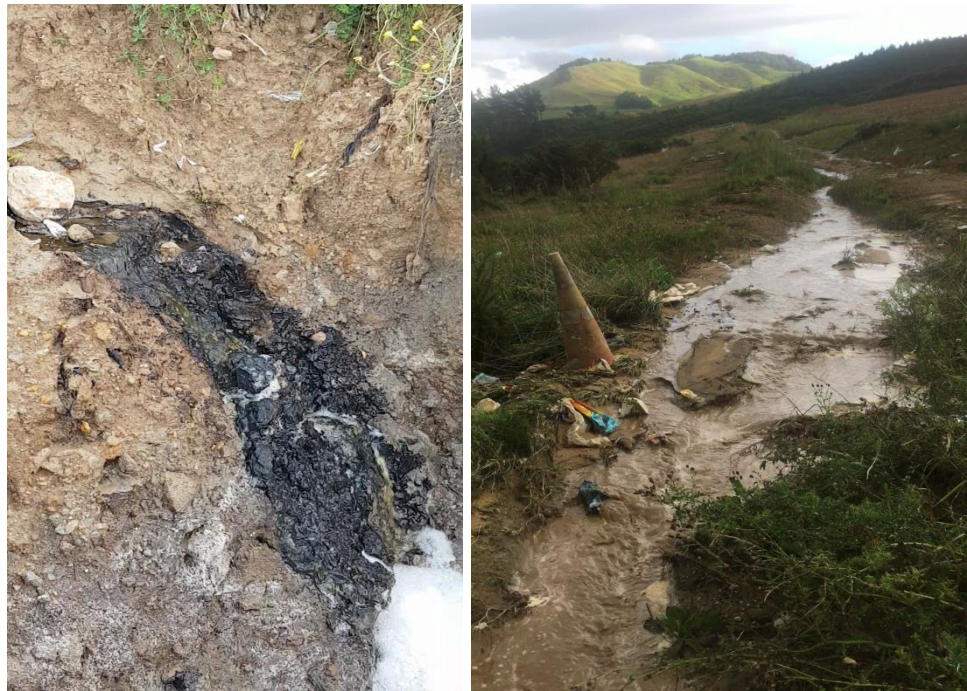
41. While the officers were inspecting the landfill site on the afternoon of 6 April 2017 they noticed a sudden increase in the volume of water flowing along the stormwater drain and into stormwater pond B. (As stated, at that time stormwater was still overflowing from stormwater pond B into the Tureporepo Stream.) The officers walked upstream to determine the source of the increased flow in the drain and found it was leachate that had broken out from the front face of Cell 6b. That leachate had previously been contained by a bund but that bund had just collapsed.

42. The following photographs show where the leachate was breaking out from the front face of Cell 6b and the resulting leachate flowpath from the collapsed bund towards the stormwater drain.<sup>4</sup>

44. A staff member of the Site Operator explained to the Council officers that the discharge of leachate into the stormwater pond that day had occurred because pipes that drain leachate from the liner and from pond 2 had been blocked by sediment. This had caused the leachate levels in pond 2 to rise and then overflow over the top of the pond's bund. The leachate had then flowed down the side of the landfill and into the stormwater drain that led to stormwater pond B.
