Follow Up Flag: Follow up
Flag Status: Completed

Categories: Executive Team

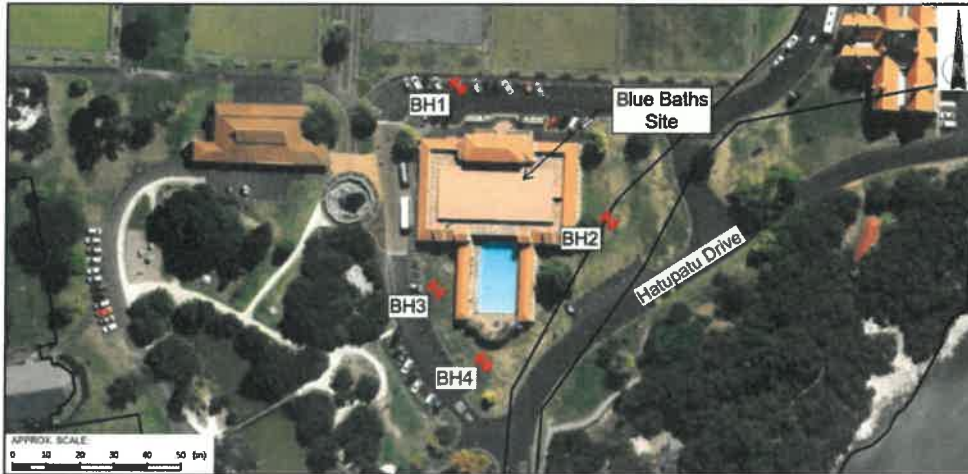
Figure 2.1: Overview of the site with recent ground investigation locations

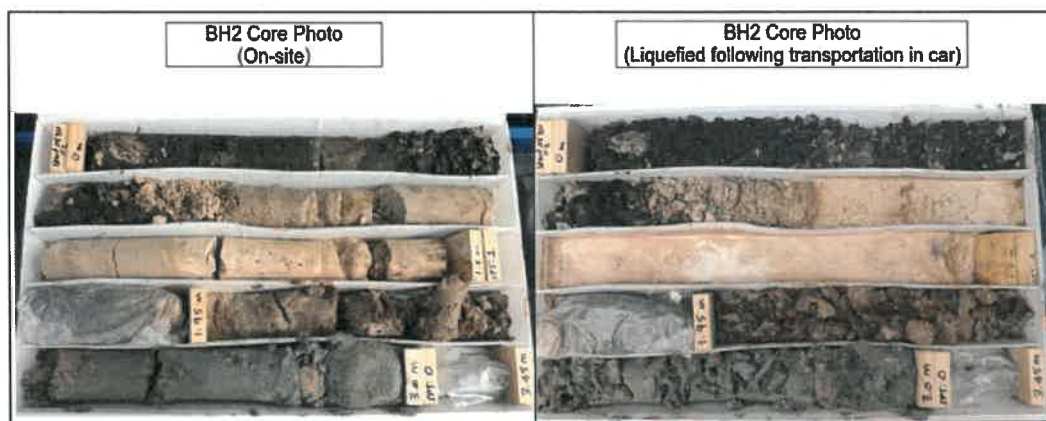
Photograph 4.1: Photo of core samples before and after transportation.

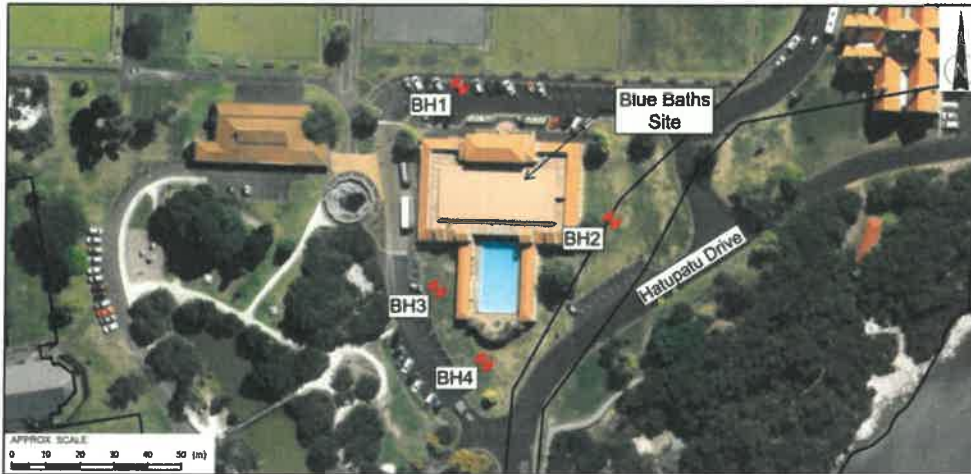
Figure 2.1: Overview of the site with recent ground investigation locations

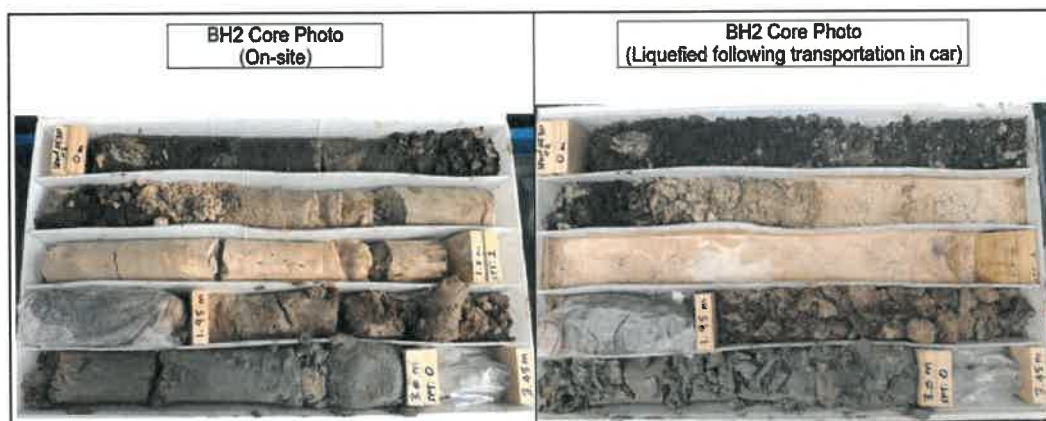
Photograph 4.1: Photo of core samples before and after transportation.

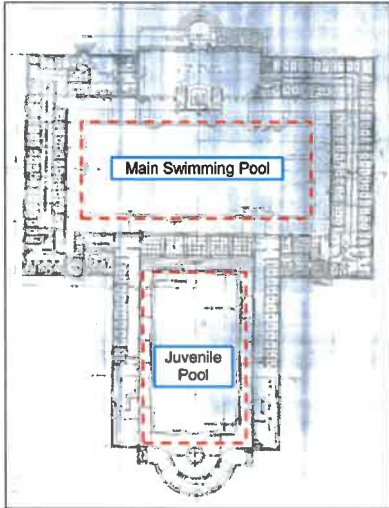
(a) 1932 – Plan view of Ground floor

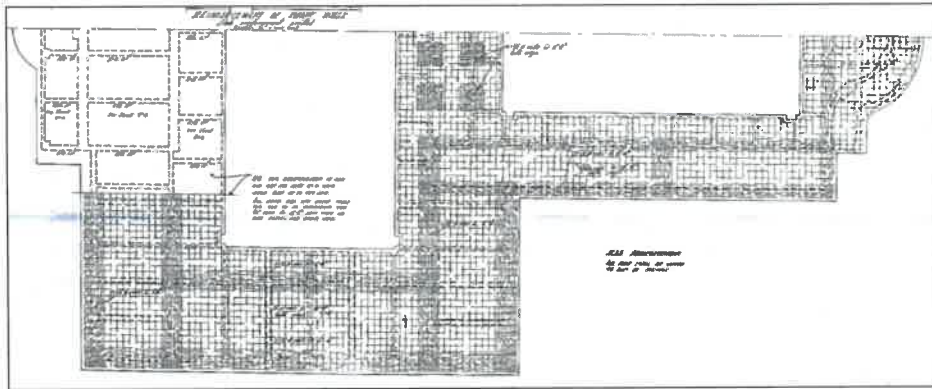
(o) Plan view of the slab reinforcement and foundation

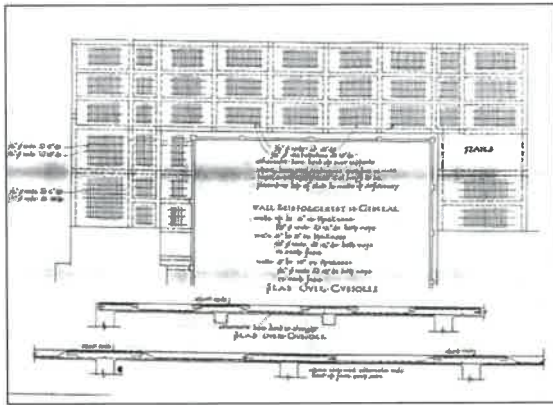
(p) Plan and section view of slab reinforcement

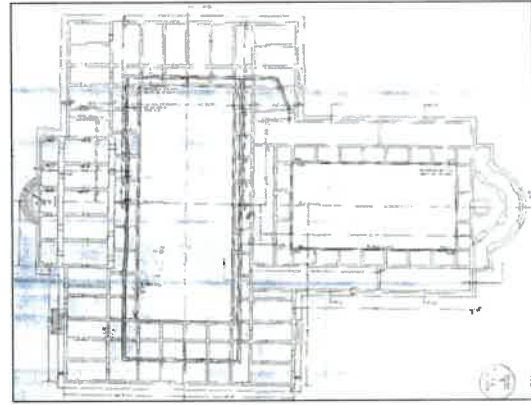
(q) Plan view of foundation

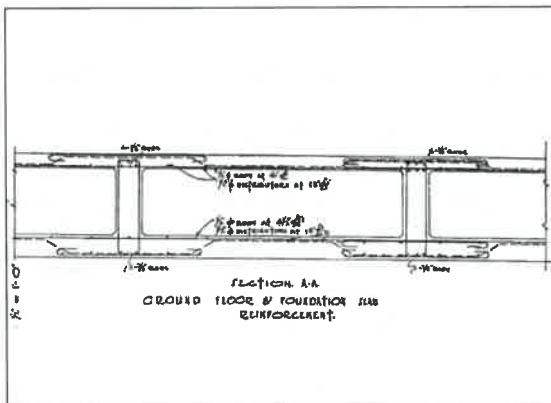
(r) Section view of the ground beam

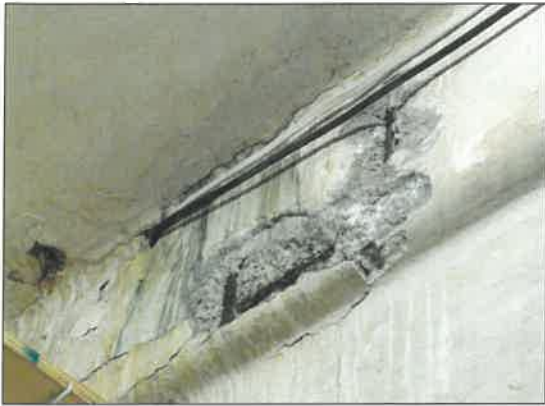
(t) Spalling of a RC beam with rusted reinforcements

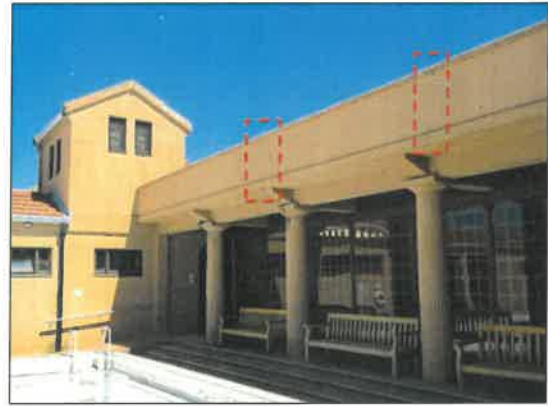
(u) Cracks across the parapet facing the pool

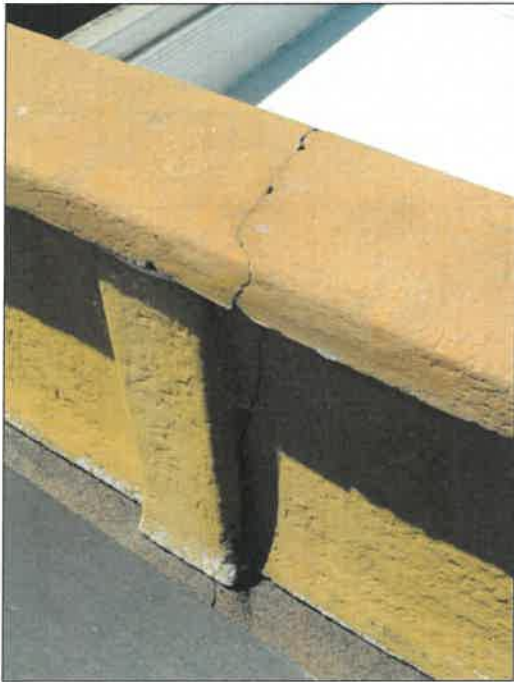
(v) Same parapet showing cracks from first floor terrace

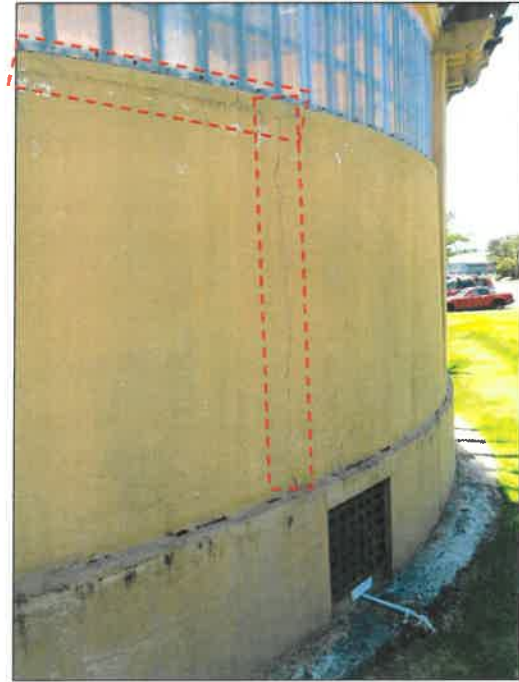
(w) Cracks along and across outside wall at southern wing

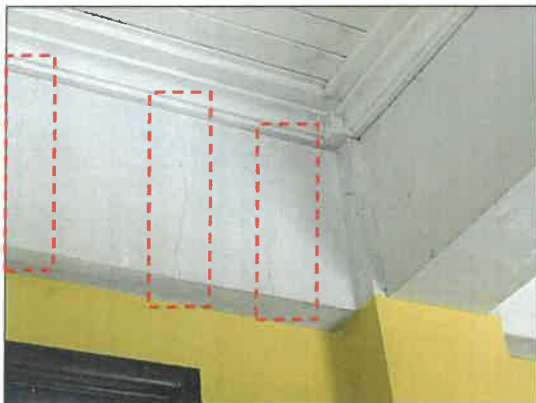
(x) Flexural cracks along the beam supporting roof structure

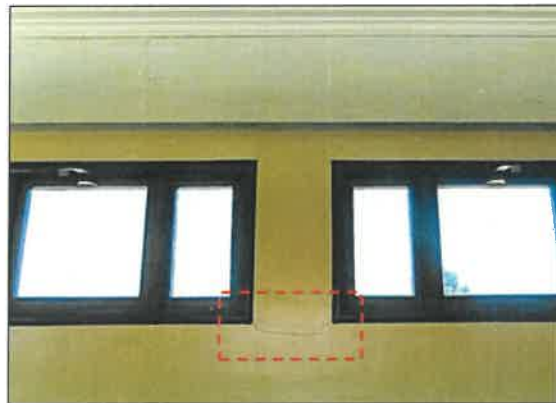
(y) Cracks between opening – Short column phenomenon

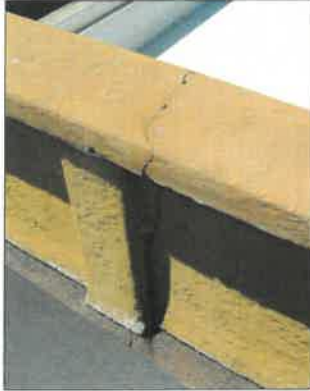
(f) Parapet showing cracks from first floor terrace

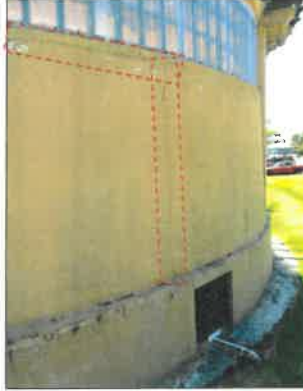
(g) Cracks along and across outside wall at southern wing

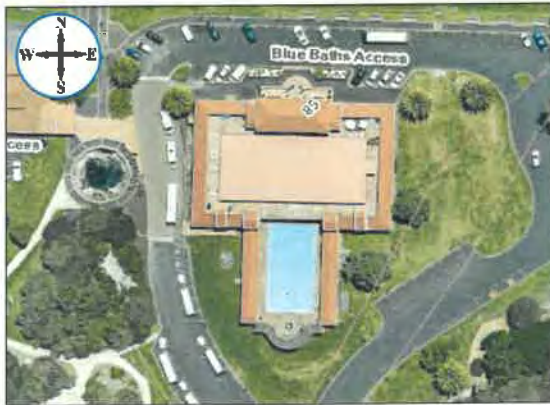
A visual internal and external inspection was conducted on 17th December 2020 with Craig Davanna, a representative from Tonkin +Taylor and Brian Stirton, a representative from Rotorua Lake Council.

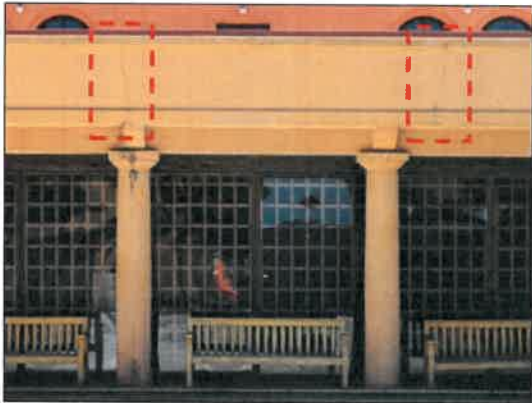
(a) Walkway next to the pool – Cracks across the parapet

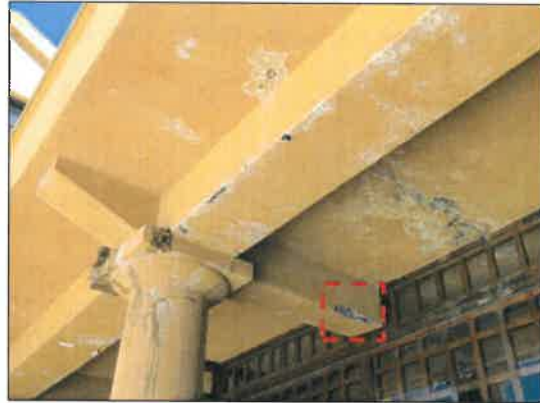
(b) Underneath the first-floor terrace – Spalling of the beam

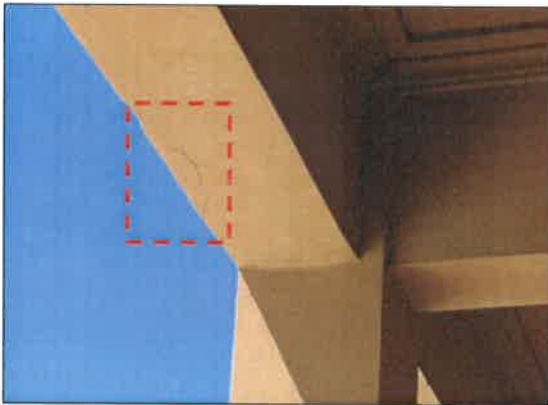
(c) Ladies side pool – Cracks at the bottom of the beam

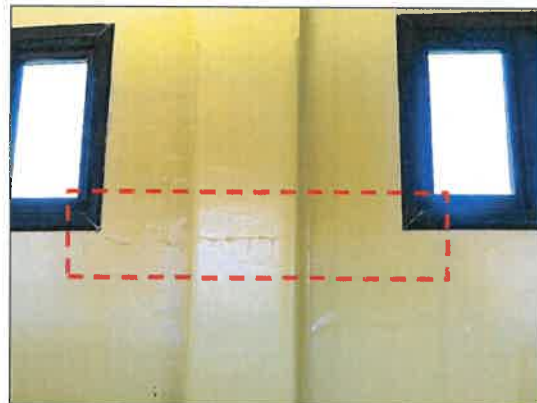
(d) Ladies bathroom – Cracks covered by plasters

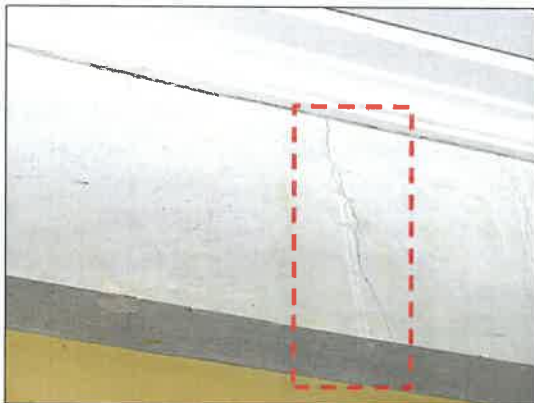
(e) Ladies bathroom – Cracks across the beam

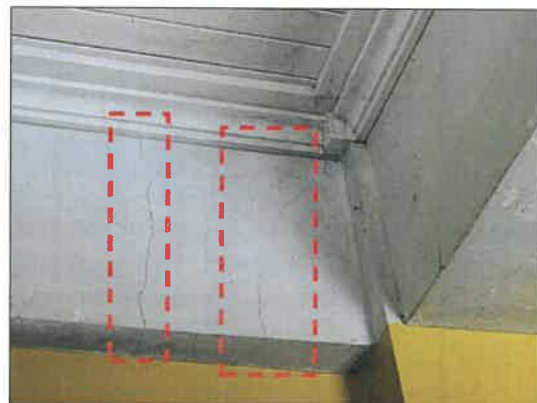
(f) Men bathroom – Cracks across the beam

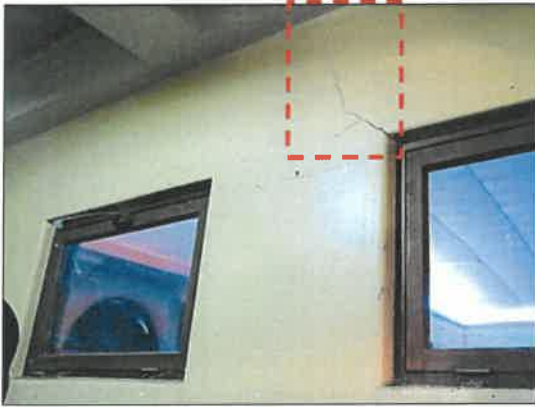
(g) Storage room on the right-hand side of the pool – Cracks across the wall

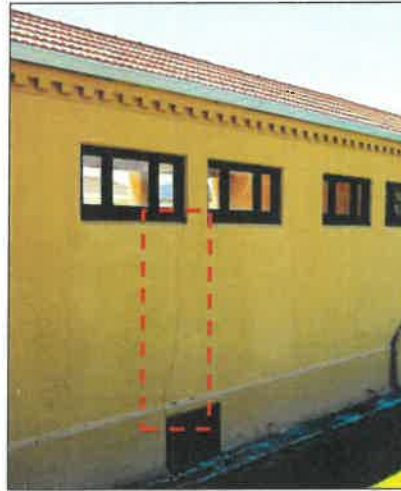
(h) Men bathroom – Cracks across the beam

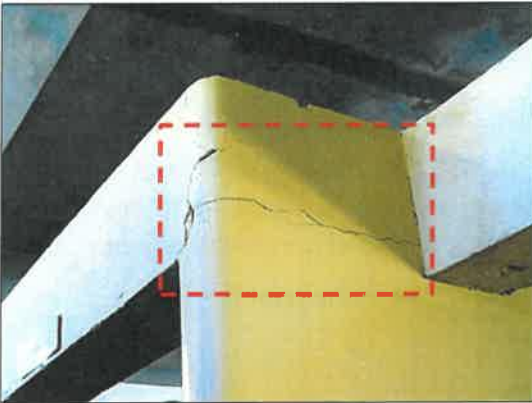
(i) Storage room on the left-hand side of the pool – Cracks across the stall walls

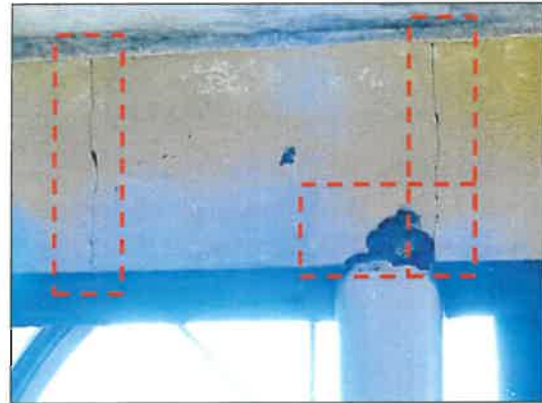
(j) Storage room on the left-hand side of the pool – Cracks across the beam and deteriorated connection between the column and the beam

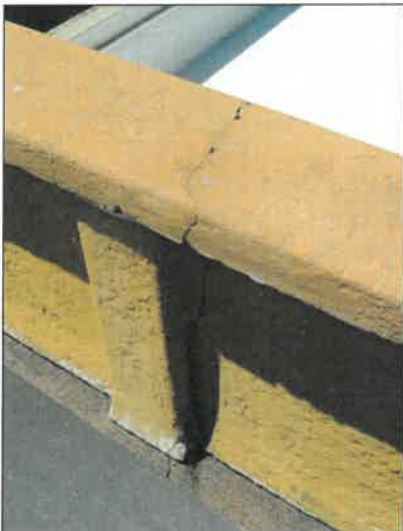
(k) First floor terrace – Cracks across the parapet

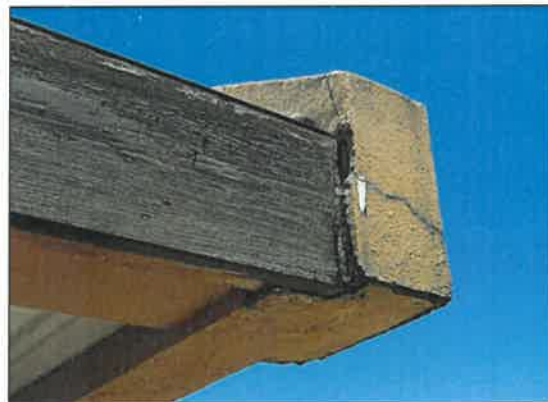
(l) Office on the first floor – Deteriorated connection at the office roof corner

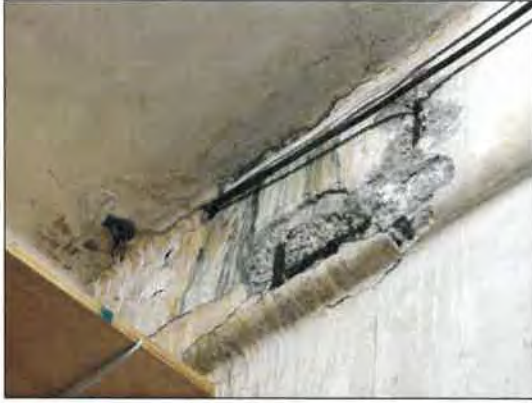
(m) Room within a courtyard area - Spalling of a RC beam with rusted reinforcements

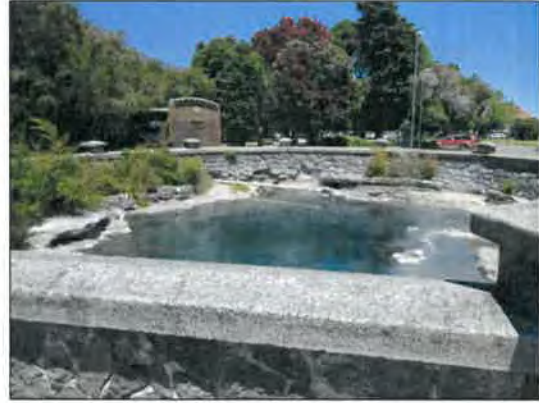
(n) Rachel Spring Whangapipiro on the west side of the building

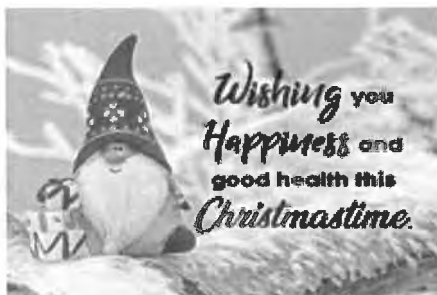
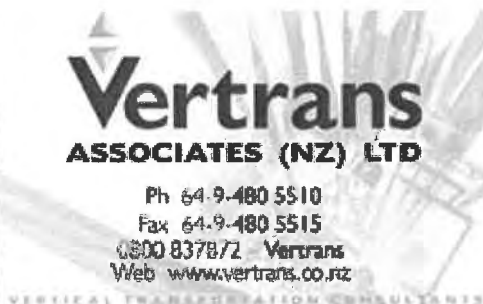
Our office will be closed from 1pm 22nd December and will re-open 11th January 2021

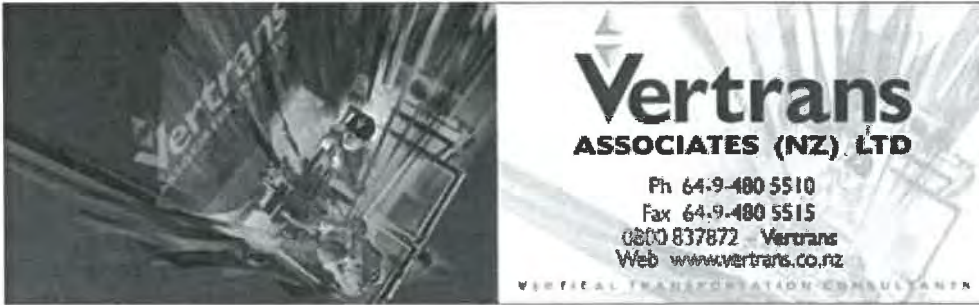
Disclaimer: This electronic message and any accompanying attachments may contain information that is privileged and confidential. If you are not the intended recipient you are advised that any use, review, dissemination, distribution or reproduction of the information is strictly prohibited and may be unlawful. Vertrans cannot accept liability for any loss or damage caused by viruses. If you have received this email in error, please notify the sender immediately and destroy the message.

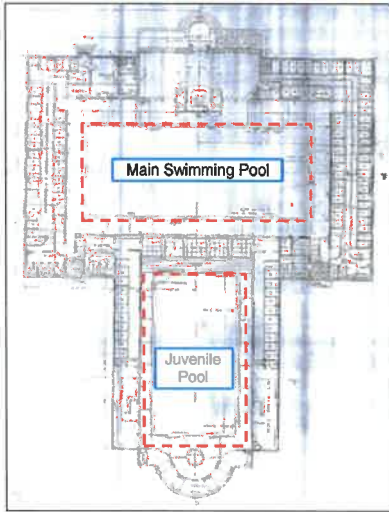
(a) 1932 – Plan view of Ground floor

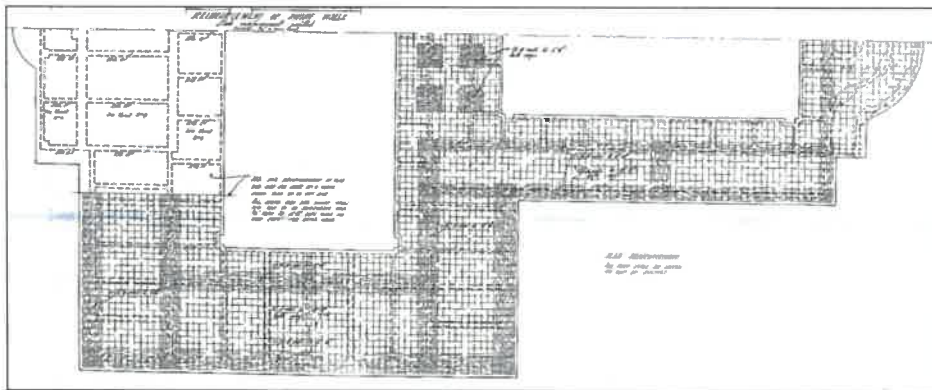
(o) Plan view of the slab reinforcement and foundation

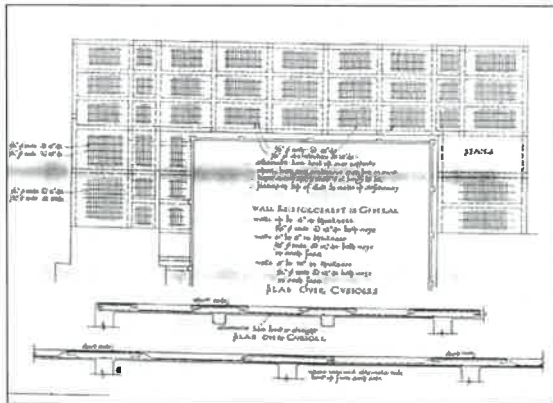
(p) Plan and section view of slab reinforcement

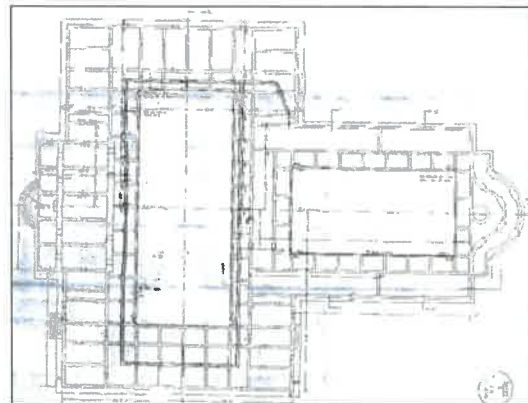
(q) Plan view of foundation

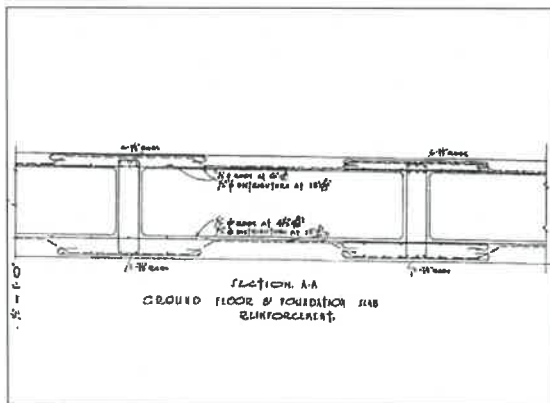
(r) Section view of the ground beam

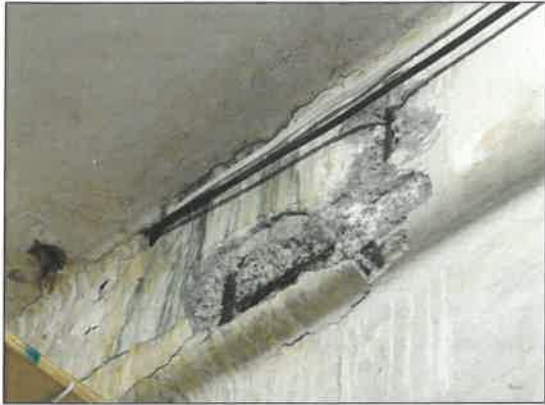
(t) Spalling of a RC beam with rusted reinforcements

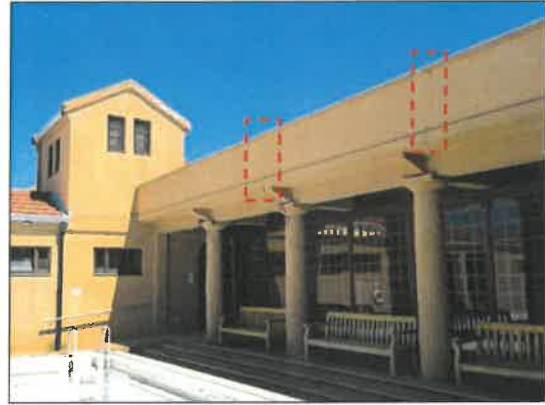
(u) Cracks across the parapet facing the pool

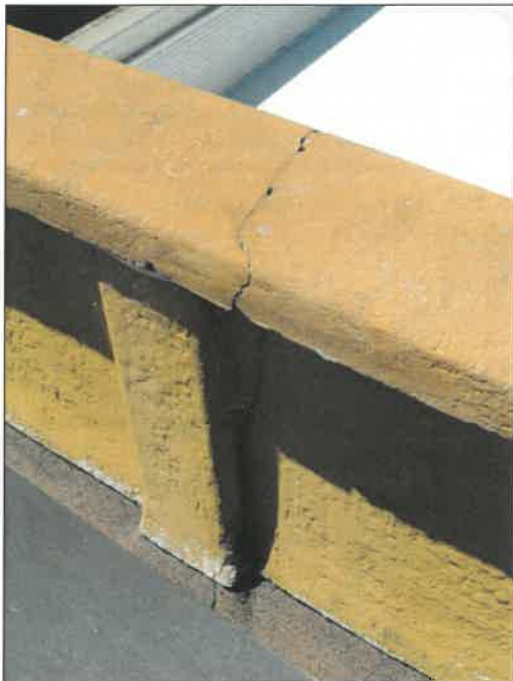
(v) Same parapet showing cracks from first floor terrace

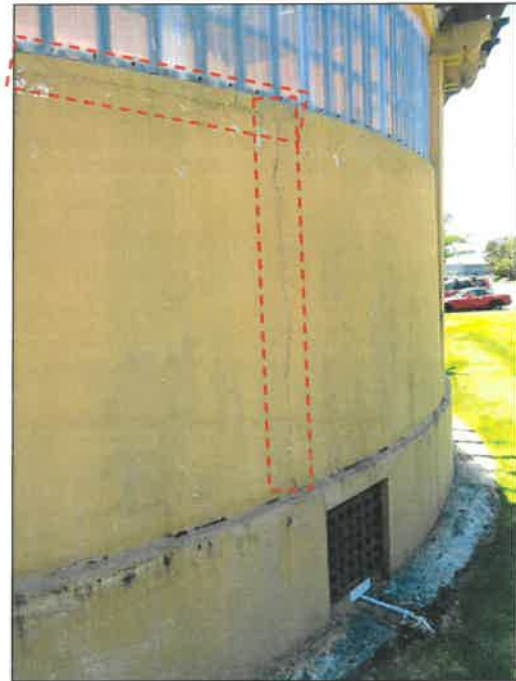
(w) Cracks along and across outside wall at southern wing

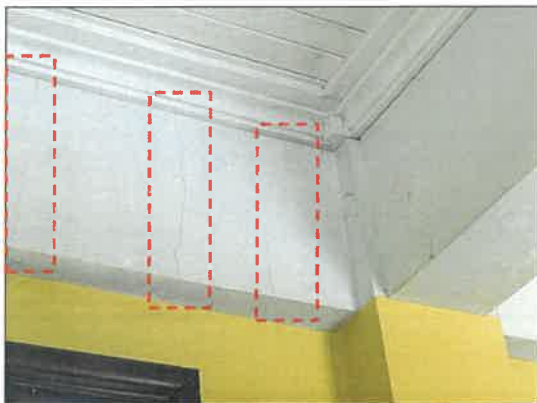
(x) Flexural cracks along the beam supporting roof structure

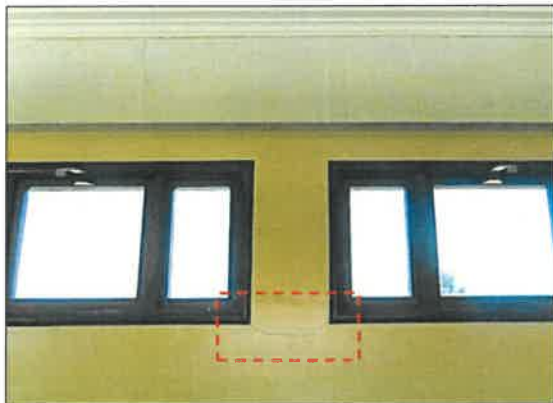
(y) Cracks between opening – Short column phenomenon

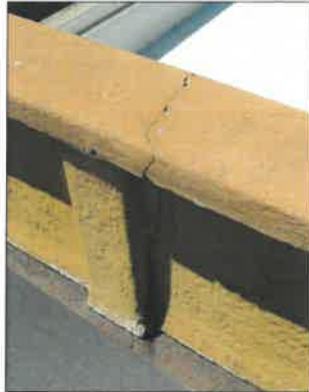
(f) Parapet showing cracks from first floor terrace

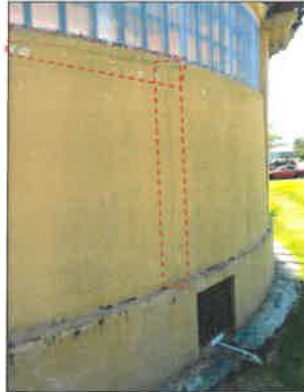
(g) Cracks along and across outside wall at southern wing

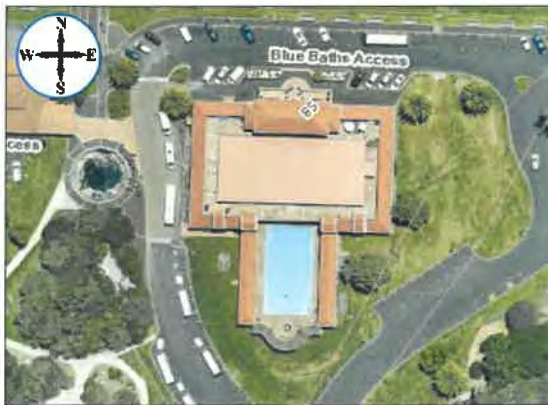
A visual internal and external inspection was conducted on 17th December 2020 with ██████████ a representative from Tonkin + Taylor and Brian Stirton, a representative from Rotorua Lake Council.

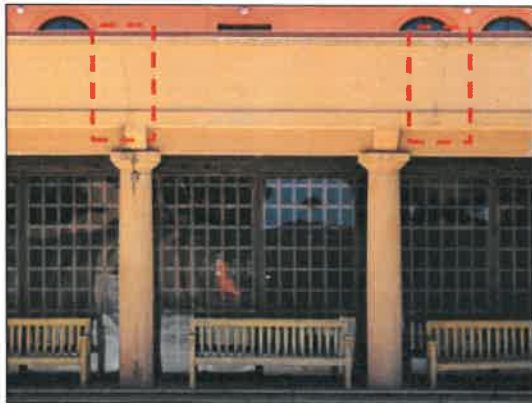
(a) Walkway next to the pool – Cracks across the parapet

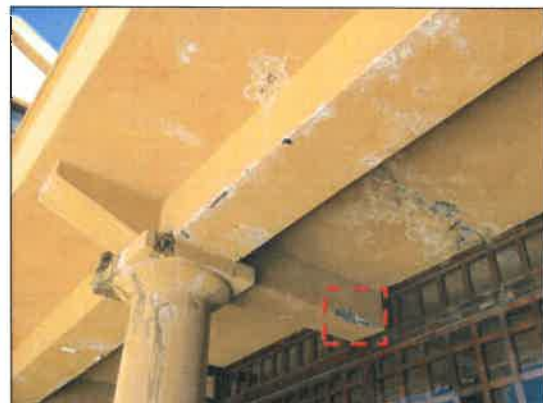
(b) Underneath the first-floor terrace – Spalling of the beam

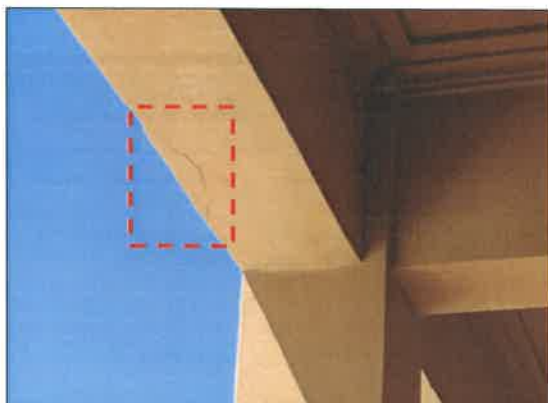
(c) Ladies side pool – Cracks at the bottom of the beam

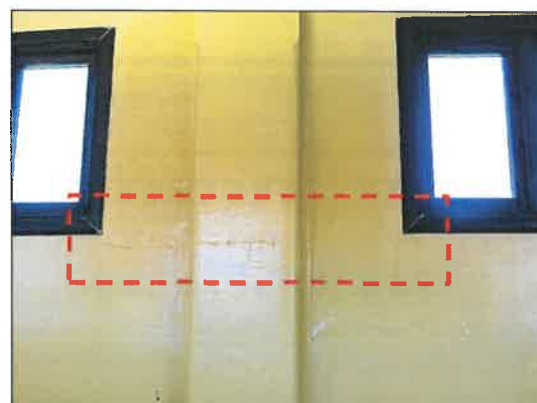
(d) Ladies bathroom – Cracks covered by plasters

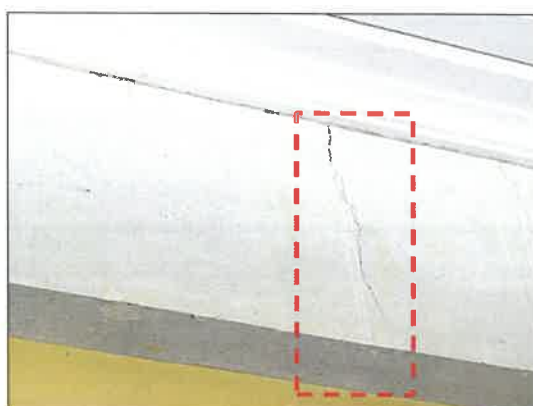
(e) Ladies bathroom – Cracks across the beam

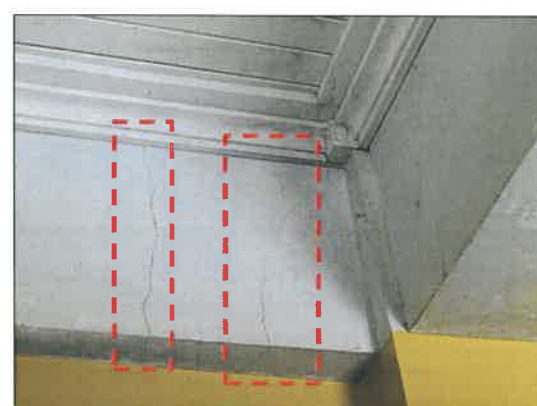
(f) Men bathroom – Cracks across the beam

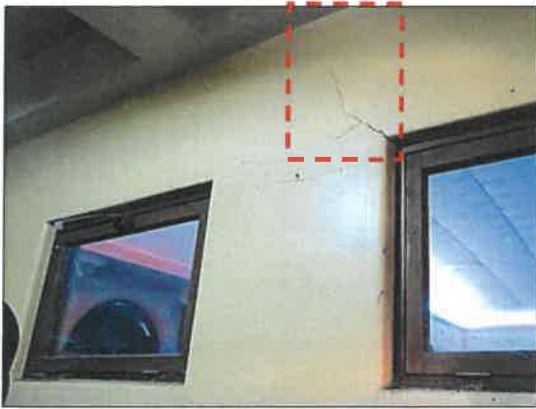
(g) Storage room on the right-hand side of the pool – Cracks across the wall

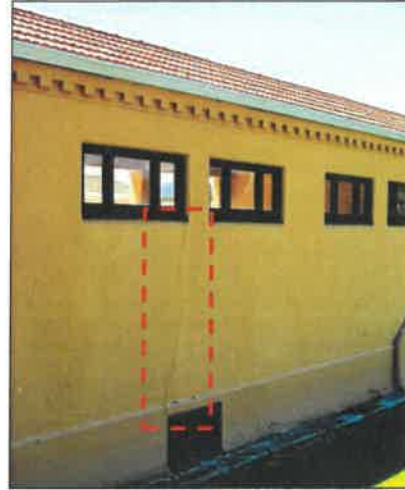
(h) Men bathroom – Cracks across the beam

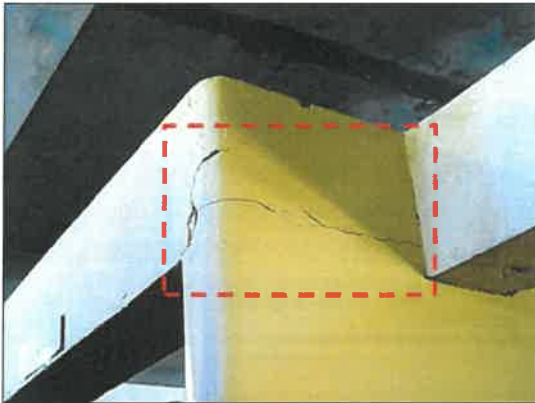
(i) Storage room on the left-hand side of the pool – Cracks across the stall walls

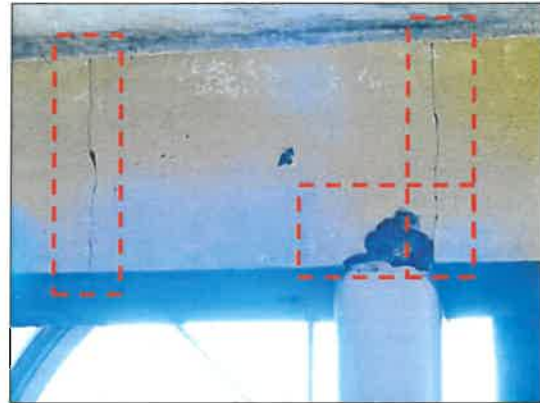
(j) Storage room on the left-hand side of the pool – Cracks across the beam and deteriorated connection between the column and the beam

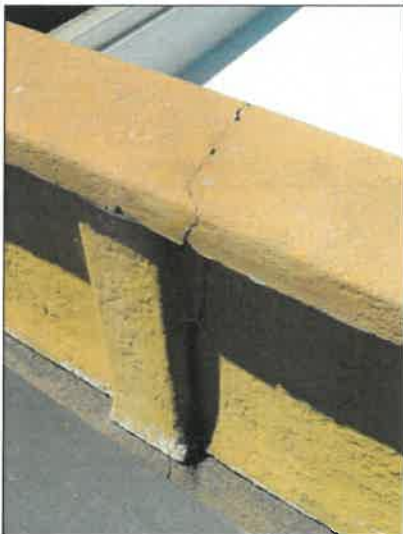
(k) First floor terrace – Cracks across the parapet

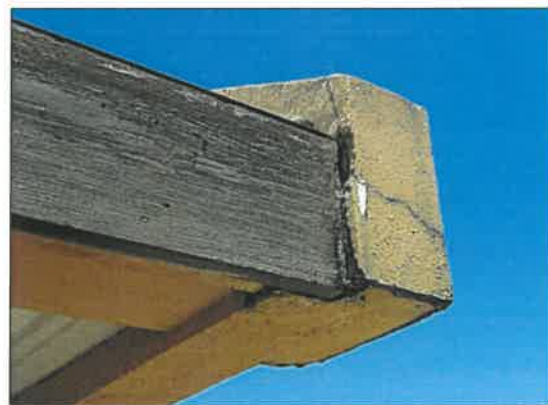
(l) Office on the first floor – Deteriorated connection at the office roof corner

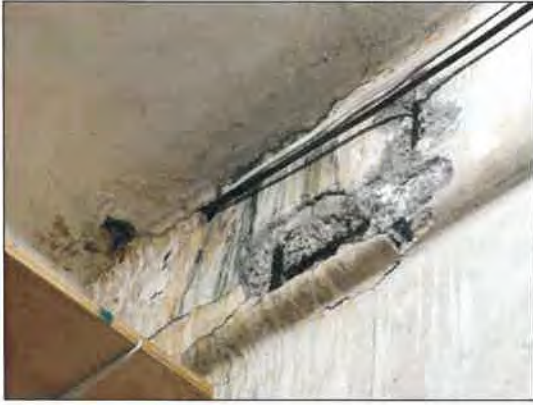
(m) Room within a courtyard area - Spalling of a RC beam with rusted reinforcements

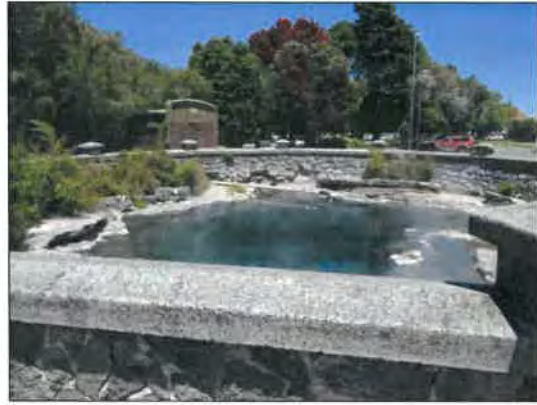
(n) Rachel Spring Whangapipiro on the west side of the building

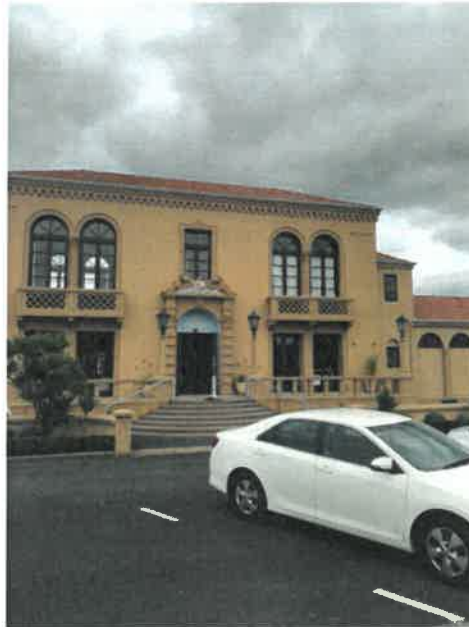
Central Blue Baths Building
Queens Drive
Government Gardens
Rotorua

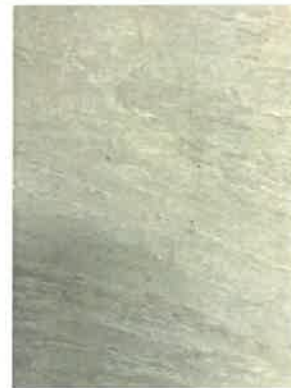
Recommendation: Manage & Re-Inspect

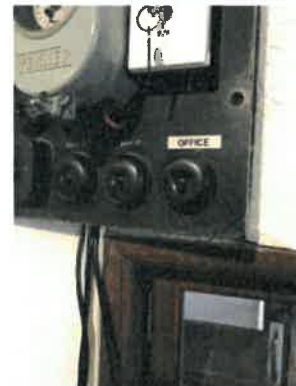
Recommendation: Manage & Re-Inspect

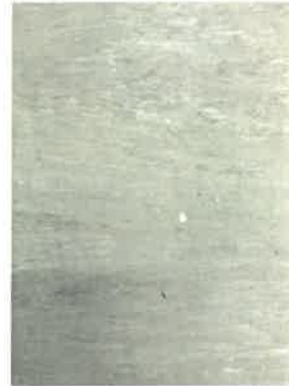
Recommendation: Manage & Re-Inspect

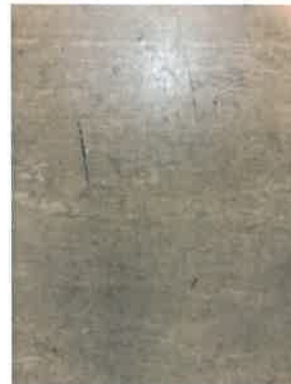
Recommendation: Manage & Re-Inspect

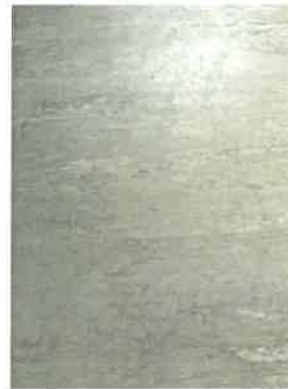
Recommendation: Manage & Re-Inspect

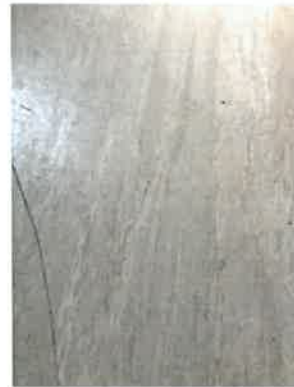
Recommendation: Manage & Re-Inspect

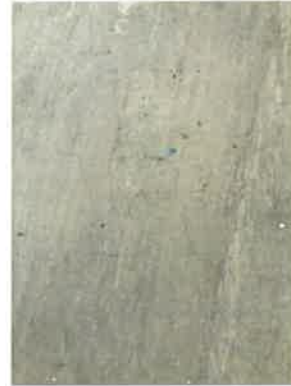
Recommendation: Manage & Re-Inspect

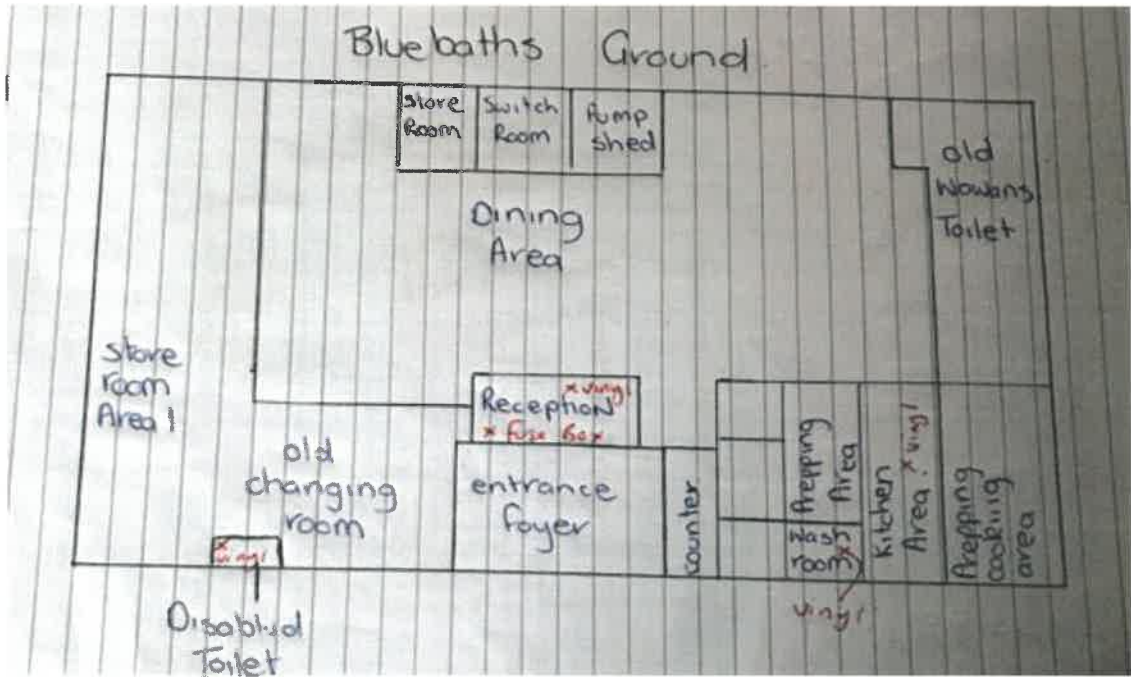
12. Asbestos Survey Results Central Blue Baths Building

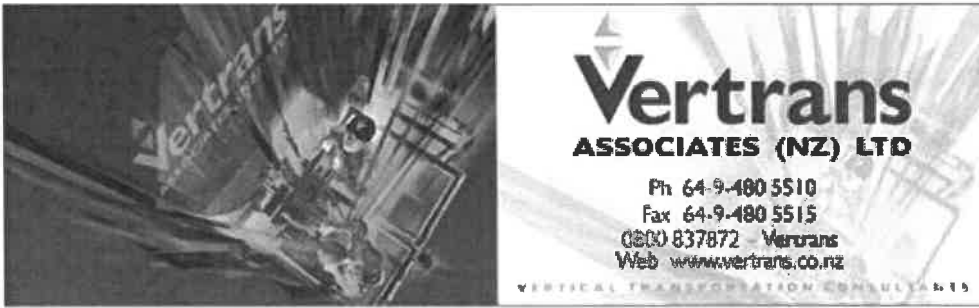
Disclaimer: This electronic message and any accompanying attachments may contain information that is privileged and confidential. If you are not the intended recipient you are advised that any use, review, dissemination, distribution or reproduction of the information is strictly prohibited and may be unlawful. Vertrans cannot accept liability for any loss or damage caused by viruses. If you have received this email in error, please notify the sender immediately and destroy the message.

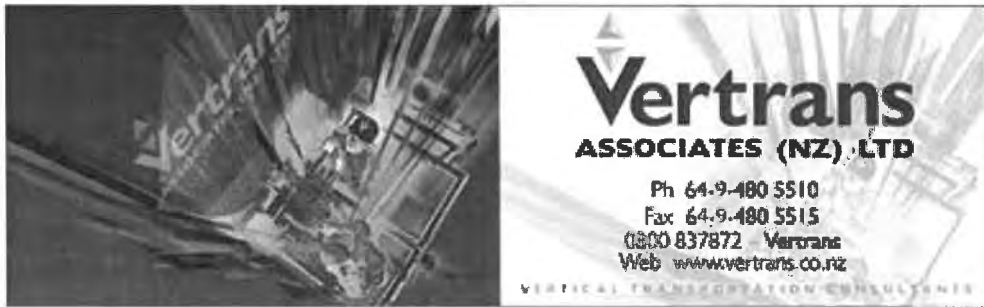
Disclaimer: This electronic message and any accompanying attachments may contain information that is privileged and confidential. If you are not the intended recipient you are advised that any use, review, dissemination, distribution or reproduction of the information is strictly prohibited and may be unlawful. Vertrans cannot accept liability for any loss or damage caused by viruses. If you have received this email in error, please notify the sender immediately and destroy the message.

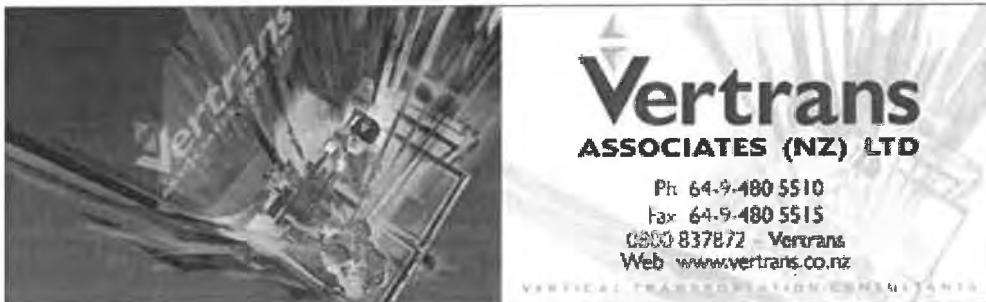
Disclaimer: This electronic message and any accompanying attachments may contain information that is privileged and confidential. If you are not the intended recipient you are advised that any use, review, dissemination, distribution or reproduction of the information is strictly prohibited and may be unlawful. Vertrans cannot accept liability for any loss or damage caused by viruses. If you have received this email in error, please notify the sender immediately and destroy the message.
