CRACK SURVEY

Rotorua Museum of Art and History, Oruawhata Drive, Rotorua

**Crack Survey Report of 1906 Built Section
December 2016**

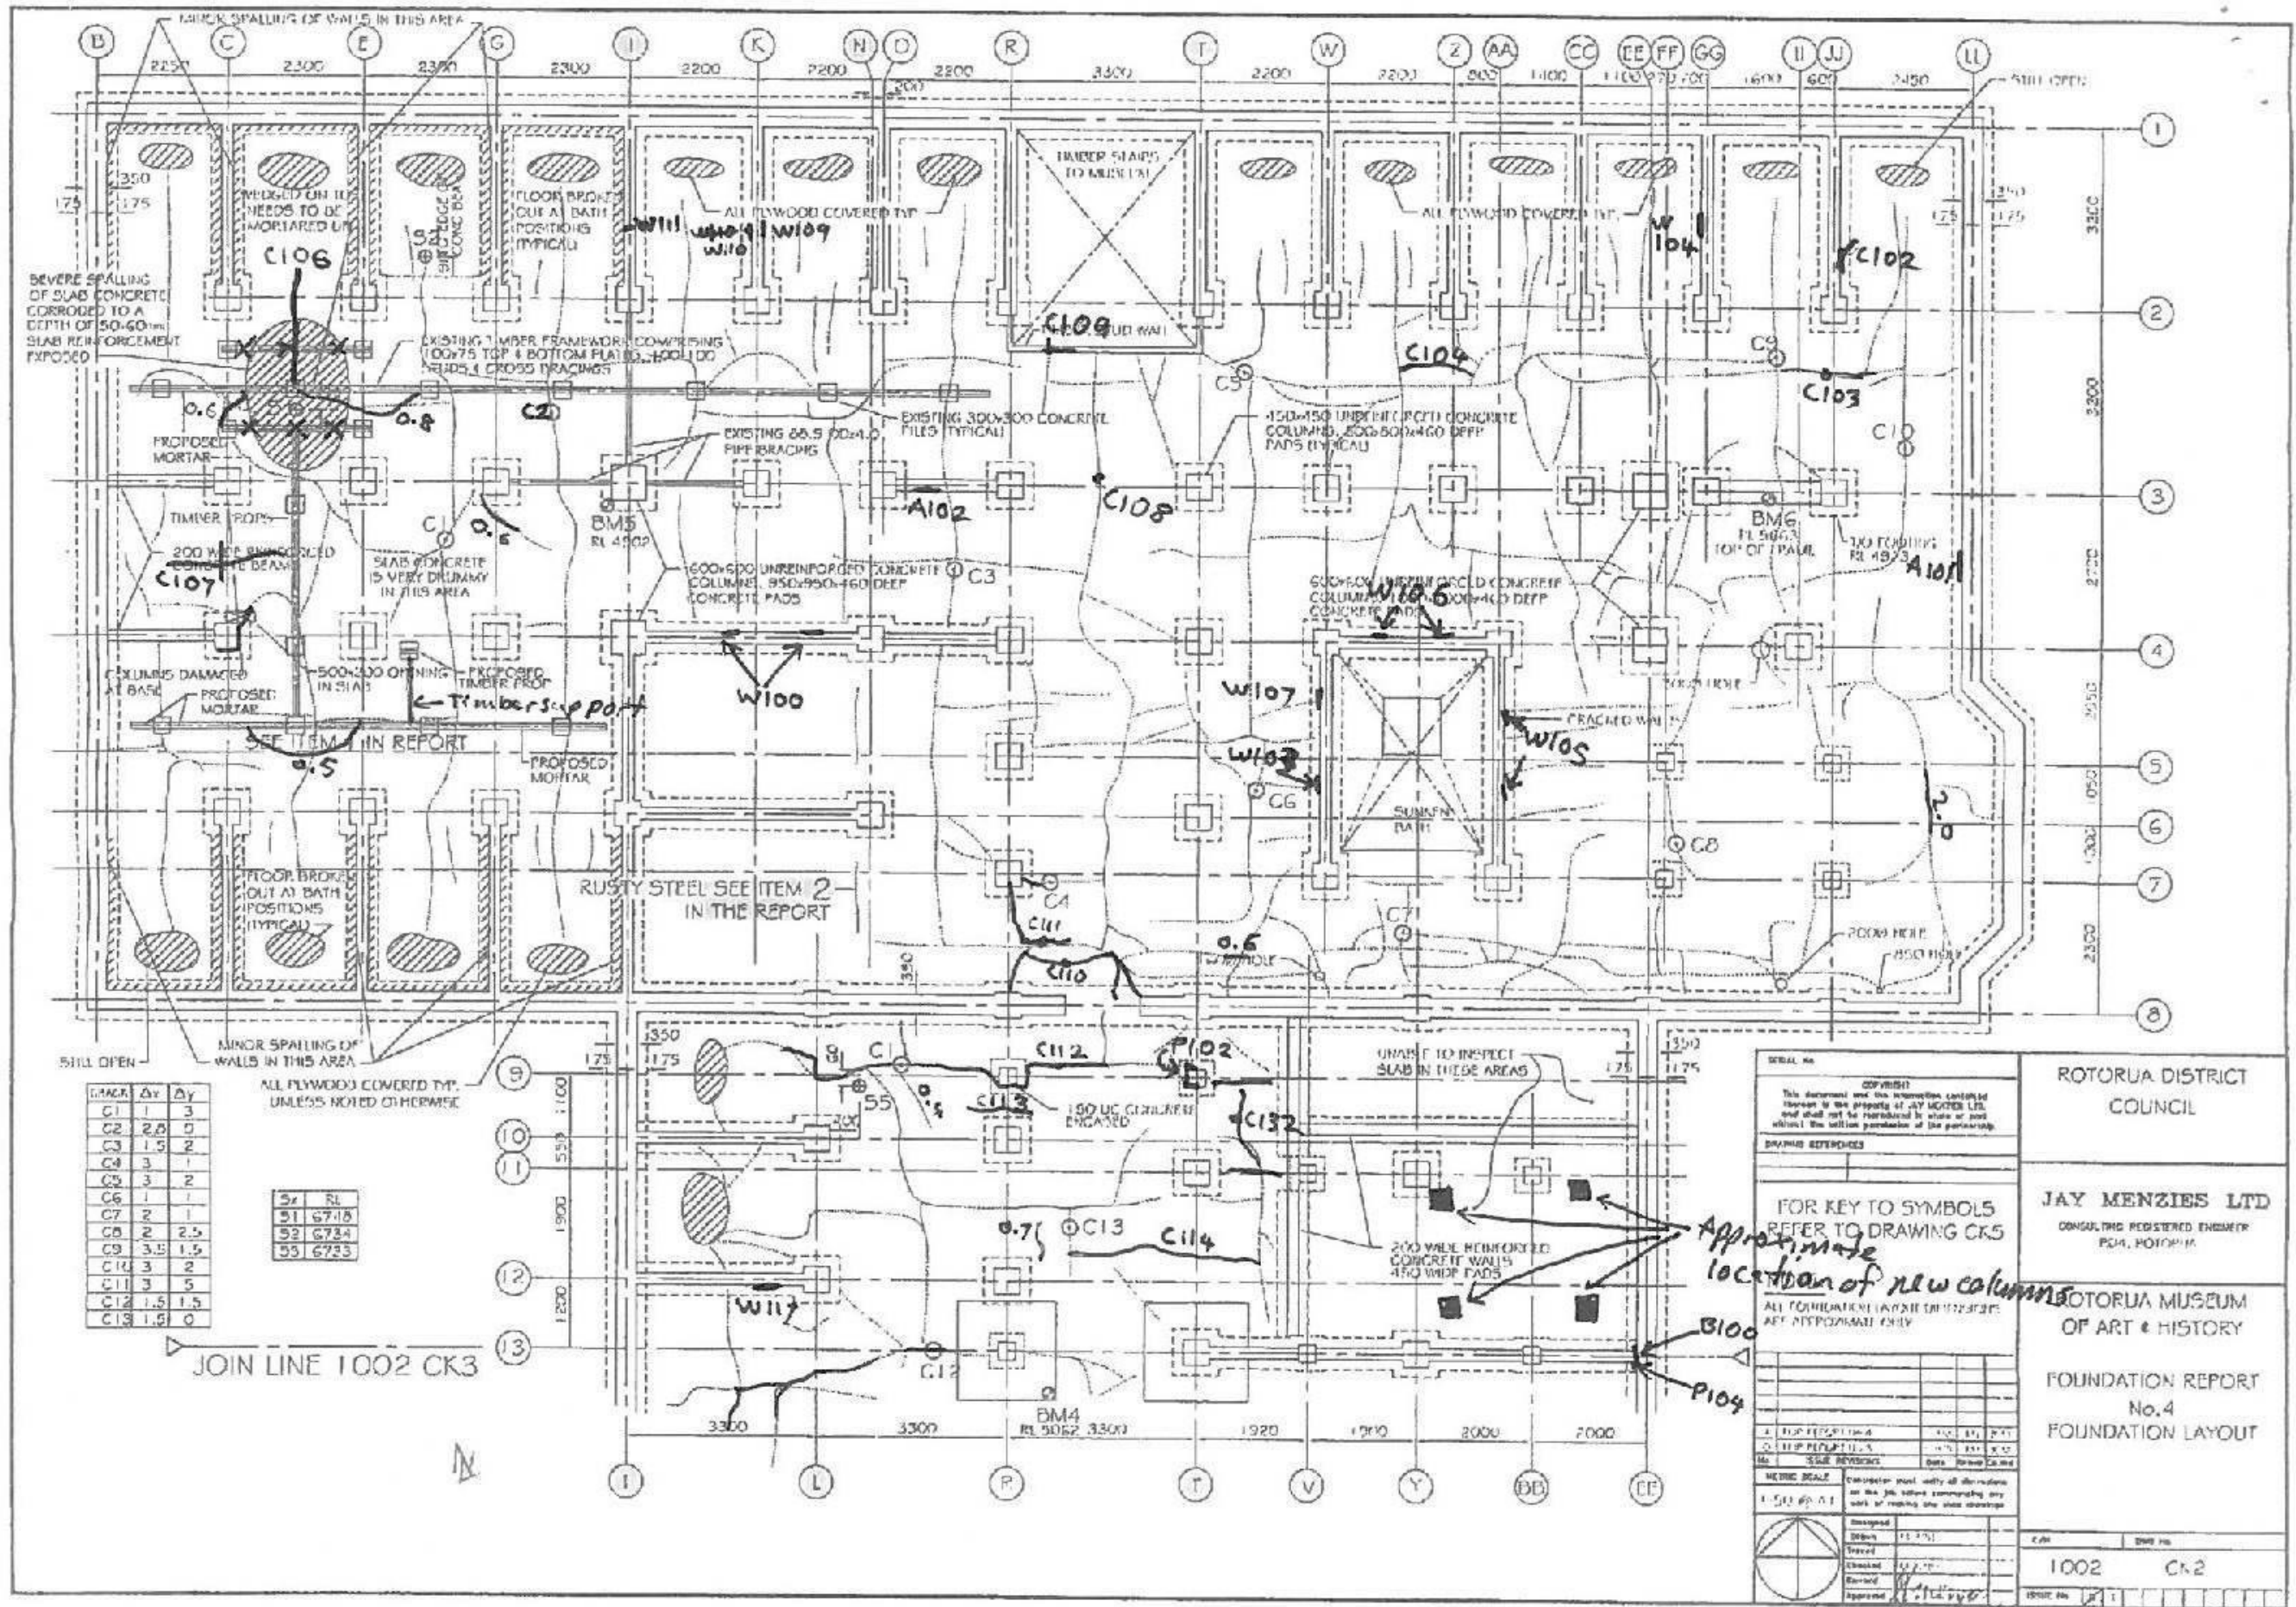
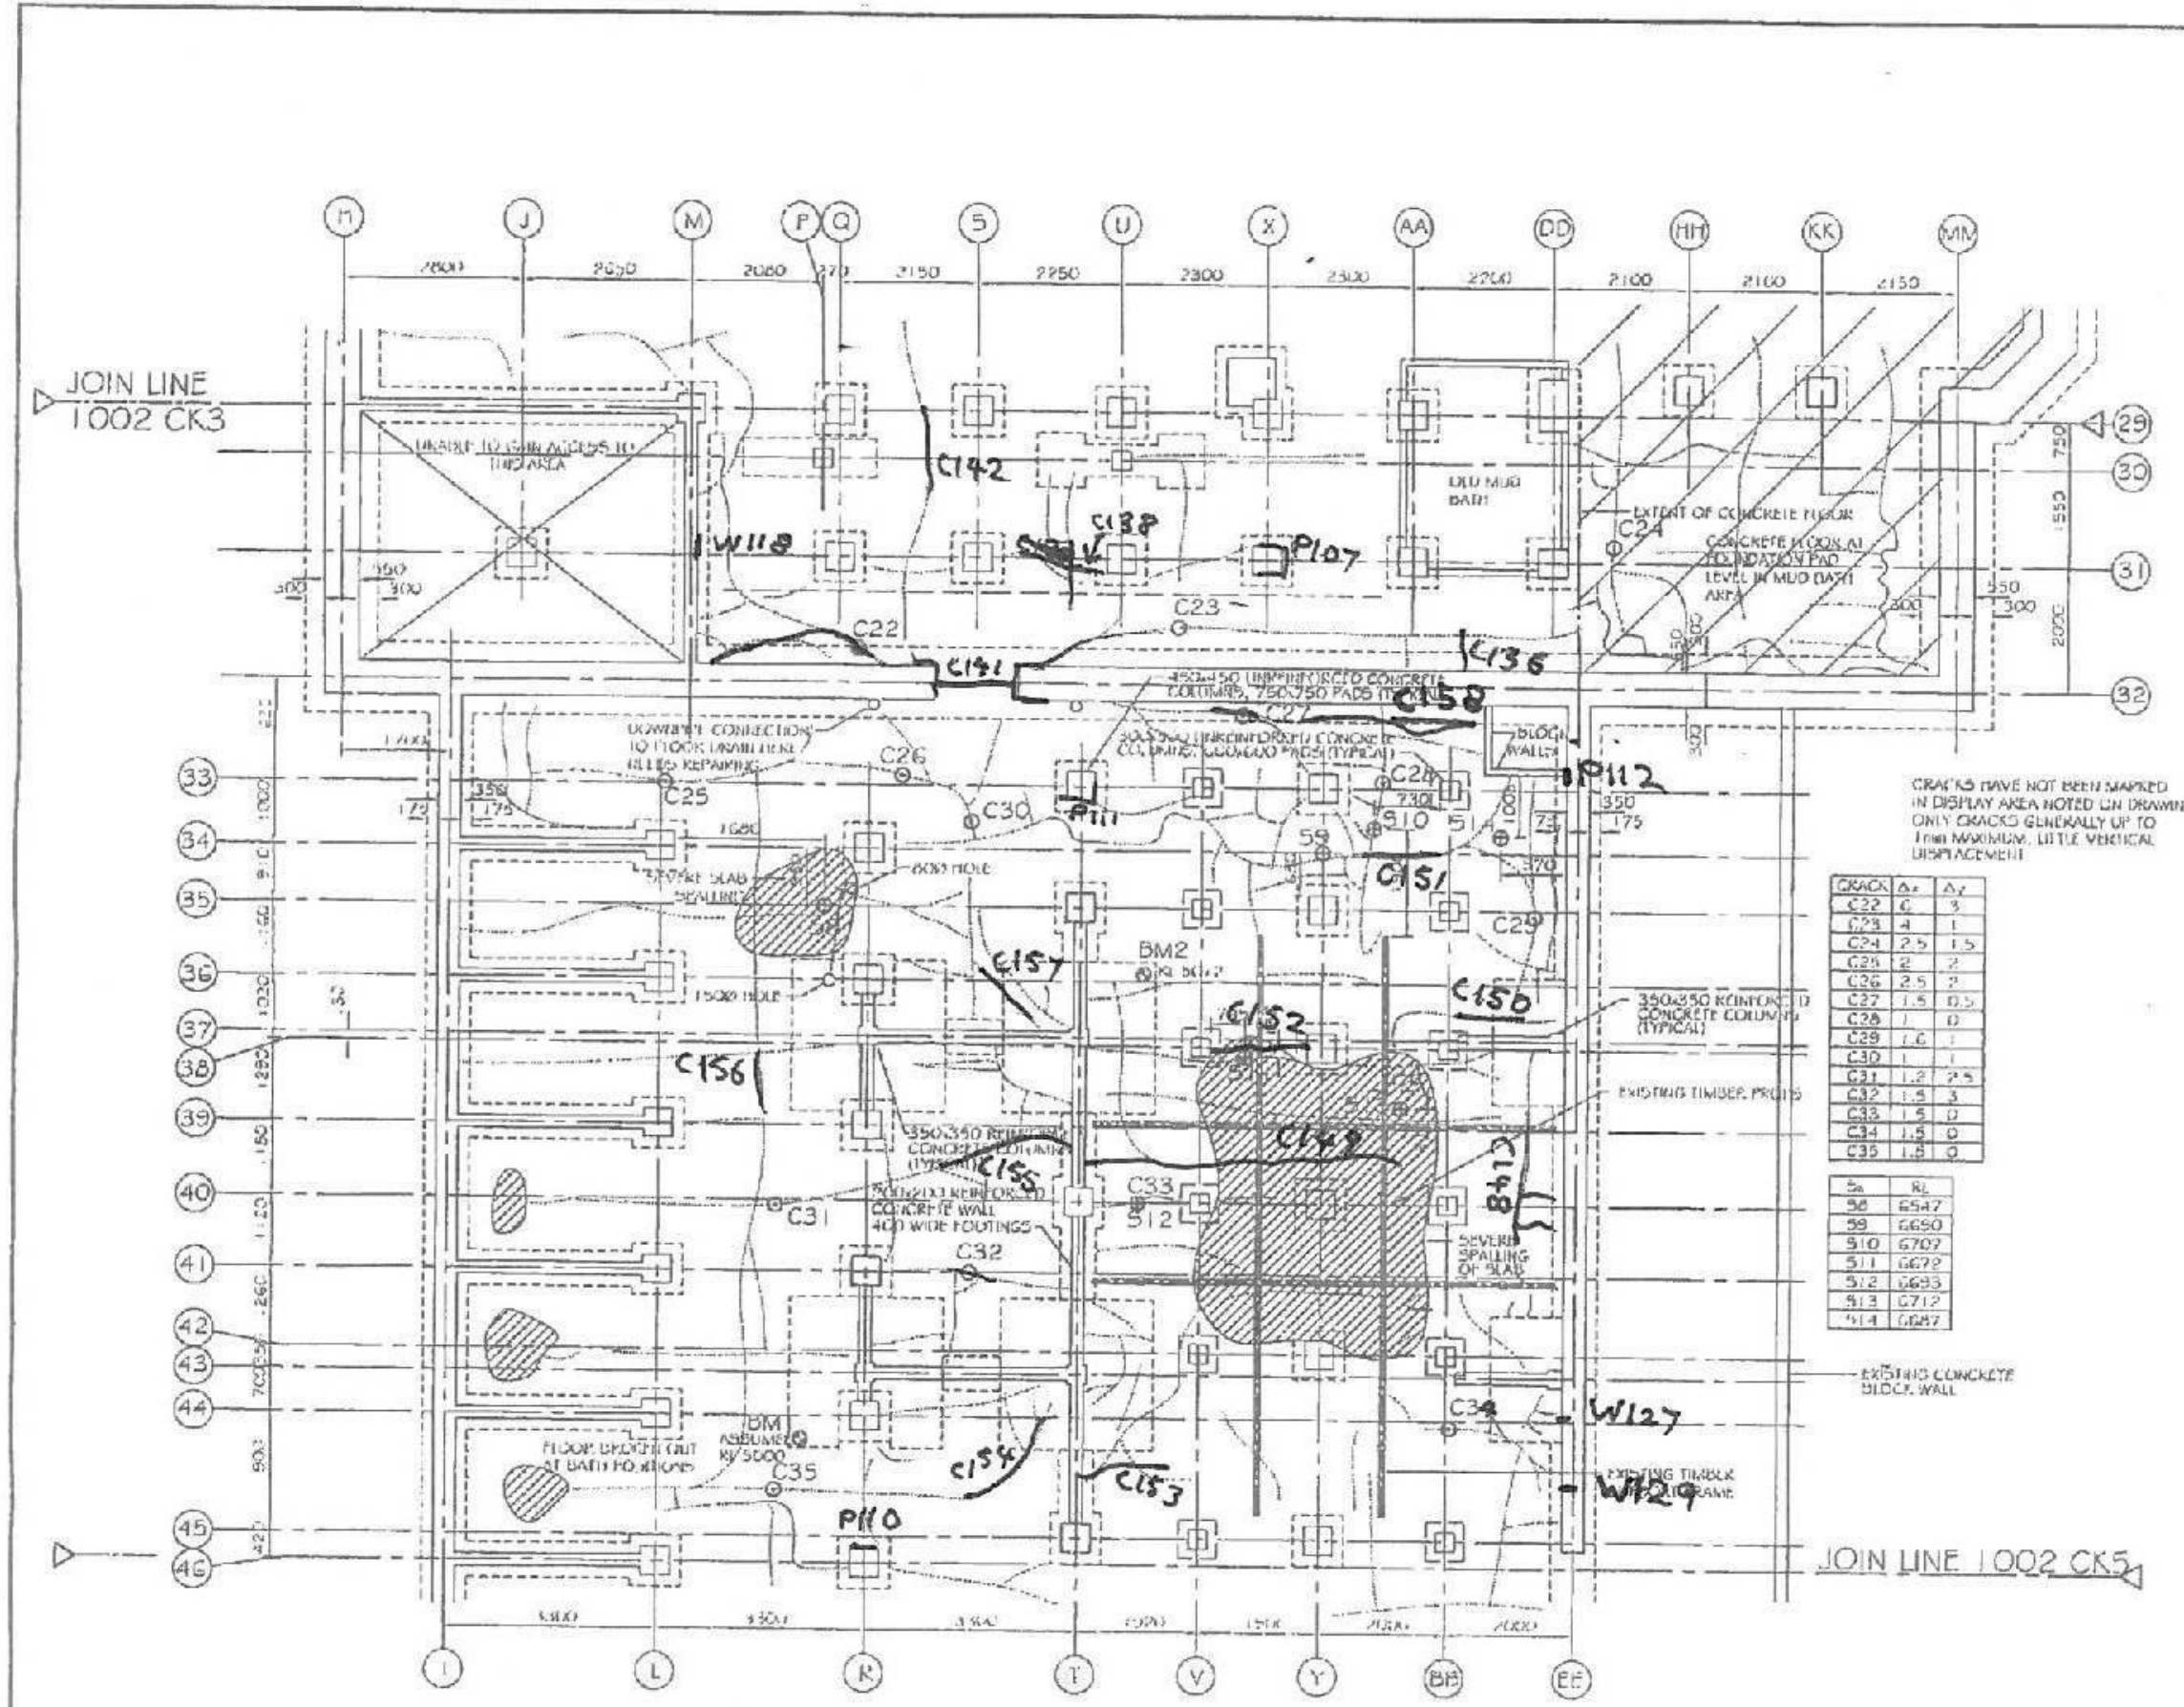
Appendix A: Map of cracks in 1906 built Basement at 6th December 2016

All cracks in the 1906 built basement (central section) only have been observed and documented, including width, length, location, settlement and spalling at the time of inspections. Areas found with noticeable and major cracks are listed below. The north-eastern bath area has multiple significant (greater than 3mm wide) cracks in the ceiling, some with settlement greater than 2mm. Under the cinema, where additional columns and beams have been constructed recently, a large opening has been left for services by the east wall, resulting in minor cracking in the new concrete beam. The fountain has two deep cracks greater than 3mm through it. A major 6 to 8mm crack over the opening between the central and intermediate-south sections has been discovered that is likely to not have been observed and recorded before. A significant 5mm crack was observed in the north-east corner of the intermediate-south section wall. Multiple cracks that are greater than 3mm in the south-east corner of the intermediate-south section. It should be noted that most holes drilled for services have developed cracks propagating away from them. The nature of this concrete is that it is a lightweight pumice concrete, with no large aggregate pieces. This means cracks that are larger than 3mm are likely to have little or no friction and resistance to movement usually resisted by large aggregate particles.

More than half of the original columns have sulphide corrosion at the base of the column greater than 50mm in depth. This sulphide corrosion leads to a brittle and spalling concrete, which is also seen in many areas on the ceiling. In some places this has been covered recently to prevent further corrosion by spray-on concrete.

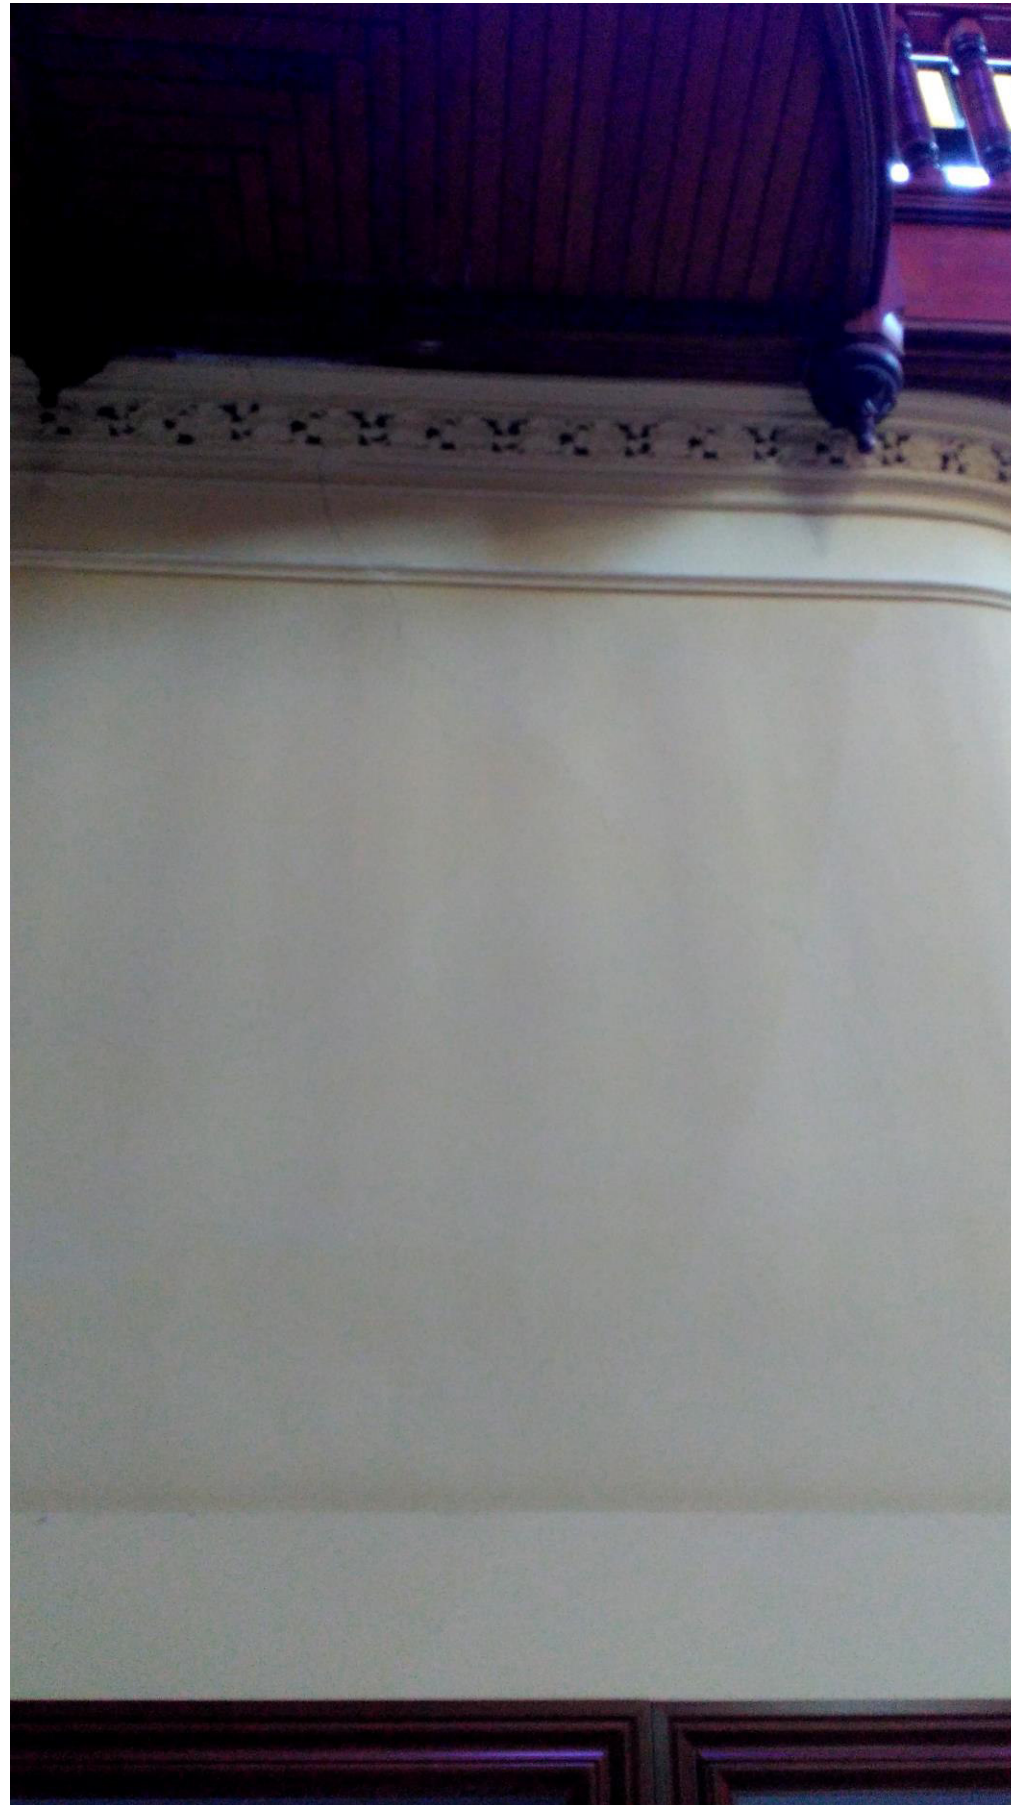
Appendix C: Photo of Crack in foyer of Museum, observed 13/12/2016

Museum staff noticed cracks appear and widen in the foyer area on the ground floor. GDC staff also noticed one crack in the foyer widen by approximately 1mm during the three weeks of investigation at the museum. This crack is shown in Appendix C.
