## **Rotorua Lakes Council**

Museum, Government Gardens, Oruawhata Drive, Rotorua

Geotechnical Interpretative Report

16592  
19 May 2017

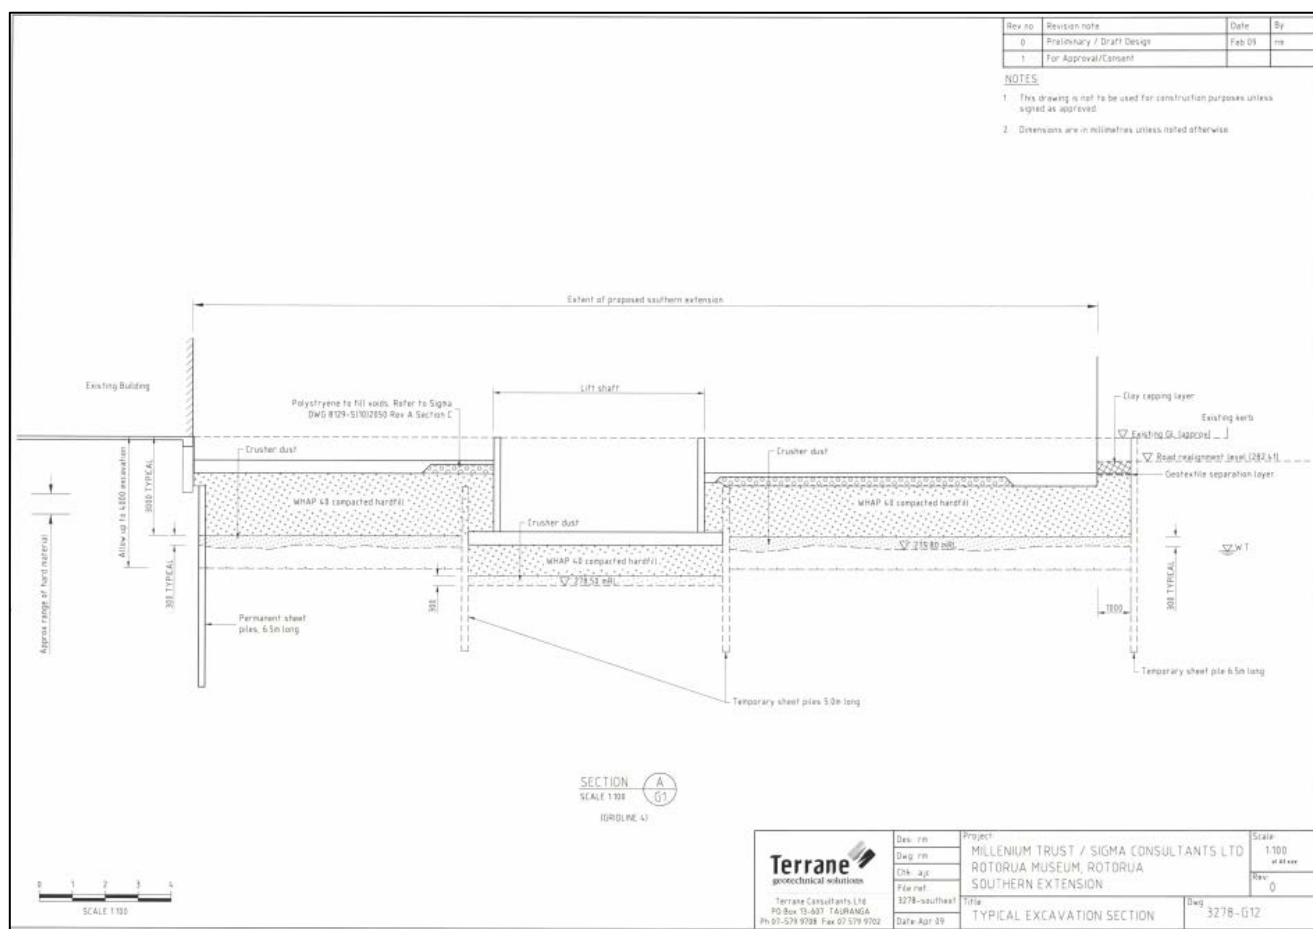
Figure 4: Typical excavation section, Dwg 3278-G12, Terrane, April 2009

From review of the above reports, we understand that the south extension is founded on cellular foundation/concrete slab with soil replacement up to 2.2m below basement level, 0.8m below lift shafts and 1.0m from the edge of the building. This approximately corresponds with 4.5m below existing ground level around the South Wing Extension. The soil replacement consists of WHAP 40 compacted hardfill underlain by thin layer (typically 300mm) of crusher dust. A gas venting system and gas membrane with geotextile separator were installed directly below foundation slab. Typical excavation sections presented in Terrane report from April 2009 listed above is show in the following Figure 4.

No as-built records or testing of the excavation during construction is available.

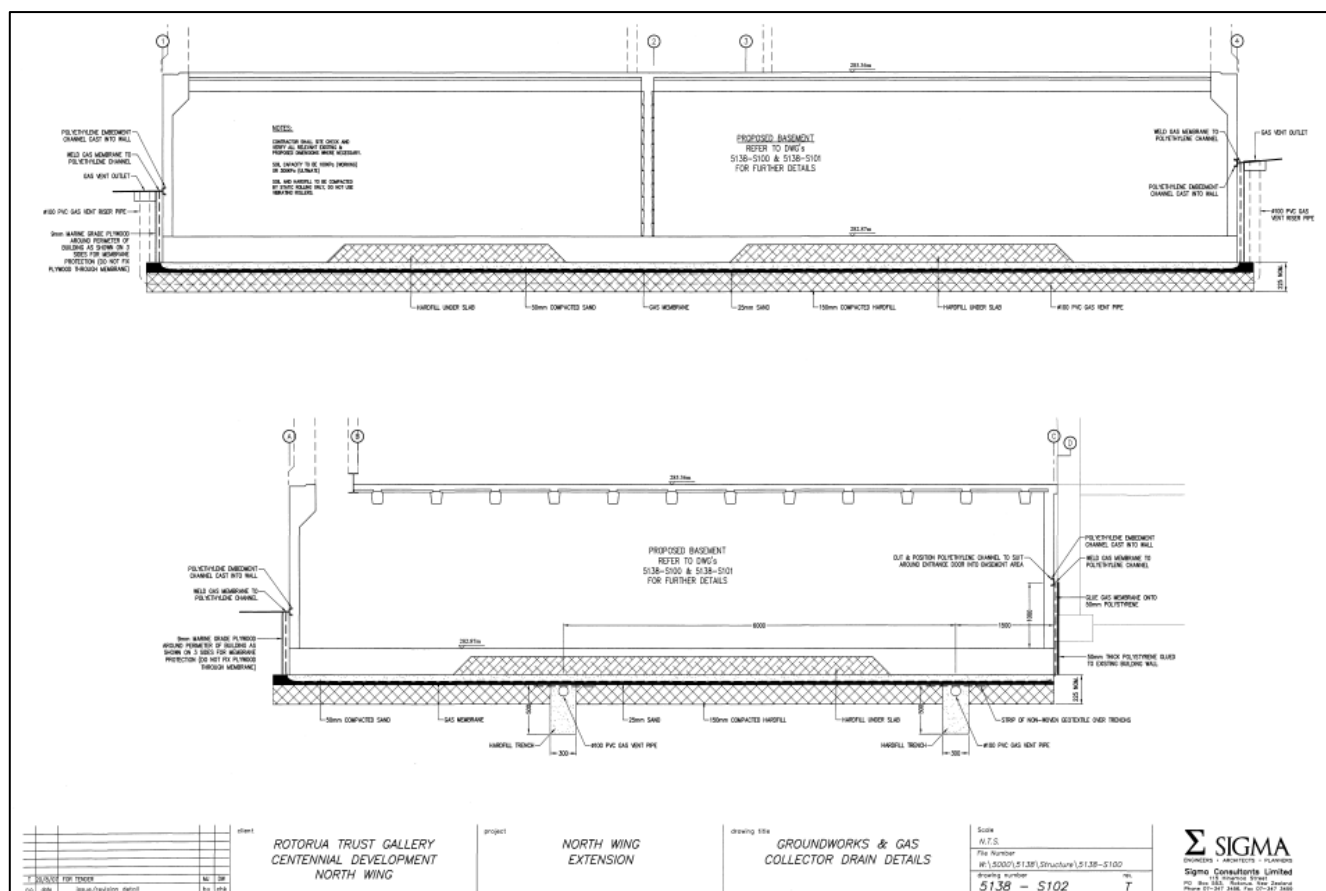
Figure 5: Sigma (2007), Groundworks & Gas collector drain details, Drawing no 5138-S102, Rev T

The report states that the ground conditions below the proposed North Wing Extension are significantly better than below South Wing Extensions. We understand that the North Wing Extension was founded on cellular foundation with shallow ground replacements consisting of 150mm of compacted hardfill. Based on available information the excavation level including soil replacement was approximately 1.5m below ground level. As below South Wing Extension, a gas venting system and gas membrane with geotextile separator were designed to be directly below the foundation slab. Typical foundation detail is show in the following Figure 5.

No as-built records or testing of the excavation during construction is available.
