DETAILED SEISMIC ASSESSMENT & CONCEPT RETROFIT REPORT

## ROTORUA MUSEUM

GOVERNMENT GARDENS ORUAWHATA DRIVE, ROTORUA

February 2022

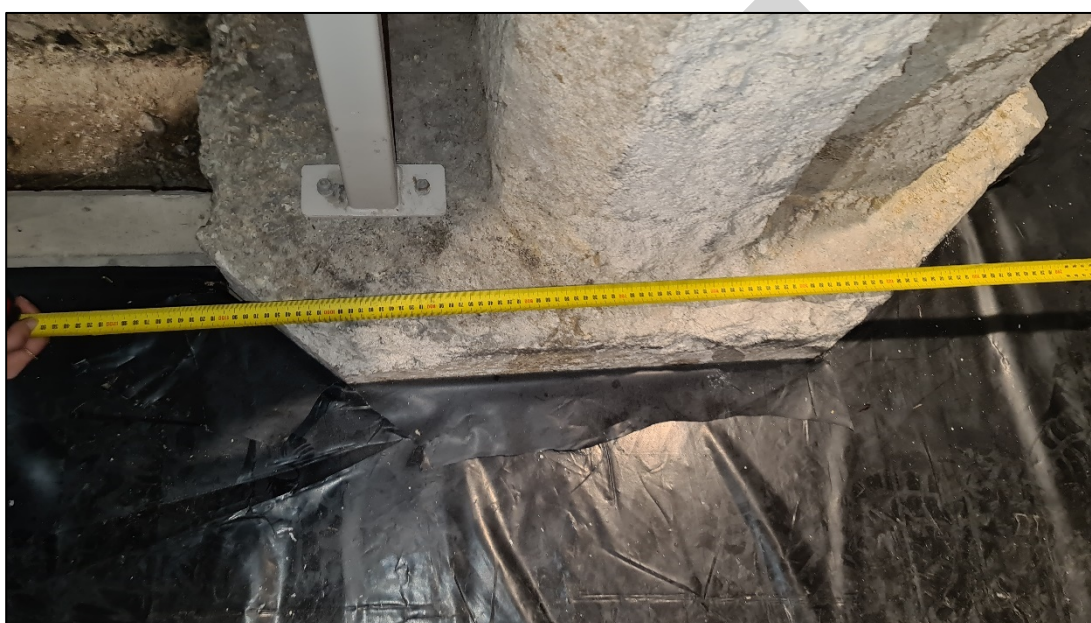
(g) Cracking of concrete at east end of basement – upward movement of ground

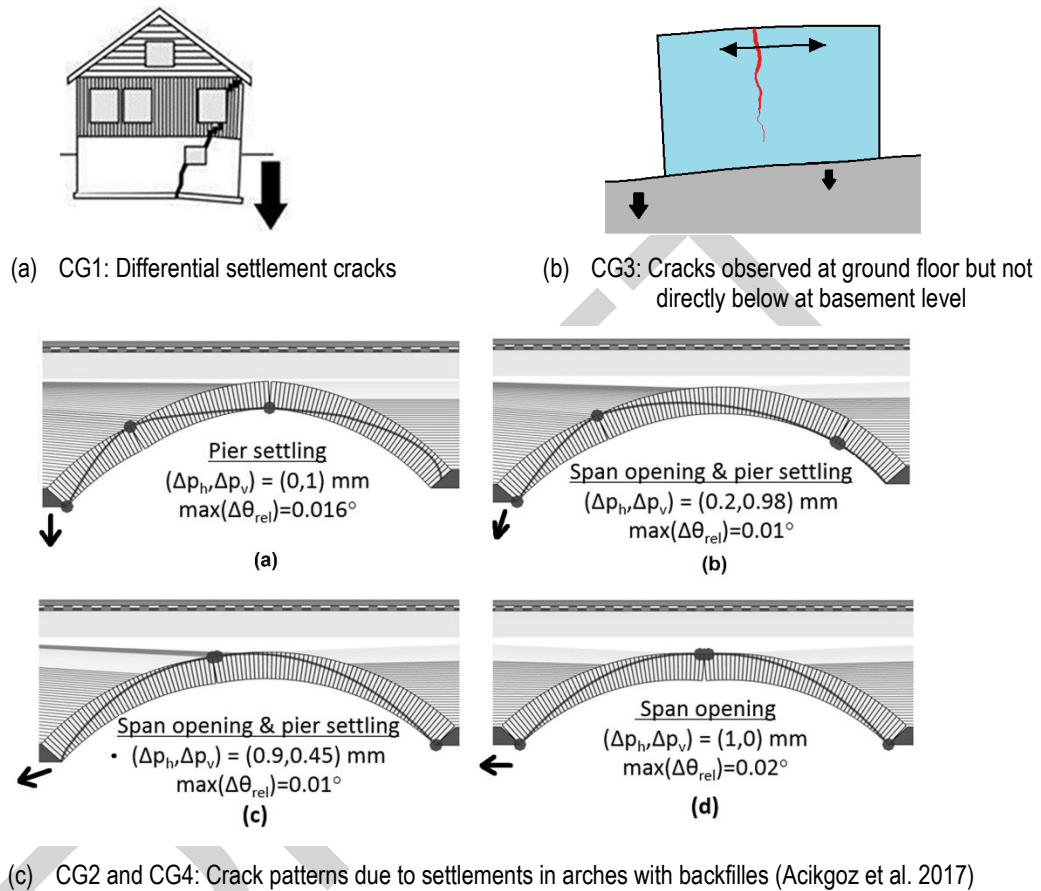
**Figure 5-6.** Summary of possible cracking mechanisms observed

**CG4:** Differential settlements between columns and possible horizontal displacement may result in cracking mechanisms described by schematics (c) and (d) of **Figure 5-6c**.

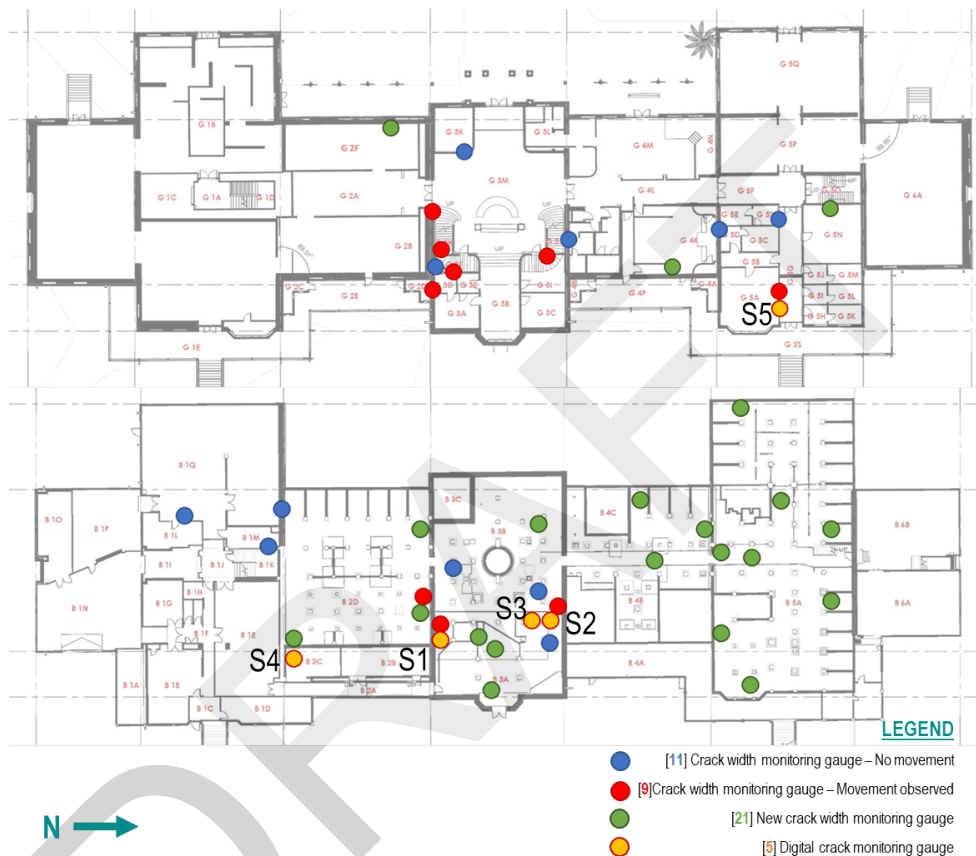
**Figure 5-11.** Crack gauge locations with identification of gauges that have exhibited movement (note: data is from Nov 2021, does not consider movement observations for new plaster gauges (green) installed during Nov 2021, nor for the digital ones (yellow))

The observations made with respect to the plaster crack monitoring gauges installed in May and November 2021 were sufficient for the purpose of providing evidence of movement and, in turn, a high-level estimate of rate of movement. Considering the relatively short timeframe in which movement was identified following the installation of the first set of plaster gauges in May 2021 (approx. 5 weeks), a more robust crack monitoring system composed of displacement transducers connected to a fully automated acquisition system was installed in the structure on the 17 December 2021. 5 digital gauges were installed in the building, the locations of which are provided in [Figure 5-10](#).

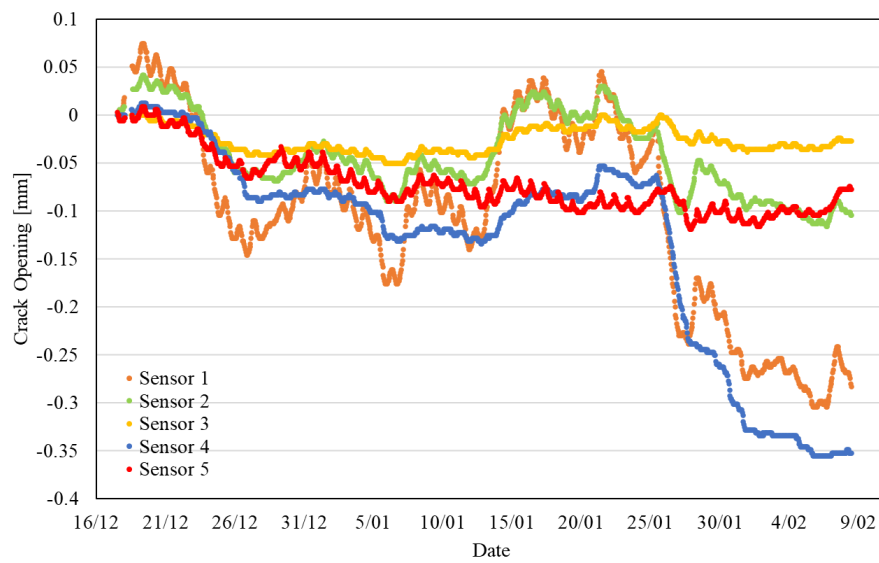
**Figure 5-12.** Data obtained over a period of 8 weeks from digital gauges installed at crack locations within building (recorded December 2021 – February 2022)

Continual monitoring over a period of eight weeks (see [Figure 5-11](#)) has shown daily cycles of expansion and contraction of approx. 0.01mm. With regard to cracks opening, it was observed that all the sensors installed experienced fluctuations in movement of between 0.1mm and 0.15mm of movement per month, which was similar to the estimates made using the plaster gauges. Sensor S2, corresponding to the connection between the Zone 3 north wall (A5 wall) and the vaulted floor, showed a monthly opening and closing of approx. 0.1mm. Sensor S5, corresponding to a crack located in Zone 5, appeared to be opening at a steady rate of approx. 0.1mm per month, also in line with observations regarding plaster gauges.

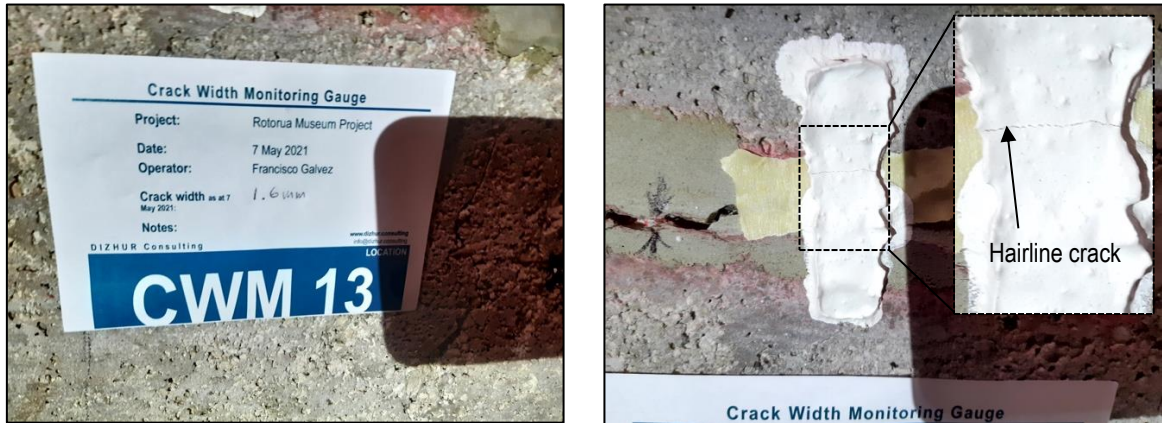
(d) CWM 13 – hairline crack (&lt;0.1mm) identified

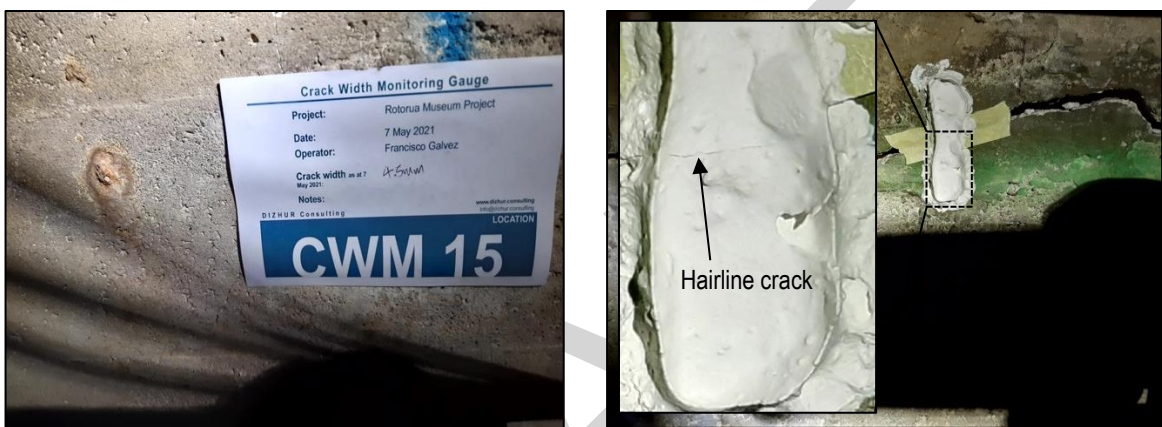
(e) CWM 15 – hairline crack (&lt;0.1mm) identified

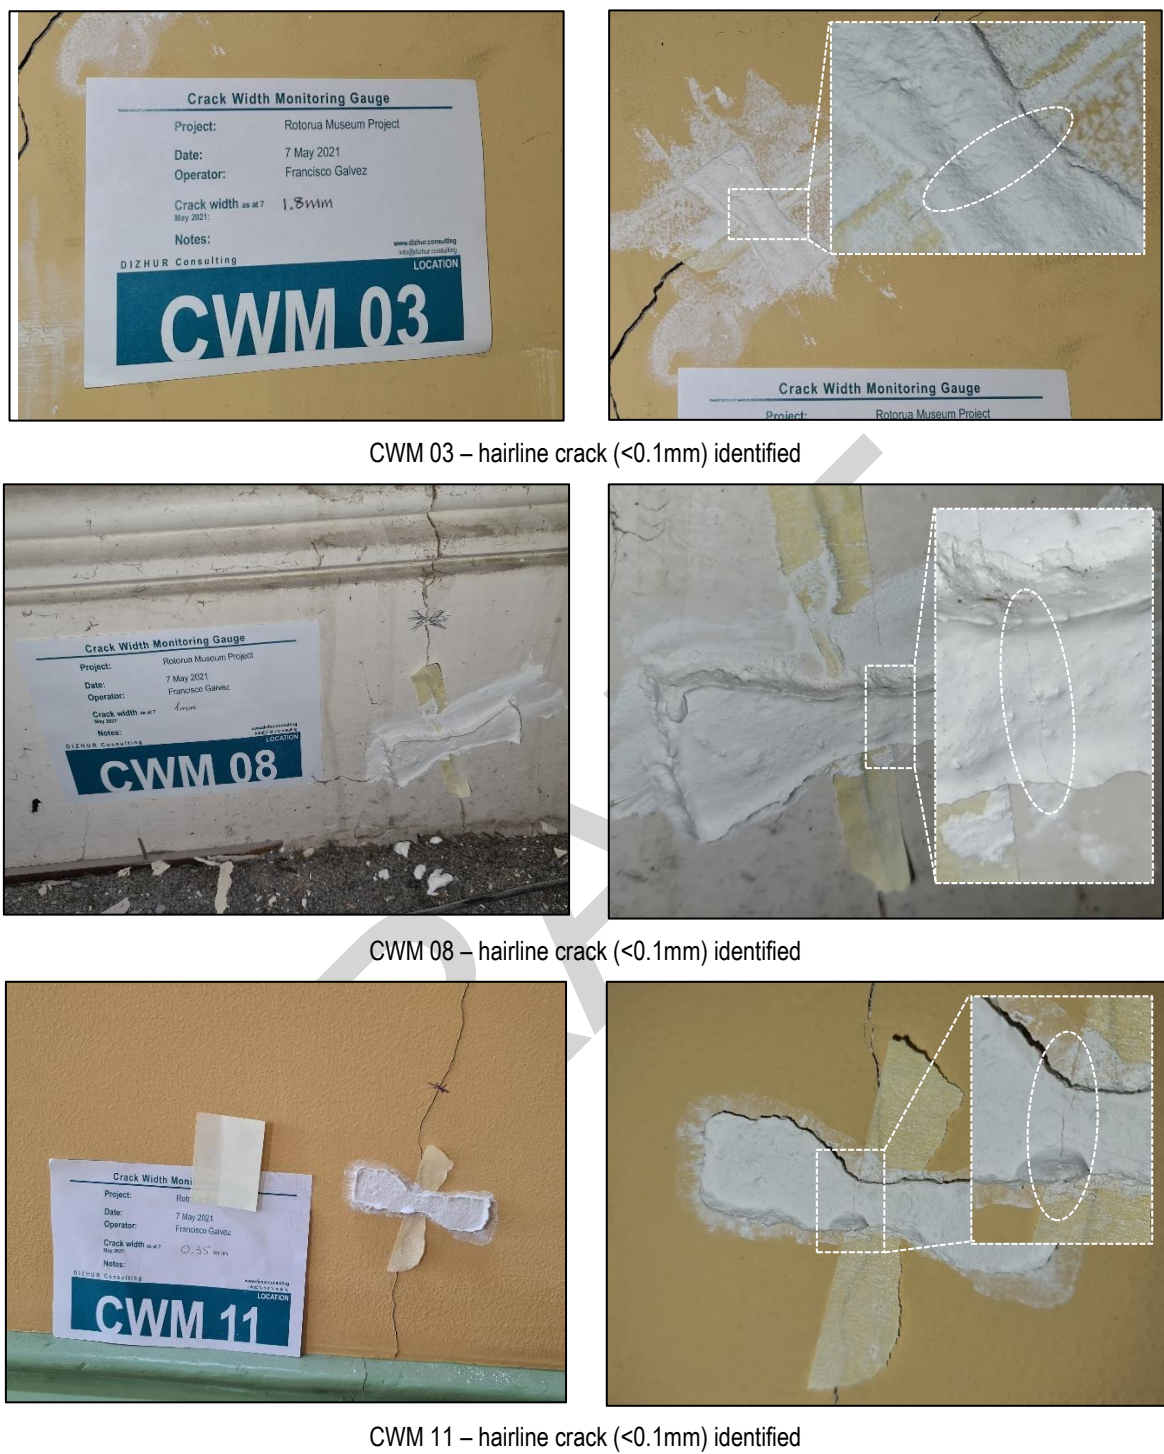
CWM 03 – hairline crack (<0.1mm) identified

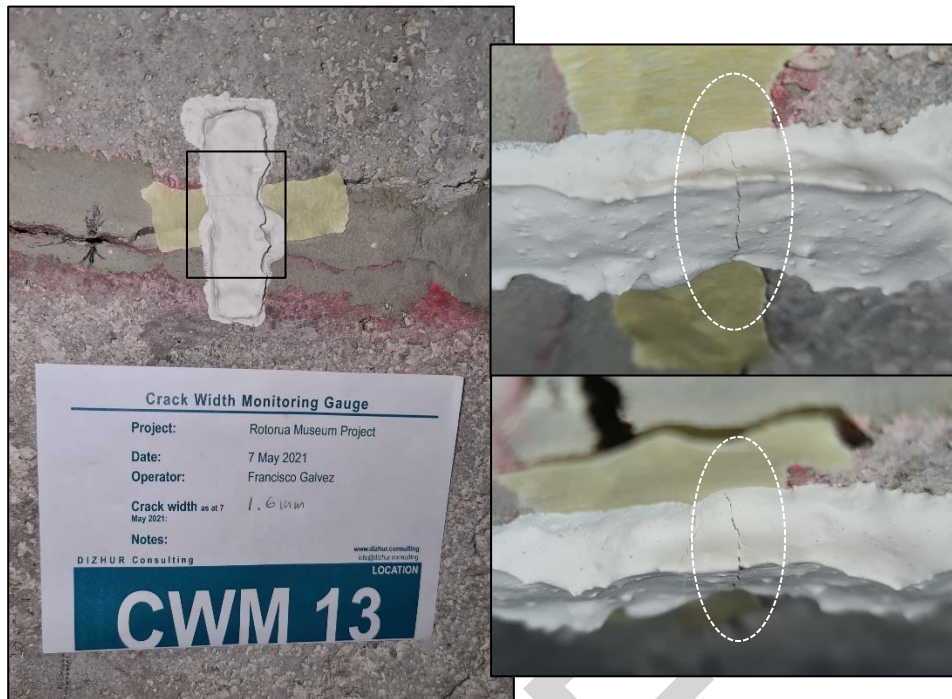
CWM 13 – hairline crack + vertical displacement – as per previous measurement

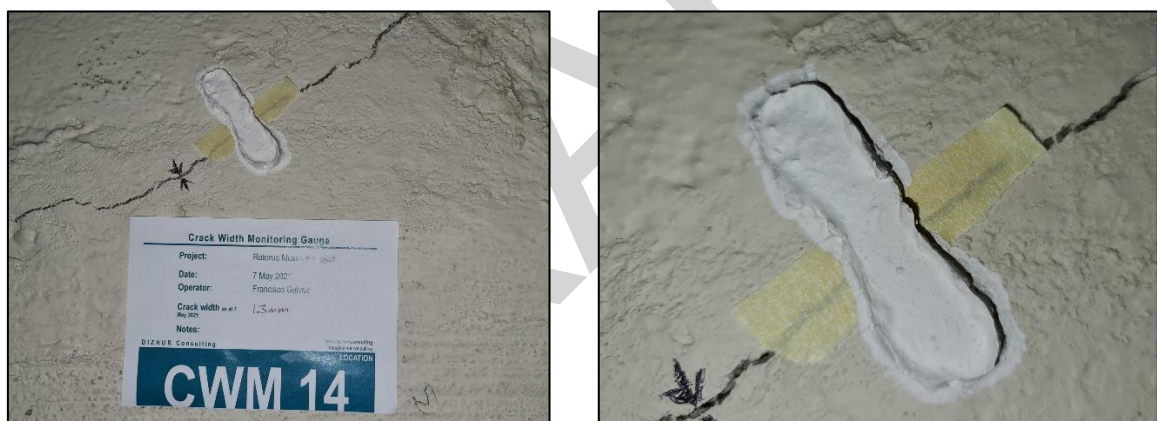
CWM 14 – no movement identified

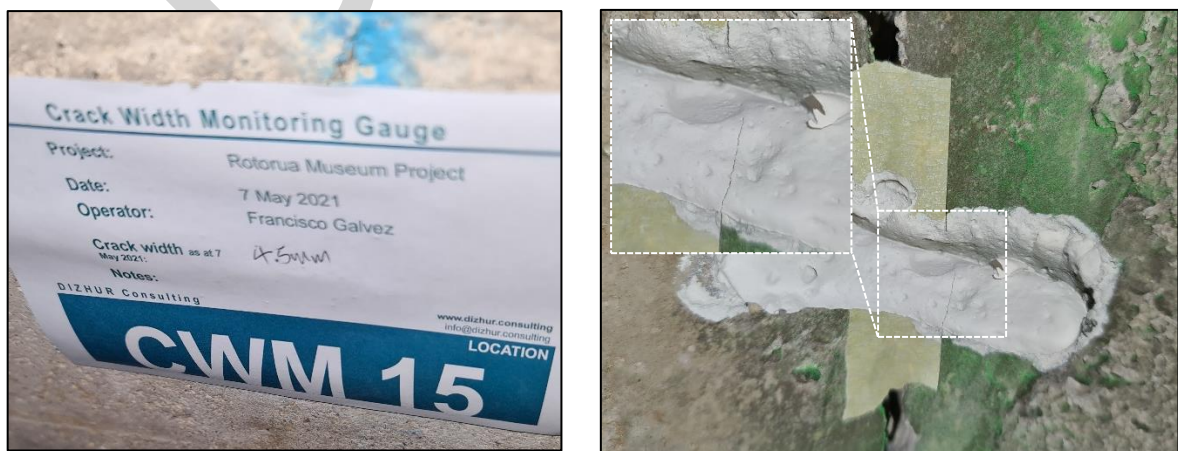
CWM 15 – hairline crack (&lt;0.1mm) – as per previous measurement
