## **Te Whare Taonga o Te Arawa - Rotorua Museum Geothermal Investigation in the Building's South Wing**

### **1 Introduction and background**

### 3 CCTV inspection of the vent pipes

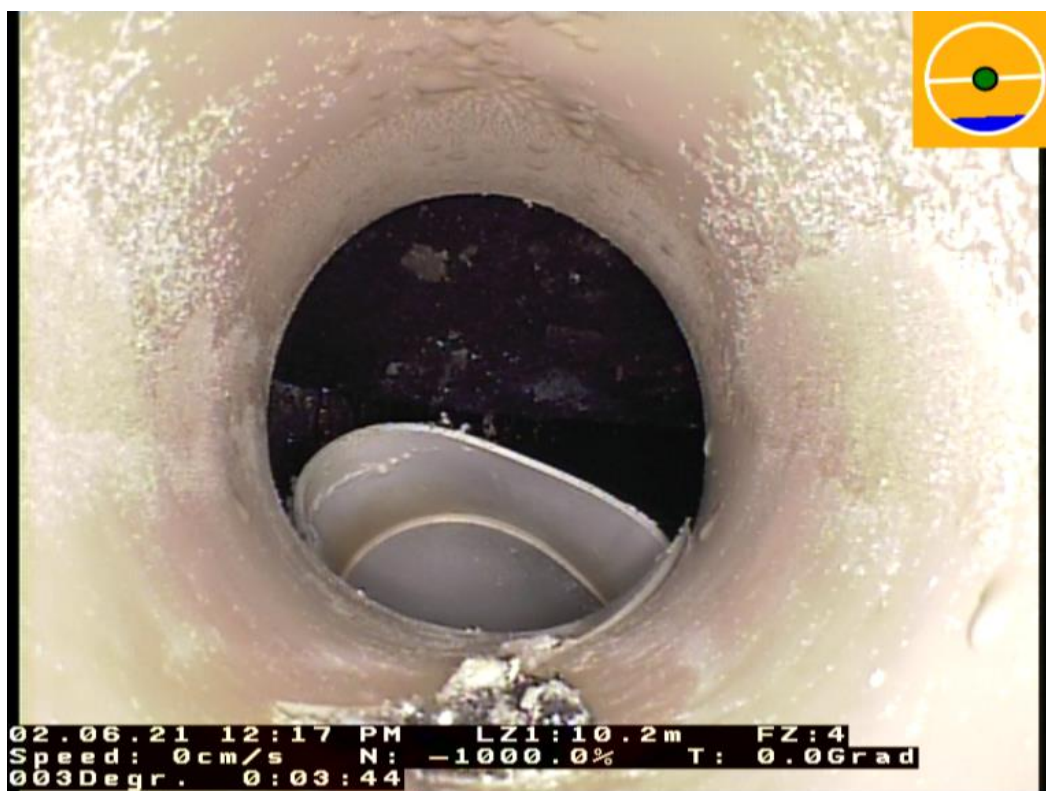
In Line V12, a small gap appears at the disjointed location, separating the western section of the pipe from the eastern section of the pipe (the vent outlet portion). The section of the pipe to the west of (beyond) the disjointed location also appears to no longer be aligned with the eastern section of the pipe. A portion of what appears to be a black sheet (possibly the gas membrane) could also be seen above the gap. Figure 3.1 and Figure 3.2 provide photographs of the disjointed pipe section in Line V12.

Figure 3.1: Disjointed pipe section in Line V12

- 2 The location of the gap in Line V12 appears to coincide with the area where the elevated temperature is currently experienced in the building's south wing. However, with the information we have available to date, there is not enough evidence to suggest that the gap is the cause of the elevated temperature in the building. The gap may have caused a movement to the gas membrane somewhere, which potentially may lead to the slab being exposed to the ground and the heat. However, to investigate this, the gas membrane will need to be exposed so it can be inspected (i.e. requires removal of the concrete slab). This may not be practical and is likely to attract high cost.

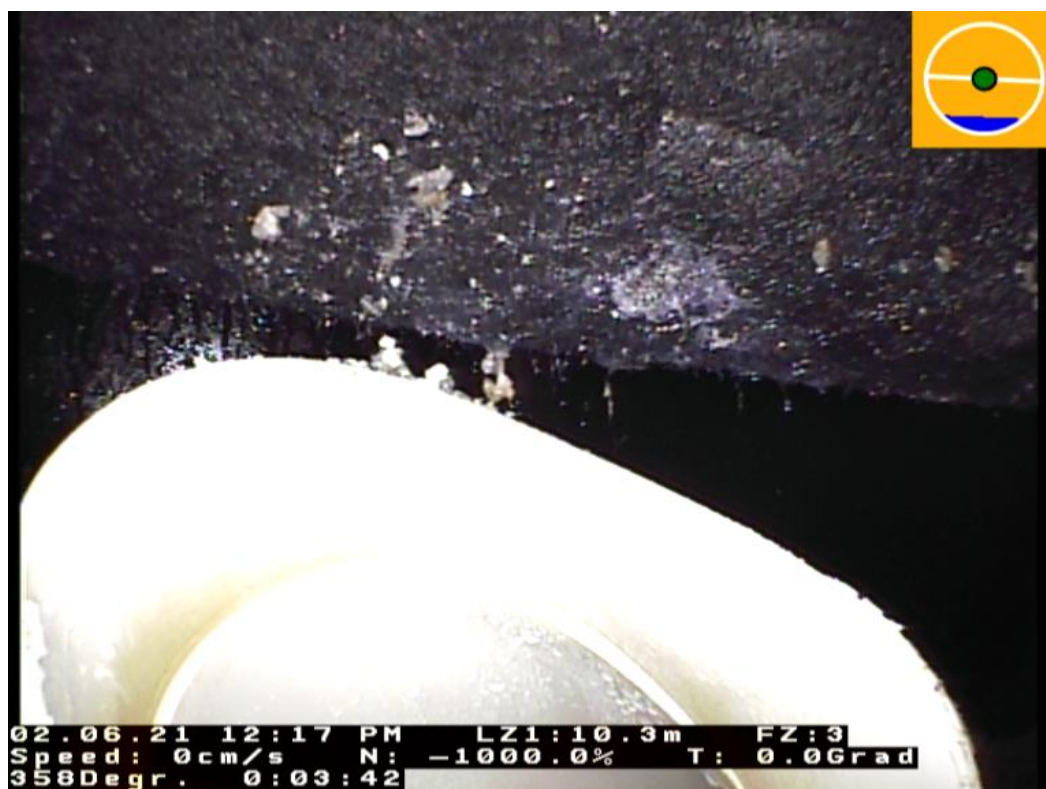
Figure 3.2: Exposed black sheet (possibly the gas membrane) above the gap at the location of the disjointed pipe section in Line V12

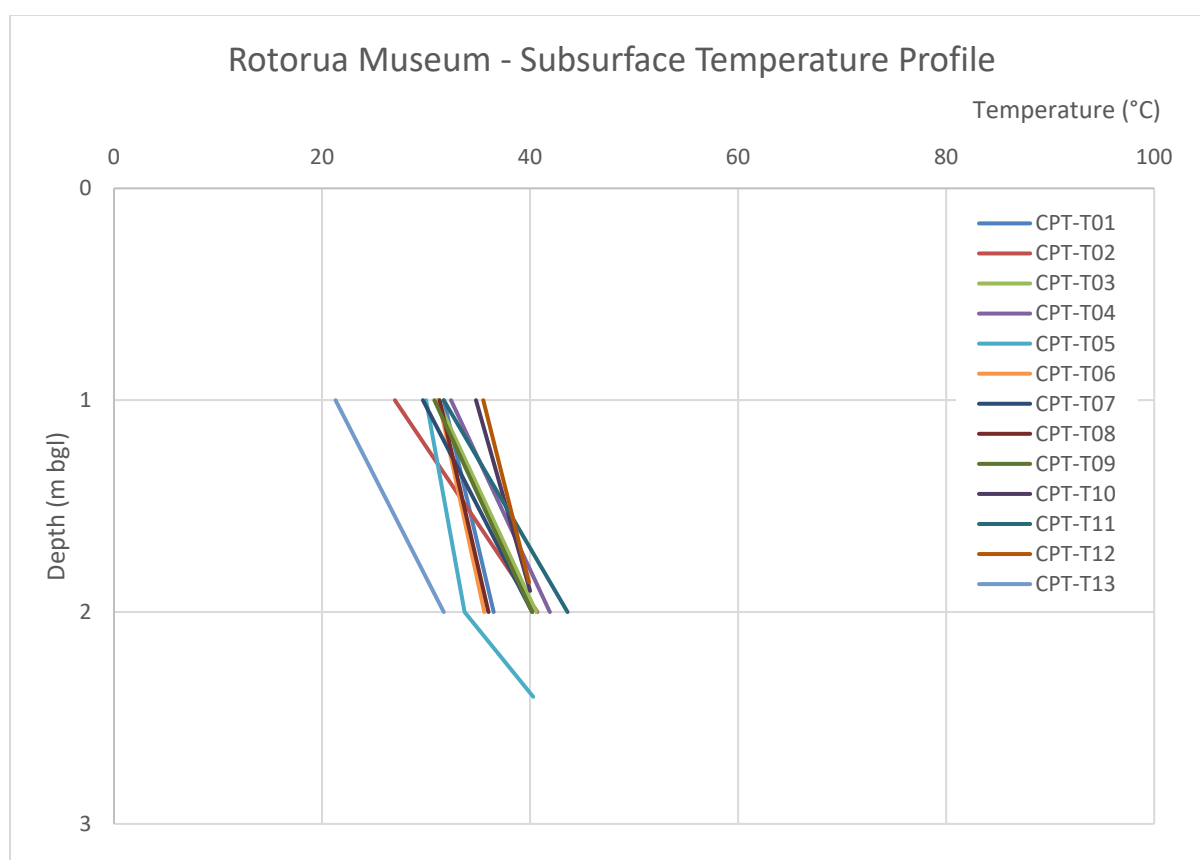
Figure 4.1: Subsurface temperature profile from 30 June 2021 CPT investigation

- 1 From the 30 June 2021 subsurface temperature readings, the temperatures within the upper 2 m of the ground across the eastern carpark area of the museum appear to be relatively uniform and are not significantly different to the ground temperature readings reported in the Terrane Consultants' report<sup>1</sup> from December 2007. Figure 5.1 provides superimposed plots comparing the temperature readings from Terrane Consultants December 2007 report and the subsurface temperature readings undertaken on 30 June 2021. This evidence suggests that currently the level of geothermal activity in the ground appears to be similar to the level that has been experienced in the past (prior to the incident in April 2020). This may be the typical subsurface temperature for the area.

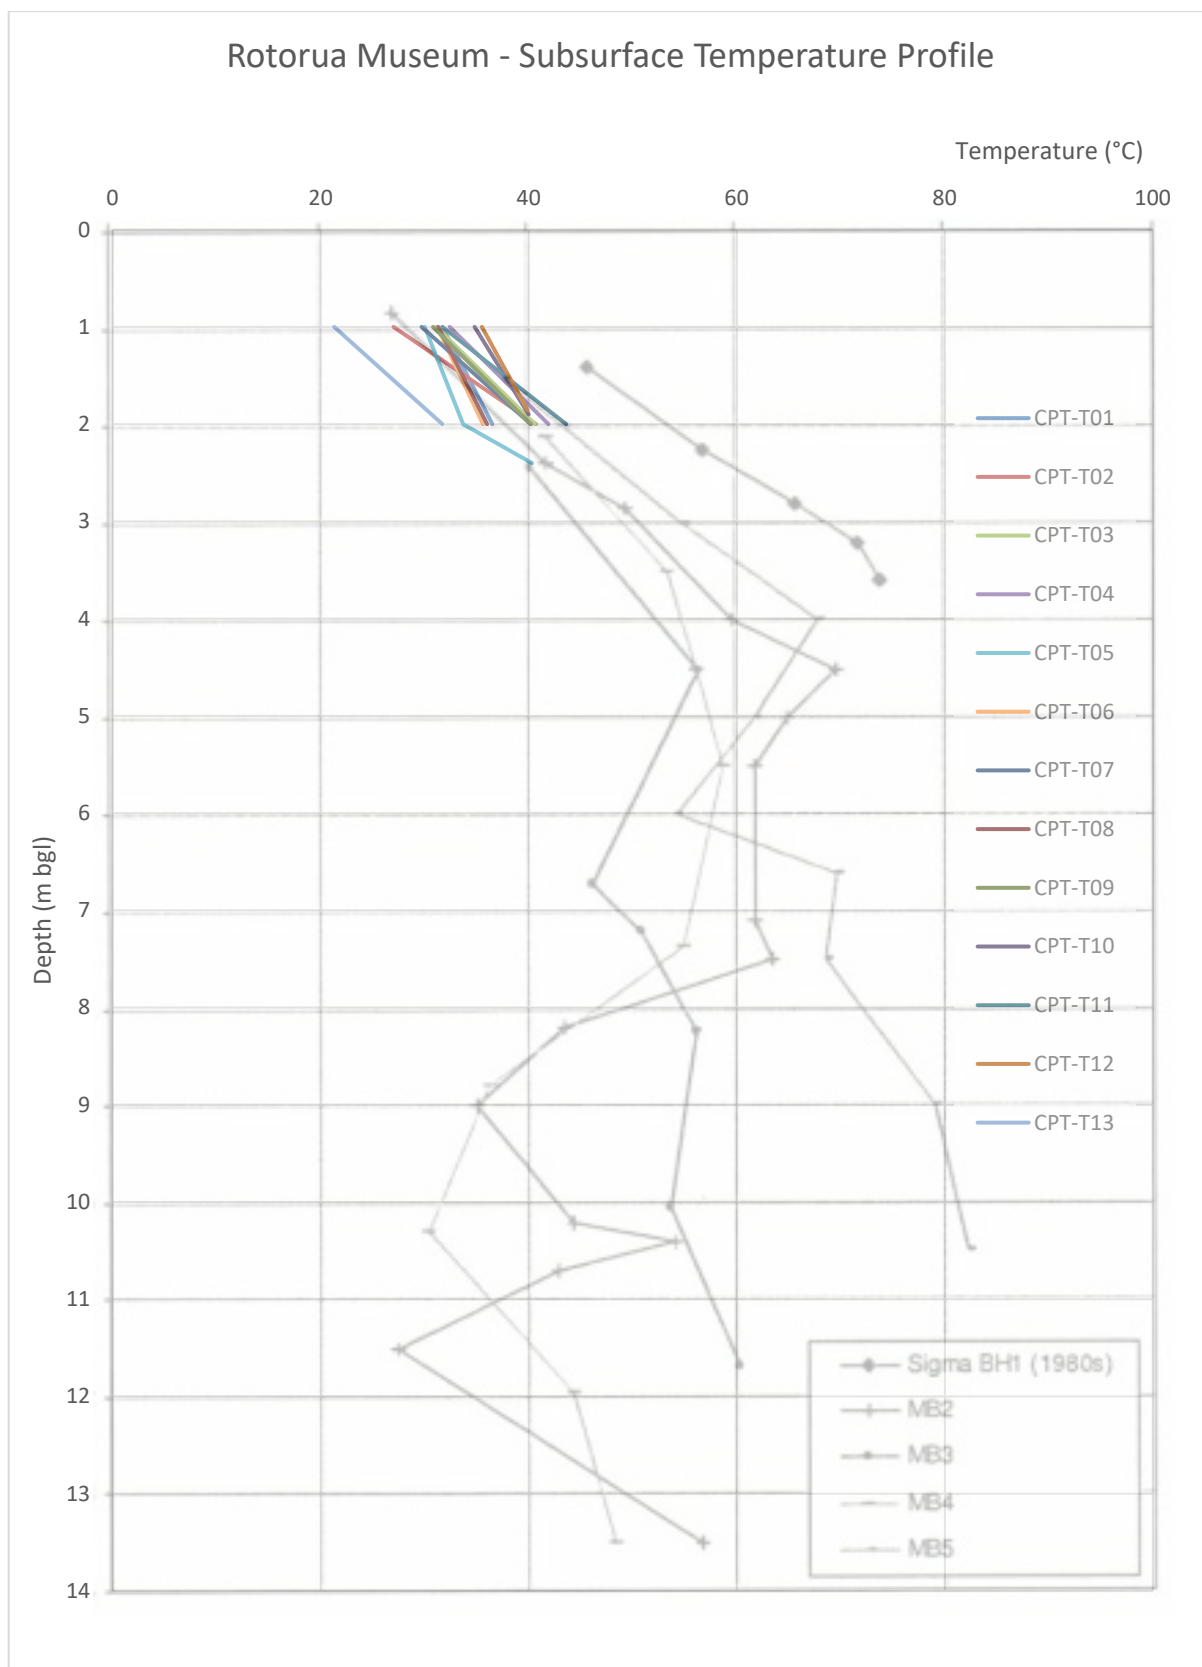
*Figure 5.1: Comparisons between the ground temperature readings from Terrane Consultants December 2007 report (black lines) and the subsurface temperature readings undertaken on 30 June 2021 (coloured lines)*

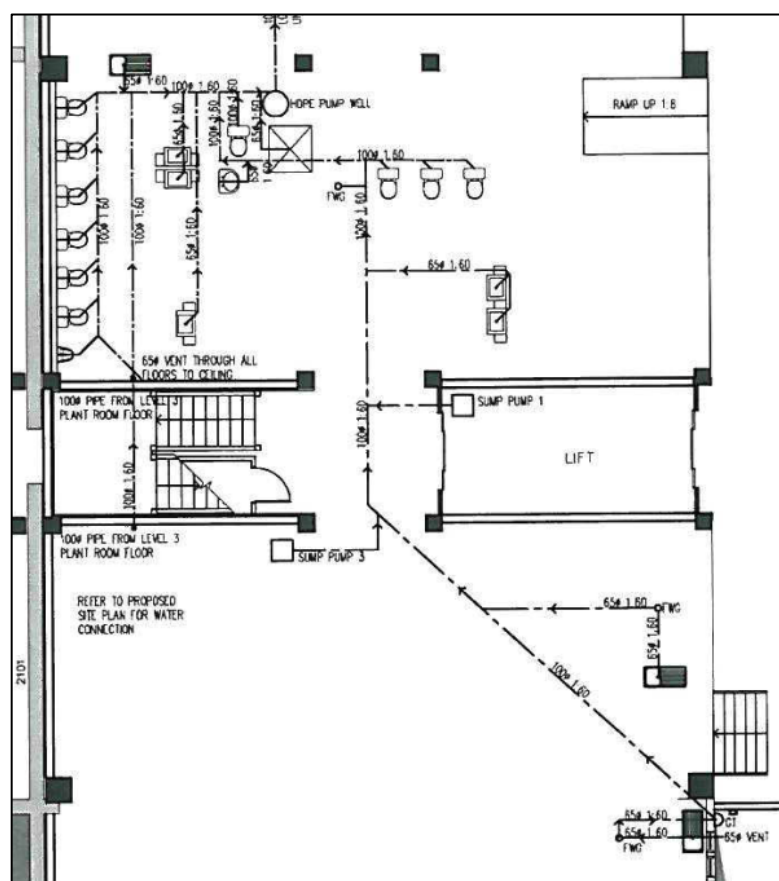
The area where the elevated temperature is currently experienced in the building's south wing also appears to coincide with the toilet area, where extensive plumbing network is present. The plumbing as-built plan also indicates an HDPE pump well is located within this area (see Figure 5.2 below). The drawing indicates that the pump well extends into the ground below the gas membrane. It is possible that this provides a path for the heat to enter the building as well as travel through the plumbing network. Additionally, with the museum being closed, there is also significantly less (or close to zero) water (which could act as a coolant) circulating in the system.

Figure 5.2: As-built plumbing plan<sup>2</sup>

The building's air conditioning system should be able to control the temperature in the building. A cooling / heat exchange system for the slab could also be considered as an additional measure. However, this is likely to attract high cost.

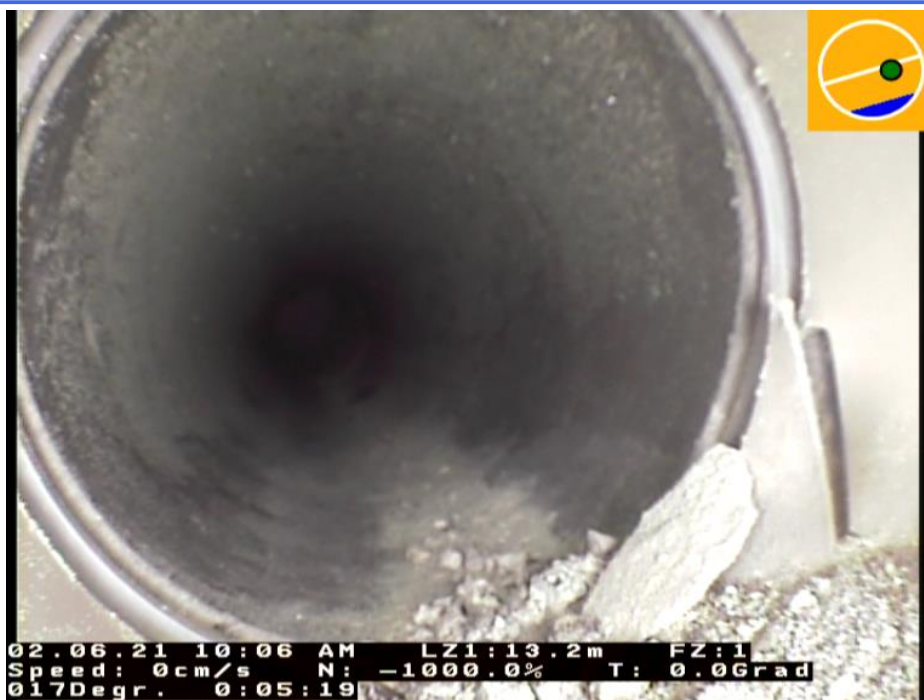
Picture 001

| 13.2 | Joint Faulty, Small, at 4 o'clock, (Joint faulty pipe split) | 1 |

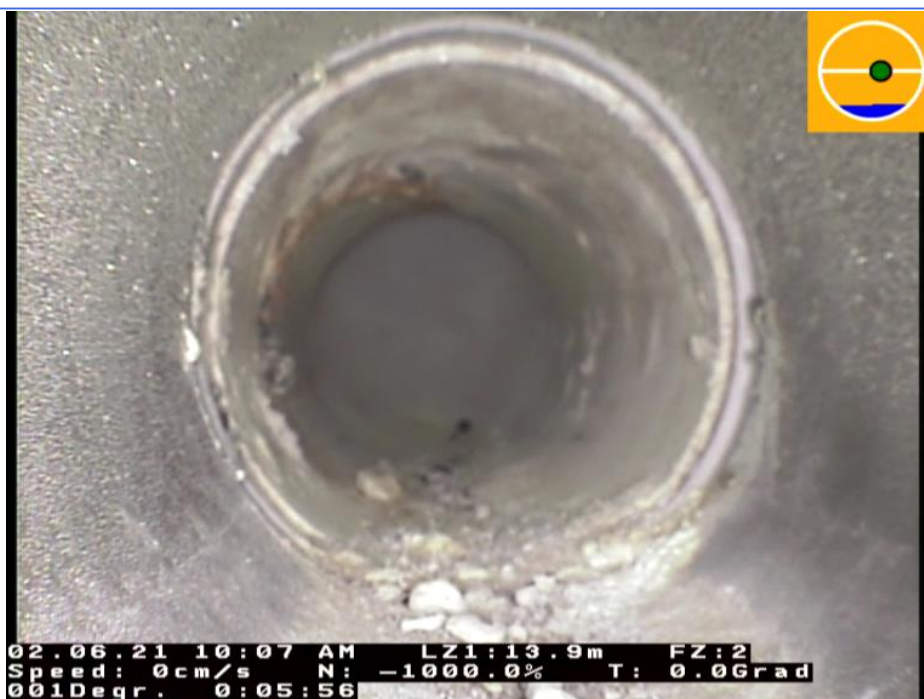
Picture 002

| 13.8 | General Comment, (staining on pipe wall) | 0 |
| 13.8 | Debris - Silty, Small, (Dirt) | 8 |

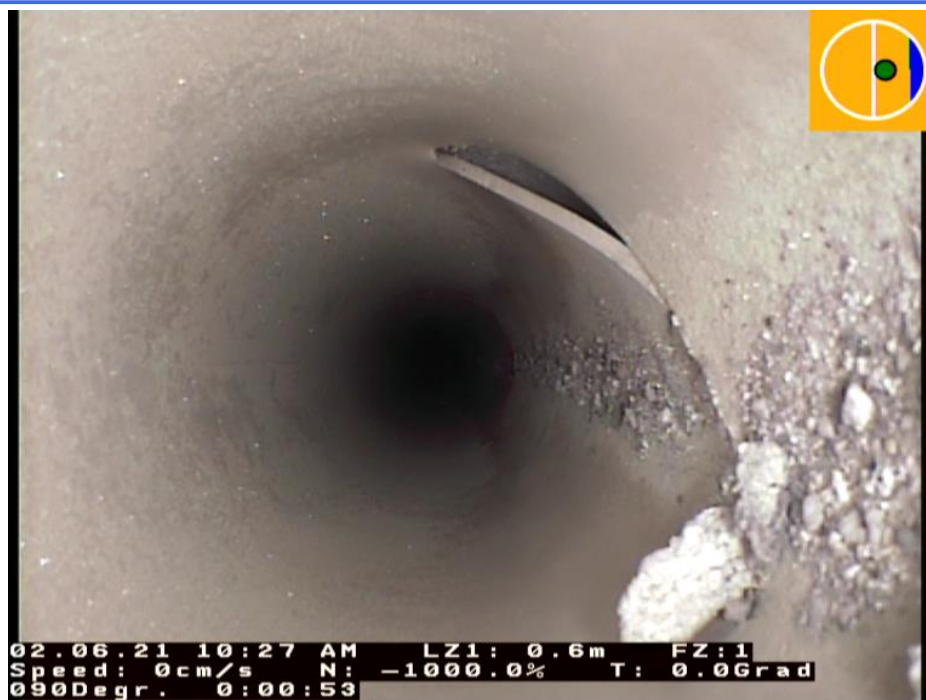
Picture 001

| 0.6 | General Comment, (Vent cut warped) | 0 |

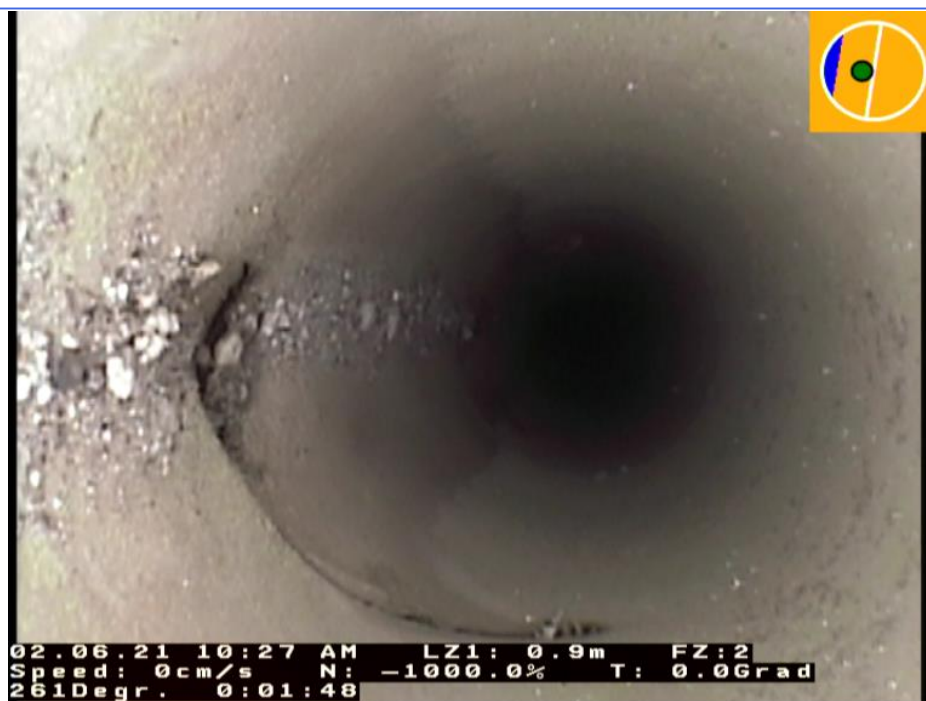
Picture 002

| 0.9 | Debris - Silty, Small, (Dirt) | 8 |

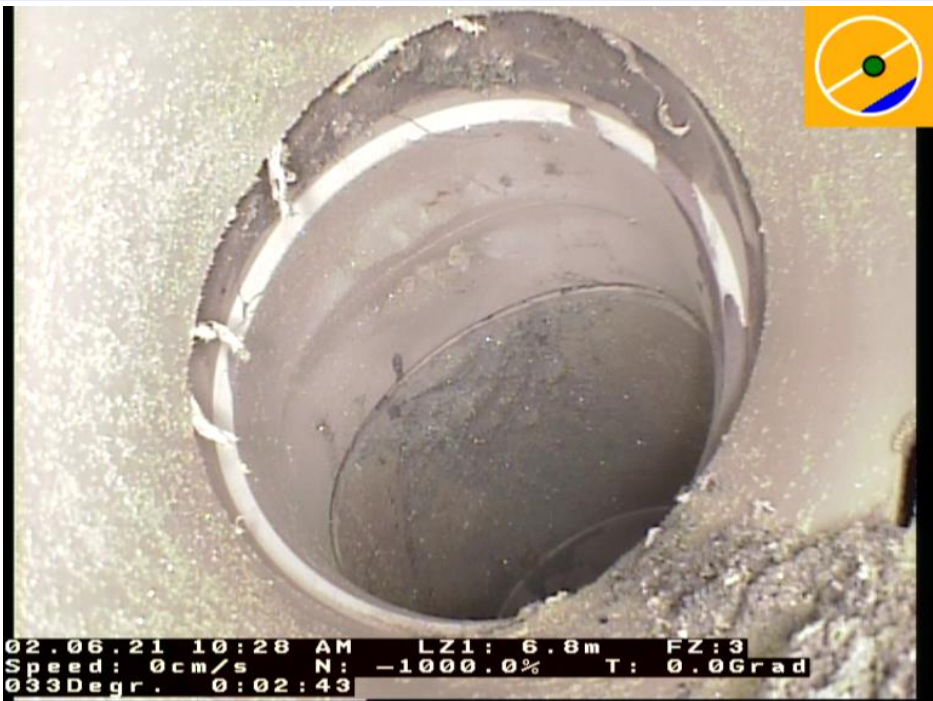
Picture 003

| 6.8 | Line Deviates Down | 0 |

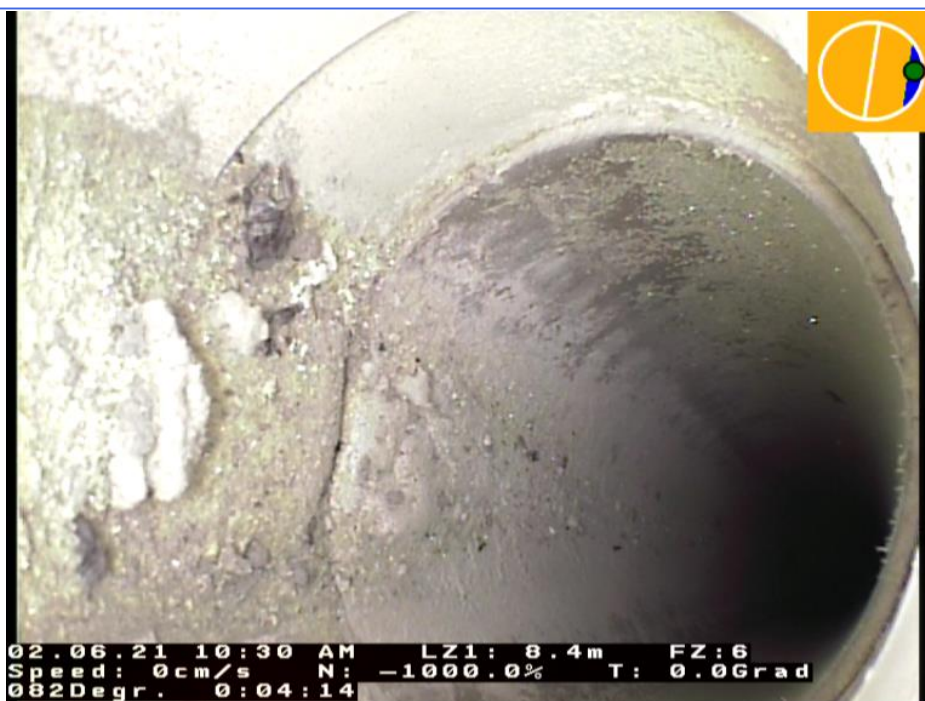
Picture 006

| 8.4 | Inspection Abandoned, (Couldnt continue further) | 0 |
| 8.4 | General Comment, (No acces to end of line) | 0 |
| 8.4 | Debris - Silty, Small, (Sulphur dust) | 8 |

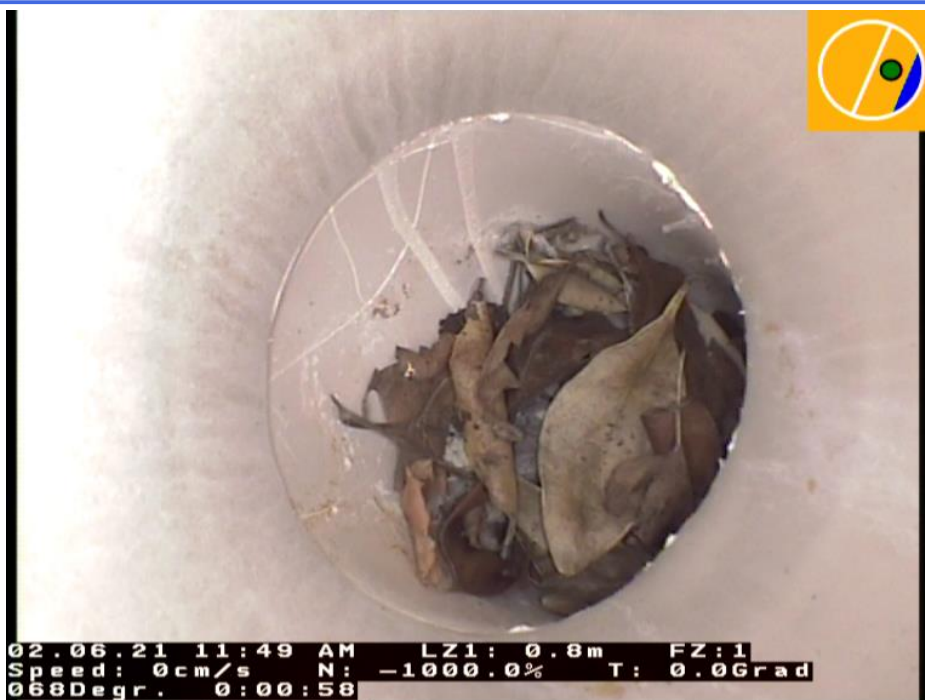
Picture 001

| Debris - Silty, Small, (Silt, leaves, stones) | 8 |

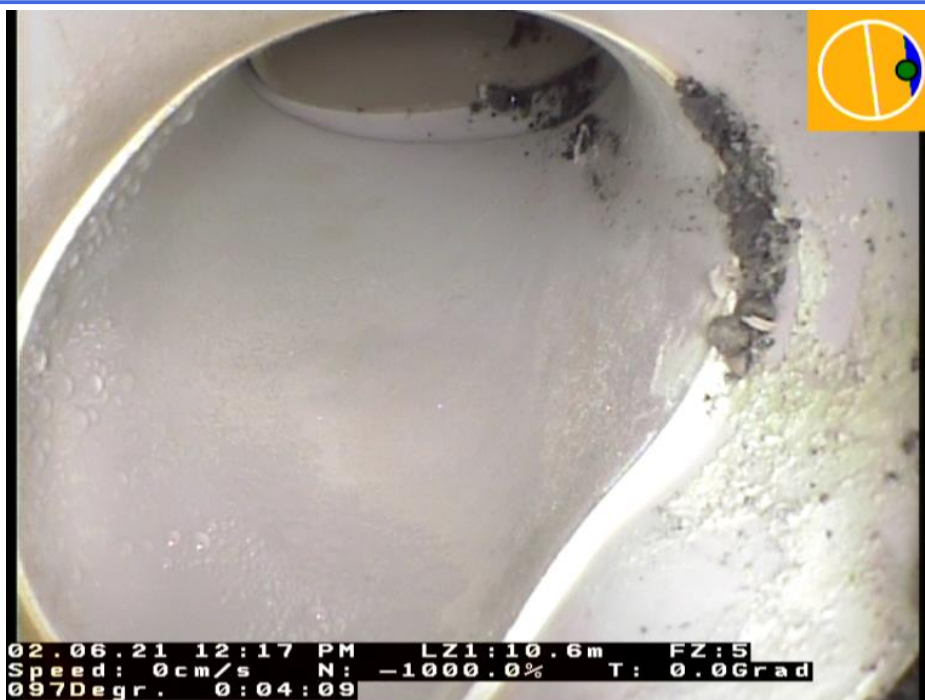
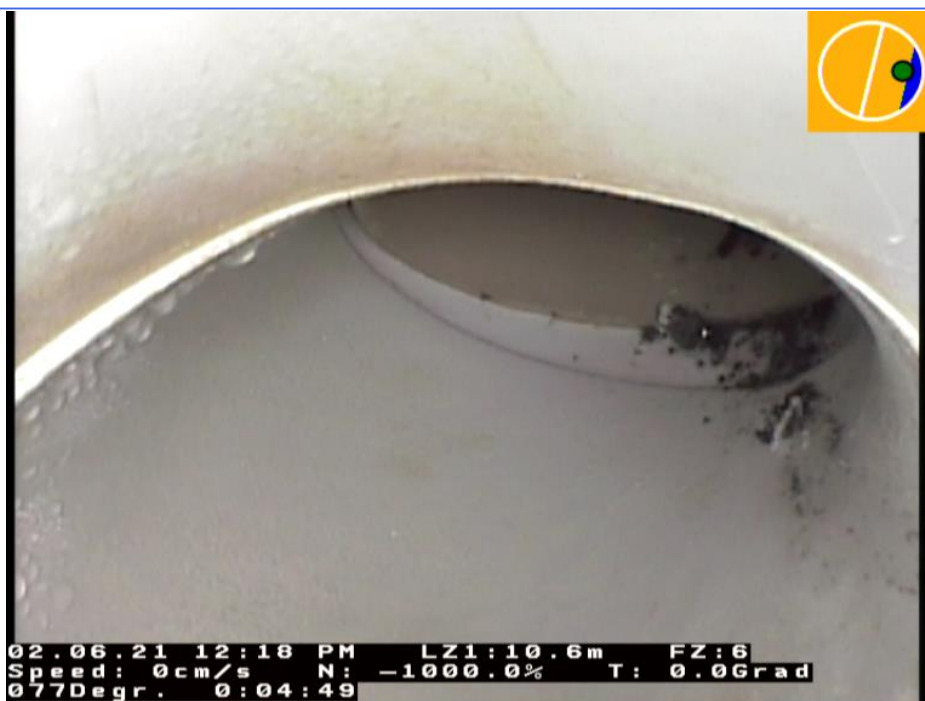
Inspection Abandoned, (joint displaced couldnt continue)

General Comment, (ground vissible )

Joint Displaced, Large
