# ROTORUA MUSEUM SEISMIC STRENGTHENING & REFURBISHMENT CONCEPT DESIGN REPORT

MAY 2018

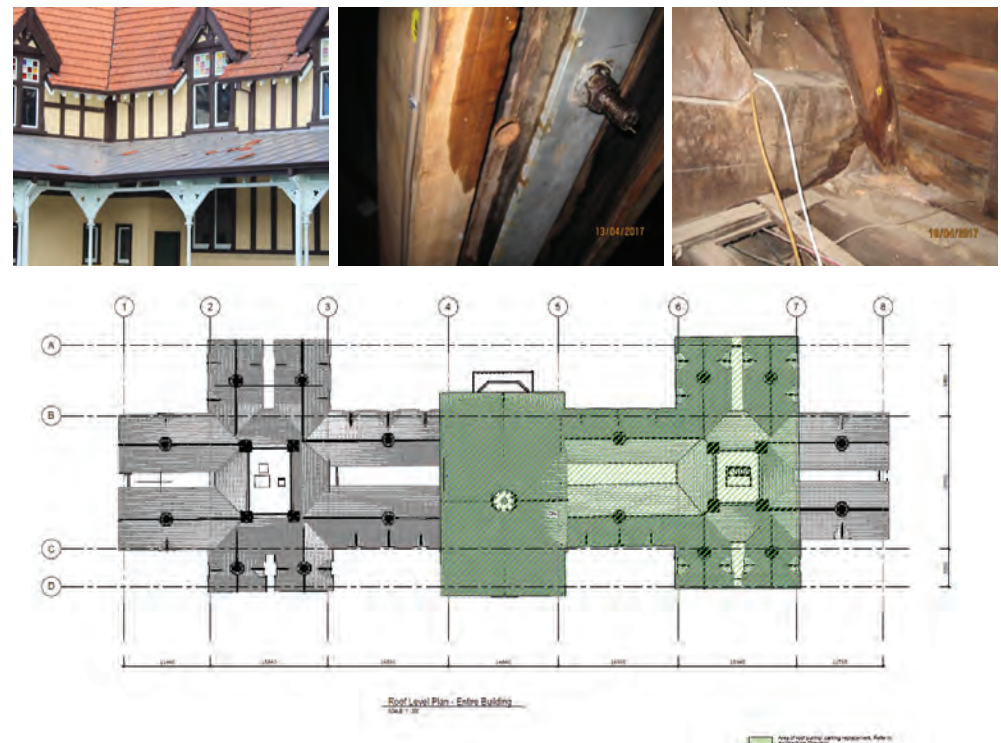
3.1.2 – Roof

**Issue**  
Terracotta Marseille roof tiles are separating and cracking causing severe leaking. Tile damage is significant in some areas and multiple tiles have fallen from the roof. Leaking has caused widespread moisture damage to both structural and service elements of the building. If moisture damage continues to roof framing elements the timber decay will cause severe structural weakness.

**Issue**  
Native timber roof framing and t&g roof sarking has decayed due to continuous leaking of the roof tiles. Decay extends to the structural fixings between different framing elements. Decayed roof framing timbers (beams and rafters) no longer provide sufficient structural strength. Deteriorated fixings and connections have weakened global structure. T&g sarking decay has reduced capacity as a structural diaphragm.

**Solution**  
Substantial repair or replacement of the roof tiles is required to prevent any further decay of timber framing elements. Replacement of the existing heavy clay roof tiles with a lightweight alternative will also reduce the seismic demand on the overall structure and will reduce the scale and complexity of structural upgrade works required in supporting structure. Removal of the existing roof tile will also allow structural works in the roof space to be carried out more easily.

**Solution**  
Replace severely decayed roof framing (beams and rafters) and repair or strengthen those that can be. Install new structural fixings (steel plates, bolts and nails) between elements. Replace sarking in areas required with structural ply.

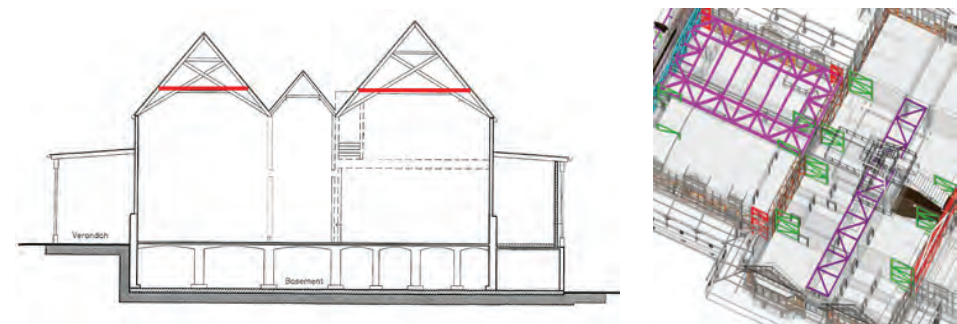
3.1.3 – Ceiling Diaphragm

**Issue**  
The current global structure lacks an effective ceiling diaphragm to tie together the separate structural walls into a single cohesive structure. The exiting timber sarking is too far decayed and at too steep a pitch to provide an effective diaphragm. Without an effective diaphragm the global structure is weak in the horizontal plane against lateral forces by seismic loading.

**Solution**  
Install horizontal steel cross bracing in roof the space to create a structural diaphragm above the ceiling joists. The roof tiles and sarking will need to be removed to allow installation of these braces.

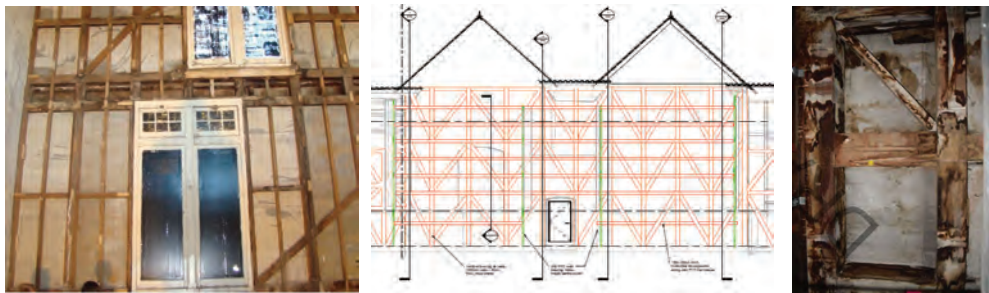
3.1.4 – Timber Wall Framing

**Issue**  
Shear capacity of Mortise and Tenon joints in native timber wall framing elements are not sufficient for the seismic demand. These walls may fail under in plane seismic loading. Periodic leaking between wall framing, panels and windows/doors has caused decay to native timber wall framing elements.

**Solution**  
Increase in plane shear capacity of timber framed walls by installing steel brace frames. Replace severely decayed wall framing elements.

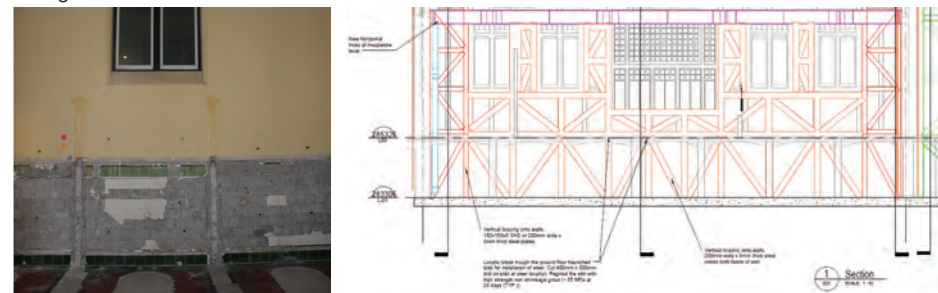
3.1.5 – Concrete Nib Walls

**Issue**  
The unreinforced concrete nib walls, upon which timber wall framing is founded, is weak against out of plane forces. Nib walls may fail under excessive deflection caused by out of plane seismic loading. This will lead to catastrophic failure of timber wall framing above and supported roof structure.

**Solution**  
Strengthen unreinforced concrete nib walls against out of plane loading. Install structural steel plate frames continuously over timber wall framing, concrete nib walls and down into foundation walls and footings.

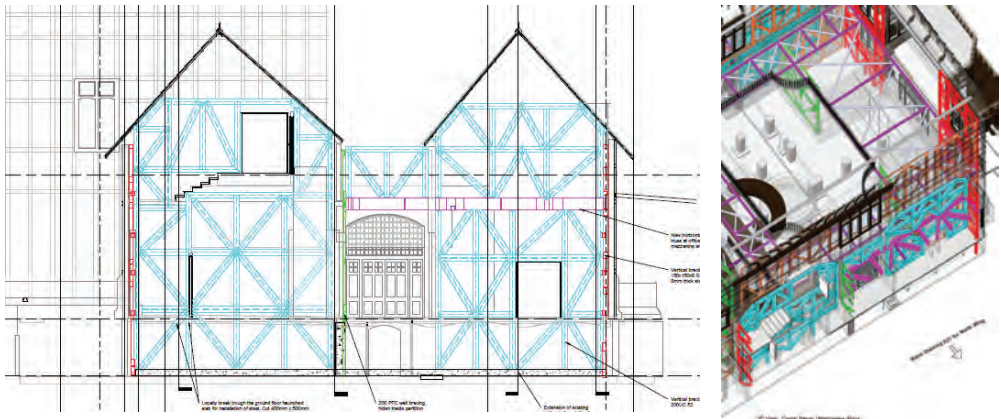
3.1.6 – Full Height Concrete Gable End Walls

**Issue**  
Four of the original five full height unreinforced concrete gable end walls constructed in 1906 remain and are severely weak against out of plane flexural forces caused by seismic loading.

These walls may suffer overturning failure under excessive deflection caused by out of plane seismic loading. This will lead to catastrophic failure and collapse of the walls and supported roof structure. Collapse of these 12+m high walls will cause critical damage to adjacent building elements.

**Solution**  
These walls are the most significant structural weakness in the building and require immediate replacement or strengthening works.

Strengthen the walls with steel brace frames bolted to the concrete walls. Strengthen lower perpendicular adjacent walls and their connection to the full height concrete walls to provide lateral support against overturning. Create structural diaphragm out of existing mezzanine floor by installing steel bracing to floor framing and replacing timber T&G flooring with structural plywood sheet flooring.

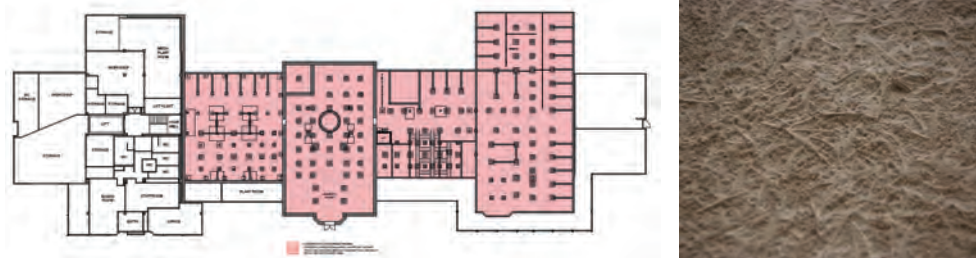
3.1.7 – Suspended Concrete Floor

**Issue**  
Suspended unreinforced concrete floor slab is weak against out of plane flexural forces caused by vertical loads. These include gravitational dead loads under its own weight, movement of supporting walls and piles and also live loading from temporary traffic and permanent fixtures.

Over time these vertical loads have caused significant cracking of the suspended concrete floor slab. As these loads continue, cracking has increased exponentially as the various cracks compound to create structural weakness. Although the suspended concrete floor slab is unreinforced the friction between aggregates within the concrete has provided sufficient strength to the floor preventing failure so far.

**Solution**  
Fill larger cracks with an epoxy resin that bonds either side of the crack. Spray the underside of the floor slab with glass fibre reinforced concrete approx. 100mm thick. This will provide tensile strength to the underside of the slab reducing sagging and further cracking and preventing failure of the slab.

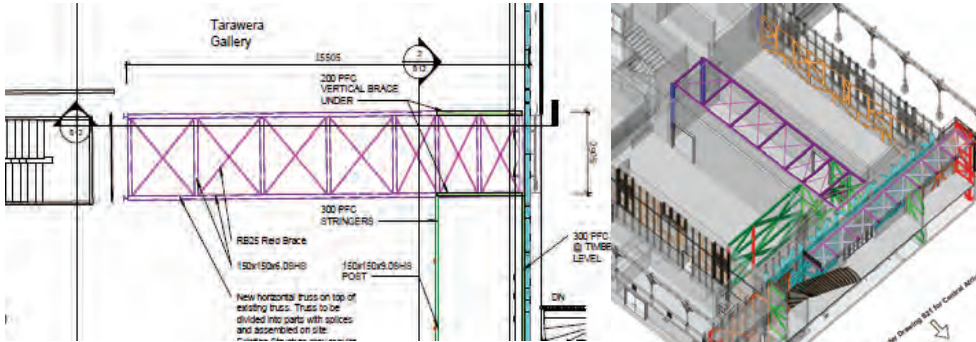
3.1.8 – Tarawera Gallery Steel

**Issue**  
Upper horizontal steel truss, omitted from final design and not installed in construction as required by structural calculations in roof space above central hallway of Tarawera Gallery.

Central steel portal in the Tarawera Gallery likely to experience excessive deflection under seismic event leading to failure.

**Solution**  
Install new horizontal steel truss above existing lower steel truss comprised of steel struts and braces, installed in parts for ease of construction in roof space above Pukaki.

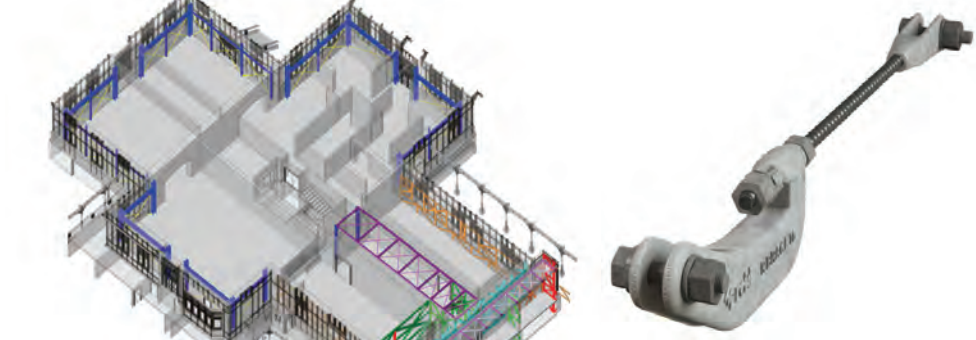
3.1.9 – Reid Bar Braces

**Issue**  
Steel brackets connecting diagonal reid-bar braces to base of structural steel framing are too rigid and will become brittle under stress from seismic loads.

**Solution**  
Replace brackets with a more ductile steel bracket. Requires removing wallinings to access. Not heritage value.
