# ROTORUA MUSEUM

## Summary of Issues to Date – 04/09/2017

Provided below is a brief summary of the numerous issues present at the Rotorua Museum to date. These issues include findings from; the Detailed Seismic Assessment by GDC Consultants Ltd; Timber Deterioration Assessment by Prendos NZ Ltd and detailed investigation by TDC Ltd.

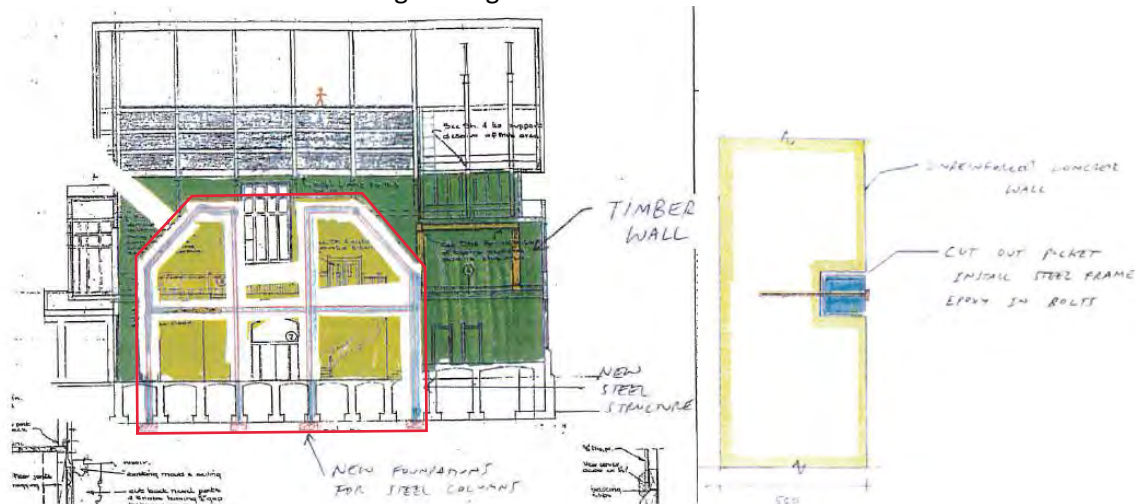
1. Unreinforced concrete full height gable end walls are weak against out of plane (perpendicular) forces. Strengthen walls with new structural steel frames, rebated into concrete, through concrete floor and into new concrete footings in the basement. Rebate can be filled after installation of steel and finished over to match existing heritage fabric.

Concrete wall elevation (yellow) with steel frame (grey) (left) and steel frame detail (right).

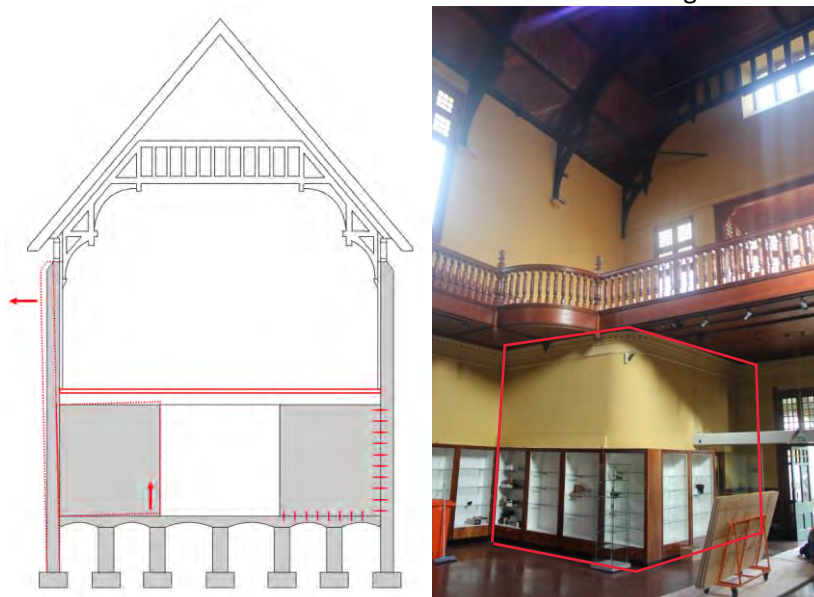
2. Unreinforced concrete walls lack bracing against overturning from out of plane (perpendicular) forces. Create new structural walls perpendicular to the concrete walls to provide bracing. Utilize existing low concrete walls by strengthening their connection to the full height unreinforced concrete walls. Install new steel brace frames into existing timber framed walls.

Diagram of full height concrete wall overturning due to out of plane forces on the left v.s. full height concrete wall braced against overturning with strengthened low concrete wall (left) and photo of low concrete wall below mezzanine (right).

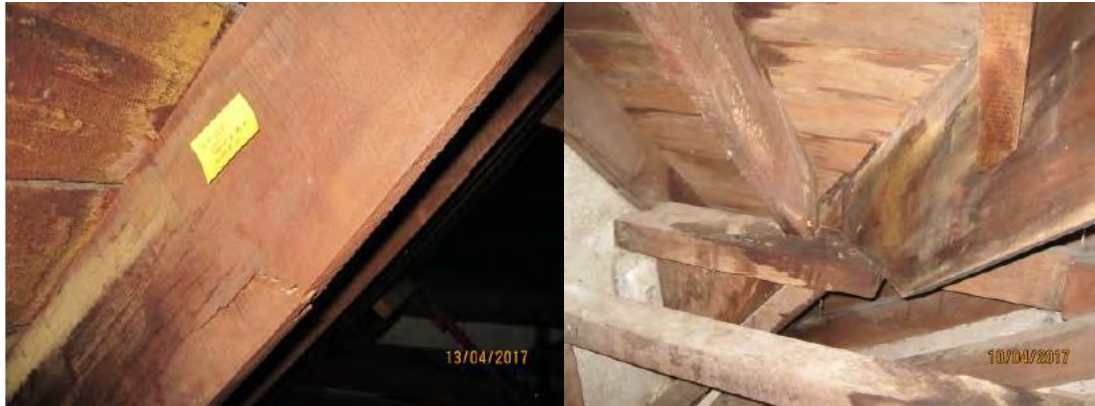
3. Numerous timber roof framing and sarking elements have decayed and their connections to the timber top plates have deteriorated due to moisture damage caused by severe leaking of roof tiles over time. Replace decayed timber and install new connections to top plate.

Cracked rafter (left) and severely moisture damaged valley rafter (right).

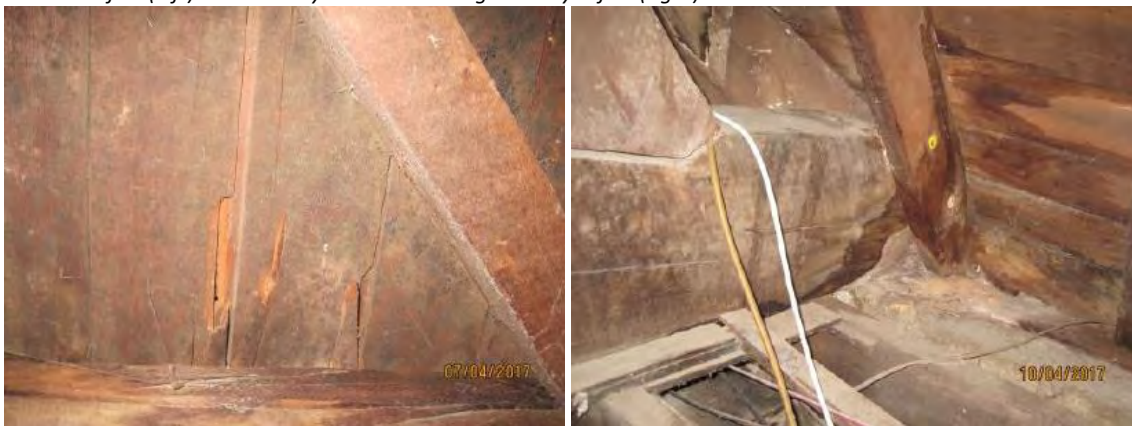
Cracked and mouldy sarking (left) and visible moisture presence to rafter (right).

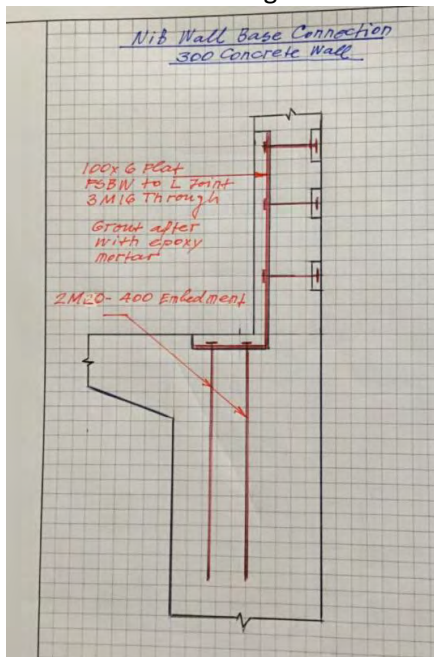
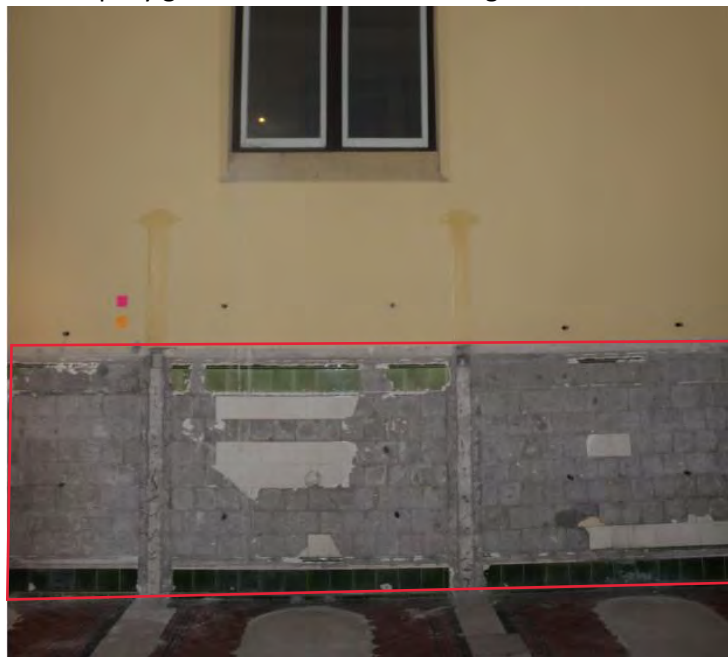
4. Concrete nib walls, weak against out of plane overturning forces, selected walls require bracing. Cut a rebate into concrete at floor-wall junction at maximum 1200mm crs and install steel angle brackets bolted through floor and nib wall. Epoxy grout over to match existing.

Bracket detail (left) and concrete nib wall exposed below lathe and plaster/timber framed wall above (right).

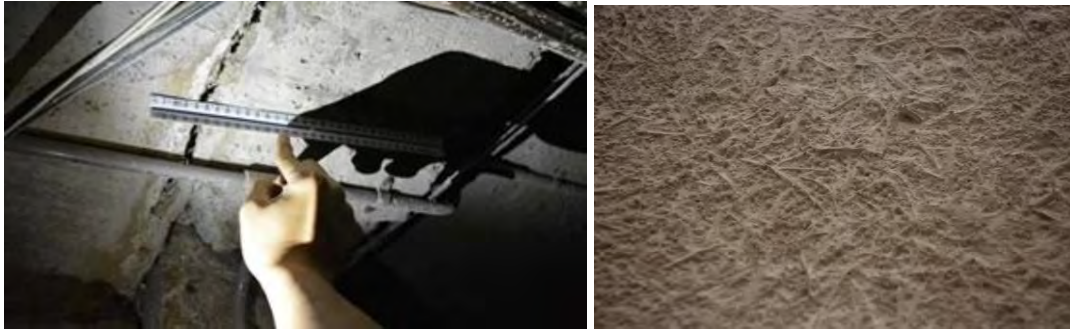
5. Concrete floor cracking under vertical loading. Injection grout fill larger cracks and spray glass fibre reinforced concrete overlay to underside of concrete to strengthen the suspended floor slab.

Photo of a larger crack in floor slab (left) and finished surface of glass fibre reinforced concrete overlay (right).

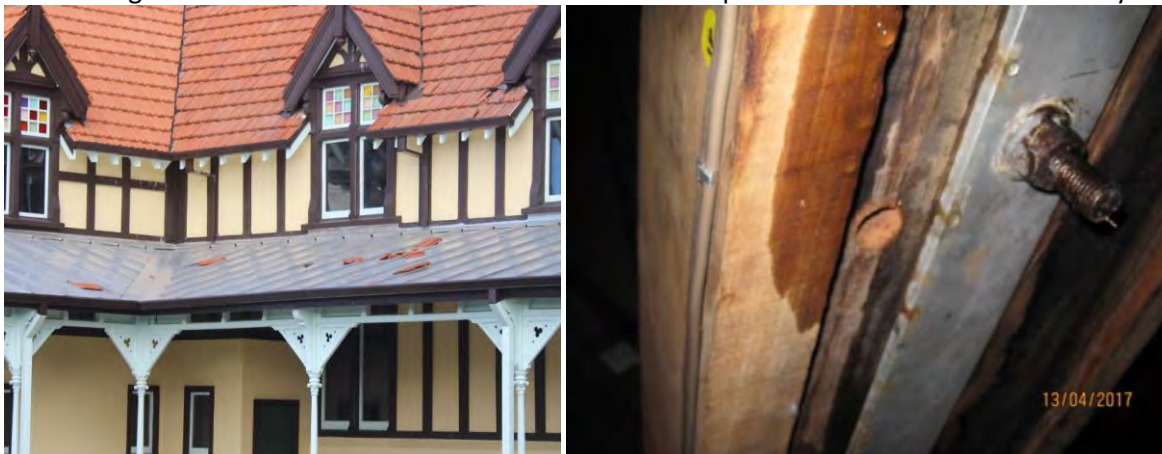
6. Clay roof tiles are leaking severely and causing widespread moisture damage to both structural and service elements of the building. If the moisture damage continues to framing elements the timber decay will cause a severe structural weakness. Repair or replacement of the roof tiles is required to prevent any further decay of timber framing elements. Replacement of the existing heavy clay roof tiles with a lightweight alternative will also reduce the seismic demand on the overall structure and may reduce the scale and complexity of structural upgrade works required. Removal of the existing roof will also allow structural works in the roof space to be carried out more easily.

Roof tiles have broken and slid completely off roof (left) and active water leak through tiles on roof framing (right).

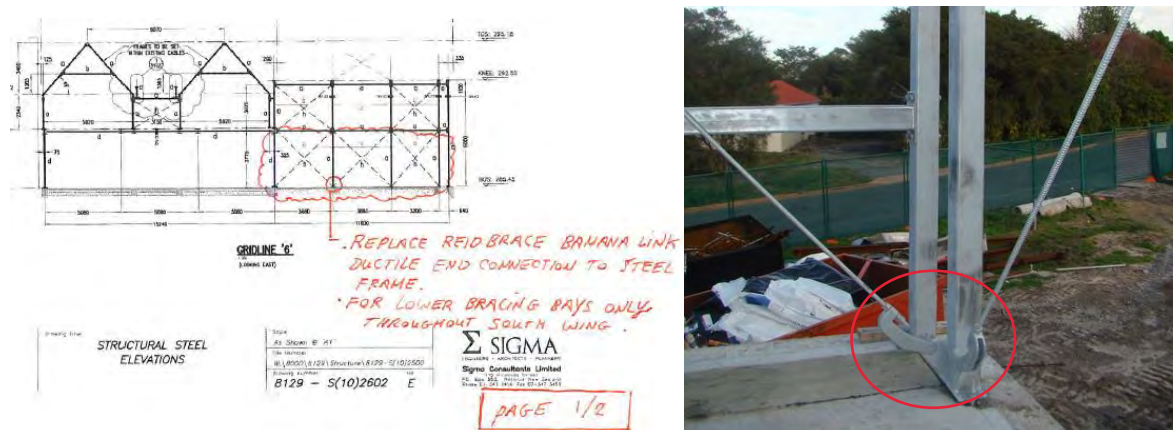
7. Replace existing rigid Reid bar brace connection lugs to structural steel portals frames with new ductile connections.

Structural steel elevation identifying diagonal bracing (left) and photo of actual existing reid-bar brace connection (right).

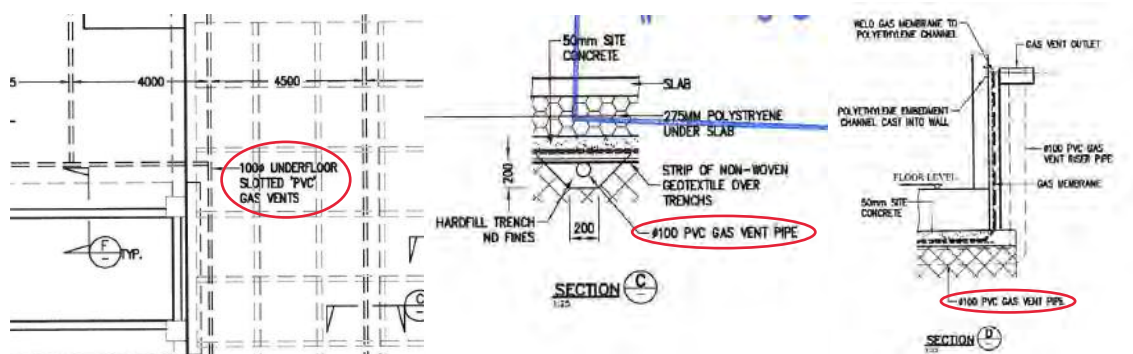
8. Gas vents possibly not installed with slotted PVC drain pipe as required to receive gas from ground. CCTV inspection of existing vents pipe required to check for slots on underside of PVC vent pipes. Thrust new slotted PVC pipe under existing slab to create effective vents or cut a vent opening in ground slab to collect gas in a sealed chamber and vent to outside.

One plan reference to the under slab gas vent pipes states 'slotted PVC' (left) and details state '100mm PVC' (right).

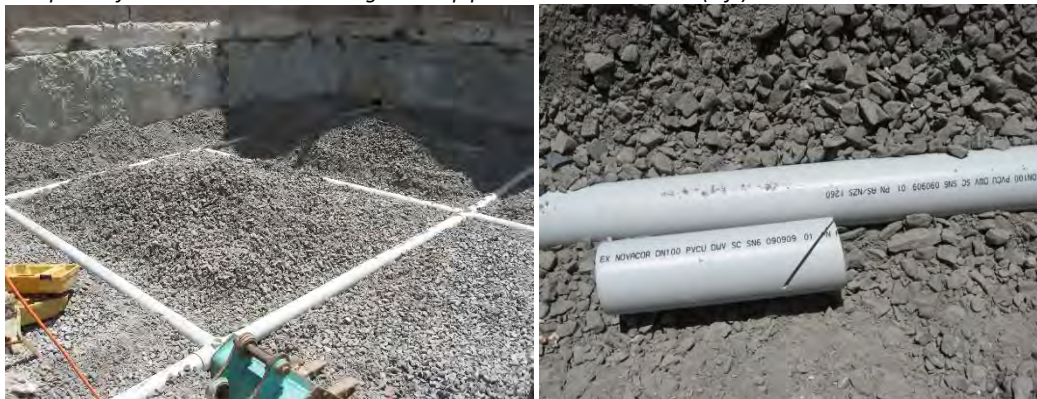
The photos of these PVC gas vent pipes show no evidence of slotted PVC pipe installed. The i.d. stamp on the PVC pipe in the photo on the right supports the fact that this pipe is not factory slotted. There is a possibility that the pipe could have been slotted on-site prior to installation and these slots are simply not visible in these photos. Therefore a CCTV inspection of the vent pipes is required to check whether the required slots are present. If the slots are present however, there is a possibility that the pipes have become blocked as the hard fill that has been backfilled around the PVC pipes contains a lot of 'fines' material despite the detail above stating 'HARDFILL TRENCH, NO FINES'.

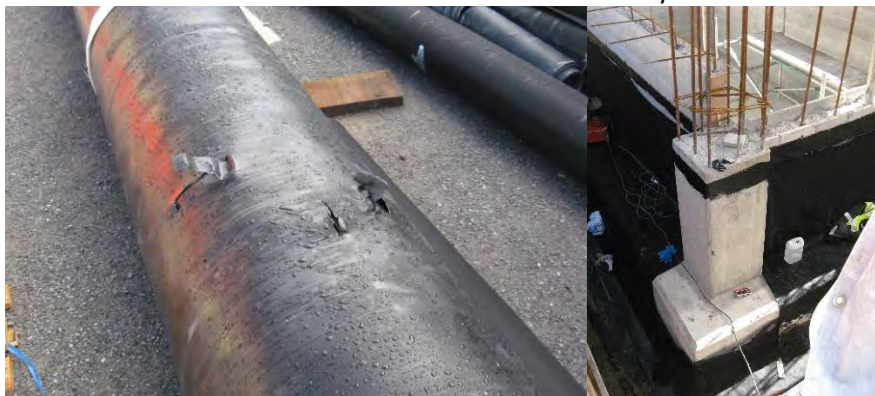
9. Membrane below slab and to exterior of basement and lift shaft walls has failed. Moisture is seeping through masonry block walls, leaving calcium deposits on basement walls and sulphur stains in the lift shaft. Re-seal concrete floor slab and masonry block walls with tanking membrane.

Damaged roll of membrane at time of construction (left) and photo of lift shaft membrane installation (right).

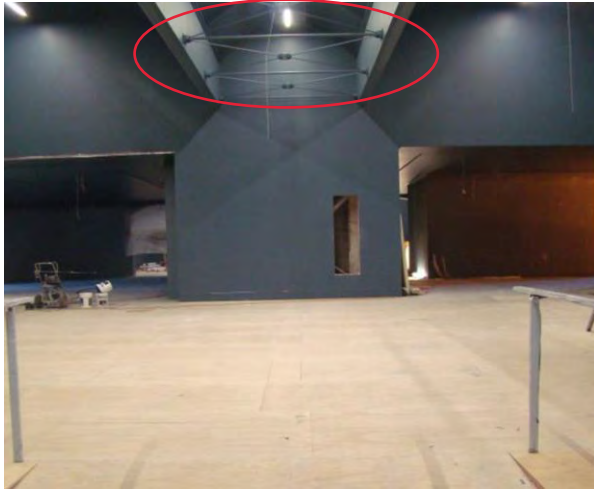
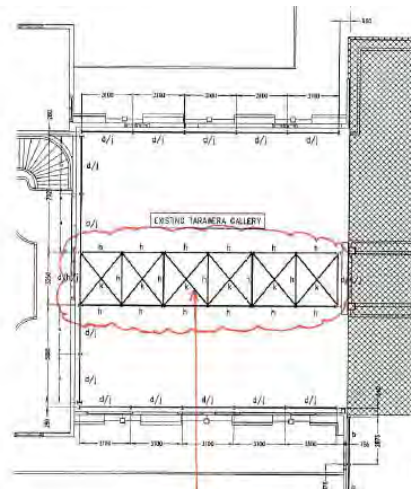
10. A second upper horizontal steel truss, omitted from final design and not installed as required by structural calculations in roof space above central hallway. Install new horizontal steel truss above existing lower steel truss comprised of steel struts and braces, installed in parts for ease of construction in roof space above Pukaki.

Tarawera Gallery prior to fit-out showing lower steel truss above central hallway (left) and structural plan of truss (right).

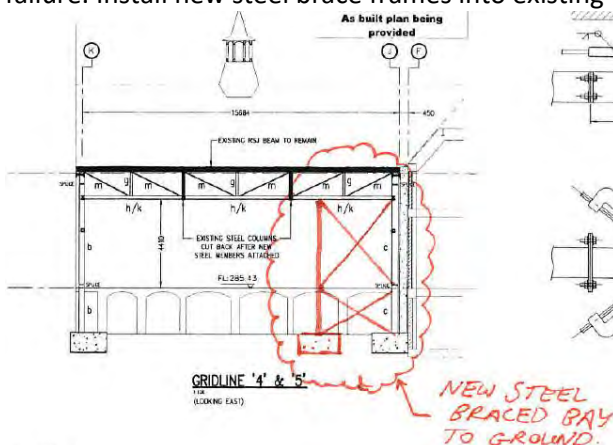
11. Central steel portal likely to experience excessive deflection under seismic event leading to failure. Install new steel brace frames into existing timber partition walls either side of Pukaki.

Sketch detail of new steel brace frame to be installed.

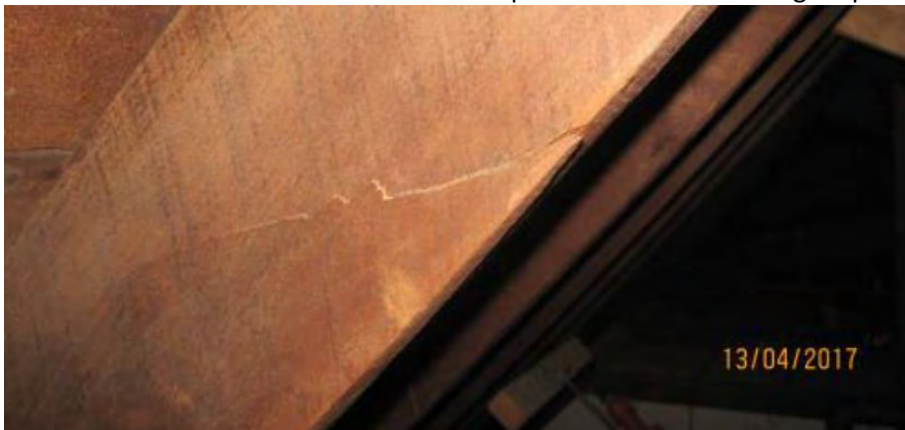
12. Timber roof beam above atrium has experienced some cracking. Replace beam and connections.

Cracked timber roof framing.

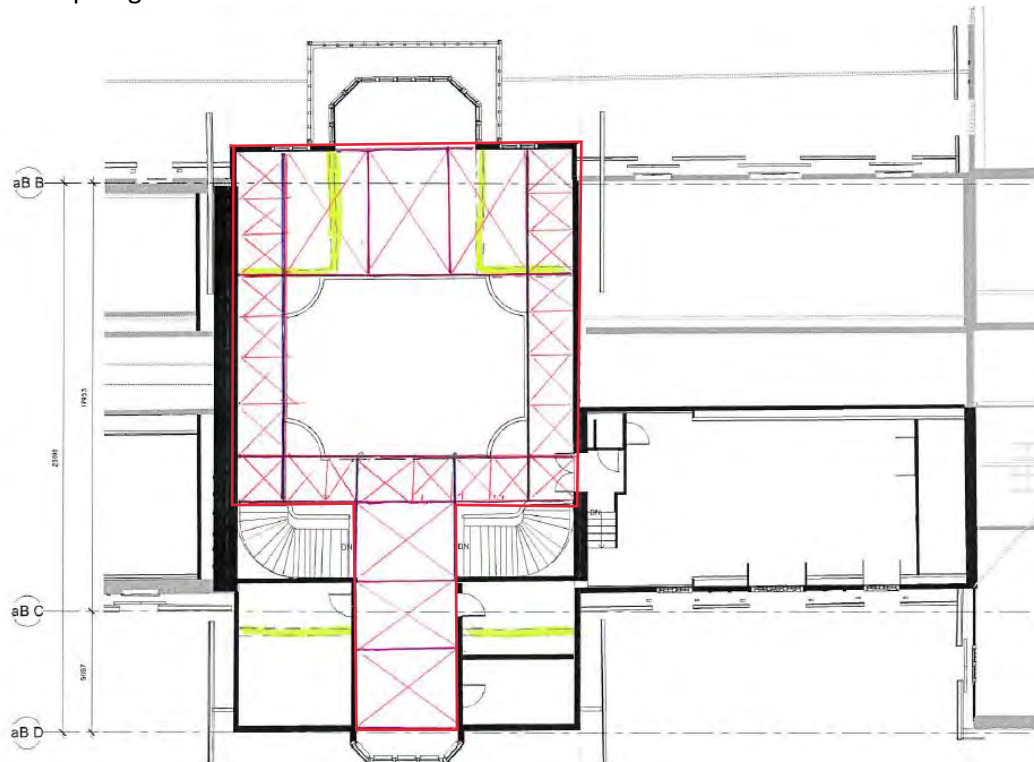
13. Lack of horizontal plane bracing to unreinforced concrete walls at mid height. Install a new horizontal floor diaphragm by removing existing mezzanine floor lining, installing steel bracing into the floor cavity and installing new structural plywood flooring screw fixed to joists to create effective floor diaphragm.

*Approximate area of mezzanine floor required for structural diaphragm.*

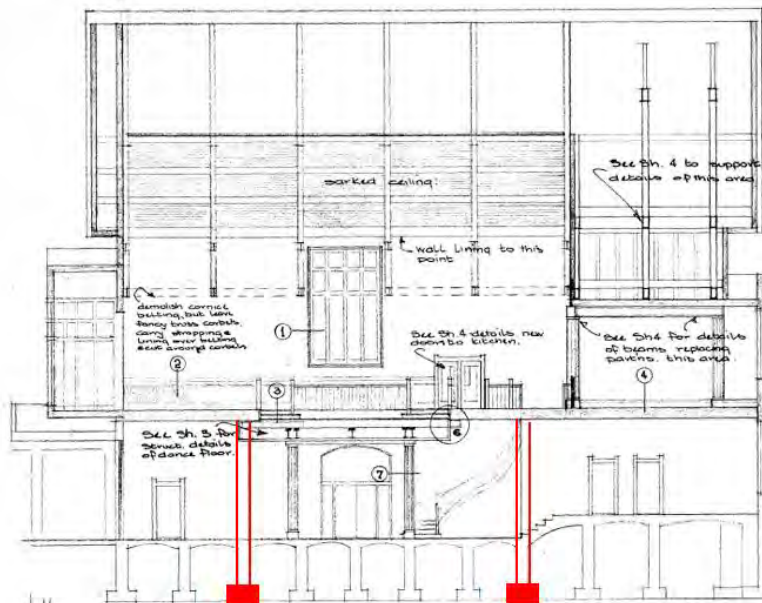
14. Selected foundation footings in Atrium below concrete walls running in the north-south direction lack bearing capacity. Footings need to be widened.

*Long section of atrium showing (red) approximate location of concrete walls requiring footings to be widened.*

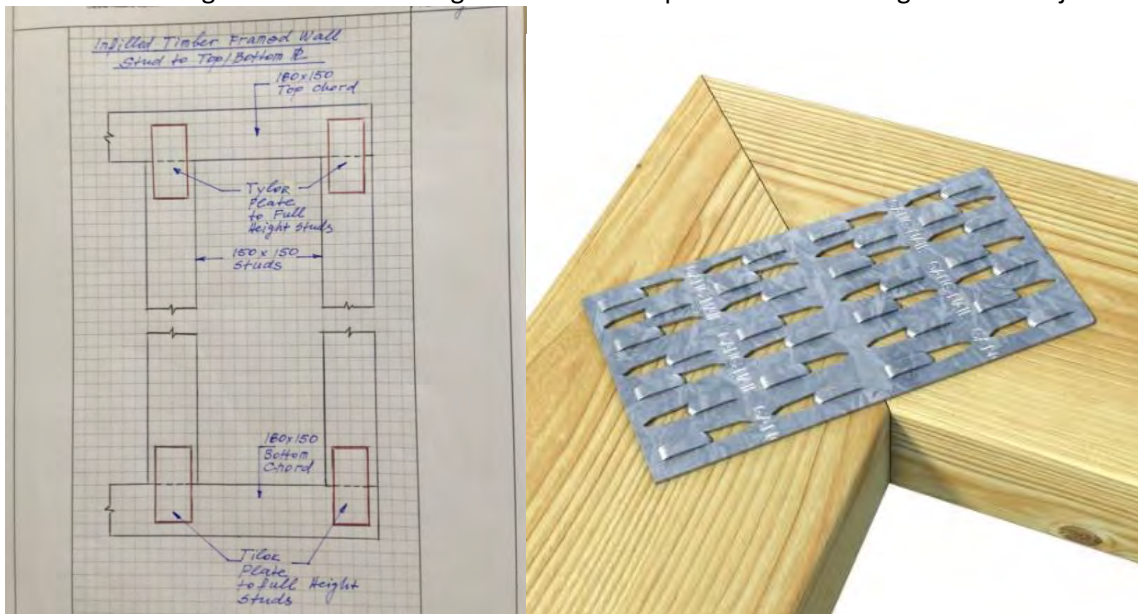
15. Existing timber framed walls lack lateral bracing capacity and require strengthening to create structural bracing walls. Remove lining and install steel plates over to strengthen timber joints.

Sketch detail of plate to stud fixing (left) and example of Tylok plate to be used to strengthen timber connections (right).

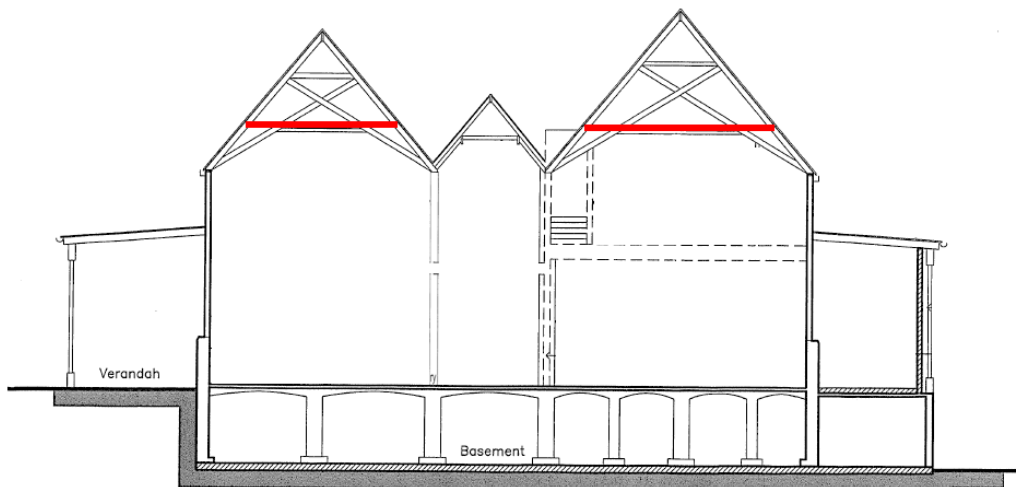
16. Lack of an effective roof diaphragm to tie together and strengthen global structure. Install horizontal steel cross bracing in roof space to create a structural diaphragm above the ceiling joists.

Cross section of Intermediate North Wing showing approximate location (red) of required steel bracing in roof space.

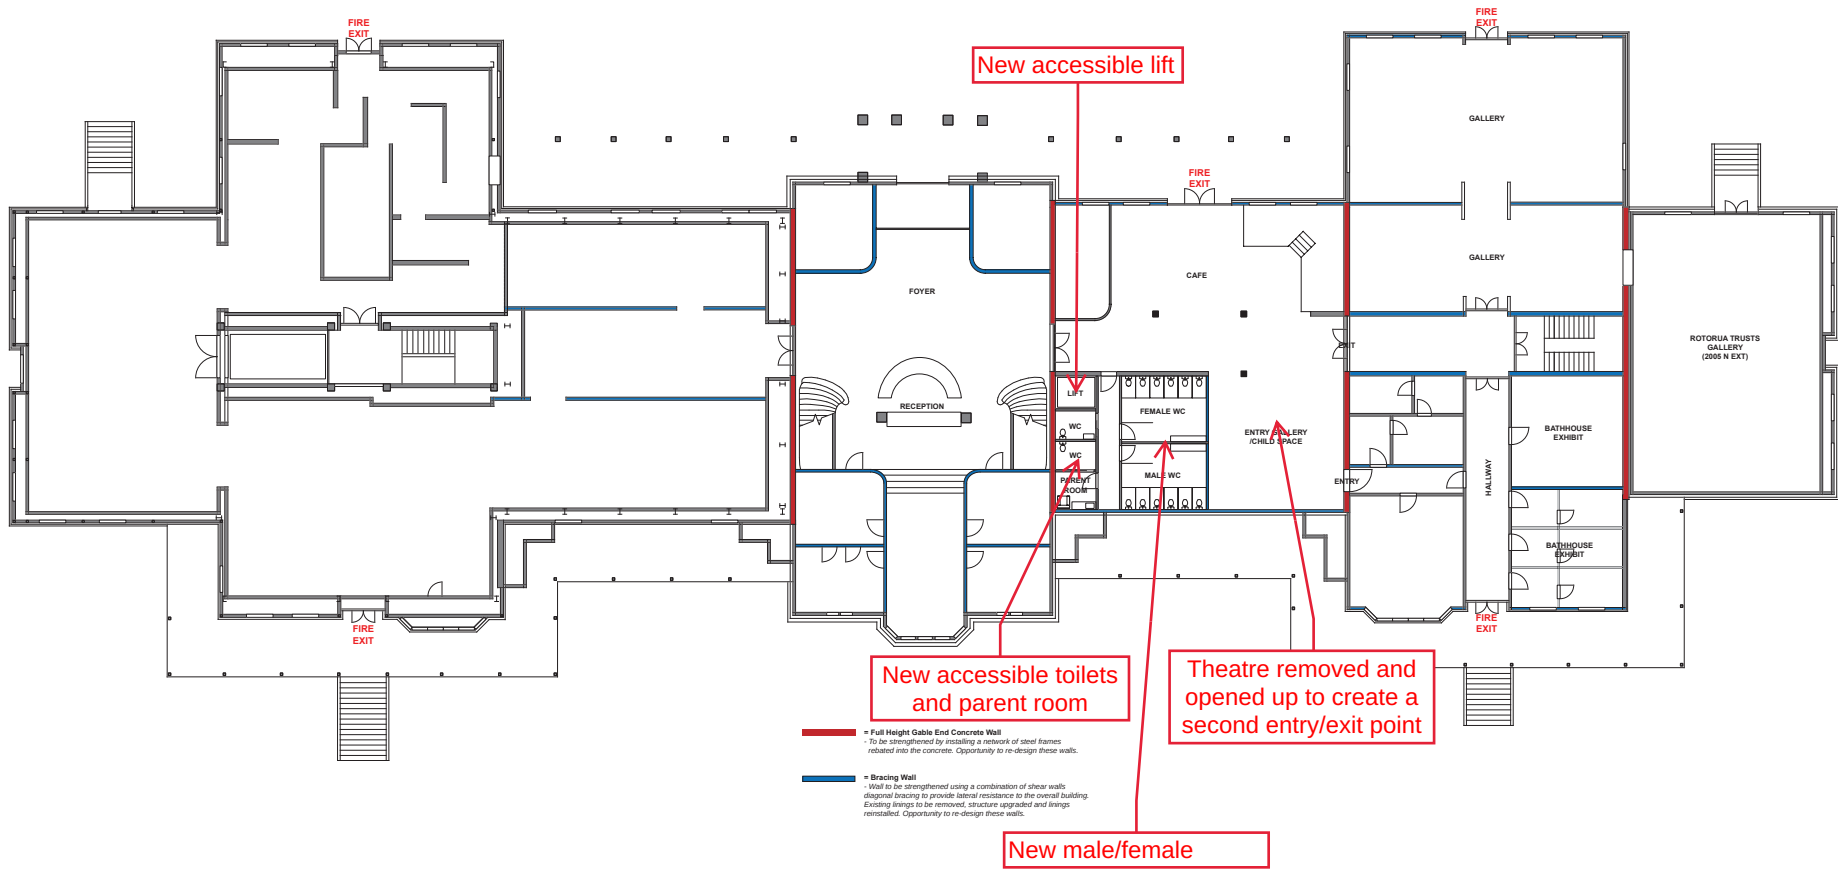
### North Wing Extension

Area affected by issues 1 & 2.
