10 February 2021

## **Rotorua Museum - Earthquake Rapid Assessment**

2-82142.00

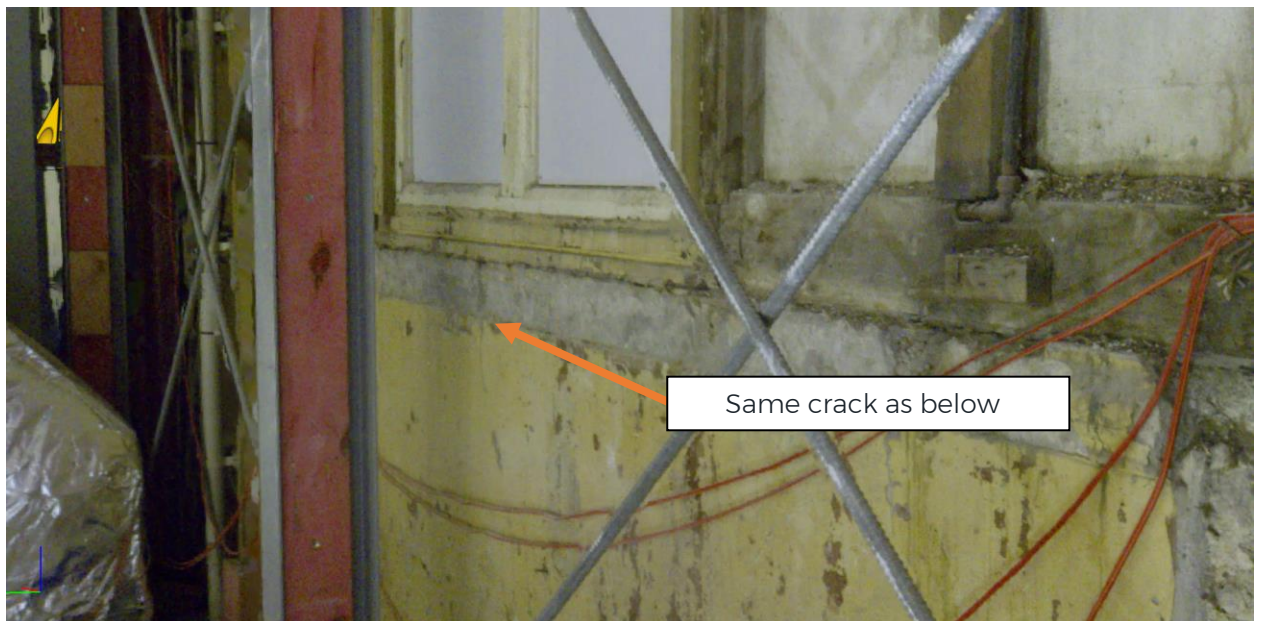
Cracking of the 1.2m high unreinforced nib walls visible. Some loose material was present at the top of the cracks. Largest cracks observed were present on the Jetstream images.

Figure 1 - Image from 2020 Jetstream data

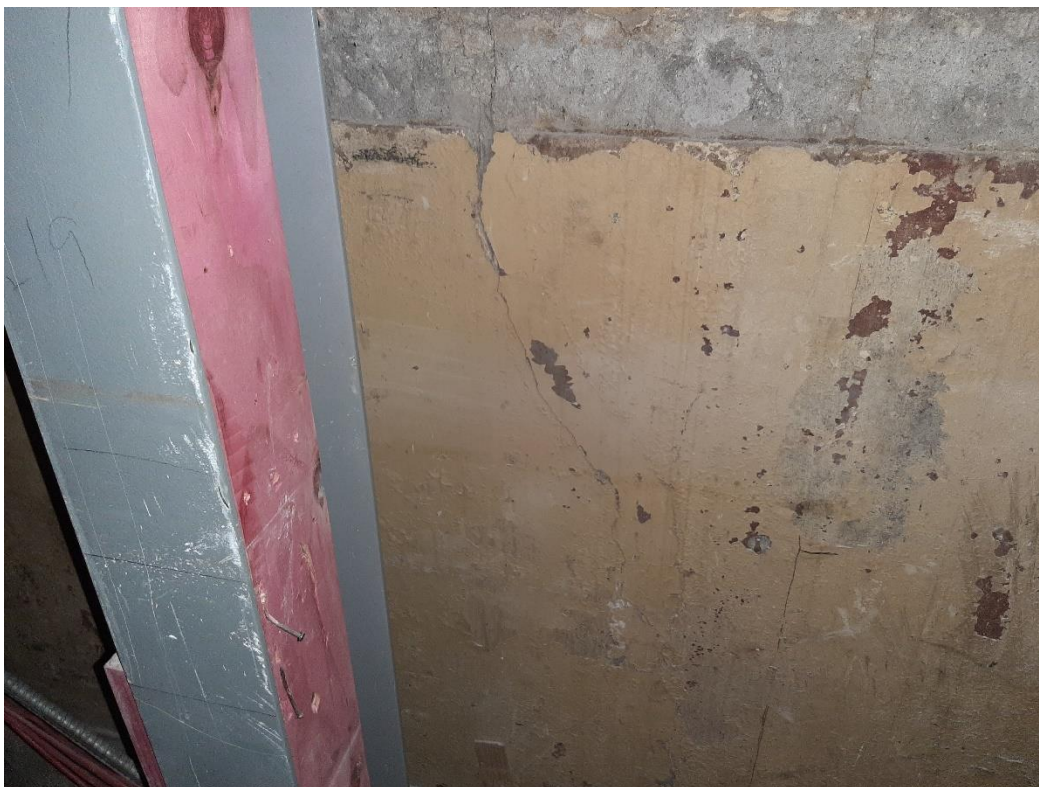
Figure 2 - Image from 26/1/21 inspection

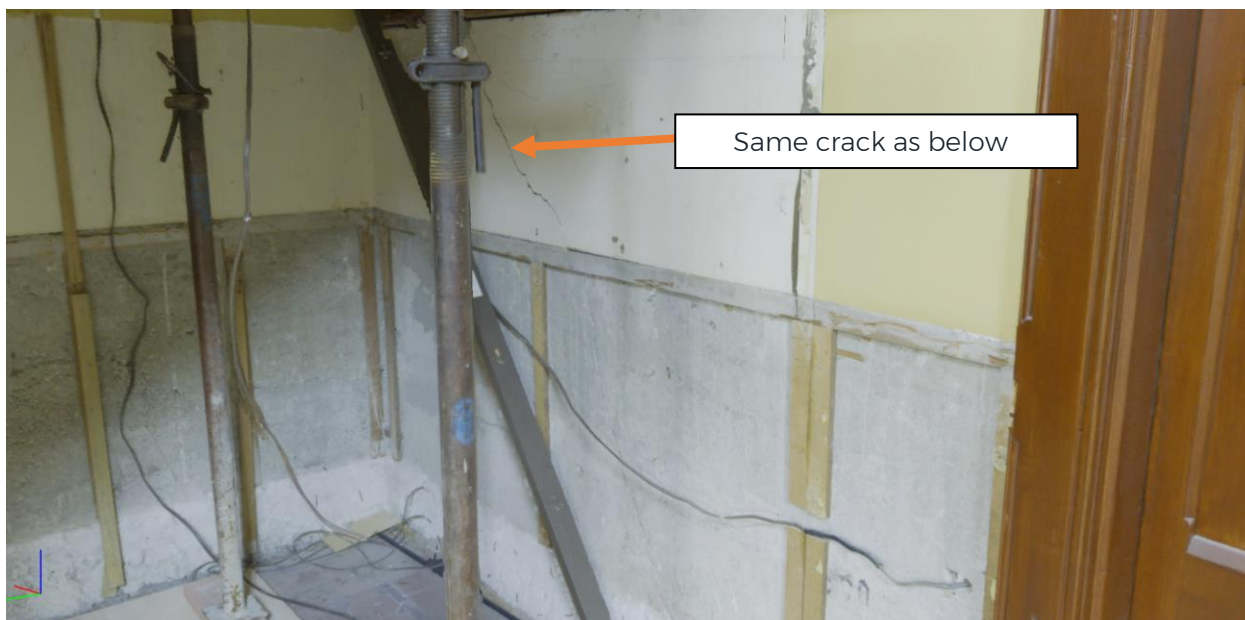
Large crack behind the north stairs. This was present in the Jetstream data.

Figure 3 - Large crack in the central atrium behind the north stairs - from 2020 Jetstream data

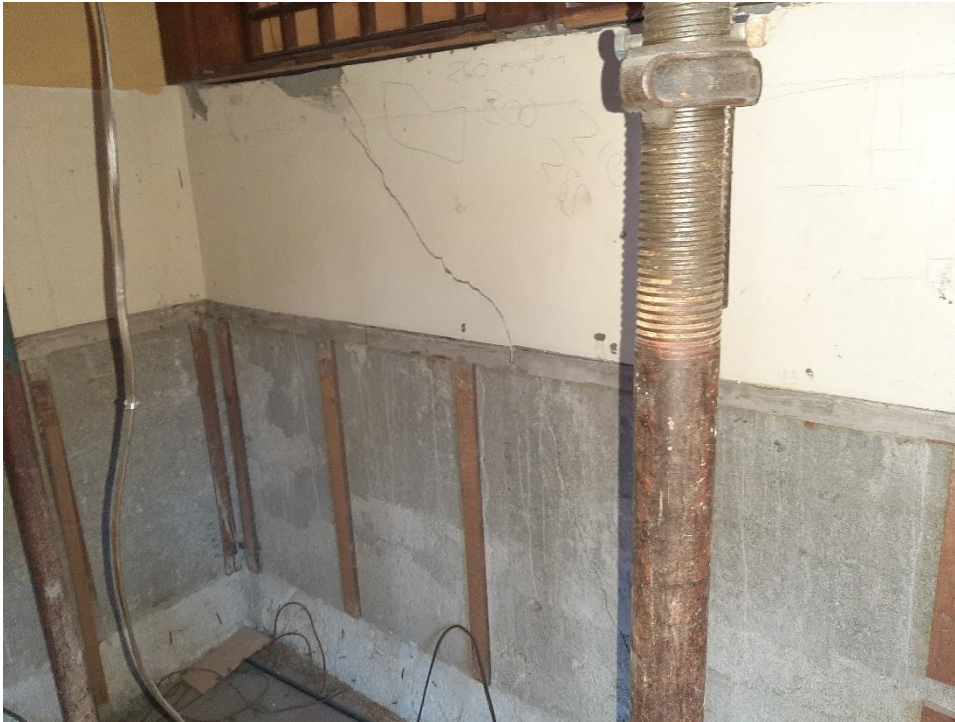
*Figure 4 - Crack in Central Atrium Behind North Stairs - 26/1/20*

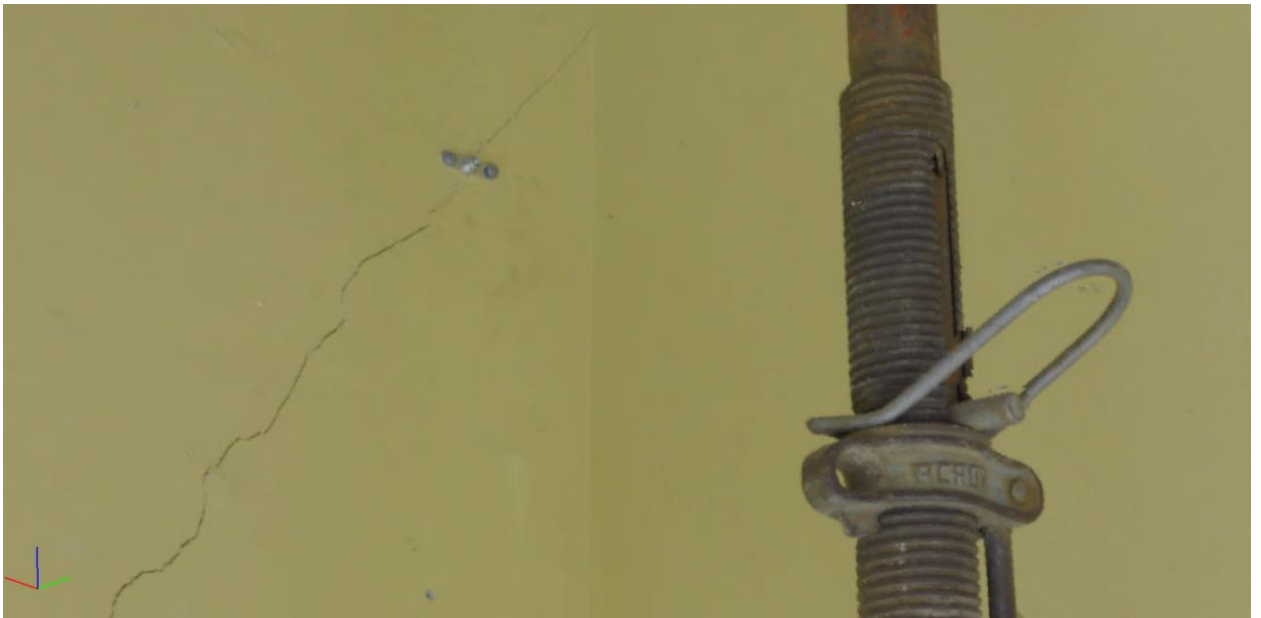
Crack with what appeared to be a crack gauge on it was present behind the south stairs. The gauge has been drilled in, and there is cracking around one of these fixings. I note that will cause the gauge to give unreliable results. I note the crack including the cracking around the fixing was present in 2020. This should still be measured and compared, although the results may not provide much reliable information.

*Figure 5 - Crack behind South Stairs in the Central Atrium - 2020 Jetstream*

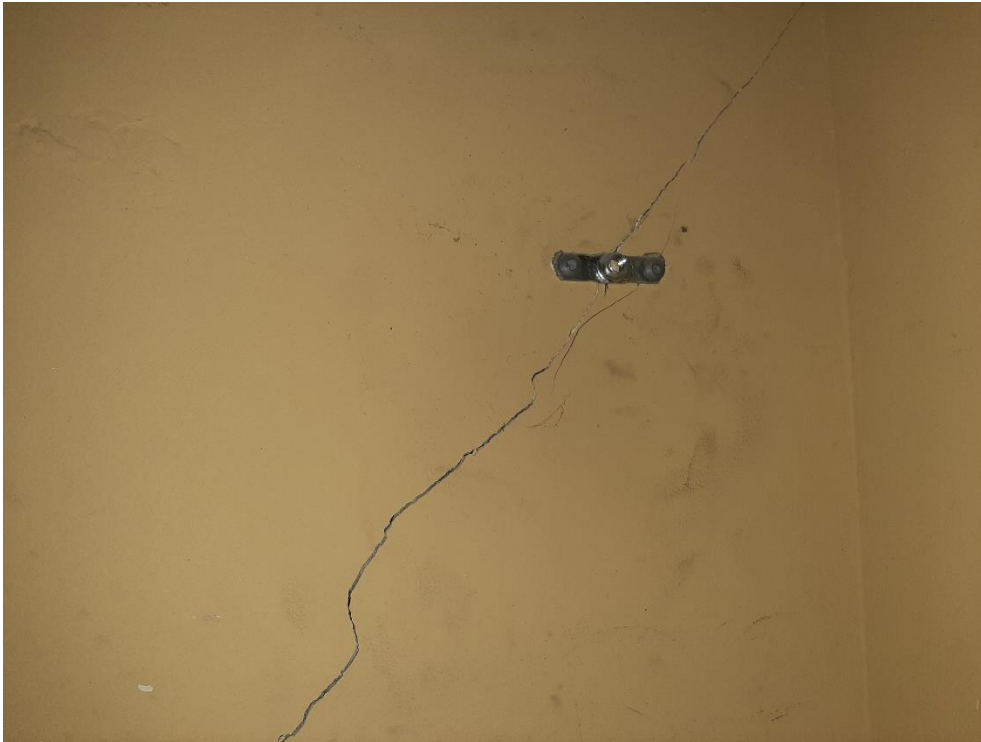
*Figure 6 - Crack behind South Stairs in the Central Atrium - 26/1/21*

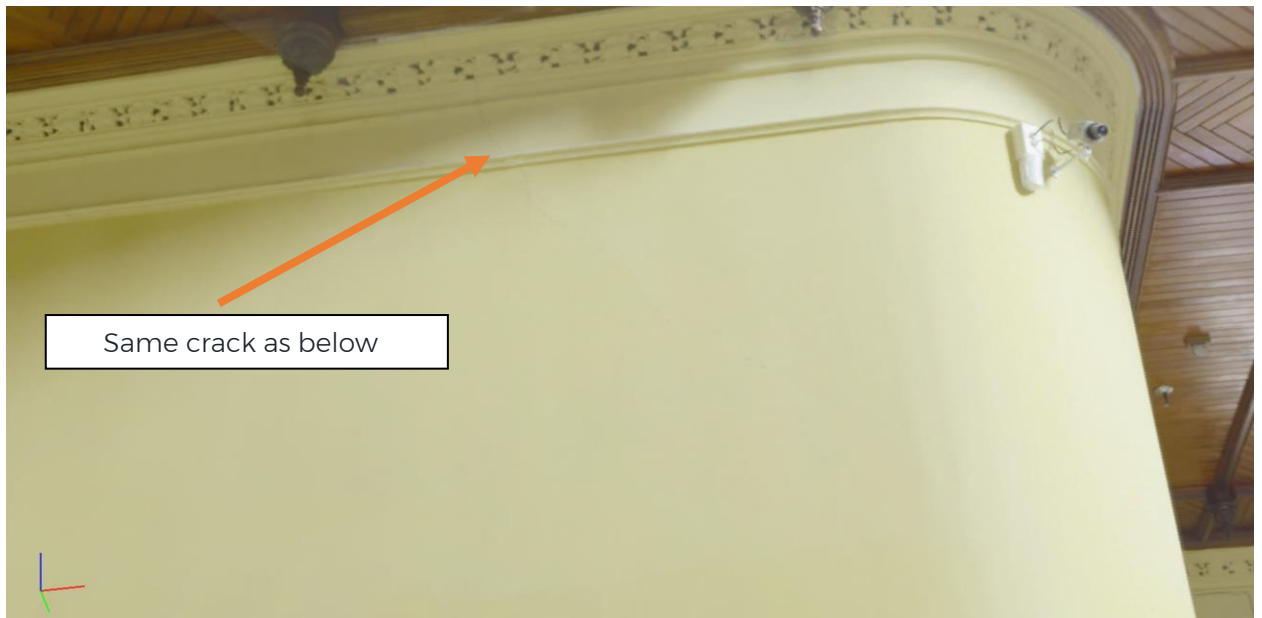
A crack going right through a pumice concrete wall is present on a south west ground floor wall of the central atrium, as per the pictures. The crack appears to extend further on the 26/1/21, although this may be the resolution of the Jetstream image. Further photos need to be sourced if possible.

*Figure 7 - Crack in SW of central atrium - Jetstream 2020*

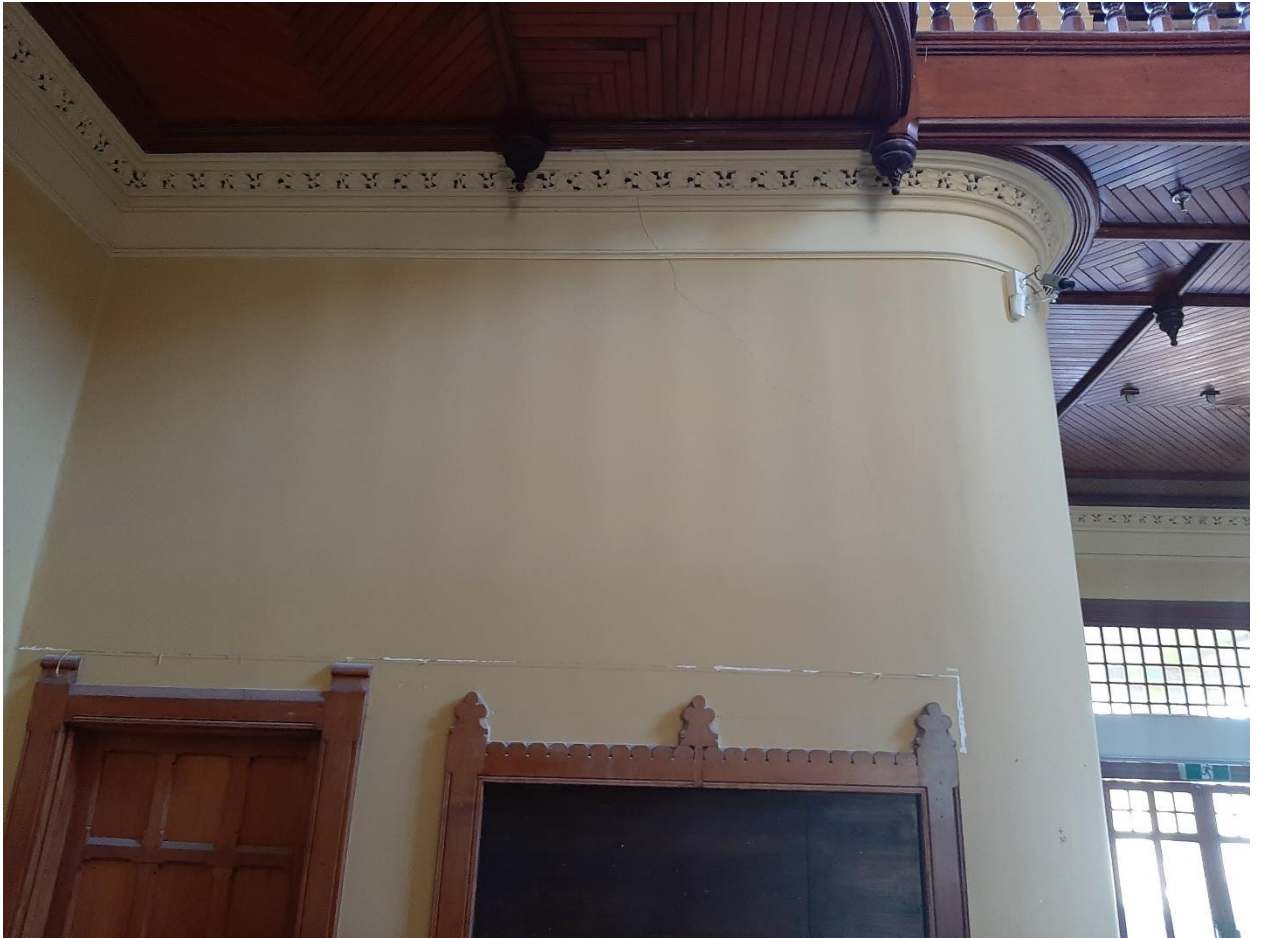
Figure 8 - Crack in SW of central atrium - 26/1/21

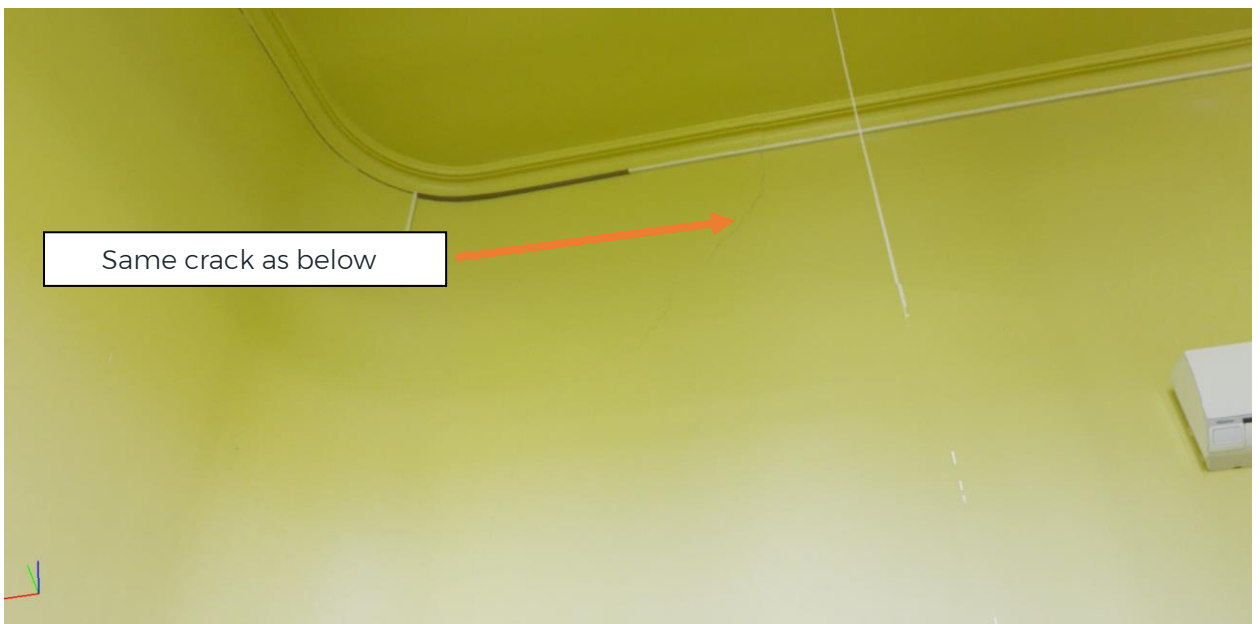
Figure 9 - Crack in SW of central atrium - Jetstream 2020, reverse side

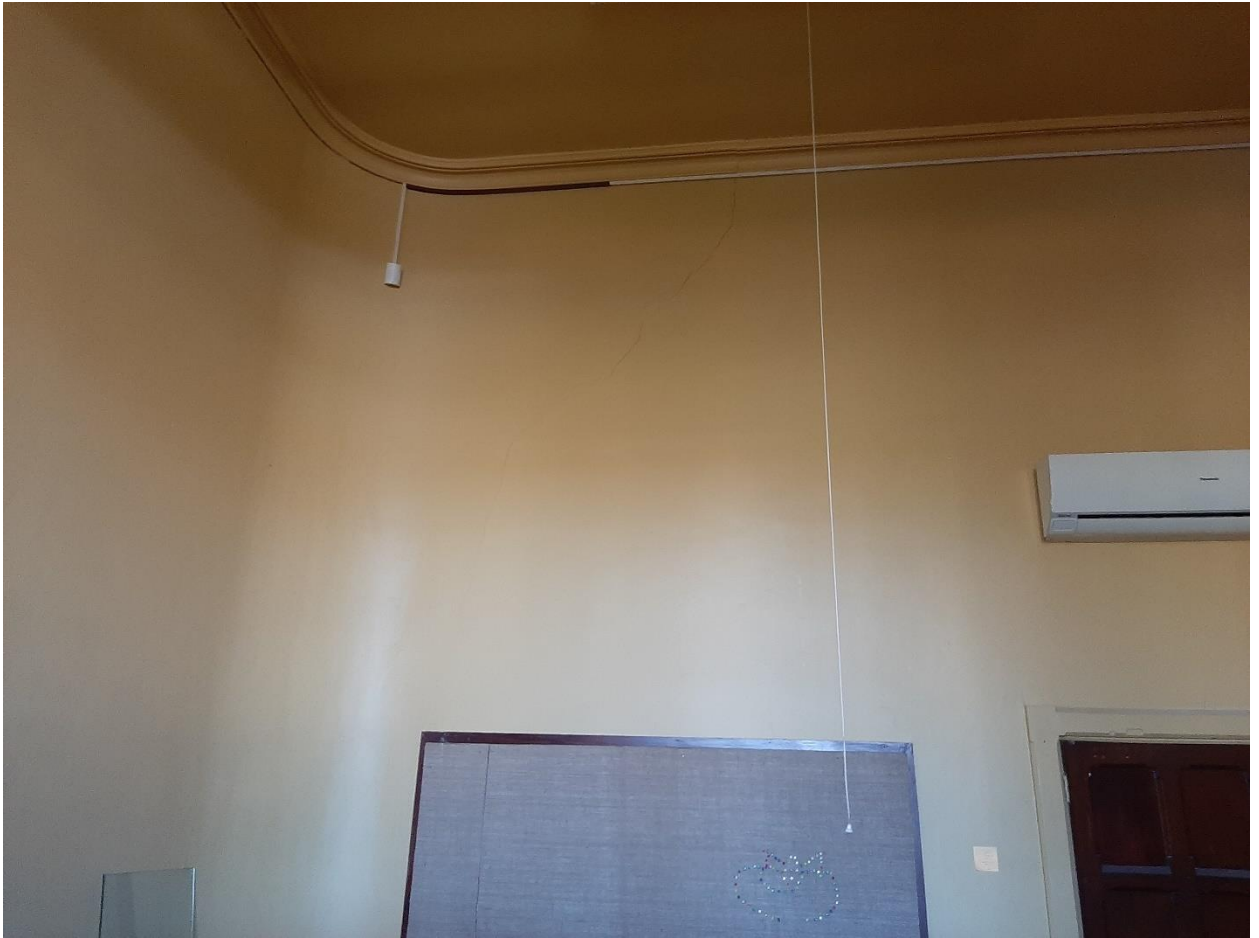
Figure 10 - Crack in SW of central atrium – 26/1/21, reverse side

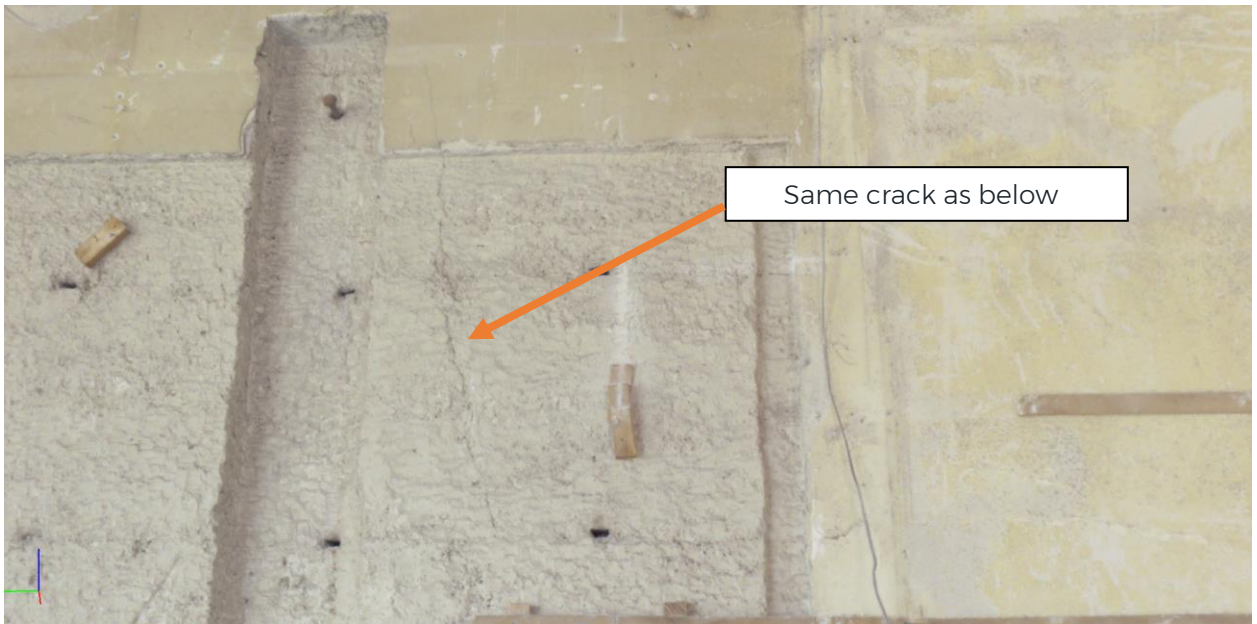
Cracks present in sections of exposed walls. These were visible on the 2020 Jetstream. The cracking in this area is less concerning than that documented in previous section.

Figure 11 - Crack in SE of Mezzanine – 2020 Jetstream

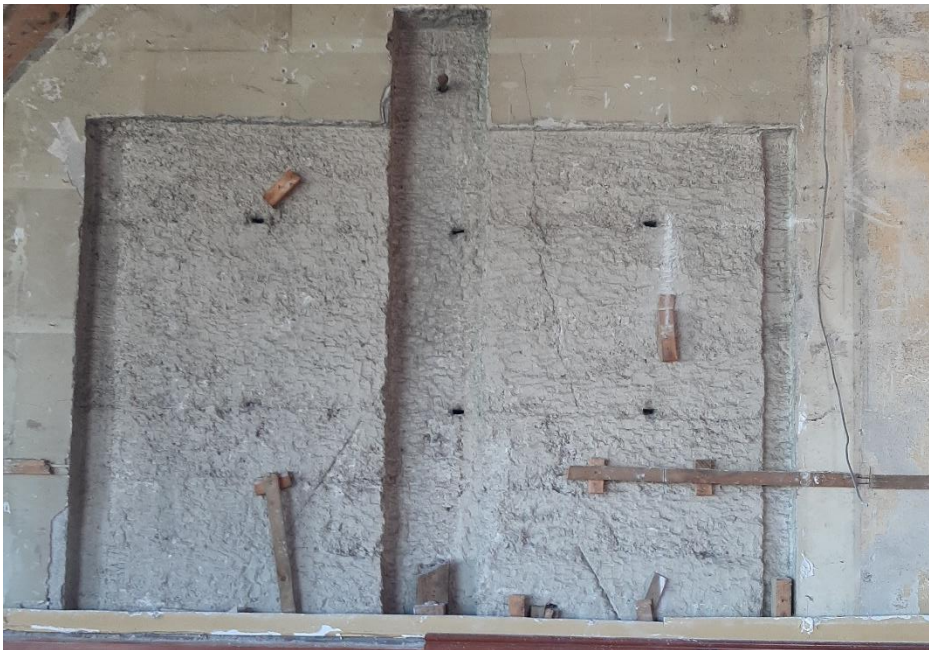
Figure 12 - Crack in SE of Mezzanine - 26/1/21

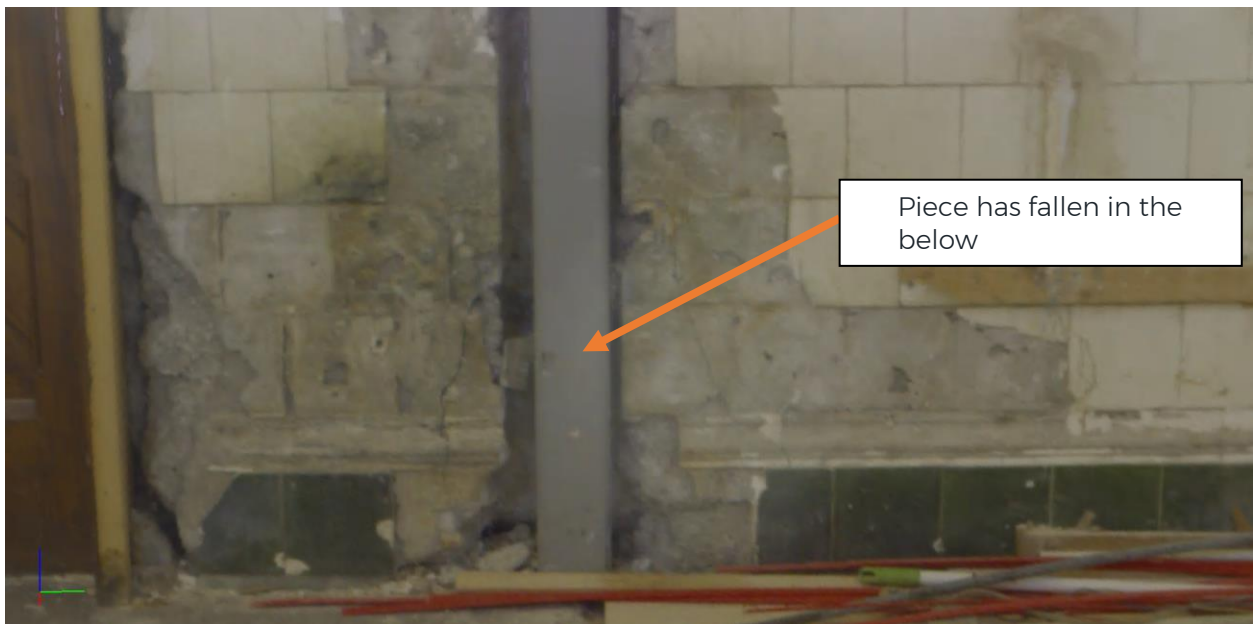
Cracks present. Detritus present in the largest crack and was visible on Jetstream. There was nothing in this area more concerning than present elsewhere. One very loose piece had fallen out between the Jetstream and the site inspection on the 26<sup>th</sup>. It's possible this was caused by the earthquake, but it's also possible it was dislodged by workers who have been

There was a small amount of plaster on the floor beside some cracks, indicating movement may have occurred, however, some of that was visible in the Jetstream data, indicating it may have more to do with the demolition work than the earthquake.

*Figure 13 - Int. North Wing 2020 Jetstream*
