6 April 2021

Rotorua Lakes Council  
1061 Haupapa Street  
Rotorua 3010

## **Rotorua Museum - Earthquake Rapid Assessment**

2-82142.00

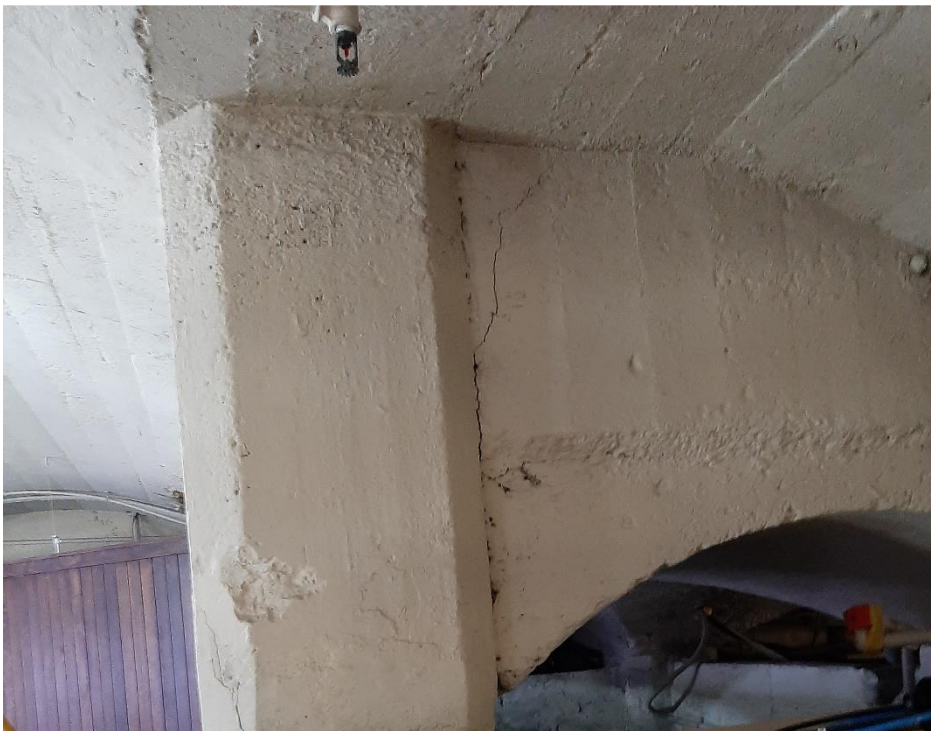
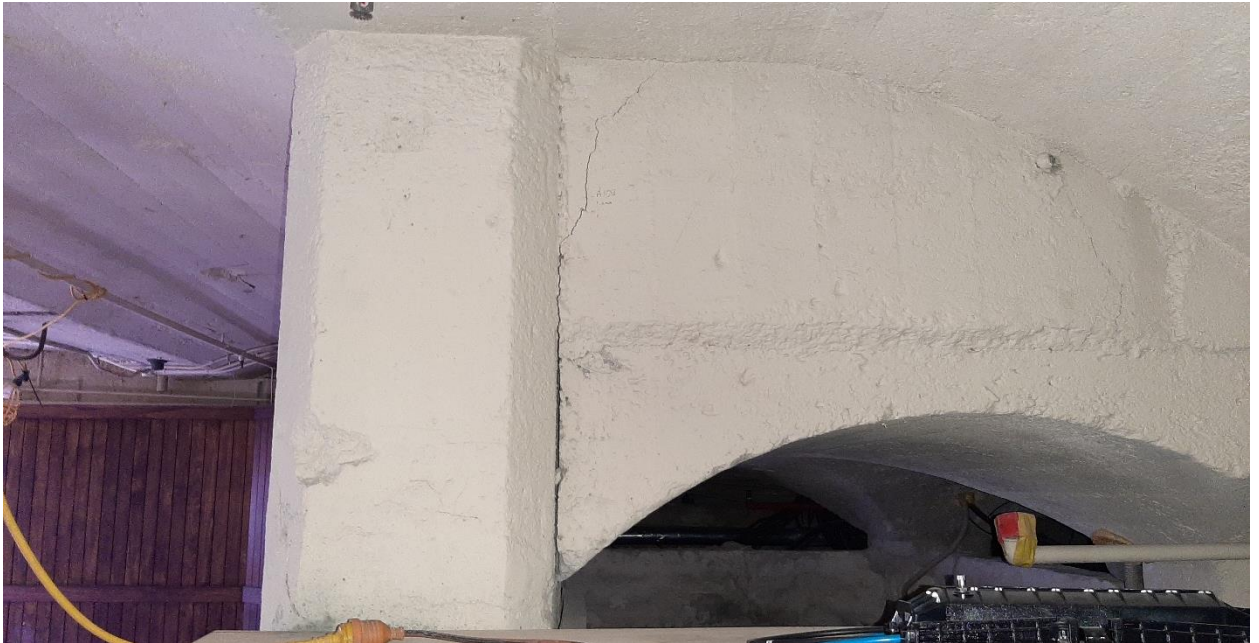
Cracks observed were significant although not obviously different than previous.

*Figure 1 - Crack in basement structure -26/1/21 inspection*

Figure 2 - Crack in basement structure -5/3/21 inspection

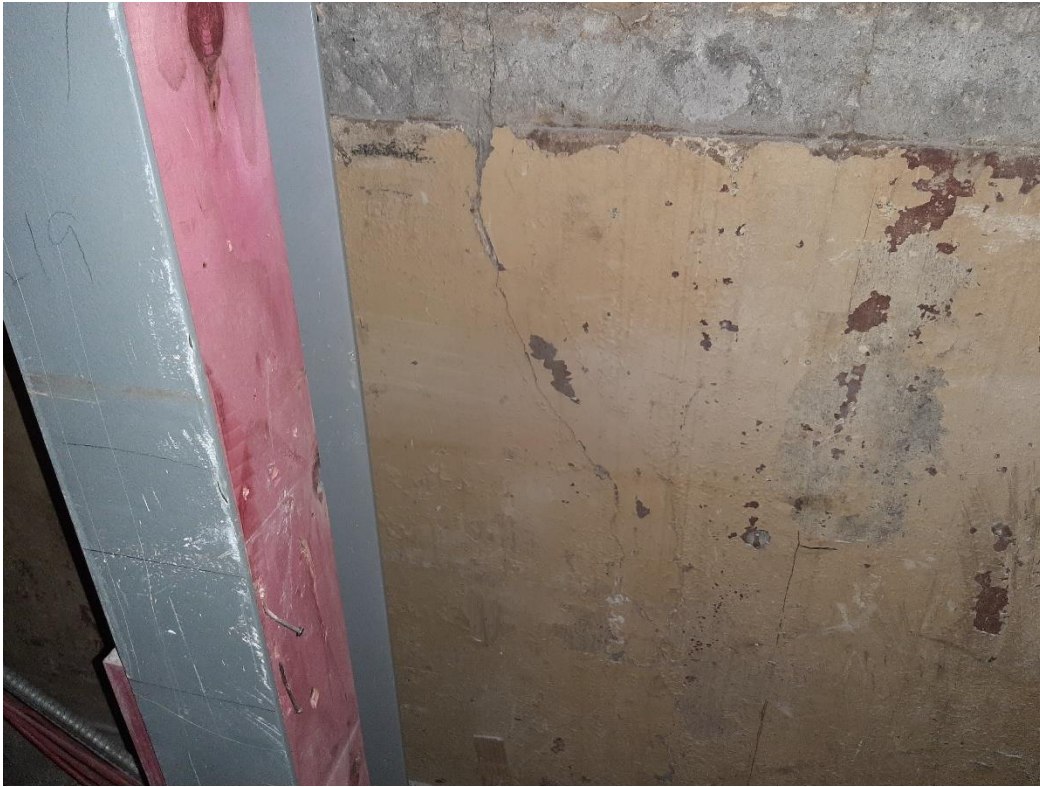
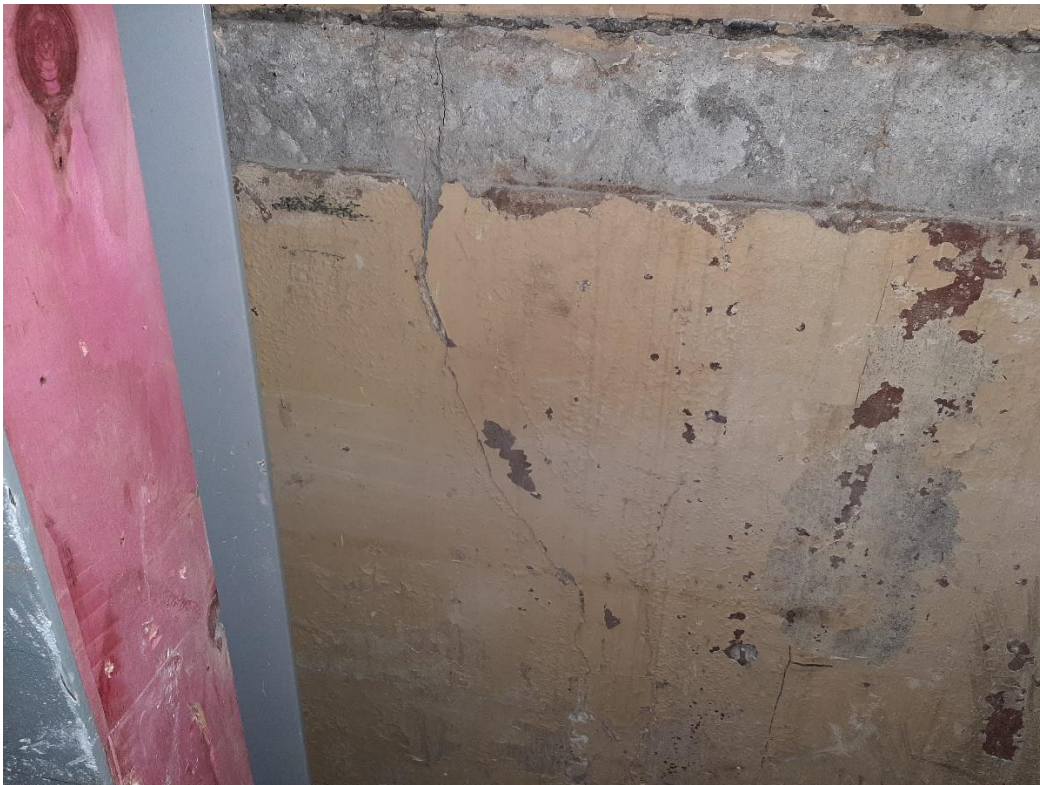
Cracking of the 1.2m high unreinforced nib walls visible. Some loose material was present at the top of the cracks. Cracks similar to those previously observed.

Figure 3 - Image from 26/1/21 inspection

Figure 4 - Image from 5/3/21 inspection

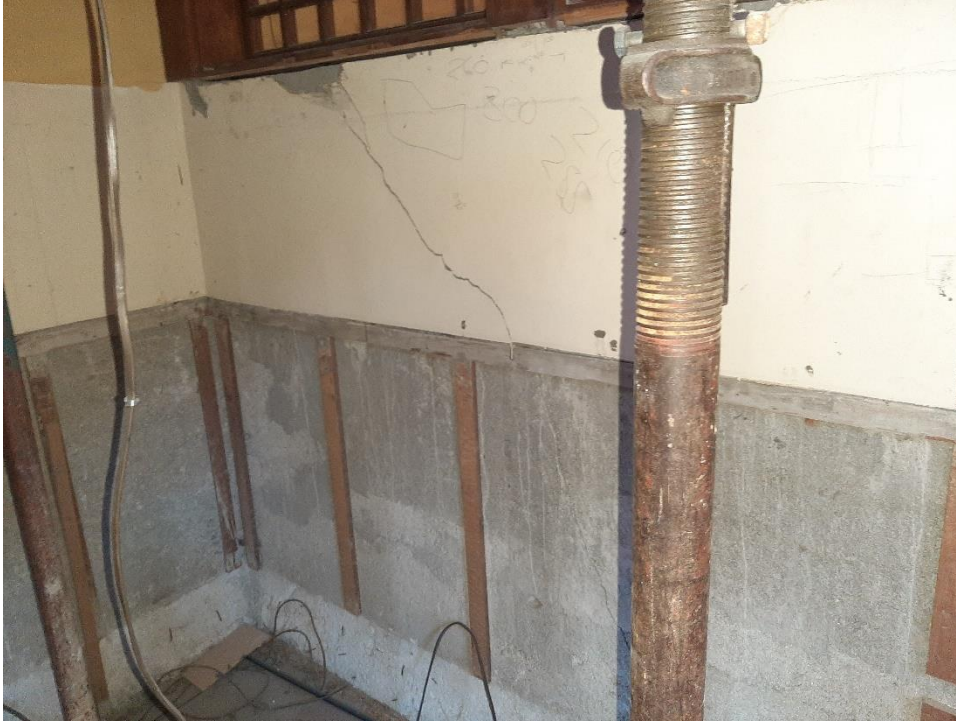
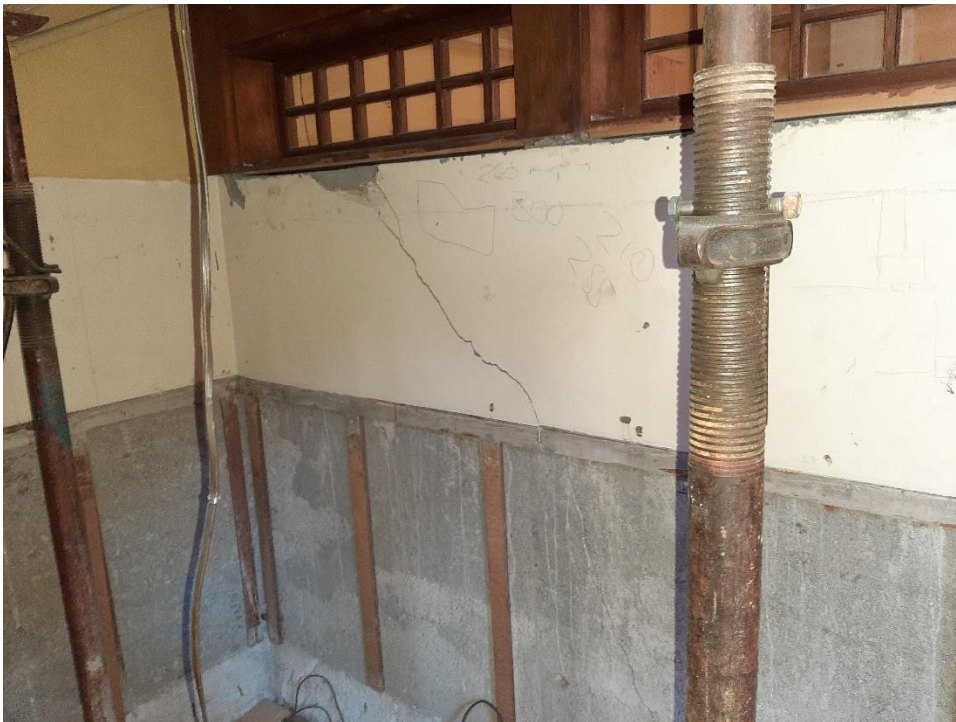
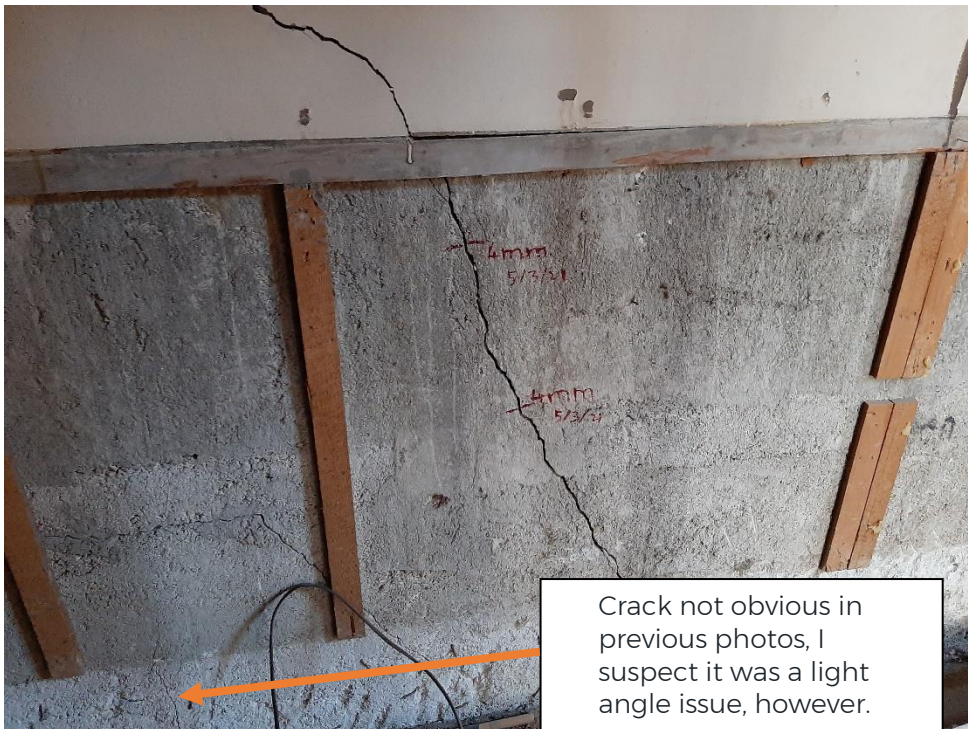
Large crack behind the north stairs. Appeared similar to previous. Crack widths added and recorded on structure.

*Figure 5 - Crack in Central Atrium Behind North Stairs - 26/1/21*

*Figure 6 - Crack in Central Atrium Behind North Stairs from 5/3/21 inspection*

Figure 7 - Crack in Central Atrium Behind North Stairs from 5/3/21 inspection with width marks

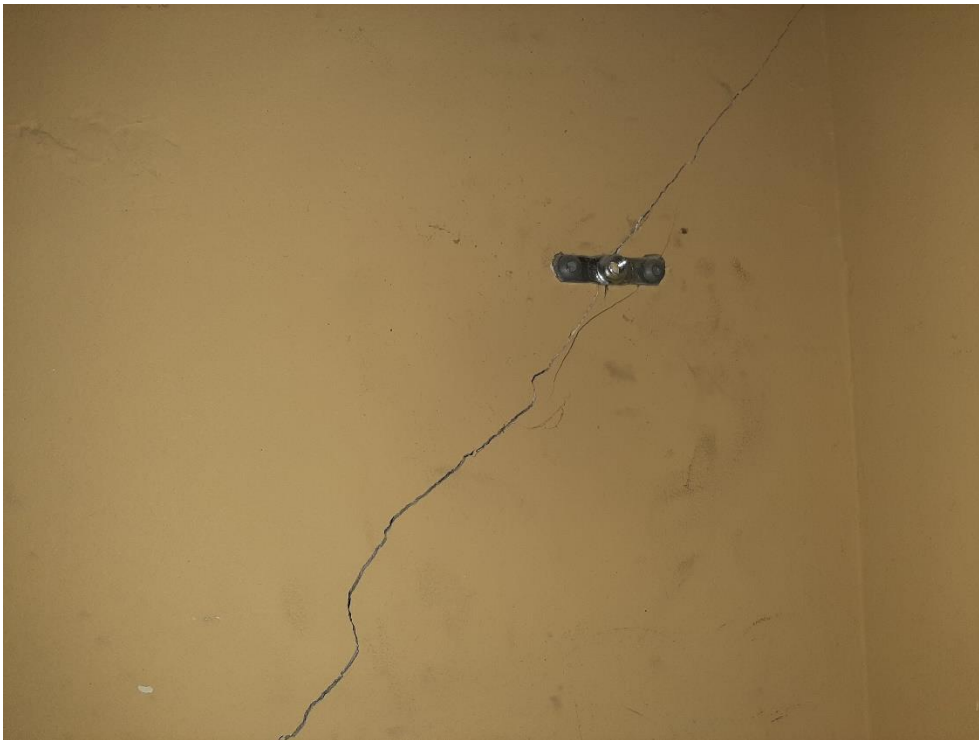
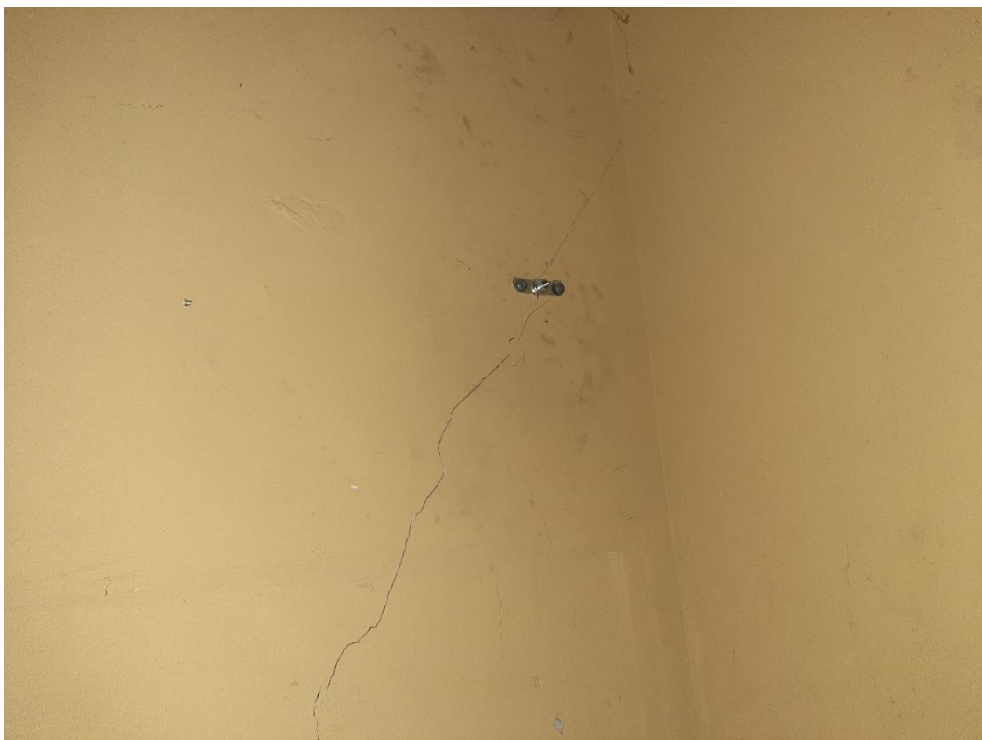
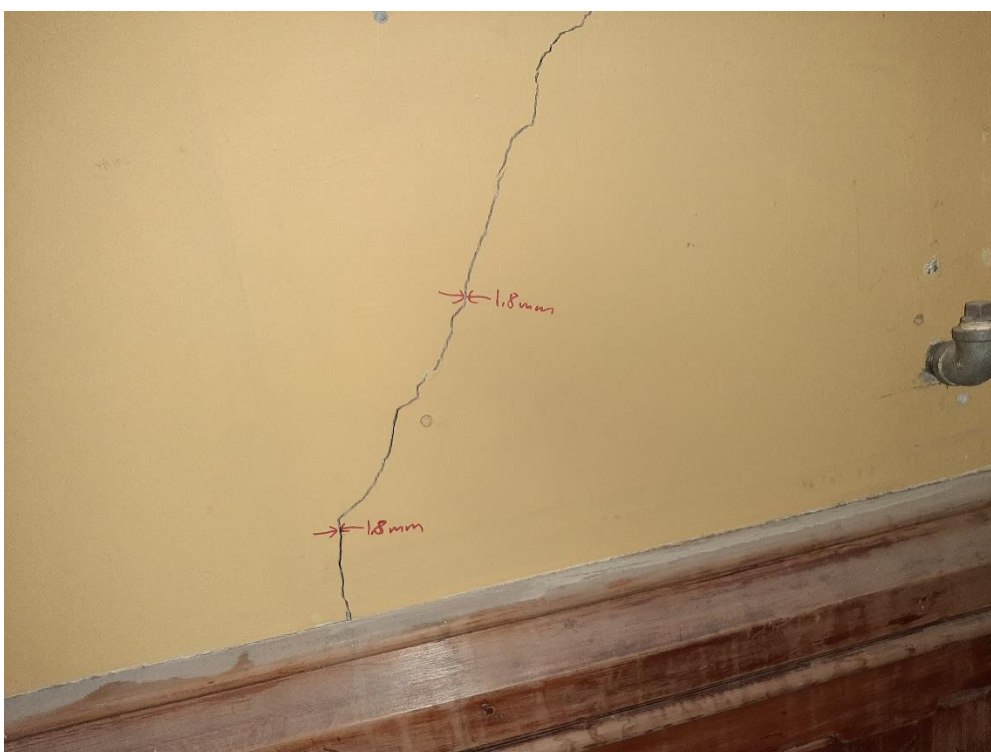
Crack with what appeared to be a crack gauge on it was present behind the south stairs. Cracks appeared similar to previous inspection. Crack widths added and recorded on structure.

Figure 8 - Crack behind South Stairs in the Central Atrium - 26/1/21

Figure 9 - Crack from 5/3/21 inspection

Figure 10 - Widths marked on above crack behind south stairs in central atrium 5/3/21

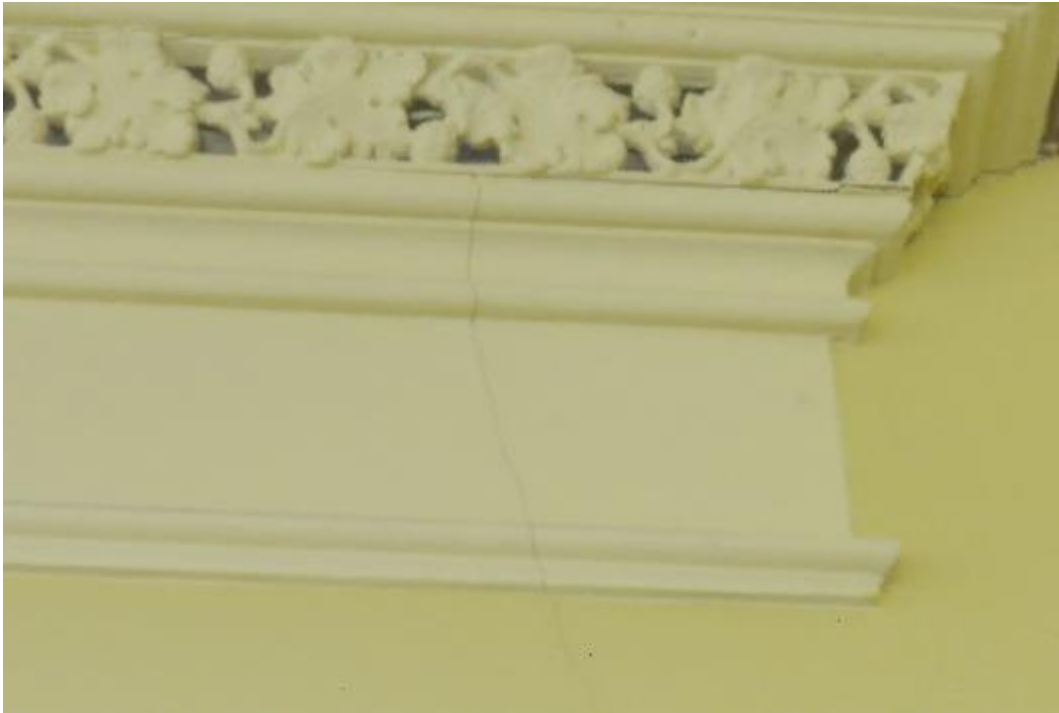
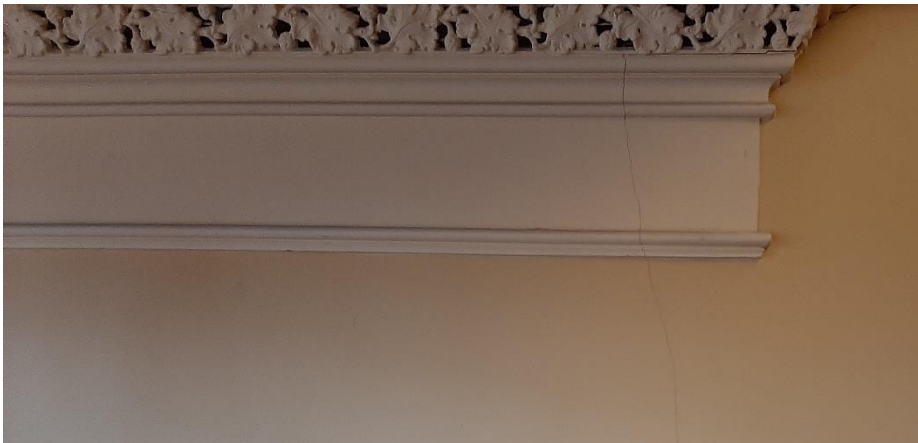
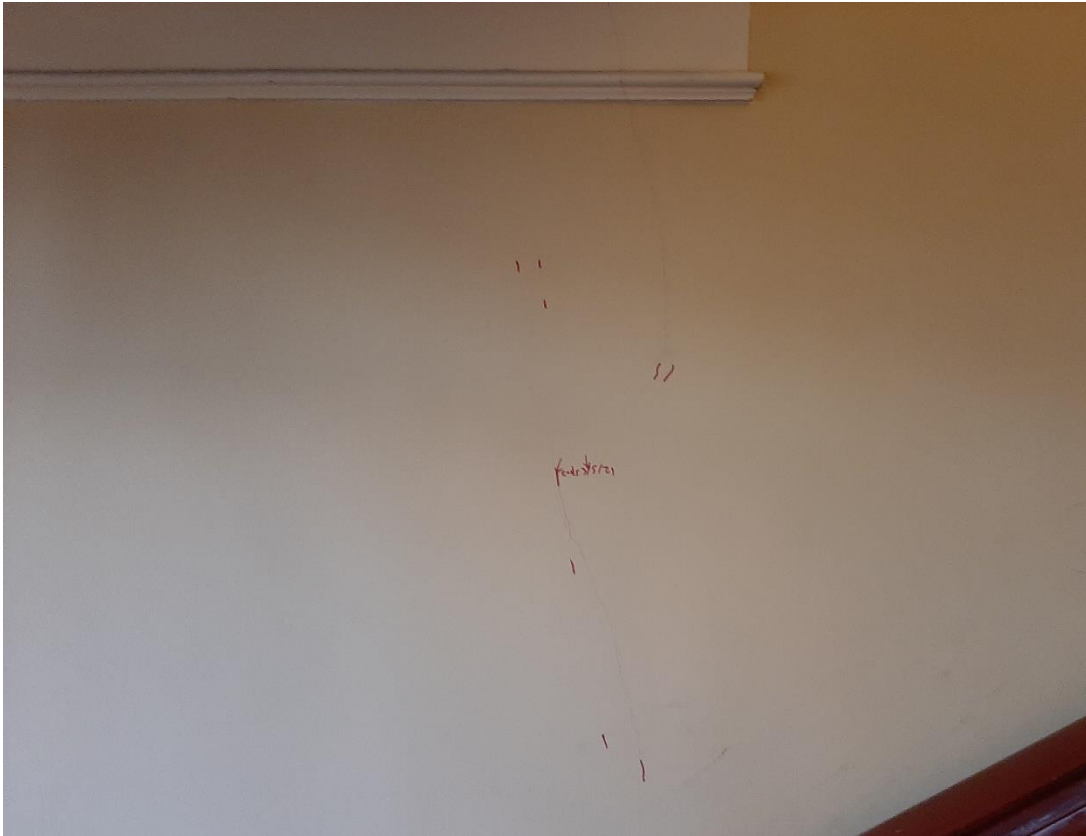
Cracks were noted about halfway up the north stairs on the left facing up the stairs. These were present in the Jetstream data. The extent of this cracking was marked on the structure.

*Figure 11 - Halfway up north stairs to mezzanine - Jetstream*

*Figure 12 - Halfway up north stairs to mezzanine- From 5/3/21 inspection*

*Figure 13 - Halfway up north stairs to mezzanine - crack extents marked*

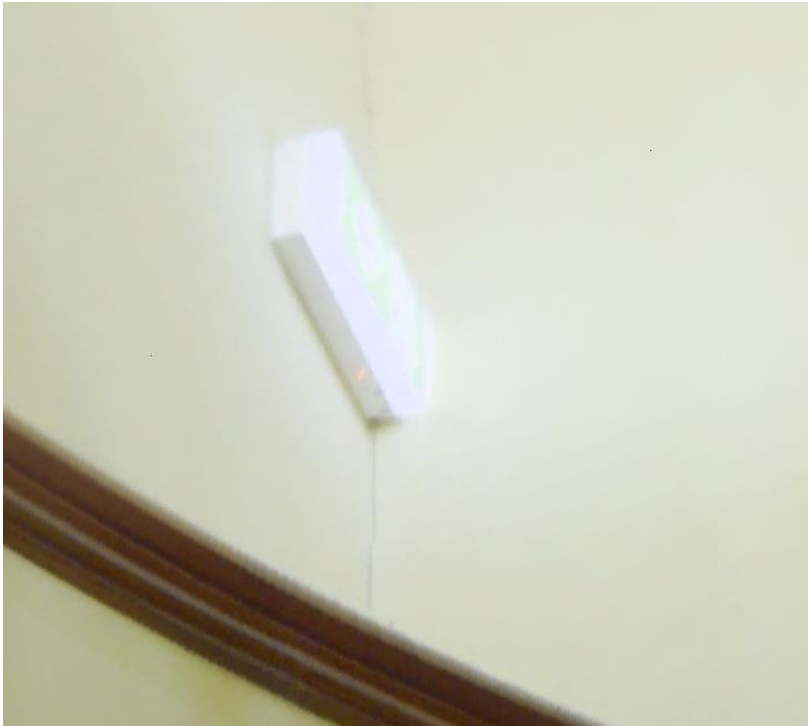
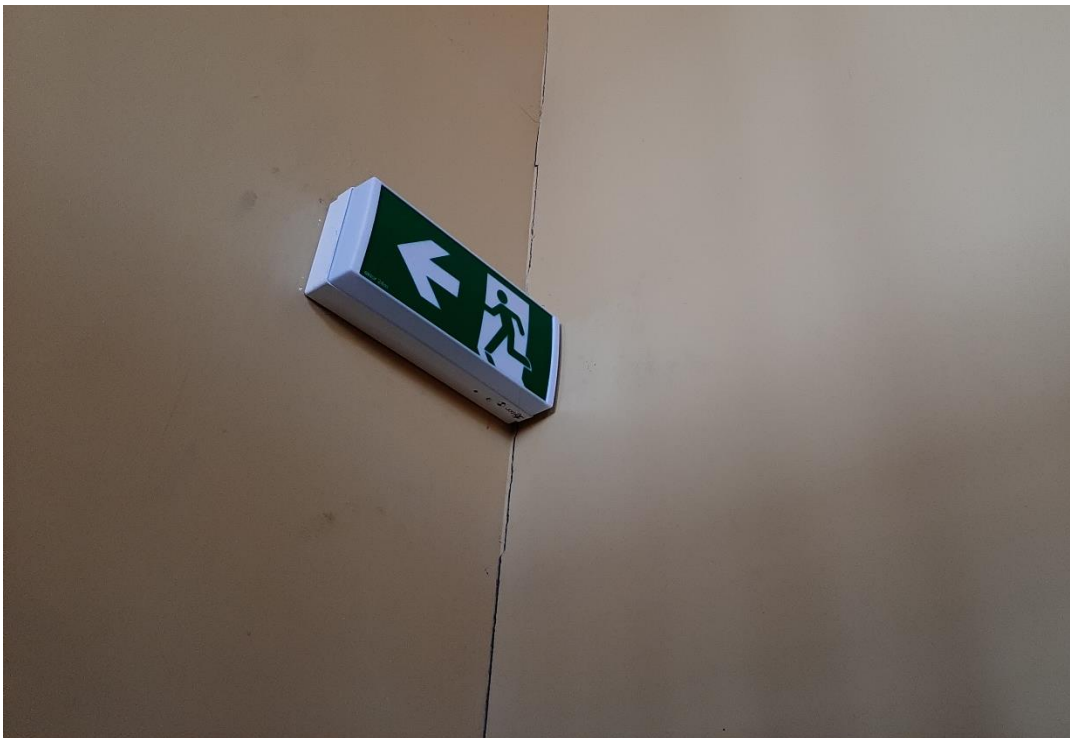
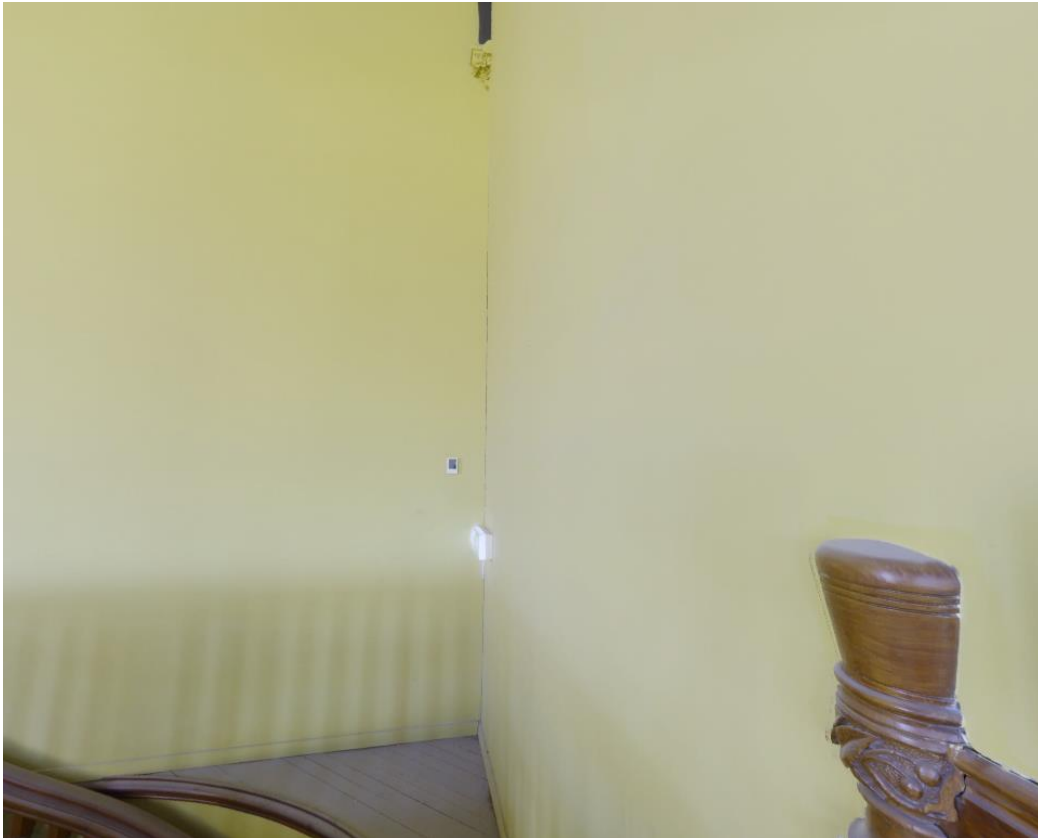
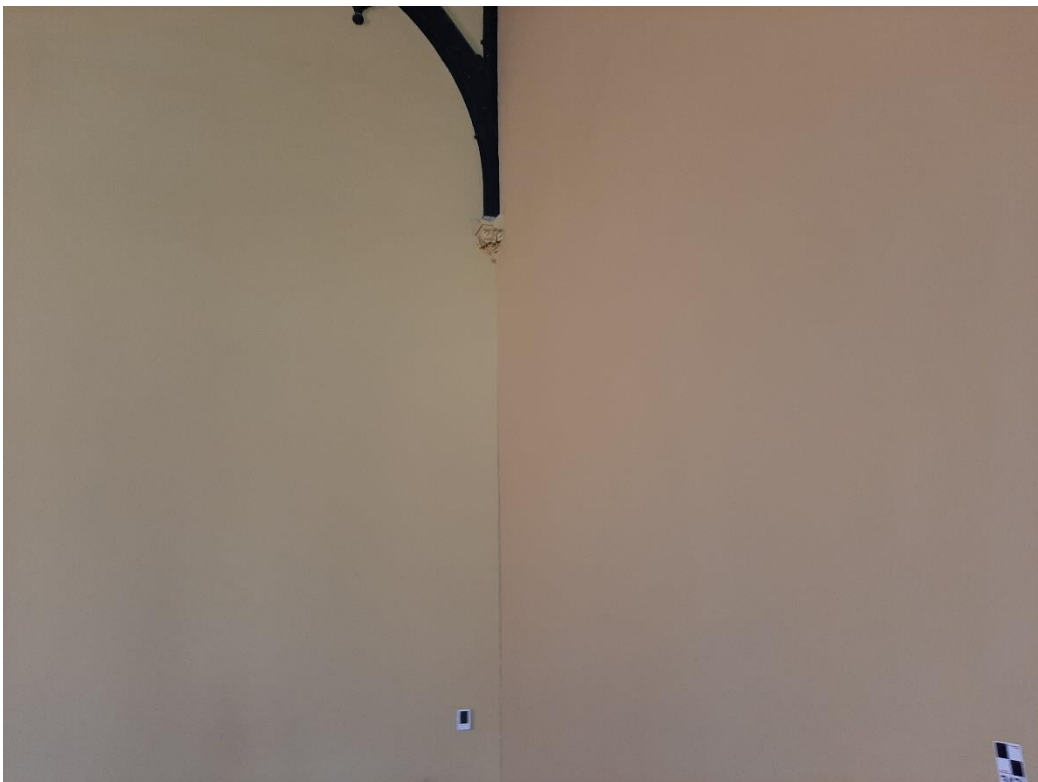
Cracking was noticed at the corner of the tops of both sets of stairs to the mezzanine as per below, between two pumice concrete shear walls at right angles. The cracking on both sides was present at the time of the Jetstream survey. To the extent possible in comparing images, the south side cracks appear similar. It is possible that the cracking on the north side is now more significant, but it is also possible that a combination of the light angles and resolution issues mean the crack is less visible in the previous Jetstream images. The crack is clear on the north side in the Jetstream images below the fire exit sign, but it is more difficult to make out above. If the crack has widened marginally, it likely would not change the seismic capacity of the building substantially.

Figure 14 - Top of north stairs to mezzanine - Jetstream

Figure 15 - Top of north stairs to mezzanine - 5/3/21 inspection

Figure 16 - Top of South stairs to mezzanine - Jetstream

Figure 17 - Top of South stairs to mezzanine - 5/3/21 inspection

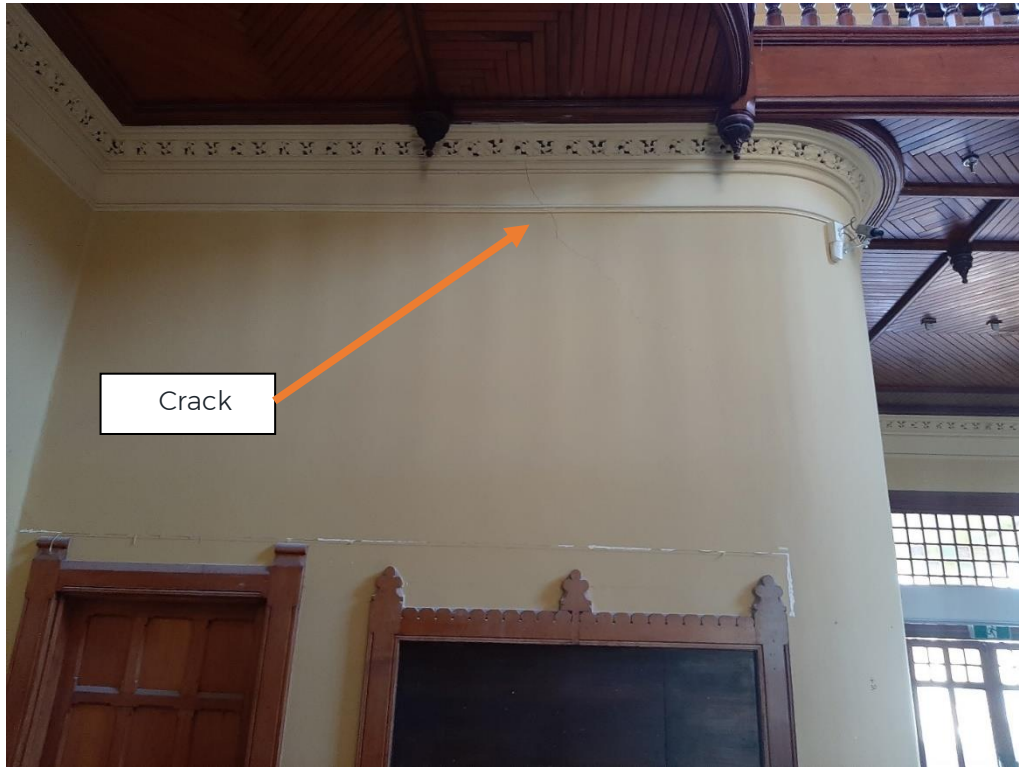
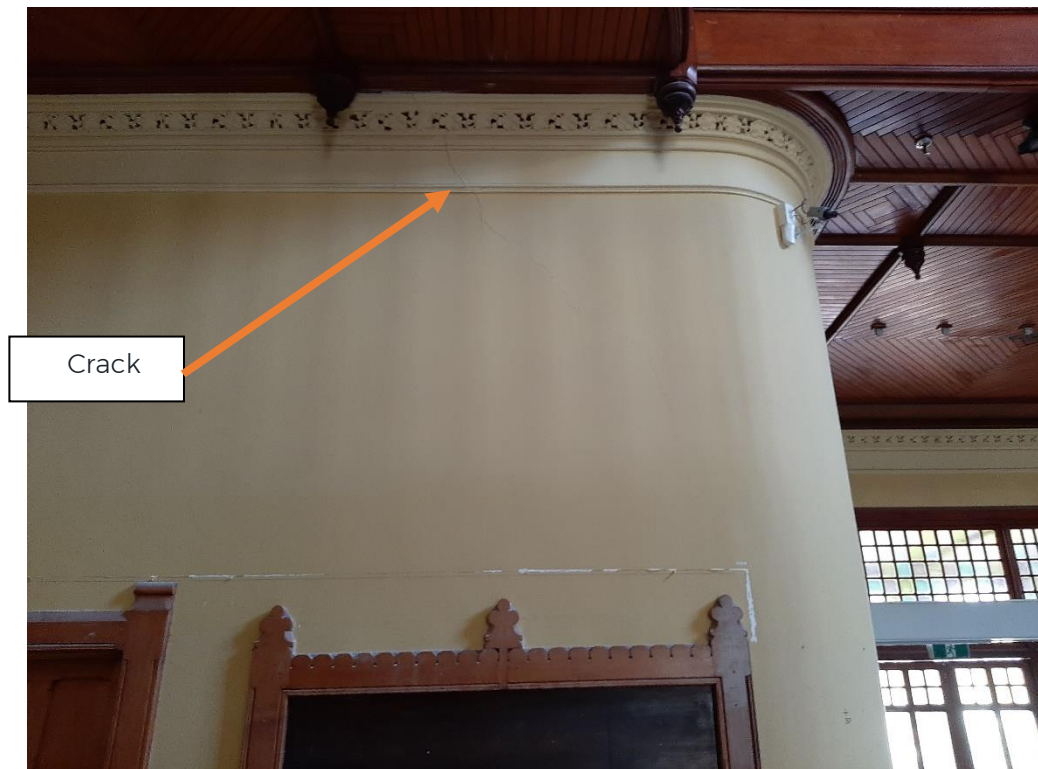
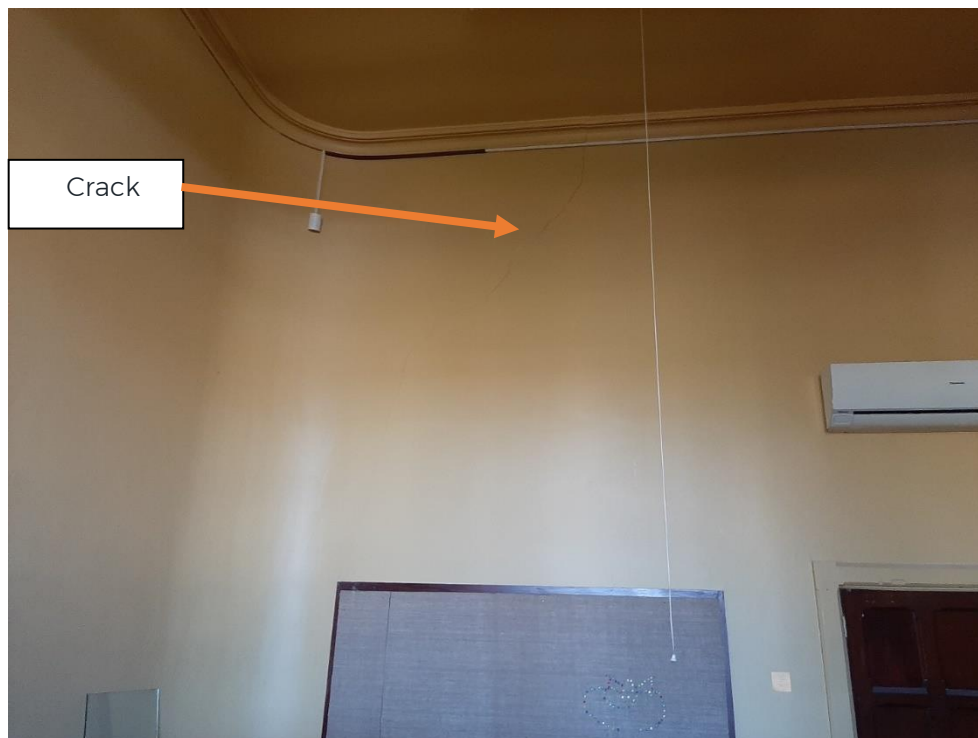
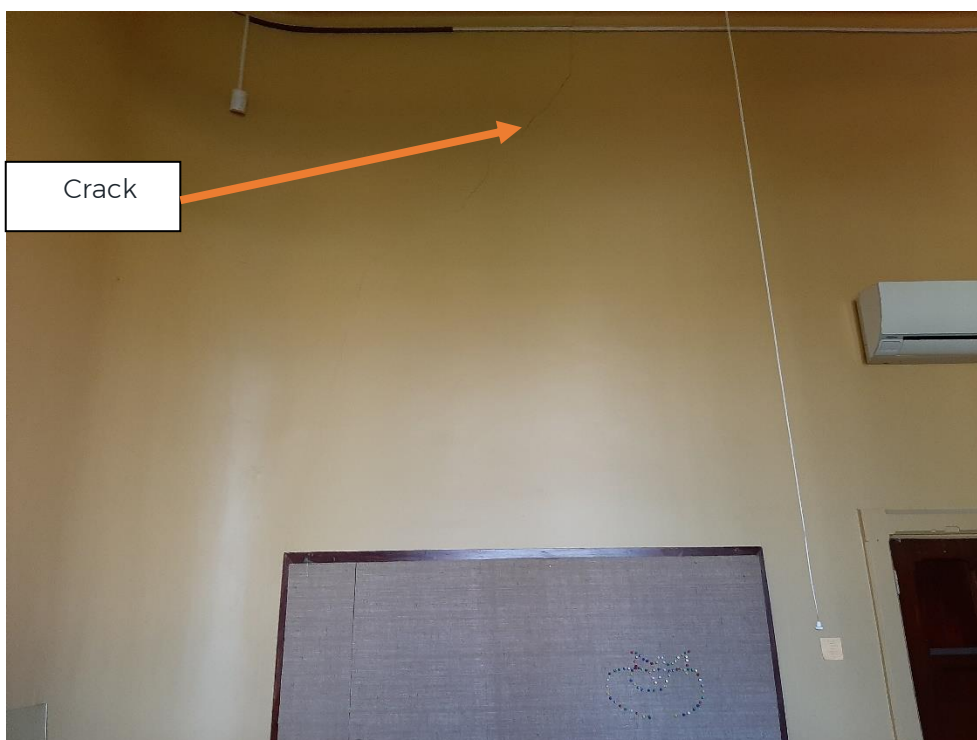
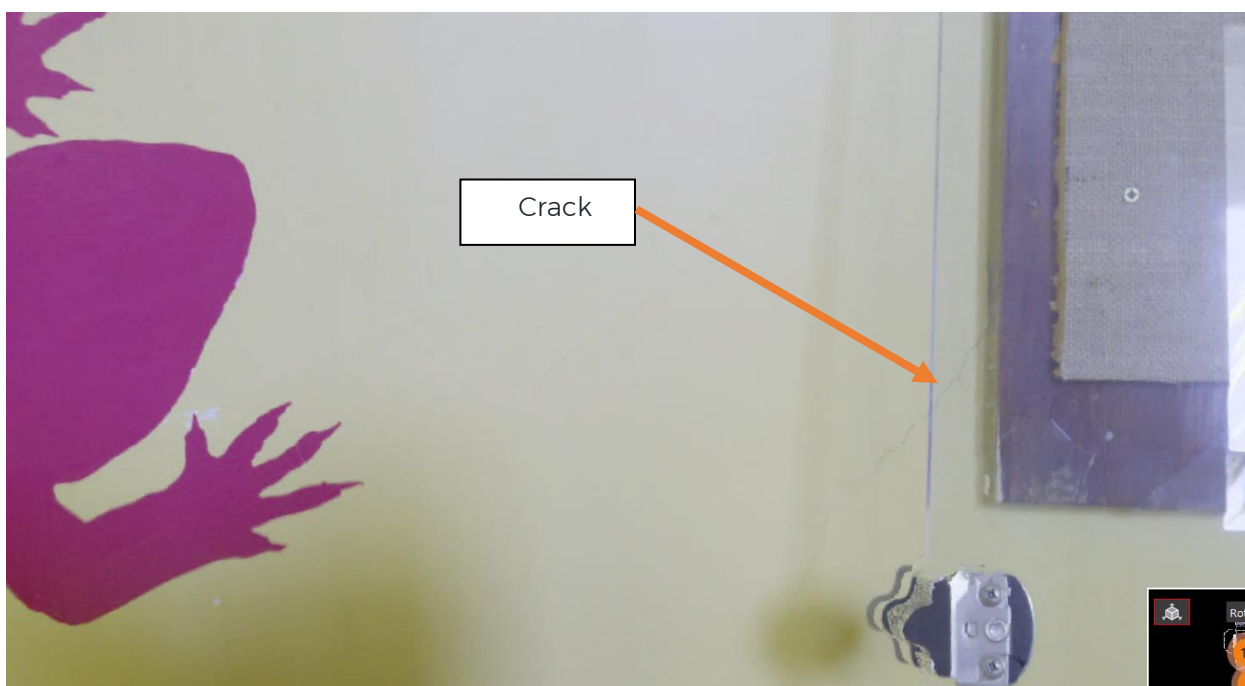
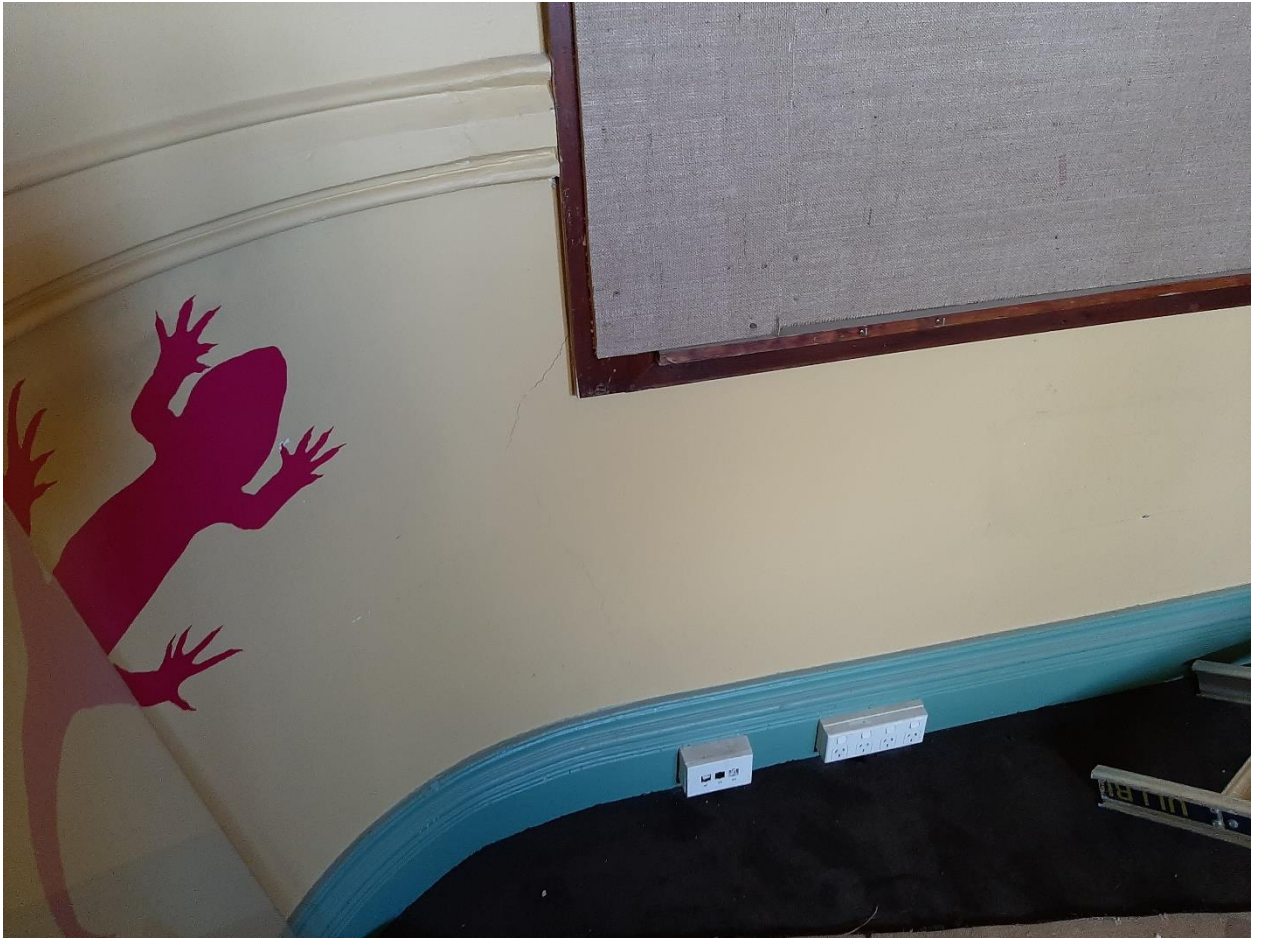
A crack going right through a pumice concrete wall is present on a south west ground floor wall of the central atrium, as per the pictures. I noted on the previous report that the crack appeared to extend further on the 26/1/21, although it was possible it was a resolution issue. Comparing photos of this inspection the cracks seem similar to previous. This crack is fairly significant and worth monitoring.

*Figure 18 - Crack in SW of central atrium - 26/1/21*

Figure 19 - Crack in SW of central atrium - 5/3/21

Figure 20 - Crack in SW of central atrium - 26/1/21, reverse side

Figure 21 - Crack in SW of central atrium - 5/3/21, reverse side

Figure 22 - Crack in SW of central atrium - Jetstream - reverse side - crack almost reaches base

Figure 23 - Crack in SW of central atrium - 5/3/21, reverse side - crack almost reaches base

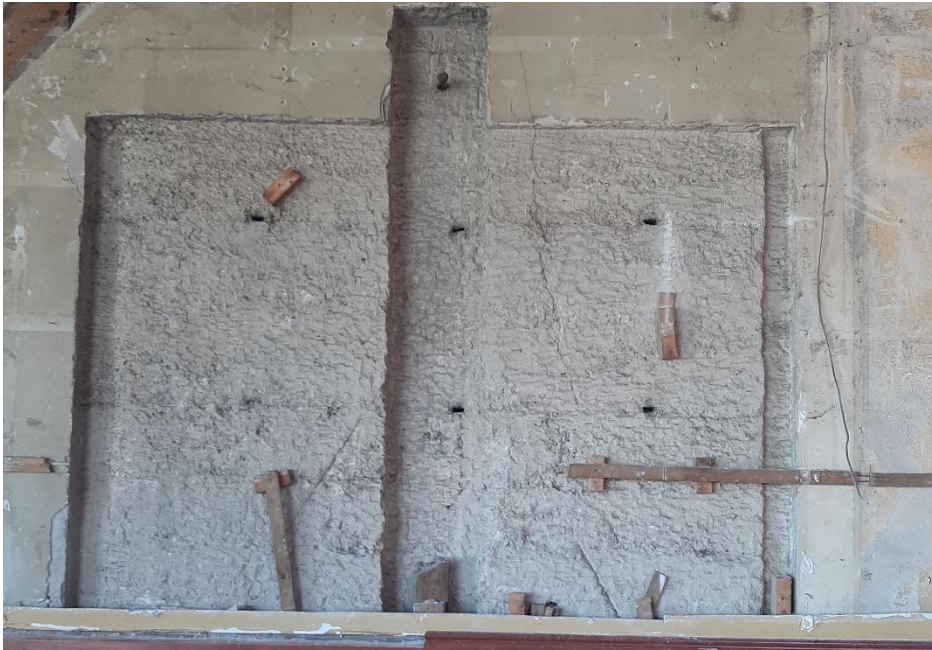
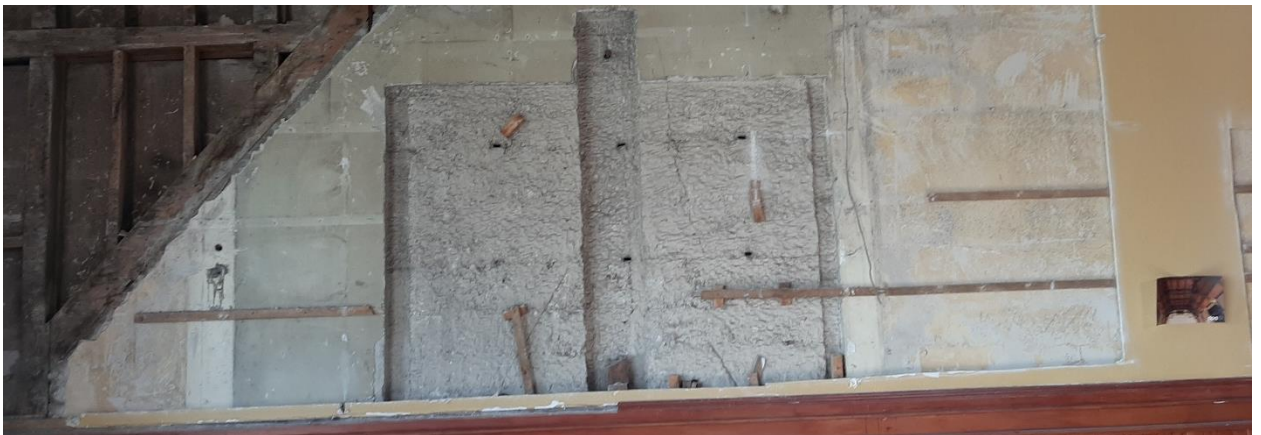
Cracks present in sections of exposed walls. These appeared similar to previously observed.

Figure 24 - Crack in SE of Mezzanine - 26/1/21

Figure 25 - Crack in SE of Mezzanine - 5/3/21

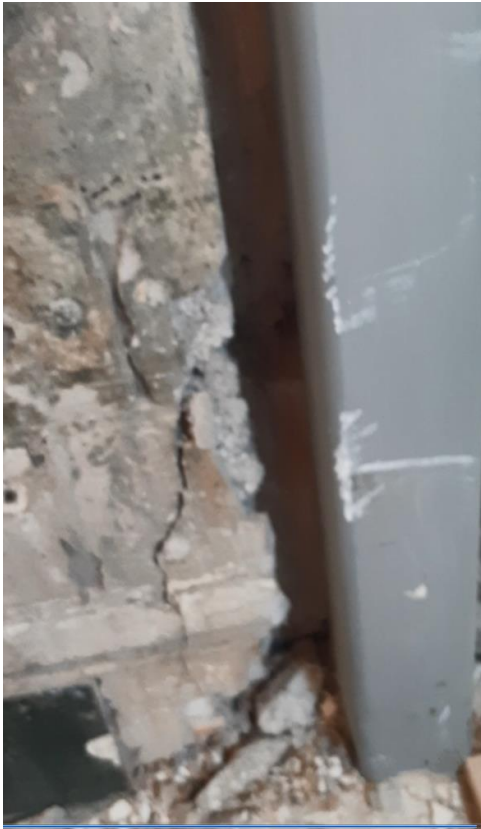
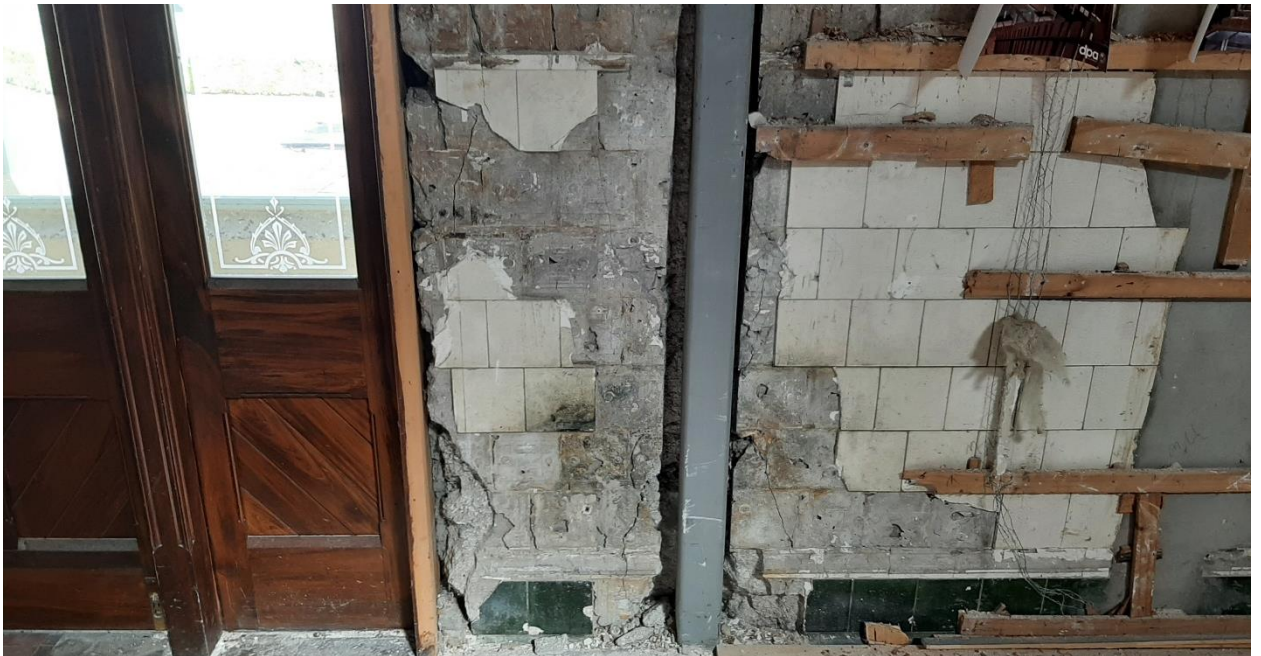
Cracks present. Cracks appeared to be similar to how they were during the previous inspection.

Figure 26 - Int. North Wing 26/1/21

Figure 27 - Int. North Wing - 5/3/21 inspection
