Linton Park East Flood Detention Pond - Dam Safety Assessment

- Proposed remedial works to address dam safety deficiencies

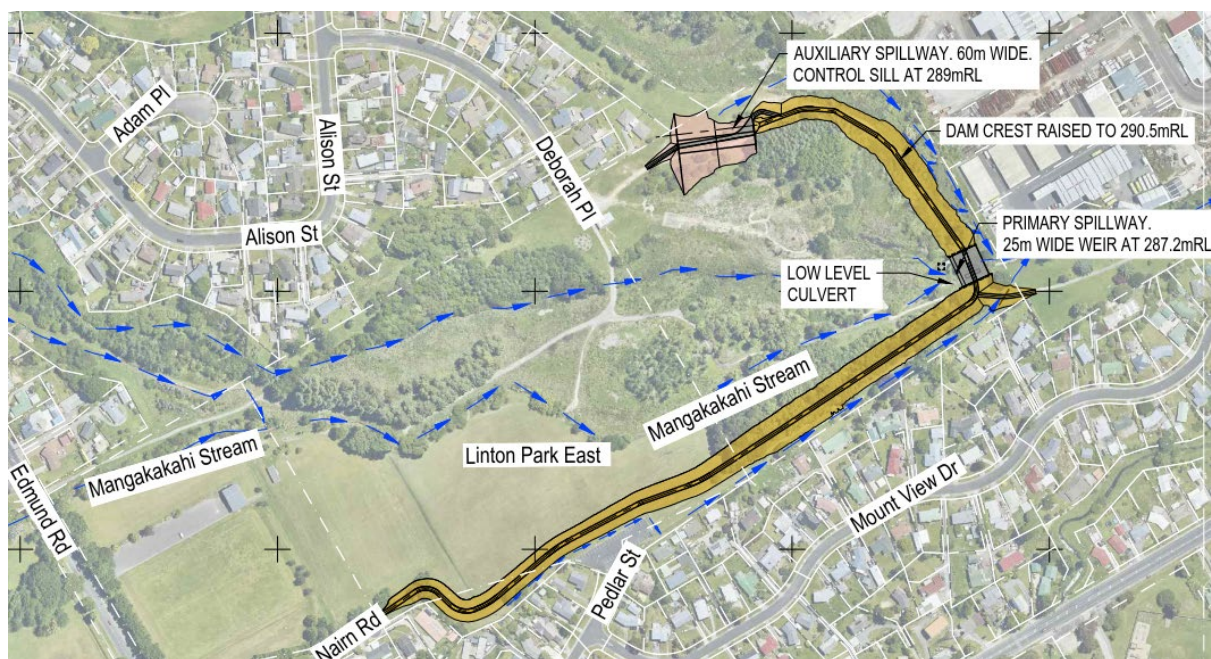
Figure 6.1: Proposed remedial works layout

The layout of the proposed works is shown in Figure 6.1.

Given the deficiencies associated with the existing dam, it is proposed to remediate the dam on the same site. The remediation will essentially involve removing the existing dam and replacing it with one that meets current recommended practice for engineering and dam safety. The proposed remediation also includes provision for peak flows to increase over the next 100 years due to intensification in the catchment, and due to expected increases in rainfall intensities associated with climate change.
