Technical Report

# Hemo Gorge Sculpture As Built Testing and Installation Report

GU7231-801 P1

Circulation: Rotorua Lakes Council, File  
Author: James Ledingham

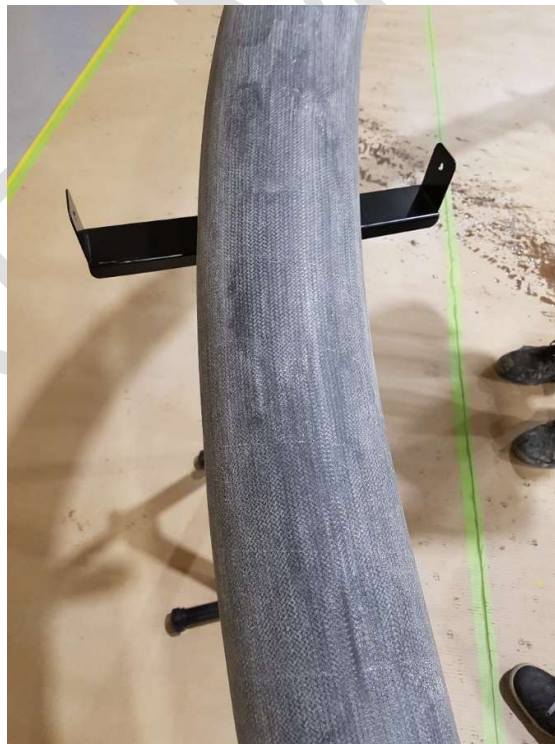
During the visits to Kilwell Fibretube several of the individual tubes were able to be inspected between lamination stages. Where observed defects were pointed out and remedial action was requested and supported with laminate repair specifications. The e-glass sock layers observed (outer tubes, final e-glass layer) did not show any significant dryness, see below.

Figure 1. Example of outer tube final e-glass sock layer during manufacture

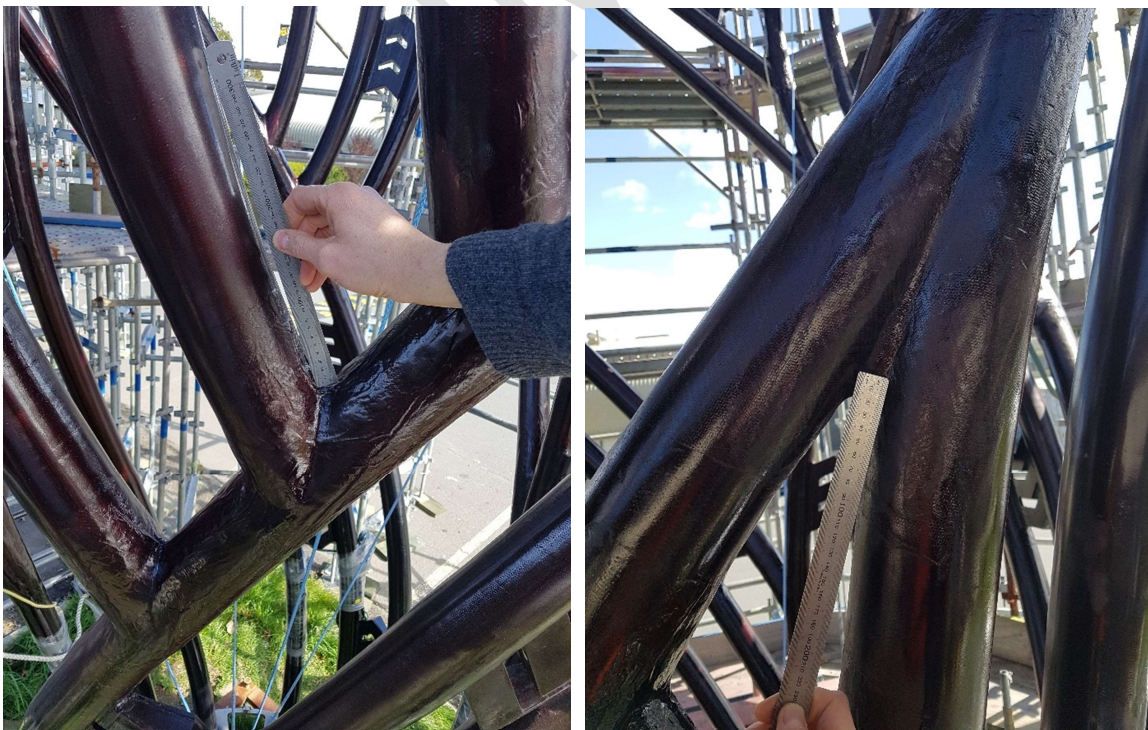
Overall, the visual quality of the taping at the tube connections was lower than expected with a high level of wrinkling in many of the taping laminates. Inspection of the wrinkles indicated that they appeared and sounded solid. i.e. they are full of resin, rather than being an air gap/void.

Figure 2. Example of inner tube connection taping checks

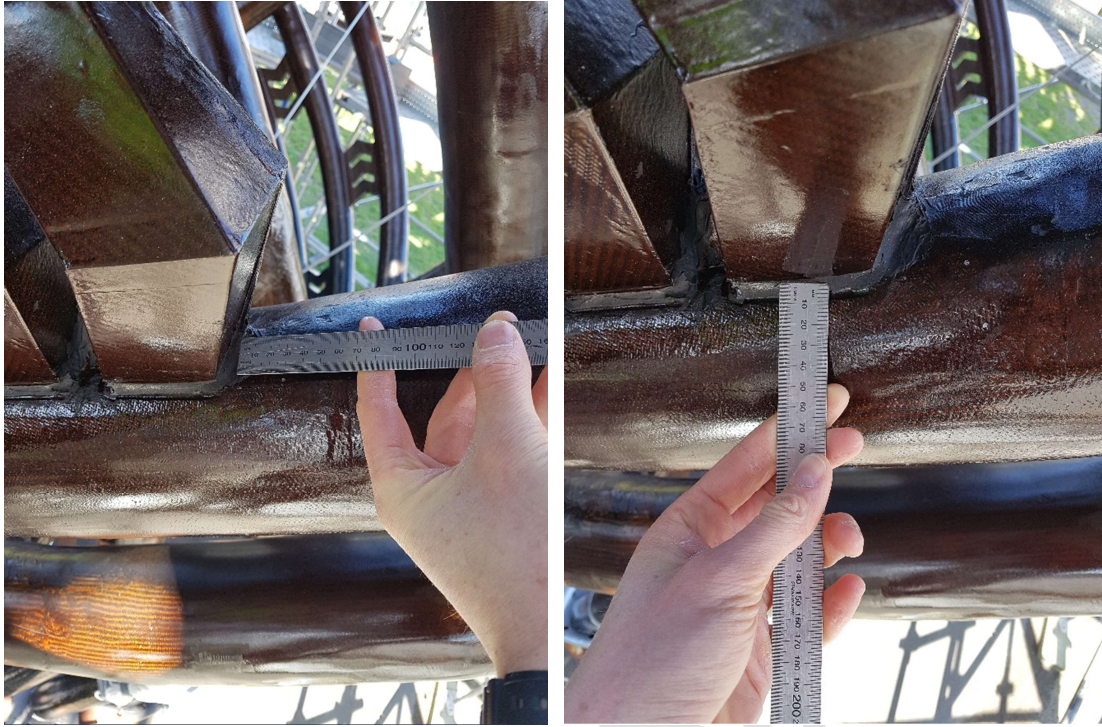
Spot checks of the taping extents for both the chevrons and tube joins measured as per the specifications. All other visually inspected taping extents appeared consistent with the specifications.

Figure 3. Example of outer tube chevron taping check

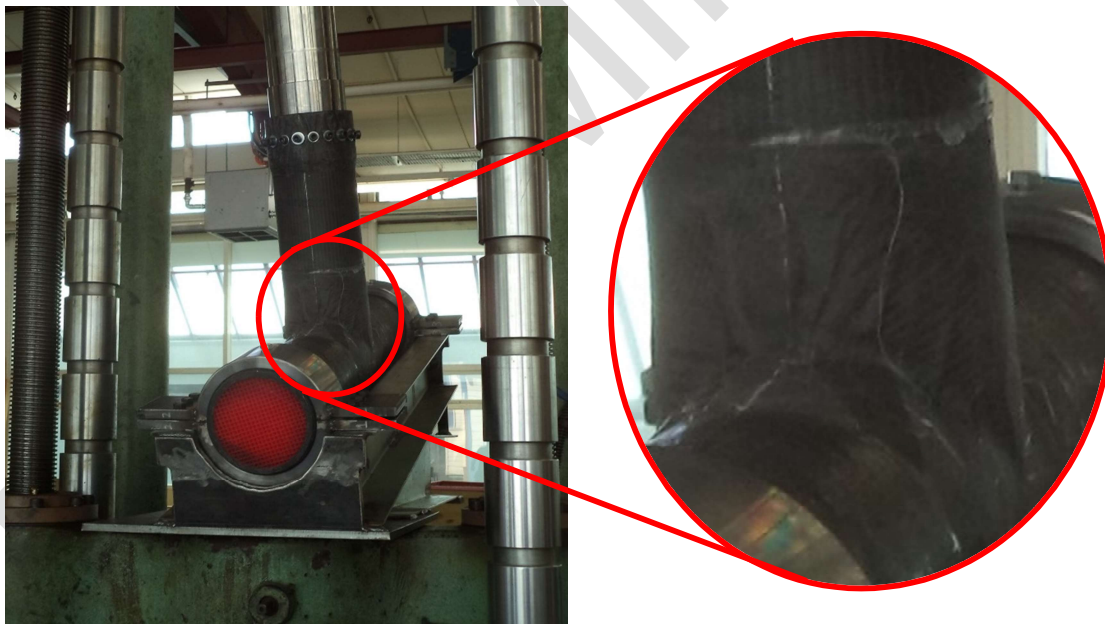
It is difficult to quantify the effect on the taping strength that wrinkling such as this may have. It is noted that expectation often exceeds requirement, particularly in cases such as this, where it is a sculpture not a critical piece of infrastructure. When compared to the tested samples, as per **Error! Reference source not found.**, the level of wrinkling appears similar and the connection testing produced satisfactory strength results.

Figure 4. Example of taping seen in tube joint testing

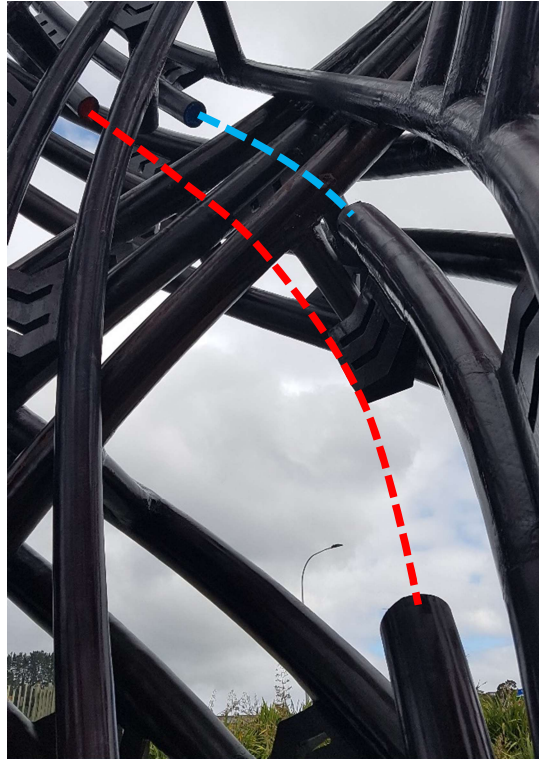
Figure 5, on the following page, shows the inner tube assembly installed correctly on the foundation and the location of two of the tubes that were cut. A third inner tube, not shown in the image, was also cut. The cuts to the tubes were approximately mirrored on the opposite side of the sculpture. (A total of six inner tubes were cut)

Figure 5. Inner tubes after installation showing locations of cut tubes

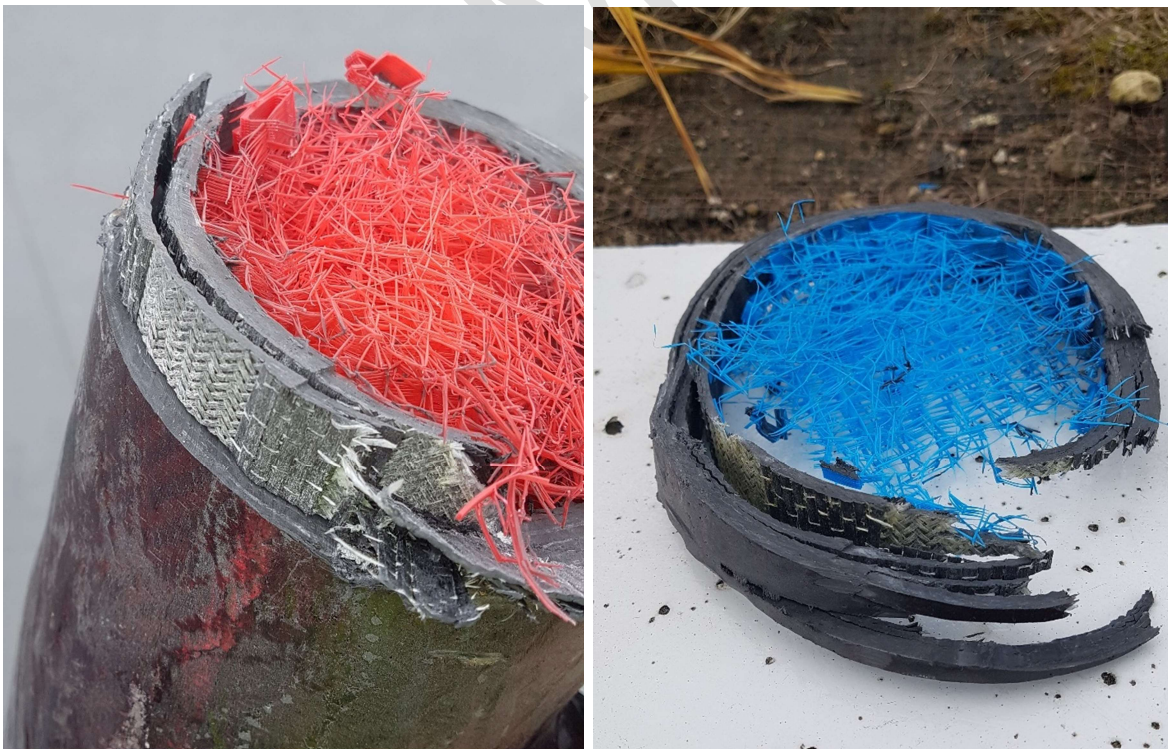
Figure 6, also overleaf, shows two of the ends from the cut tubes. There are clear lines of fracture/delamination that predominantly follow the e-glass sock (white) layers, and sometimes transitioning into the unidirectional layers. Observation of these fractures highlighted:

- The presence of dry, or resin starved, areas particularly in the e-glass sock layers in the middle of the laminate

- Interlaminar fractures. Note that it is possible that the interlaminar fractures could have resulted from cutting and hammering the tubes, or as a result of poor interlaminar strength, itself due to the dryness and poor resin impregnation.

The structural concerns associated with these observations are that there is no support for the load carrying fibres (in this case the unidirectional carbon plies) and when compressed they will fail at a load much less than expected. It was therefore decided to have samples from the cut sections tested to determine whether the defects observed were localised or systematic through the tube(s).

Figure 6. Inner tube sections removed during installation showing dry layers and interlaminar fractures/delamination

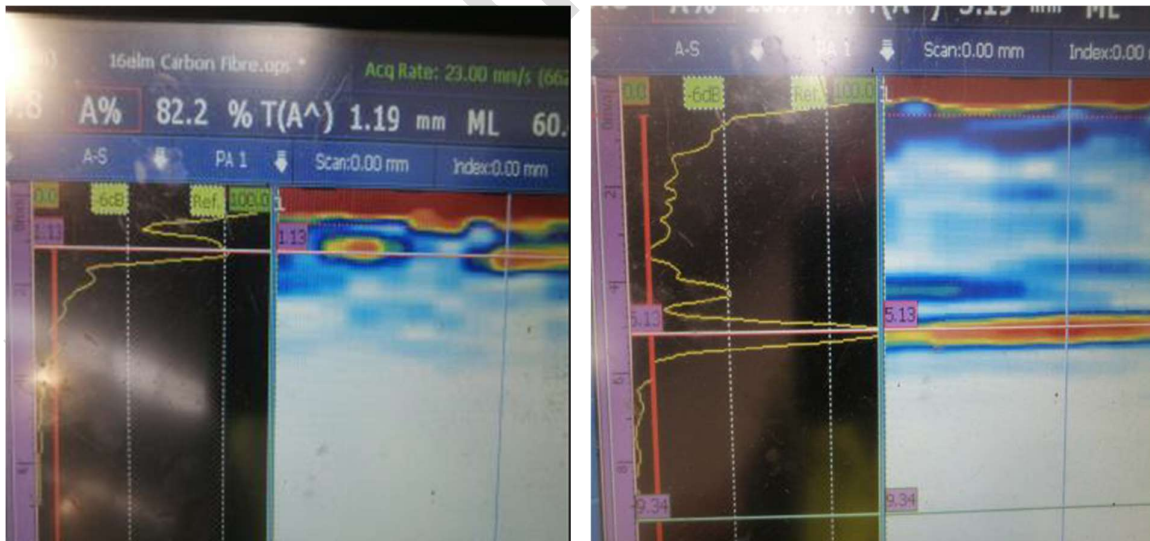
Figure 7 shows a comparison of the scan results from the main tube section compared with that of a connecting tube. The main inner tube section was produced using a combination of wet-vac hand lamination and infusion, over the 3D printed former. The connecting tube, being straight, was able to be manufactured using pre-preg material over a steel mandrel. This is a higher quality process and results in more compaction of the layers and lower voiding/porosity.

From the image on the right we observe, for the connecting tube, a clear laminate with minimal echo through the thickness, then a solid backwall echo at 5.1mm corresponding to the measured thickness. The left-hand image, of the main tube, shows a partial backwall at 1.1mm and then a very faint echo beyond, showing the ultrasound is unable to penetrate the laminate to the measured thickness of 8.9mm

Figure 7. Ultrasound results. L - main tube, poor response with variable backwall at 1.1mm depth. R – connecting tube, excellent response with solid backwall at 5.1mm depth

Instead the ultrasound readings obtained indicate that the defects observed are likely to be spread throughout the tube(s). Such a reading in the aerospace industry would not pass a QA check and the part would be rejected. As there is no definitive standard for composite quality measurement by NDT/ultrasound in the civil industry it leads us to destructive testing as a means of verifying whether the observed defects compromise the structural integrity of the sculpture.

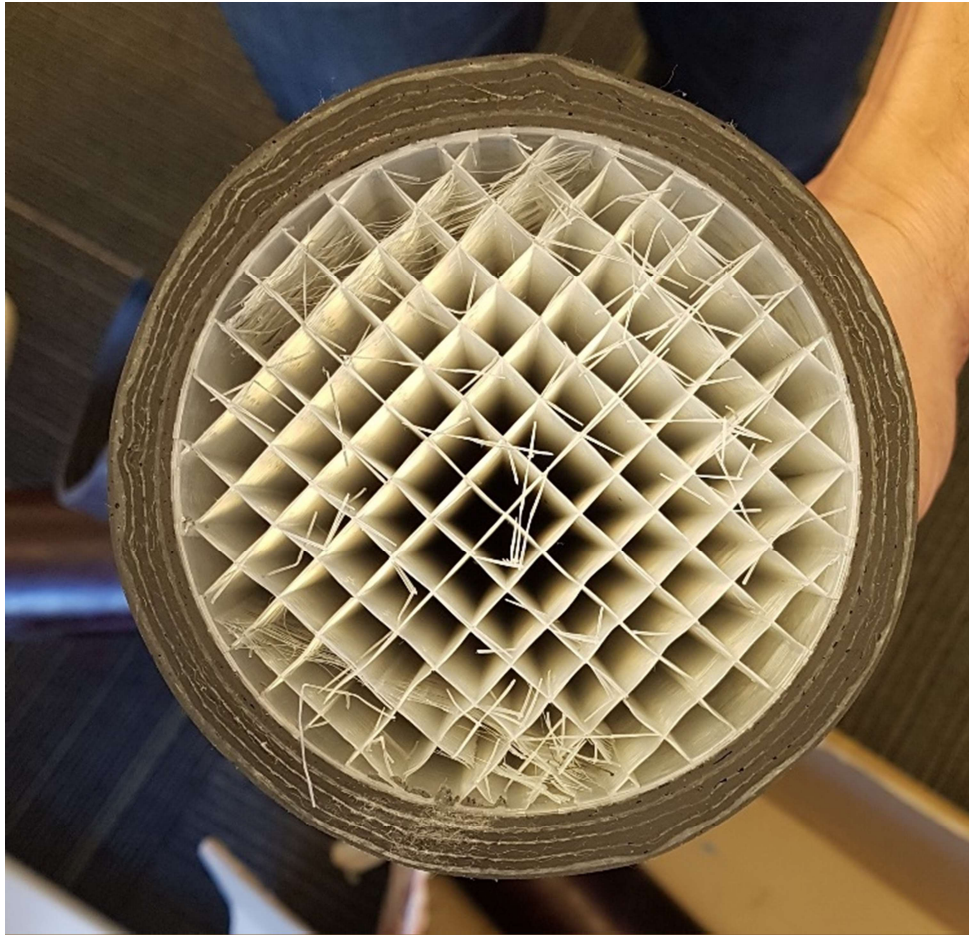
During preparation of the samples the end of the remaining cut tube (away from on-site cut/hammered region) was cleaned and inspected. See Figure 8 overleaf. This showed a moderate level of voiding/porosity, predominantly at the interface between the e-glass sock layers and the blocks of unidirectional material. However, the unidirectional layers themselves appeared to be predominantly free from voids and evenly consolidated. Several areas of the e-glass sock layers at the cut surface were visibly fluffy/dry.

**Figure 8. cross section of inner tube used for testing samples**

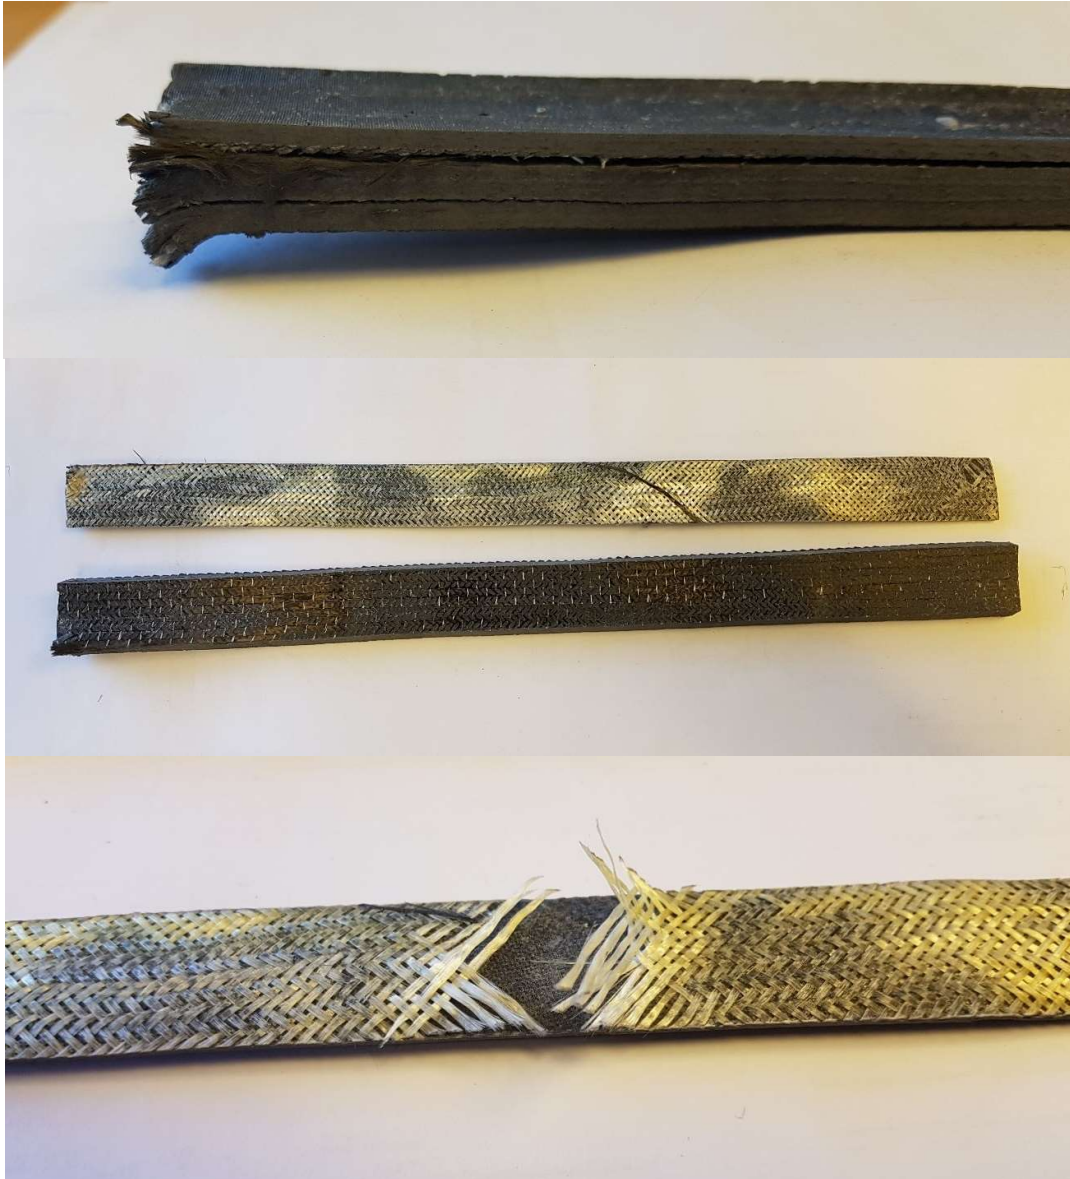
Figure 9, pg. 14, shows one of the interlaminar shear test samples where the fracture from the cut end had propagated along the length of the sample and the layers were able to be cleaved apart by hand with minimal force. Inspection of the e-glass layer along the line of separation showed dry or resin deprived areas and areas where there was no resin and the layer was not adhered to the adjacent laminate at all. This sample was not used for testing.

**Figure 9. Sample from inner tube section. Top - showing delamination at e-glass layer after first unidirectional stack. (inside of tube facing up), Mid - layers once taken apart, Btm - showing completely dry portion of e-glass layer.**

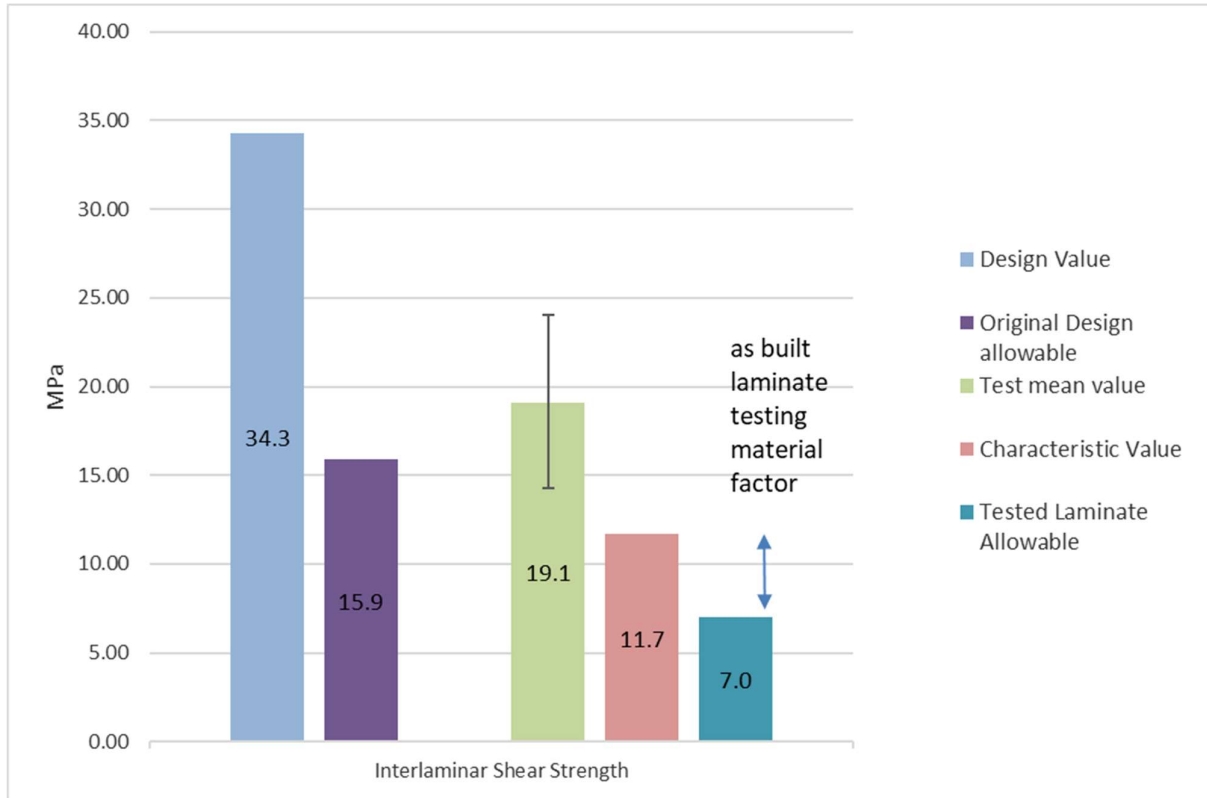
- The characteristic<sup>1</sup> interlaminar shear strength of the inner tube sample, not including material factors (see explanation below), is 11.7MPa, being 34% of the normal design value
- The tested laminate allowable interlaminar shear strength, accounting for the appropriate material factor (MF = 1.66 for tested laminates as per Eurocomp Design Code), is 7.0MPa, being 44% of the design allowable used in the analysis
- The characteristic compressive strength of the inner tube sample is 2205kN/m width, being 74% of the normal design value, but 148% of the result based on ply testing carried out earlier in the project.
- The tested laminate allowable compressive strength, accounting for the appropriate material factors, is 1328kN/m, being 192% of the design allowable used in the analysis.

For the interlaminar strength no testing was done until the laminate testing discussed in this report. The design value used in the analysis was based on Gurit's typical value, believed to be capable of being achieved by competent laminators. There was thus a large material factor applied to account for uncertainties. The characteristic value for ILSS of the as built inner tube came in at 34% of the typical value. Even with a smaller material factor, this tested allowable strength is still below the design allowable strength.

Figure 10. Interlaminar shear strengths

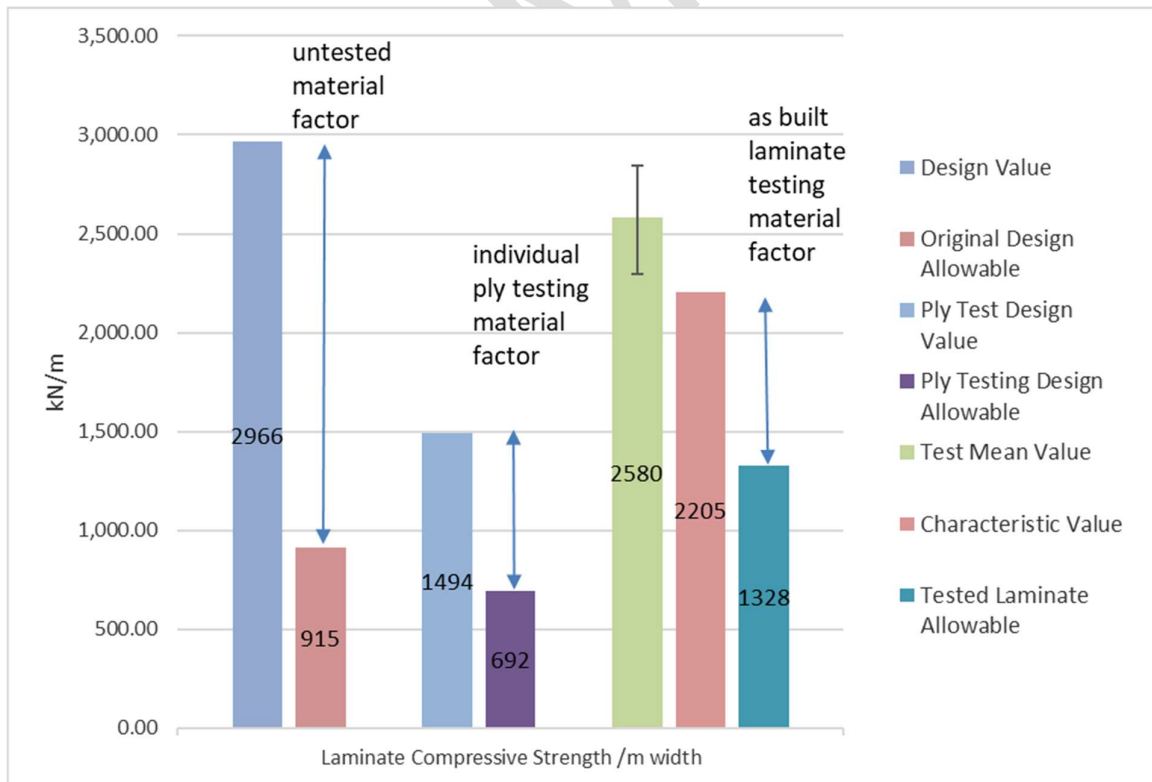
For the compressive strength, testing was done on the individual plies of both the unidirectional material and the carbon woven sock (but not the e-glass sock). The results of these tests, when applied as a laminate, produced a compressive strength approximately 50% of that expected based on our typical values. When accounting for the reduced material factor due to the ply testing this improved to 76%. The material properties used in the analysis of the sculpture were therefore reduced to match this result from the ply testing. Thus, while the as built compressive strength came in lower than Gurit's typical compressive strength value, it is higher than the ply testing value used in the analysis.

Figure 11. Compressive strengths

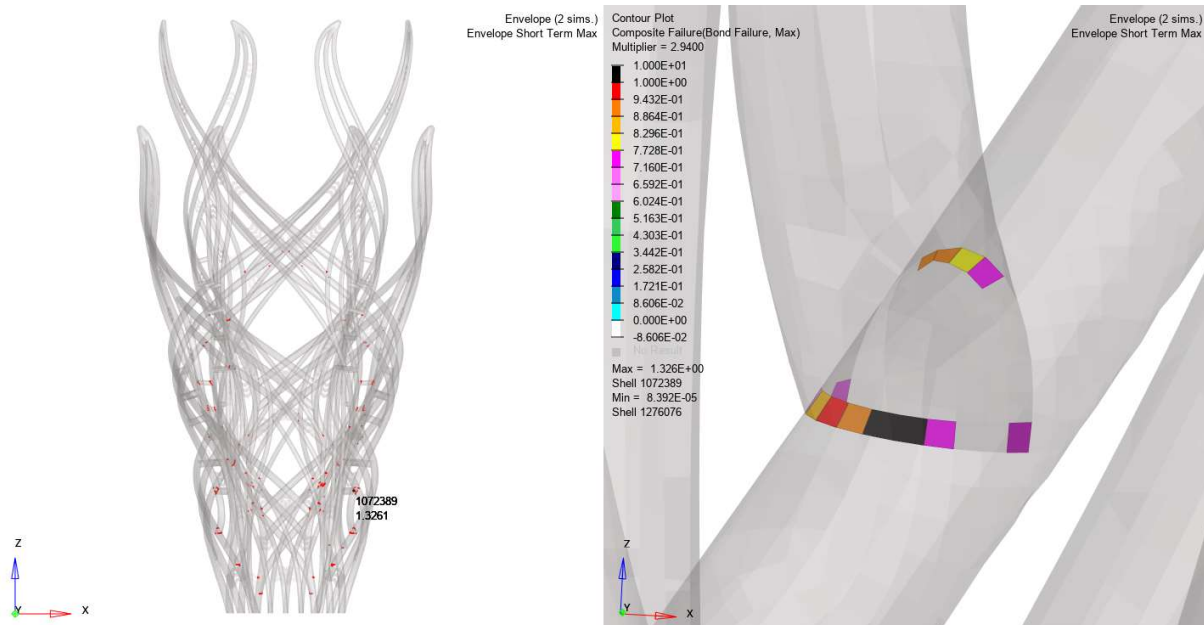
A brief review of the analysis model used in the design of the sculpture has been carried out using the lower ILSS property from the as built testing. Results from the original analysis were factored to account for the reduction in ILSS and the change in the material factor. Looking at the short-term load cases (the most onerous), this showed that the reserve factor on ILSS reduced from 1.03 to 0.45. The areas that have reserve factors less than 1.0 are predominantly in the outer tubes at the tube connections and at the connecting tubes between the inner and outer tubes. This is shown in Figure 12 below.

**Figure 12. Short term load cases. Bond failure index factored to represent tested ILSS. L – elements with RF <1.0 highlighted in red, R - tube connection showing elements with RF <1.0**

The model shows that some elements not only above the requirement but are physically failing. However, the locations of these elements all fall within areas where there is some question around the model validity as items such as the glue coving and secondary taping are not modelled, and the stresses shown may be exaggerated as a result.

- Change to the expected lifespan to reduce the design loads. Extension of lifespan could be achieved by regular inspection.
- Refinement of the analysis method to validate the areas of concern in the modelling.
- Updated analysis to include progressive failure effects, as opposed to pass/fail criteria.
- Remedial lamination to areas of concern.
- Remedial work via means of additional members/structure.
