# Hemo Gorge Sculpture As Built Inner Tube Connection Test

GU7231-802 A

27<sup>th</sup> November 2020

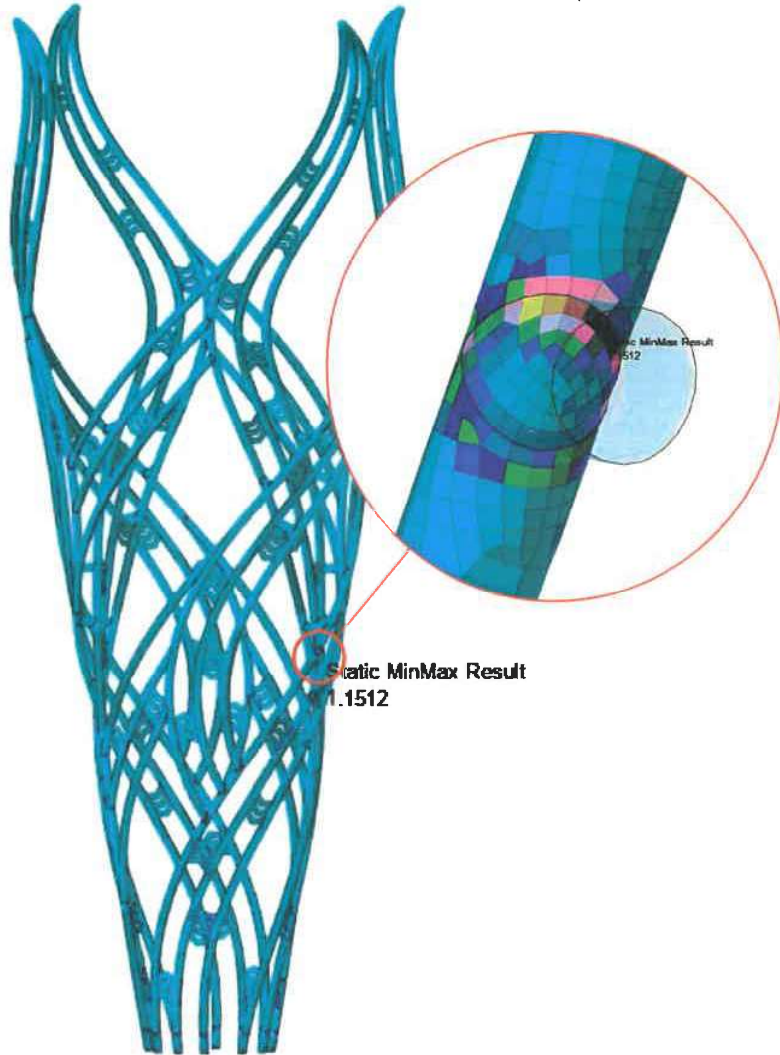
In designing the connection test it was found that, due to the difference in geometry of the larger diameter outer tube and the smaller diameter inner tube available for the test, it was not possible to generate the maximum ILSS in the test assembly without risking a failure in the inner tube via the secondary mode of compression in the circumferential direction, due to bending across the tube. Such a failure would invalidate the test. Instead the point of maximum ILSS from the inner tubes was used to design the connection test. See Figure 3. The outer tubes have a 19% higher maximum ILSS than the inner tubes.

Figure 3. Bond failure index, factored to match test results. Inner tubes only

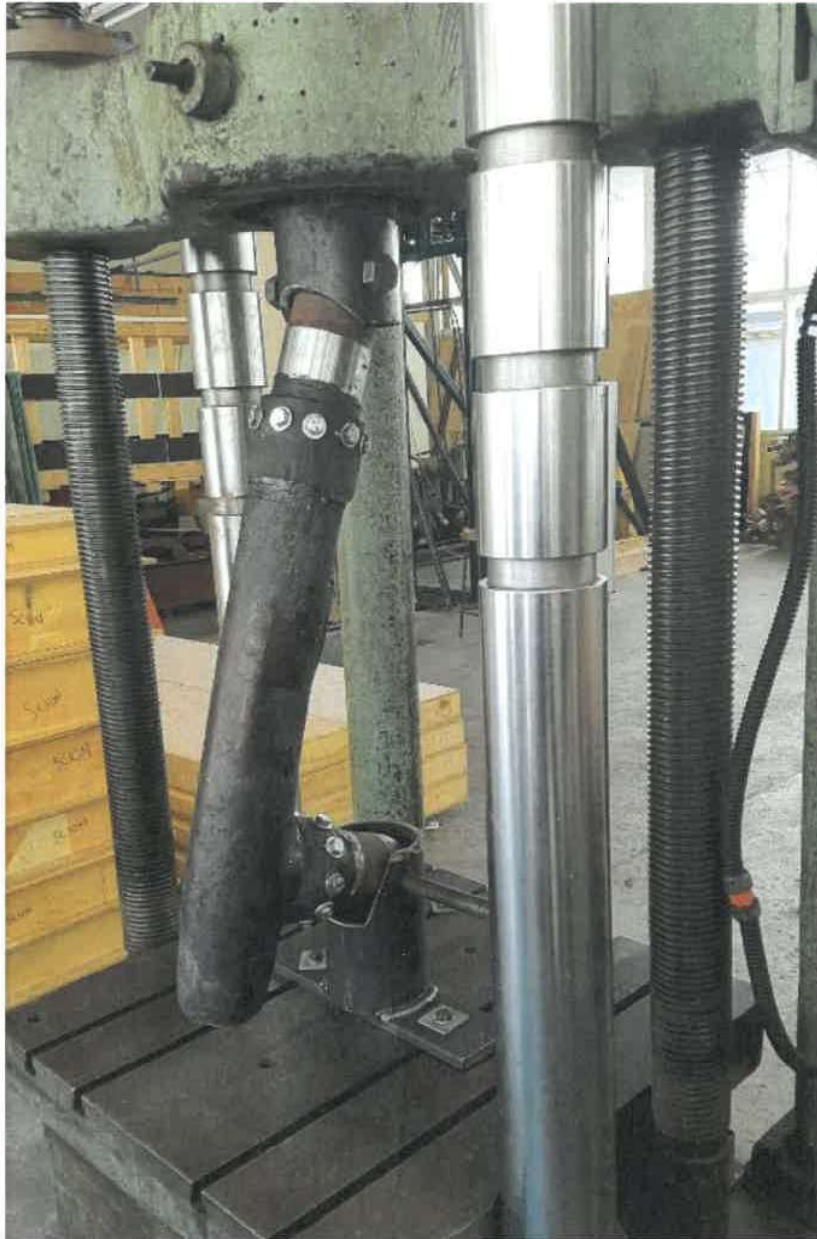
Figure 6, below, shows the tube assembly installed in the mechanical testing rig. The inner tube and attached joiner tube were cut to length to produce the correct load ratio and additional laminate was added in way of the fasteners to prevent bearing failure in the composite laminate. Machined steel end fittings were then bolted and bonded into the ends of the tubes. Steel adaptors were constructed to attach the tube assembly to the testing rig.

Figure 6. tube assembly installed in mechanical testing rig

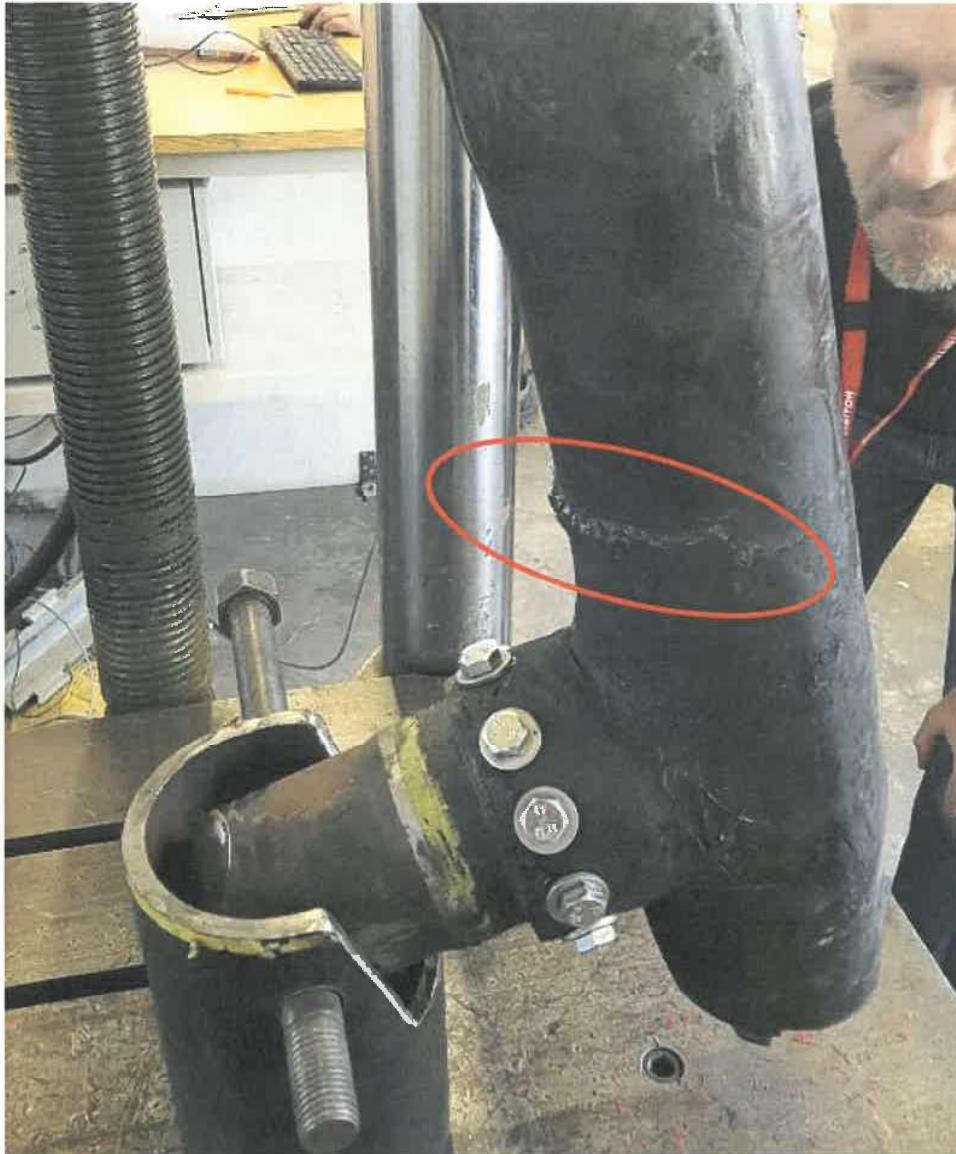
The max load graph shows a relatively linear increase in load to around 55,000N, after which it starts to taper off. There was an audible crack at 63,000N, which corresponded to the slight drop in load seen at this point on the graph. The connection continued to hold load up to a maximum of 72,357N at which point explosive cracking was heard and the main tube was visibly seen to have failed in compression just outside the extents of the joiner tube taping, as shown in Figure 10 on page 14.

**Figure 10. Post max load test, showing compressive failure in inner tube**

A successful test was carried out on the inner tube connection. The test assembly withstood the calculated proof load with no visual or audible damage and was subsequently loaded past the expected failure load to a final compressive failure at 72,357N. This load is 6.2 times the load at which the analysis predicted interlaminar shear failure due to the low interlaminar strength from the coupon tests. From this perspective we can consider that the inner tubes in the sculpture have the capacity to withstand, and likely exceed, the design loads.
