4 Road Characteristics and Condition

4.1 Introduction

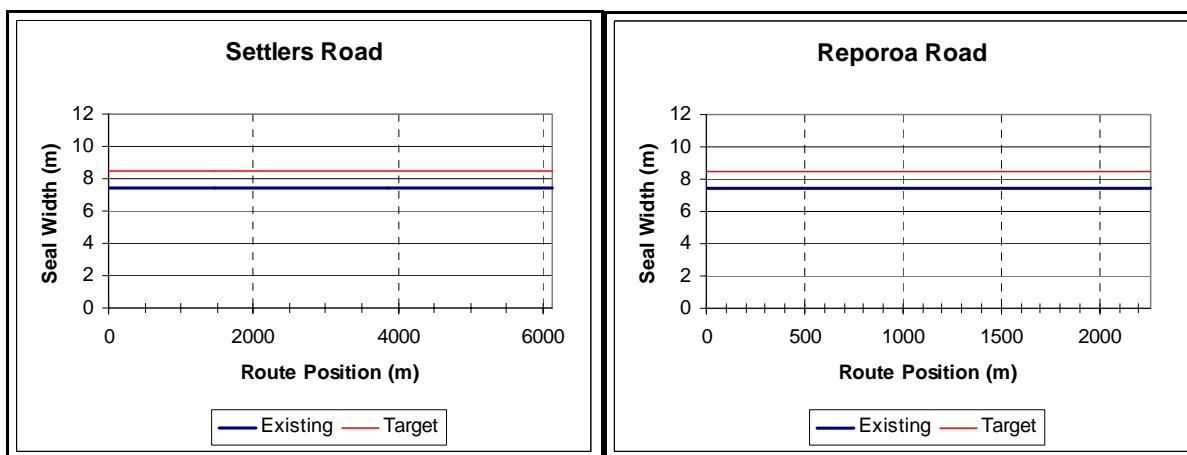
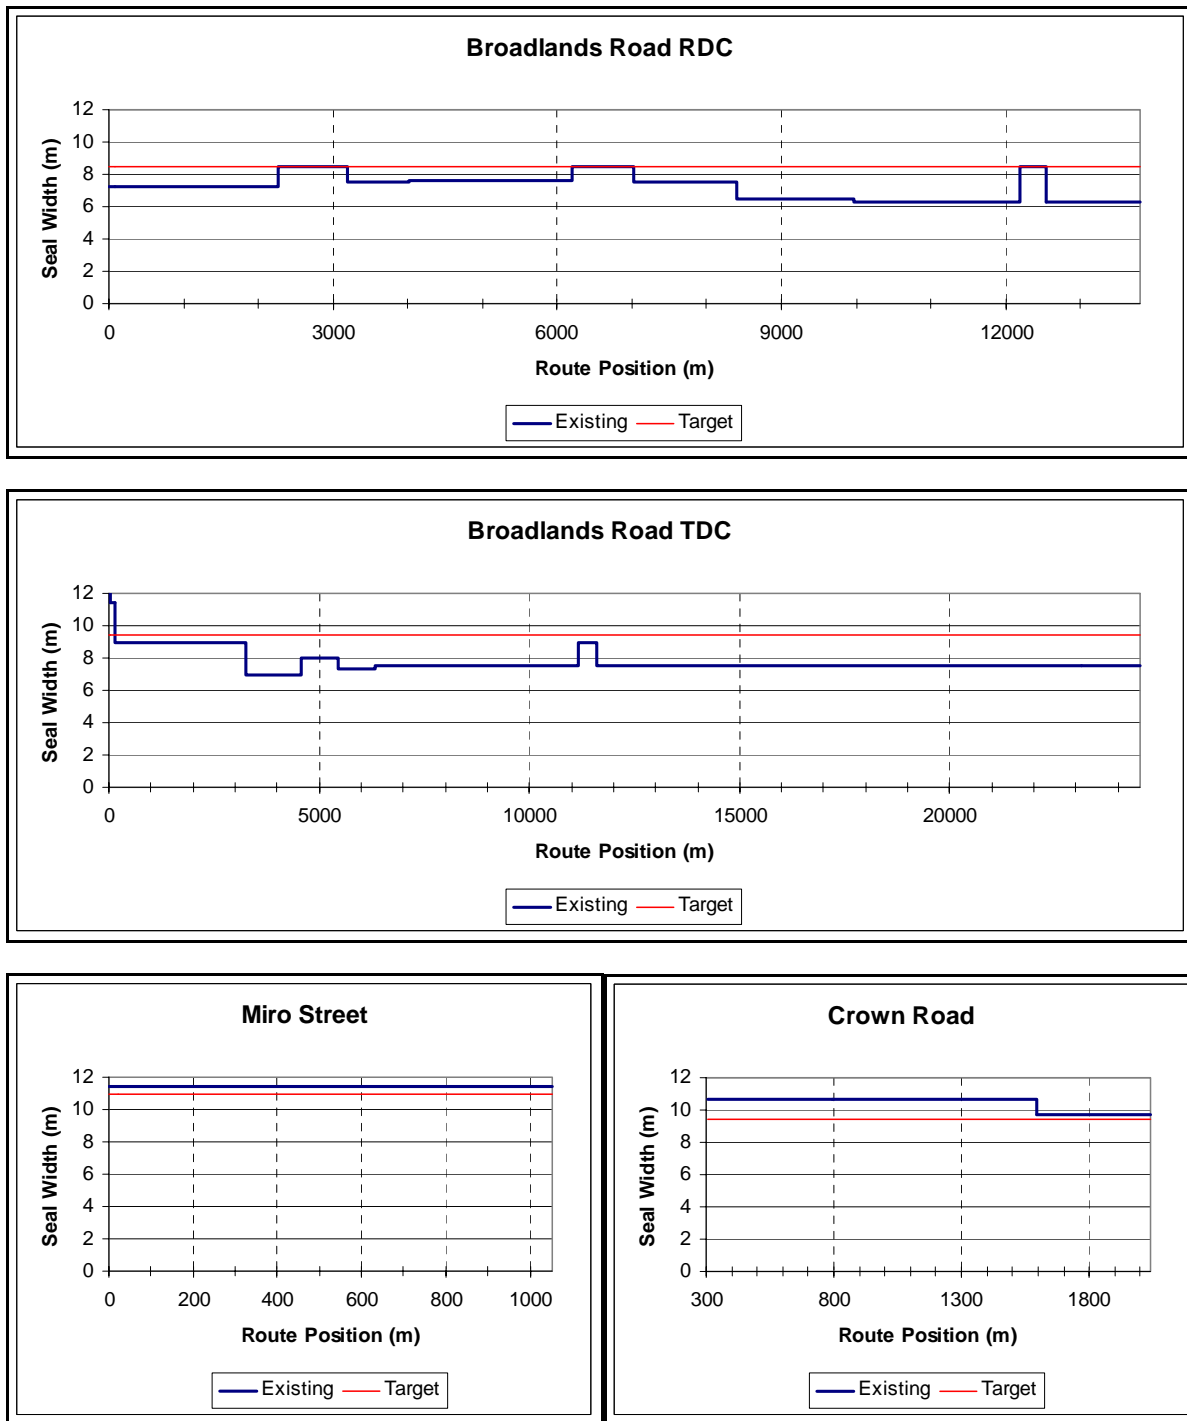
Figure 10. Seal widths on each subsection

Significant lengths of the study route have seal widths below the respective guidelines adopted by RDC and TDC.

The recommended strategy is to increase seal width on the route, using a two-pronged approach:

- Widen the seal to guideline standards where possible, in conjunction with reconstruction and rehabilitation works, or large maintenance patching.
- Identify specific projects involving creation of cycleways and/or increased shoulder widths on the route and apply for funding from Transfund's cycling projects budget.

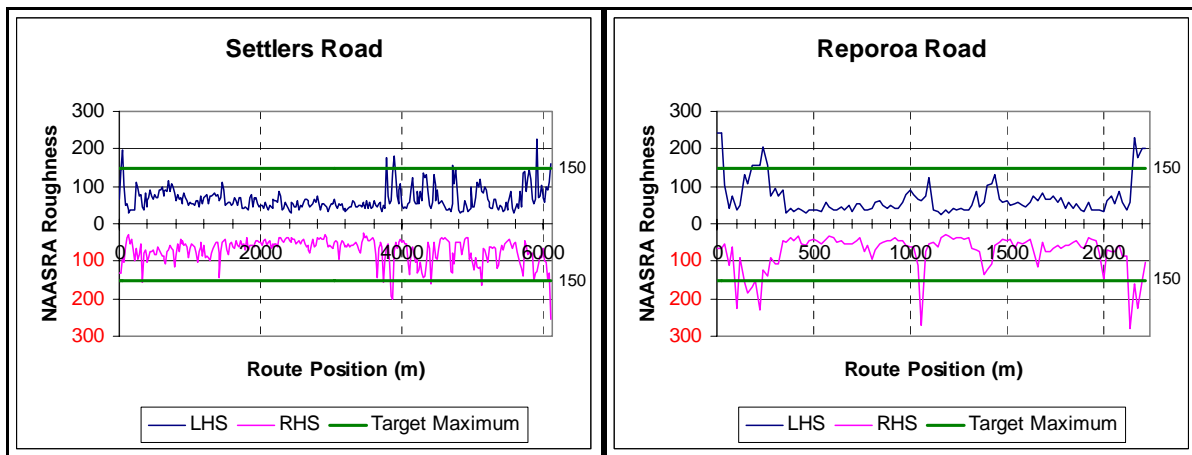
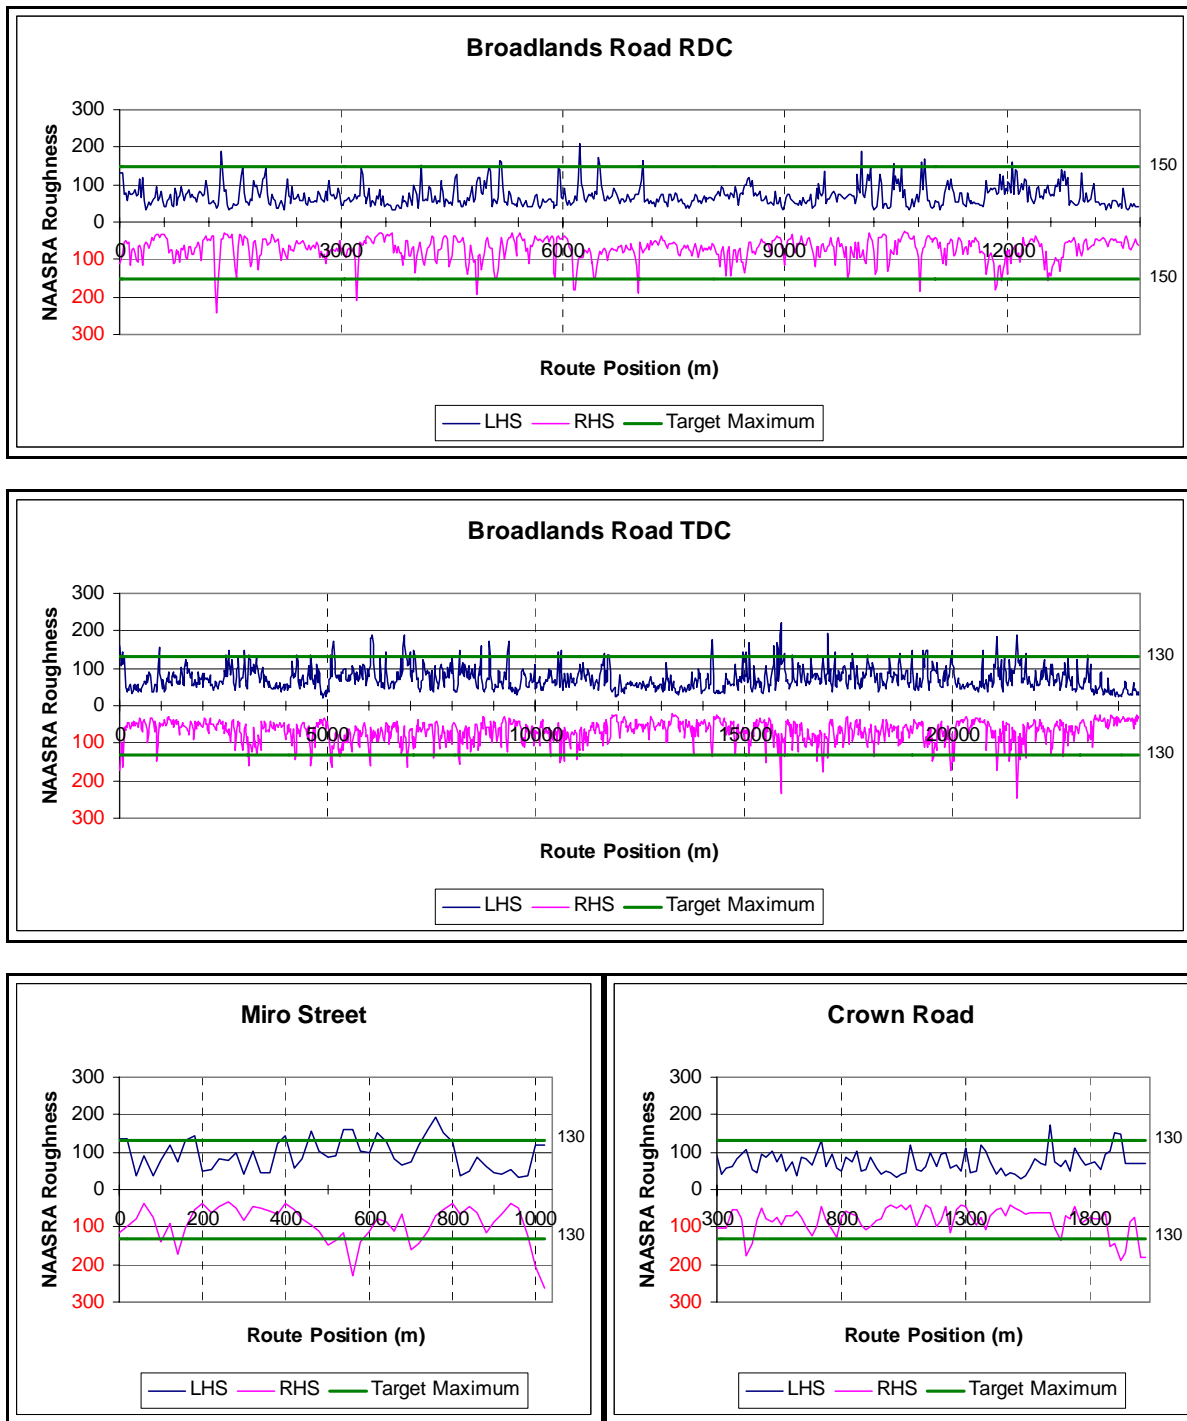
Figure 13. Roughness along each subsection

High roughness levels occur over several isolated sections of the study route, but the roughness of subsections is generally within the target levels specified, indicating current maintenance practices are generally achieving the desired outcome in terms of roughness levels.

Table 26 lists portions of pavement where roughness levels are above target levels for a length of at least 100m. The proposed timeframe of pavement rehabilitation, based on the prioritised programme identified in Appendix 2 of this report, is also given.

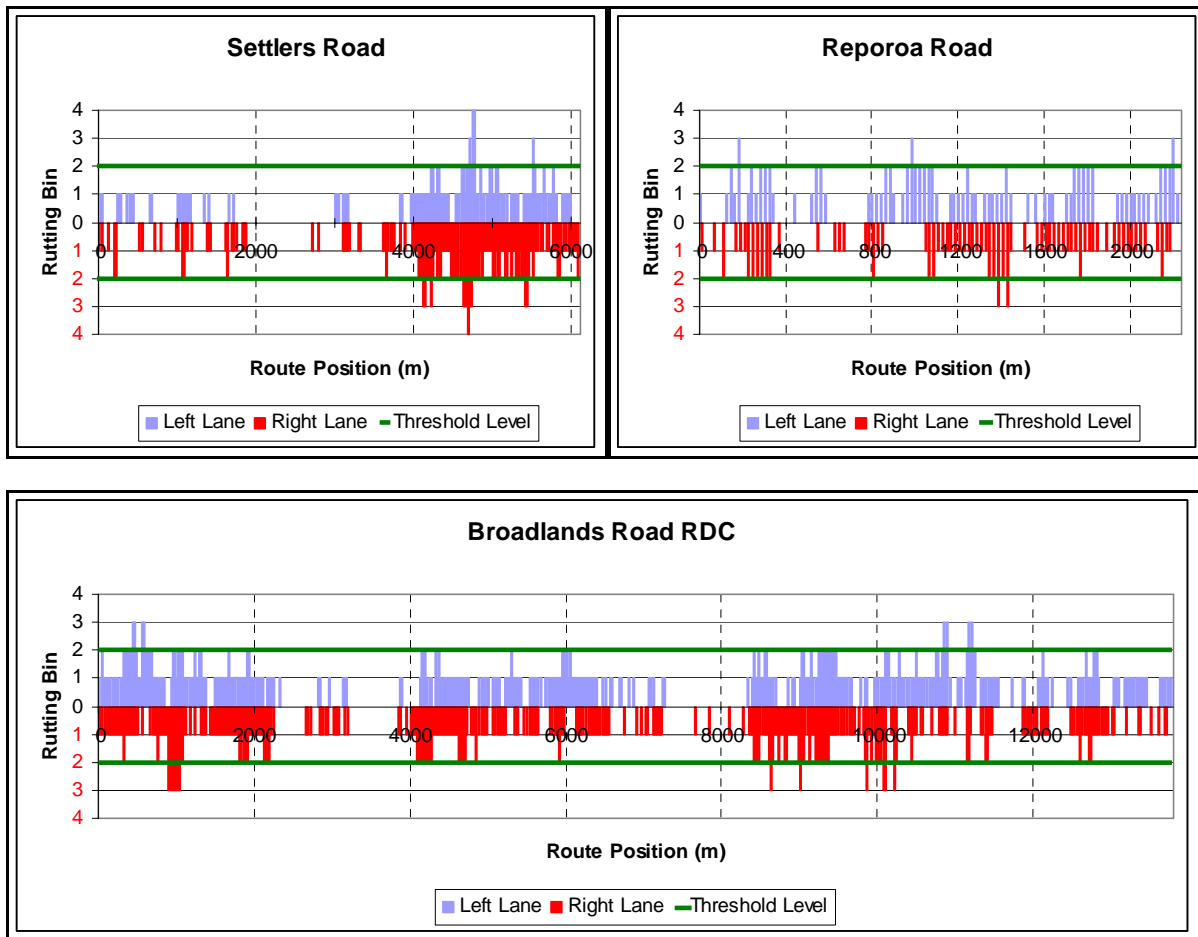
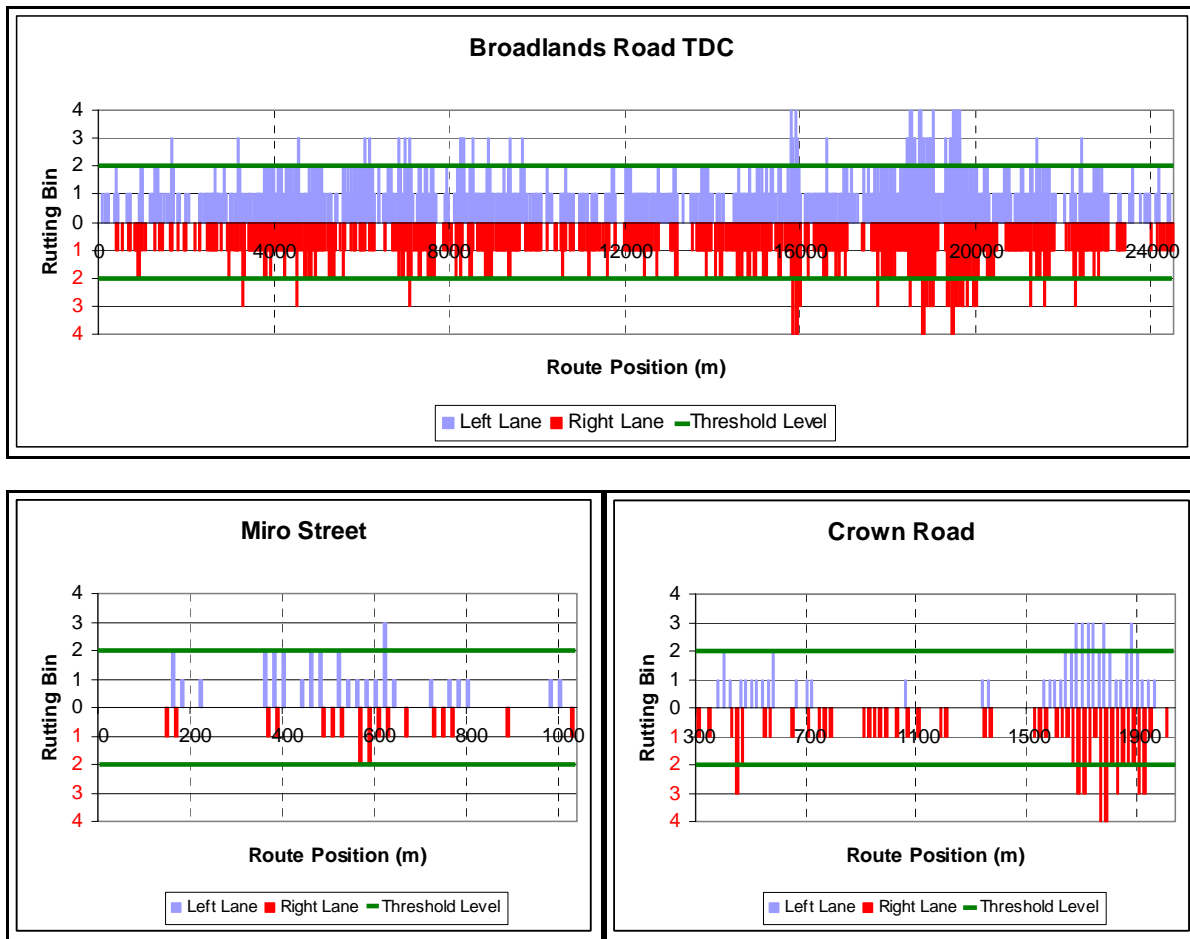
Figure 14. Rutting on each subsection

Settlers Road from RP 0-4,000 demonstrates the effectiveness of pavement rehabilitation on managing rutting. This section was last reconstructed between 1998-2000, while the final section of Settlers Road, from RP 4,000-6,130, was last reconstructed in 1985. This final section shows significantly more rutting than the first section.

Subsequent resurfacing on Crown Road included two-coat sealing in wheel ruts, which has resulted in a minor improvement. The final section of Crown Road, where rutting is most prevalent, will essentially be bypassed by the East Taupo Arterial when this is constructed.

Rutting can be improved by rut filling repairs or rehabilitation/renewal of the pavement. Sections of pavement greater than 50m in length with rutting in bin 3 or higher are detailed in Table 28 below. These sections should be considered for repairs or rehabilitation work. The prioritised rehabilitation programme in Appendix 2 of this report has taken rutting into account in prioritising rehabilitation works.

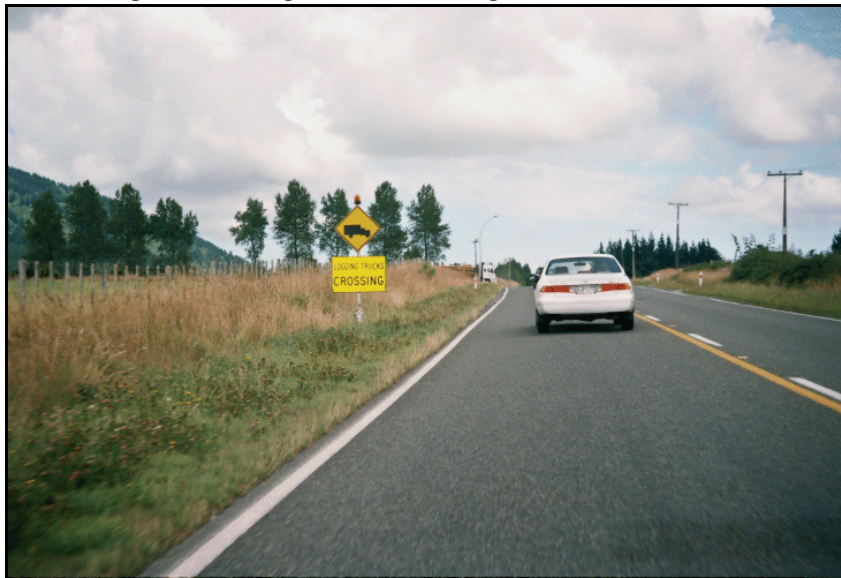
Figure 22. Approach to Off Highway Road intersection from the north

- In foggy/poor visibility conditions, vehicles approaching on Broadlands Road find it difficult to see oversized trucks crossing at the intersection, and vice versa. This creates a significant potential hazard to traffic approaching at speed, as it can take oversized vehicles up to 30 seconds to clear the intersection. Currently, flashing orange lights have been installed on the advanced warning sign, to warn traffic that a truck is using the crossing, as shown in Figure 22.

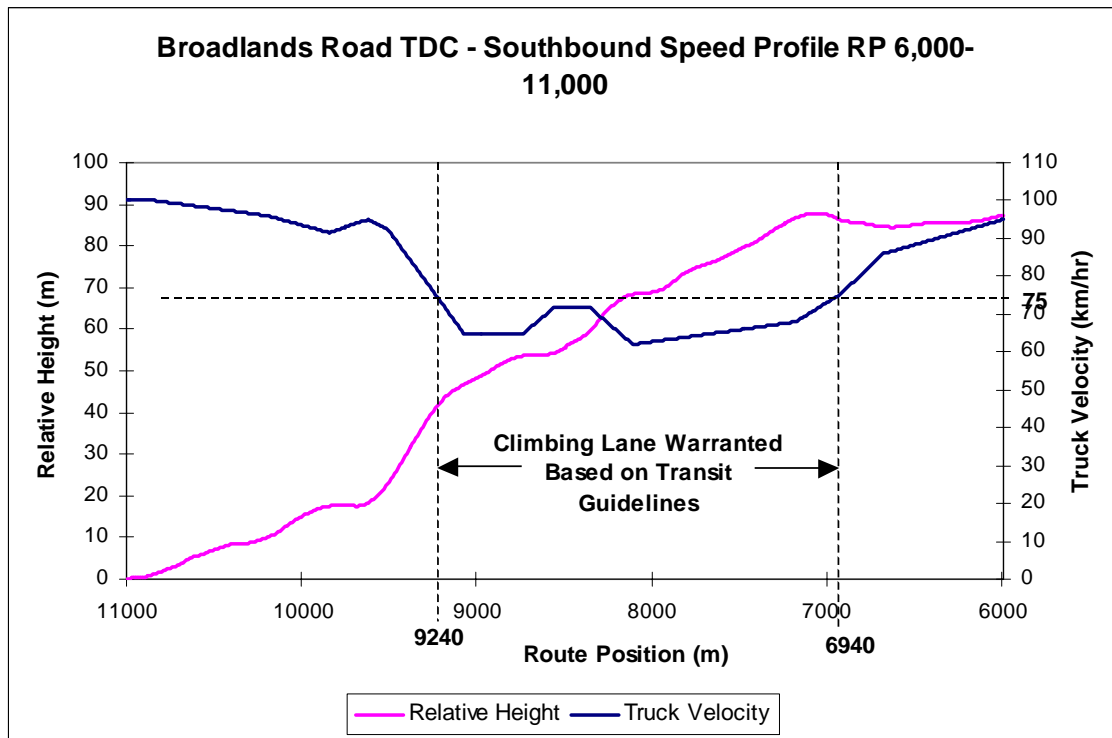
Figure 24. Climbing lane warrant (using Transit criteria)

Transit (2001) provides criteria for climbing lane warrants, based on truck performance curves and deviation in heavy vehicle speed from the average speed of the section of road. Studies have shown the accident involvement rate for slow vehicles increases more rapidly when the vehicle speed reduction is greater than 15 km/h. Therefore, a climbing lane should normally be introduced at the point where the design vehicle is expected to experience a 15 km/h speed reduction below the design speed of the road. For the purposes of this initial analysis, we have used a truck speed of 75 km/h as the start point for a climbing lane, as it is 15 km/h below the 90 km/h legal speed limit for trucks on New Zealand roads. Based on these criteria, a climbing lane is warranted in the southbound (decreasing RP) direction on Broadlands Road TDC from RP 6,940-9,240, as shown in Figure 24.

We recommend that the existing limitations on passing opportunities be recognised and where possible, seal widening carried out in conjunction with rehabilitation work. Construction of the identified climbing lane should be investigated further and possibly put forward for funding. Monitoring and maintenance of rutting will also improve the safety of passing manoeuvres in wet conditions.
