# Remediation Options Assessment

Prince's Gate Arch and Gateway, 9 Queens Drive, Central Rotorua, Rotorua.

Rotorua Lakes Council

Blueline Project: 10141

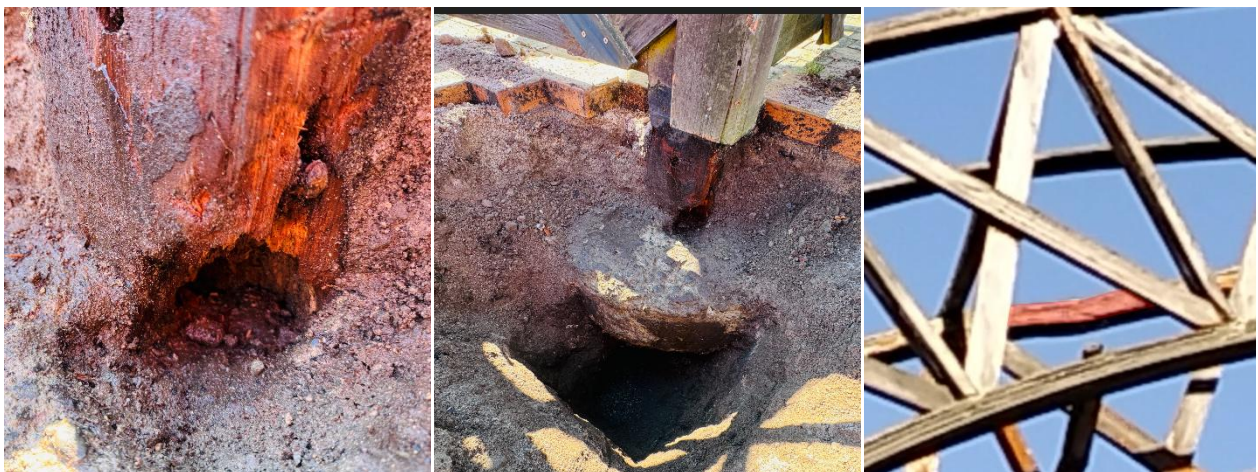
The condition assessment conducted by Prendos Property Group on 09/07/21, along with a visual assessment of the foundation system by Blueline Consulting, identified several damaged or defective members that pose a risk to the structural integrity of the structure. In particular, damage to one of the top chords due to the flag mast pole falling on it, which has subsequently caused stress to be redistributed throughout the structure. Additionally, rot at the base of the columns has created a disconnect in the foundation system, further overstressing the superstructure during uplift and lateral actions.

Figure 2,3,4: Decay of post in contact with in-situ soils; exposed 600 x 220mm concrete footing; & damaged top chord.

Due to the rot at the base of the columns it's likely the uplift on the foundation during the ULS wind event will also exceed the capacity of the foundation. Based on prelim assessment, a minimum footing size of 600ø x 1.8m would be required to resist uplift forces. The moment on the top chord is due to the broken chord being unsupported for some length.

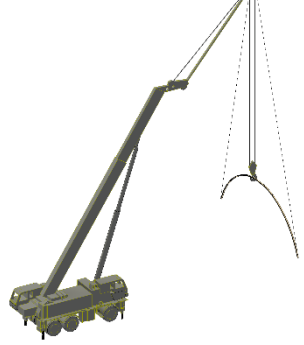
| Step (3) | Crane into position 1/90x20 laminate arch at a time, lap over intercepting arches as per engineering plan, clamping them together using a steel plate and U bolt shackle. Once all four timbers comprising one complete arch segment are in place fix to steel brackets as per engineering plan. Fix to strut & diagonal bracing. Reinstall cross bracing and inner chord as required. Repeat steps (1-4) until all four 4/90x20 top chords are replaced. | |
