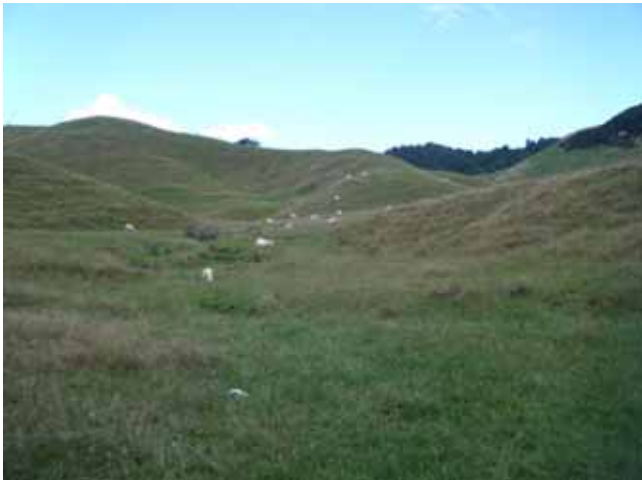
a) Upper pasture reaches of Okareka Loop Road stream

The upper extent of the permanent stream appeared to be a large pool southwest of the intersection of Okareka Loop Road and Benn Road (Figure 17). Above the Okareka Loop Road culvert, the stream is channelised, wide (mean width 2.93 m) and moderately deep (ranging from 0.05 to 0.45 m). Stream substrate comprised pumice-type fine grained silt/sand with abundant large woody debris and some fine organic detritus. The mid-upper reaches of the stream are poorly shaded and support high aquatic plant and algae biomass that choke the channel and restrict stream flow in places (Figure 17b). Aquatic macrophyte species include duckweed (*Lemna minor*) and watercress (*Nasturtium officinale*). Above the Okareka Loop Road culvert the stream opens into a wetland containing raupo (*Typha orientalis*), *Carex* spp., kiokio (*Blechnum novaeseelandiae*) and karamu (*Coprosma robusta*). The stream drains a semi-urban land use with roads and urban housing on the true left streambank and native vegetation (replanted and remnant) on the true right streambank. The mid-catchment section of Okareka Loop Road stream provides poor aquatic habitat for fish and invertebrates.

Figure 17: Stream habitat conditions in the a) upper and b) mid-reaches of the Okareka Loop Road stream running parallel to Okareka Loop Road.

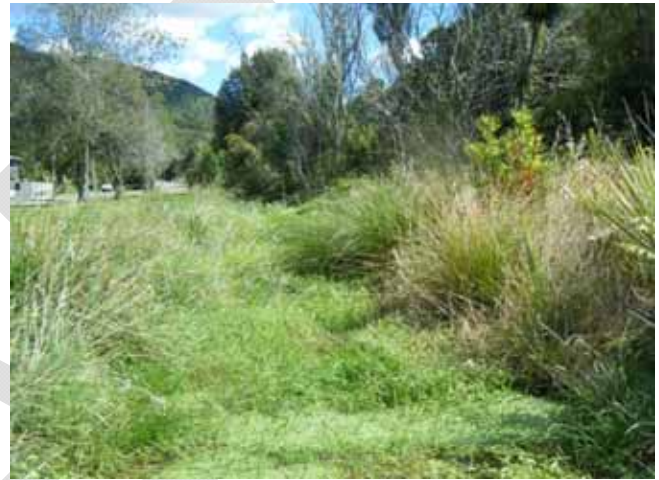
b) Permanent stream channel of Okareka Loop Road stream

Below the Okareka Loop Road culvert is a short stream section that flows to Lake Okareka. The stream is narrow (1.8 m wide) and shallow (0.02 to 0.1 m deep) with a small gravel and silt/sand substrate. No woody debris was observed within the sampling reach, and aquatic plants including duckweed, water pepper (*Persicaria hydropiper*) and water cress, provided limited instream habitat for invertebrates (Figure 17a).

Riparian vegetation comprises native shrubs including karamu and five finger (*Pseudopanax arboreus*) on the true right bank and grasses/low stature shrubs including giant umbrella sedge (*Cyperus ustulatus* f. *ustulatus*) and fiddle dock (*Rumex pulcher*) on the true left bank providing 5 to 10% shade throughout the stream length. Macrophyte cover comprises approximately 25%. No evidence of streambank erosion was observed, but channel scour was observed below the road culvert.

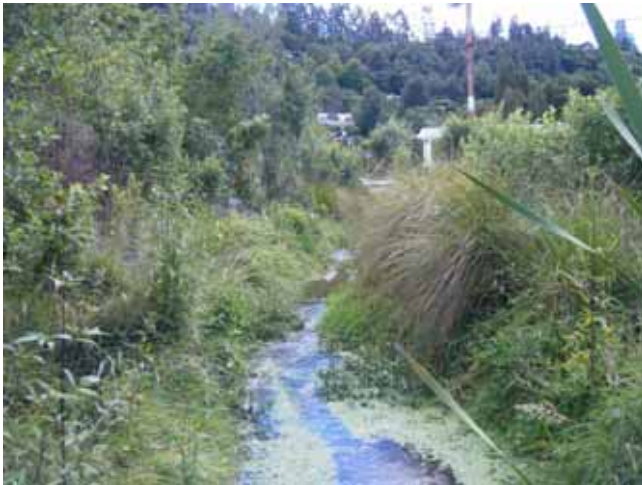
a) Lower reach of Okareka Loop Road stream

Figure 18: Instream habitat conditions observed in the a) lower section of Okareka Loop Road stream and b) Benn Road stream.

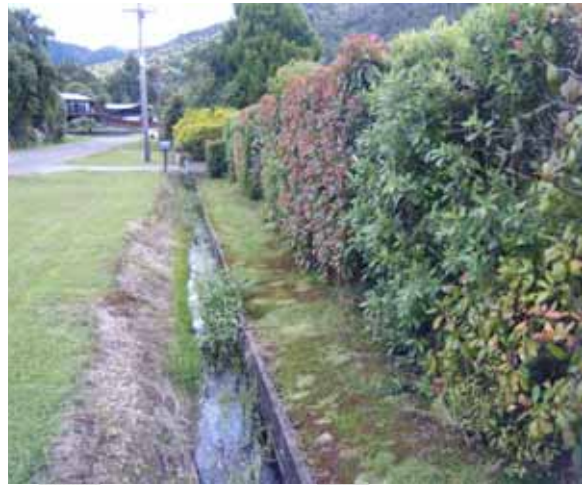
b) Instream habitat within the Benn Road stream

Both streams were highly artificial, straightened, reinforced drains with low ecological value (Figure 18b). Macrophyte cover comprised approximately 50% and riparian vegetation provided approximately 20% channel shade. Both stream channels are piped below Acacia Road and drain into Lake Okareka.

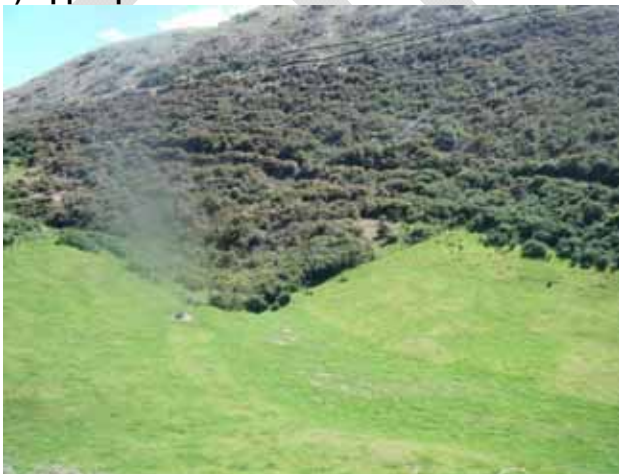
a) Upper pasture reach of The Wash catchment

The Wash is located on the northern side of the settlement and drains a predominantly rural sub-catchment (Figure 2). The catchment land use is mainly pasture with mixed exotic (gorse and pine) and remnant native bush vegetation in the upper reaches. Both the left and right tributaries of The Wash were identified as swampy, ephemeral drains with little aquatic habitat value (Figure 19a). The Wash becomes a highly modified open drain below the Millar Road culvert until it reaches Lake Okareka east of Steep Street. The Wash sub-catchment contained no surface water at the time of sampling and as such, provided no aquatic habitat. Instream modifications observed within the lower reaches of The Wash included reinforced streambanks (wooden boxing and gabion baskets), artificial stream substrates, numerous stormwater outlet pipes and check dams within the channel (Figure 19b). Vegetation cover was generally poor, and was restricted to patchy native plantings including flax (*Phormium tenax*) and akeake (*Dodonaea viscosa*) and large exotic trees providing minimal shade (5 to 20%).

Figure 19: Instream habitat conditions observed in the a) upper reach and b) lower reach of The Wash sub-catchment.

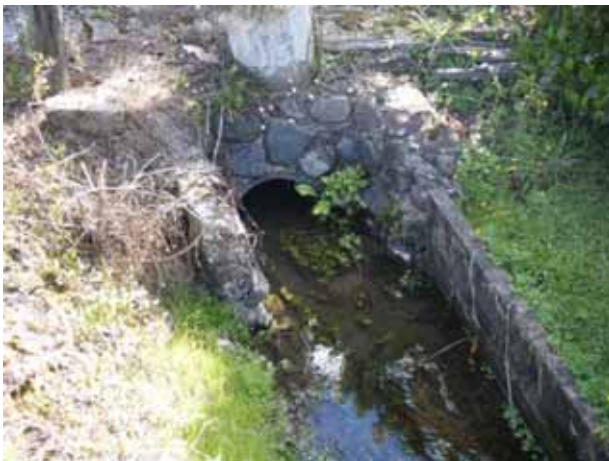
A potential barrier to upstream fish passage was identified within Benn Road stream that comprised of heavily silted culverts that could potentially restrict fish movement (Figure 20). Barriers to upstream fish passage are of only minor concern in the sub-catchments surrounding Lake Okareka because the streams are typically very short with moderate-poor habitat and are unlikely to support diverse fish communities.

Figure 20: Potential artificial barrier (culvert) to fish passage observed within Benn Road Stream.

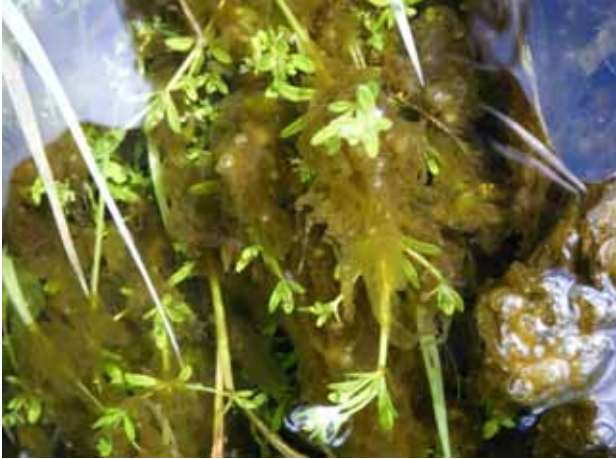
a) Excessive algae growth on aquatic macrophytes observed in the Okareka Loop Road stream

The upper reaches of the Okareka Loop Road stream on the boundary of the settlement area contains high periphyton and aquatic plant biomass, slow flow, high sedimentation and generally poor aquatic habitat. Periphyton observed at the time of sampling comprised long filamentous green algae and gelatinous green mat algae that proliferated on macrophyte surfaces (Figure 21a). Excessive algae growth is indicative of nutrient enrichment and the high algal cover observed within the stream is likely a reflection of the surrounding rural catchment. High algae and macrophyte cover reduces instream aesthetic and benthic biodiversity values. High sedimentation in Okareka Loop Road stream resulted in poor streambed stability, smothering of benthic substrates and loss of habitat for invertebrate species (Figure 21b).

Figure 21: Degraded receiving environments observed within Okareka Loop Road stream including a) excessive algae growth and b) silt deposition.
