Title: Rotorua Lakefront Redevelopment, Stage 2 Geotechnical Factual Report					
Date	Version	Description	Prepared by:	Reviewed by:	Authorised by:
6/12/2018	01	Final Issue	Caitlin Murphy	Peter Molyneaux	Craig Davanna

**Rotorua Lakefront
Redevelopment**
Stage 2 Geotechnical Factual Report
Prepared for
Rotorua Lakes Council
Prepared by
Tonkin & Taylor Ltd
Date
November 2018
Job Number
1007467.1000.v01

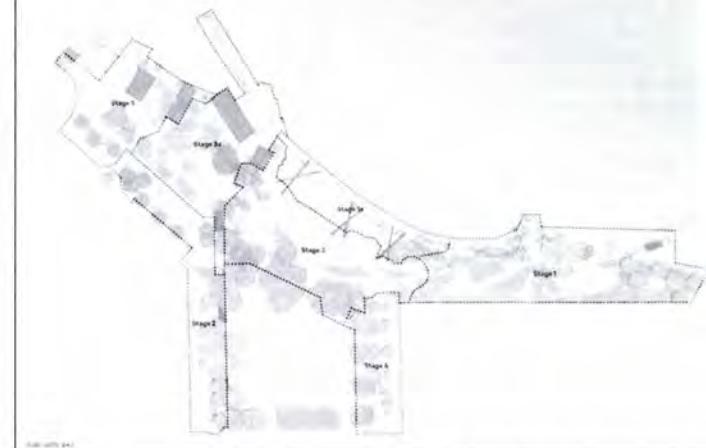
Figure 2.3: Proposed staging plan extracted from RLC Lakefront Redevelopment Developed Design for Stage 1 & 1a, dated August 2018.

Layout.
Staging Plan.

The boardwalk and terracing are included within Stages 1, 1a and 3a. Stage 2 includes car and bus parking and pavements. Play spaces are located within Stage 3. Future restaurants, café and kiosks are included within Stage 3a. Stage 4 includes further car parking and pavements. The Wharewaka and Waka Ama buildings, car and trailer parking are included within the Stage 5 works. Footpaths, paving and landscaping are included in all proposed stages. The masterplan and staging plan prepared by Isthmus are presented below in Figure 2.2 and Figure 2.3.

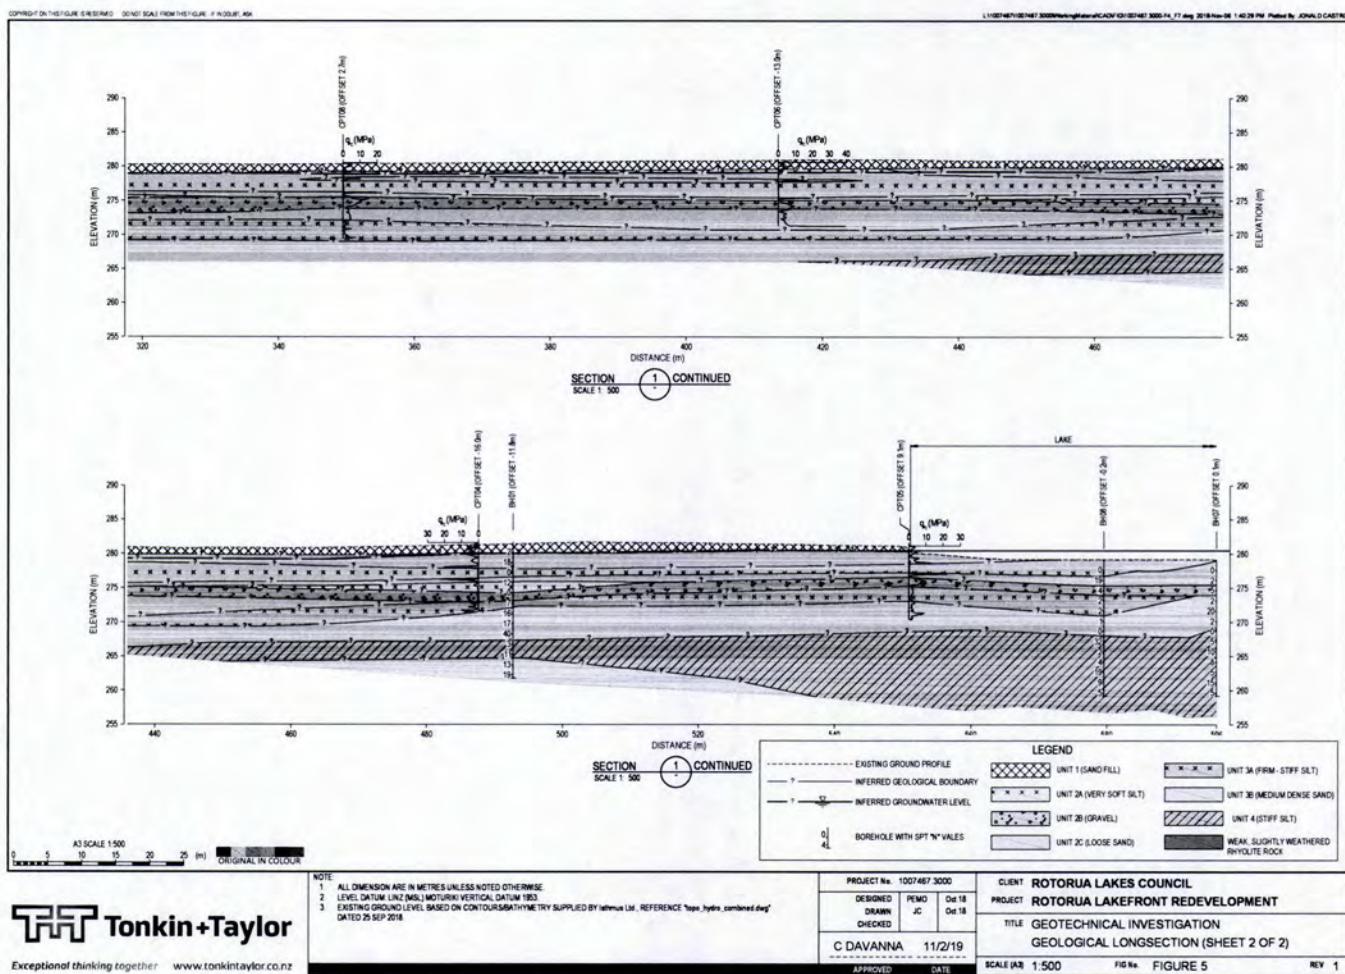
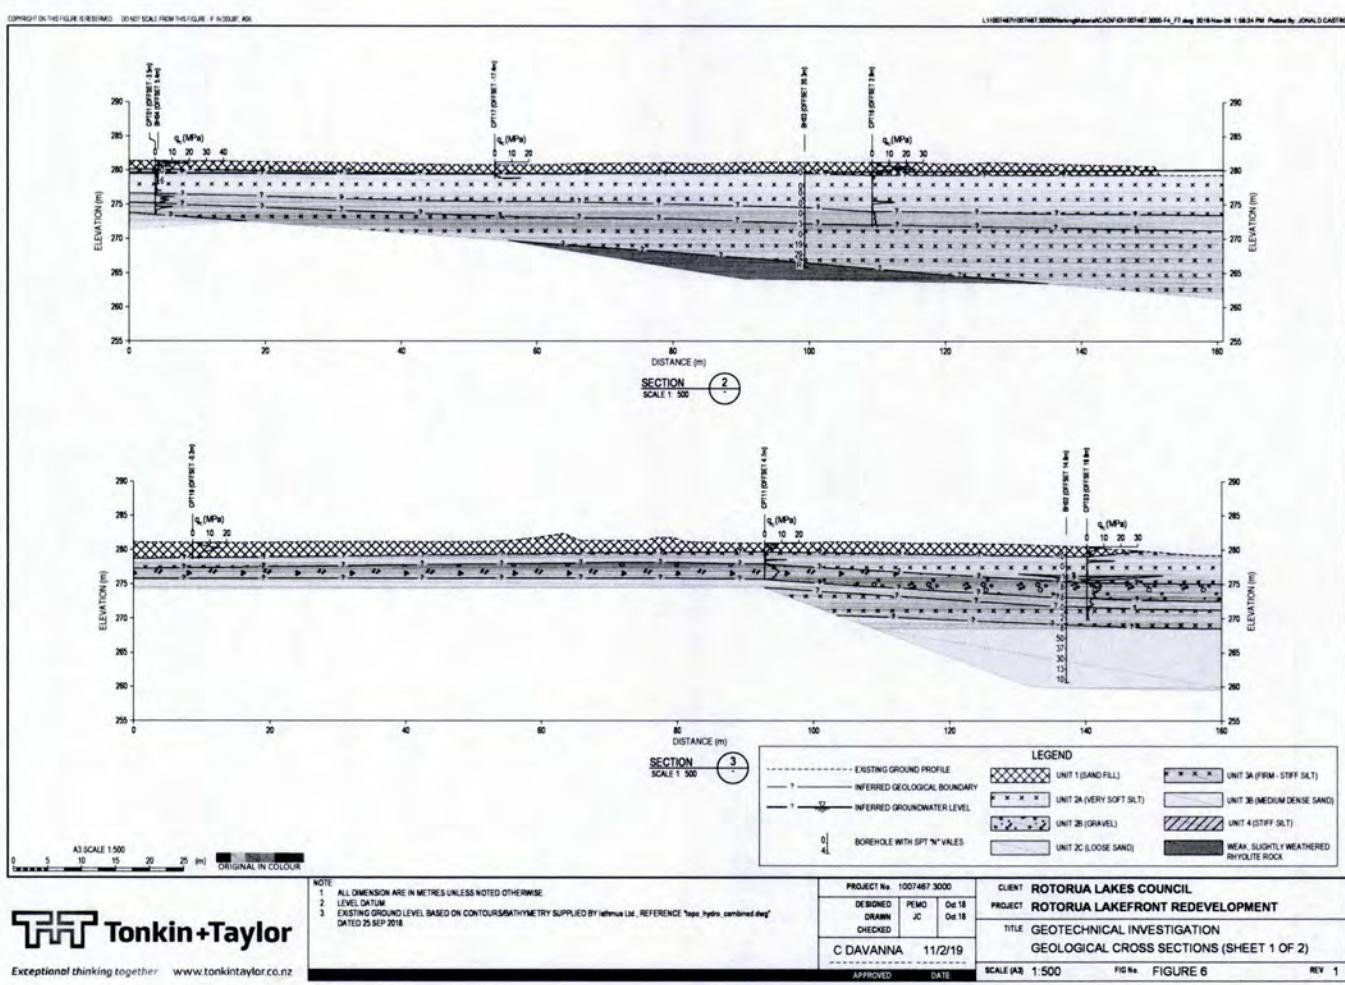
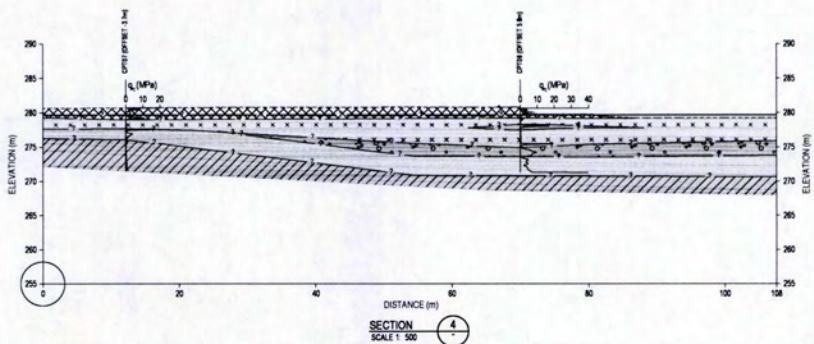
Appendix C: Geological cross sections

LEGEND	
----- EXISTING GROUND PROFILE	UNIT 1 (SAND FILL)
— INFERRED GEOLOGICAL BOUNDARY	UNIT 3A (FIRM - STIFF SILT)
- - - INFERRED GROUNDWATER LEVEL	UNIT 3B (MEDIUM DENSE SAND)
— BOREHOLE WITH SPT 'N' VALUES	UNIT 4 (STIFF SILT)
— UNIT 2B (GRAVEL)	UNIT 2C (LOOSE SAND)
— UNIT 2A (VERY SOFT SILT)	WEAK SLIGHTLY WEATHERED RHYOLITE ROCK
