# **Rotorua Lakes Council**

Museum, Government Gardens, Oruawhata Drive, Rotorua

Geotechnical Factual Report

16592  
15 May 2017

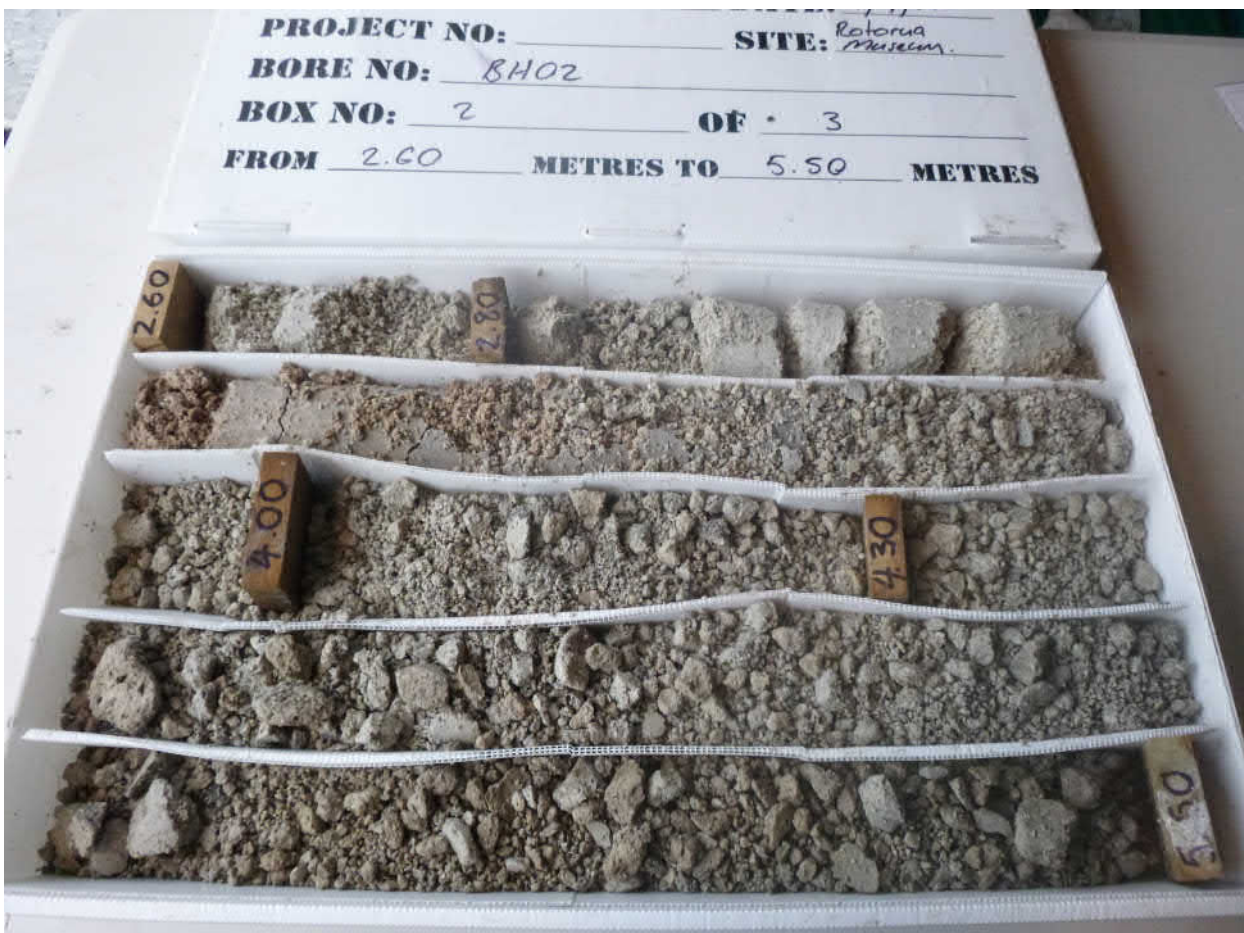
**BH02: Box01 (0-2.6m) and Box02 (2.6-5.5m)**

The purpose of BH2 was to assess the ground directly below the Bath House in the central section of the museum. As a drill rig cannot access the building basement, BH2 was drilled approximately 2m from the bath house at an angle of 60° from horizontal to below the museum.

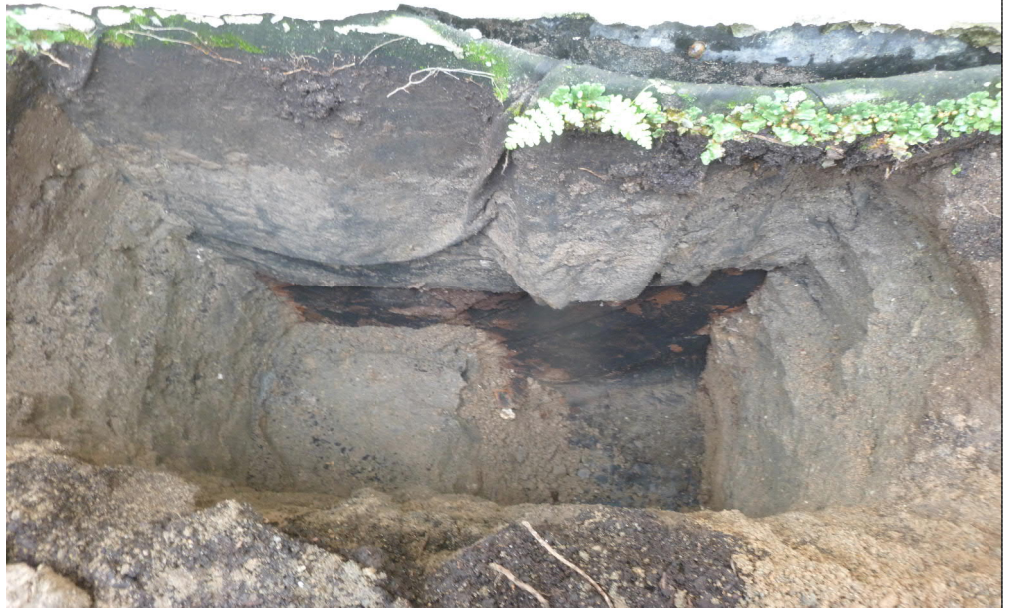
FILL - SAND with some silt, dark brown to dark grey, moist

**REMARKS:** Black geotextile and geomembrane located on the side of building foundation and bottom of excavation

Two trial pits were excavated at the edge of the Northern and Southern extensions to the building at the locations shown in Appendix 1. The purpose of these pits was to confirm the foundation types of the Northern and Southern extensions.
