## ROTORUA BATH HOUSE HERITAGE IMPACT STATEMENT

FEBRUARY 2019

#### DPA Architects

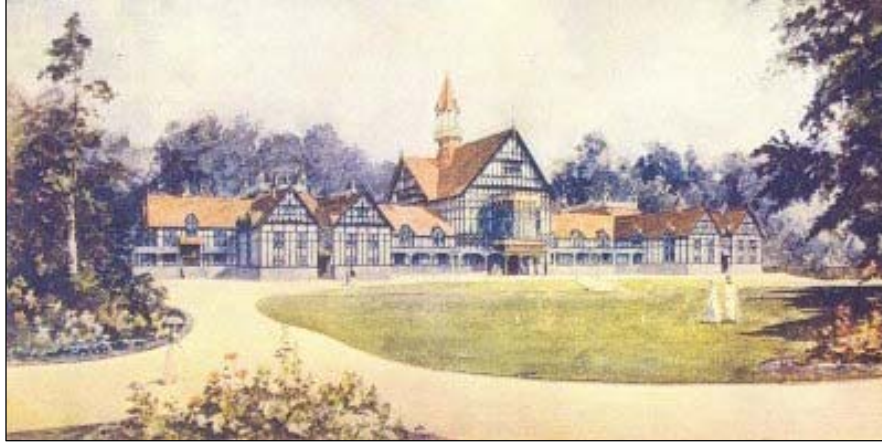
Figure 1 – Bath House original concept. A “homely timbered building” (Rotorua Museum)

In fact, before the end of September that year Wohlmann had already prepared and sent to Wellington a revision of his original plan. Wohlmann provided initial drawings, played a guiding role throughout the planning, and kept a critical eye on the construction.

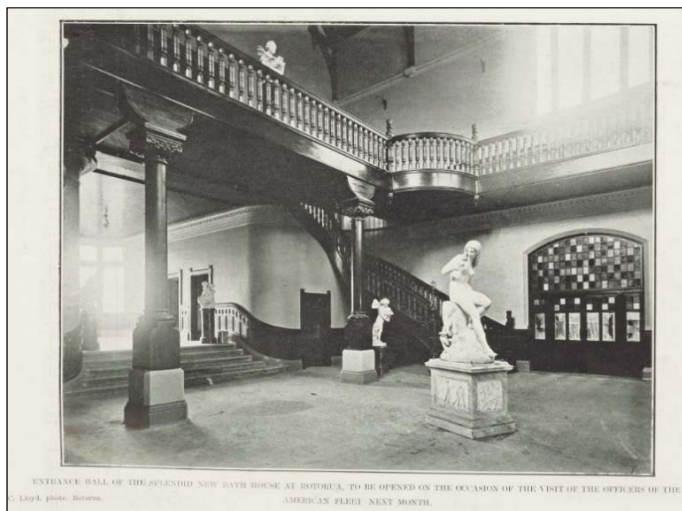
Figure 4 - The central hall prior to the opening of the bath house in 1908 (Auckland City Libraries Heritage Images)

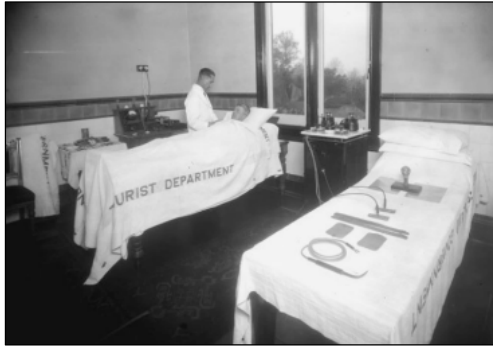
Figure 5 – Treatments as the Rotorua Bath House in the 1920s (Alexander Turnbull Library)

Treatments included the Turkish Baths and Russian Baths; the first a steam bath followed by shower and massage, the second a hot air bath. Both were supplied from a 50hp boiler which also heated the building. The inhalation baths were supplied with steam from one of the cones of the artificial Malfroy Geyser. The Rachel Bath was the largest in the building and designed to promote relaxation.

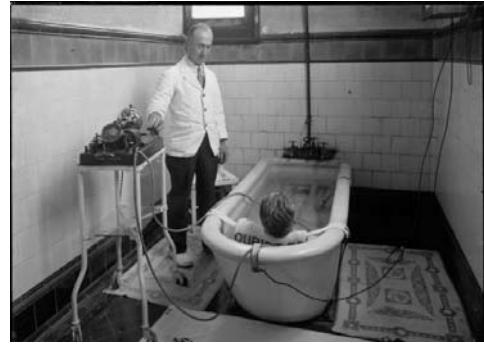
Figure 6 – Treatments as the Rotorua Bath House in the 1920s (Alexander Turnbull Library)

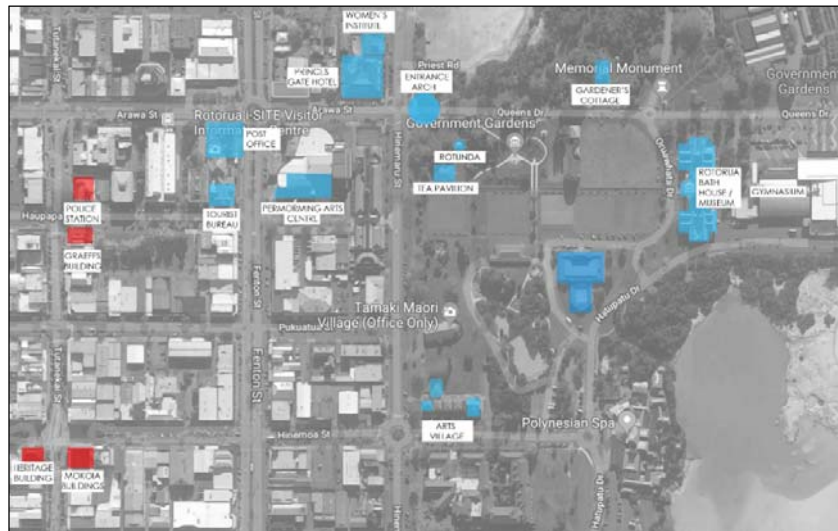
Figure 9 - The Rotorua Bath House situated within Government Gardens showing surrounding listed heritage buildings (blue) and unlisted (red). (DPA Architects)

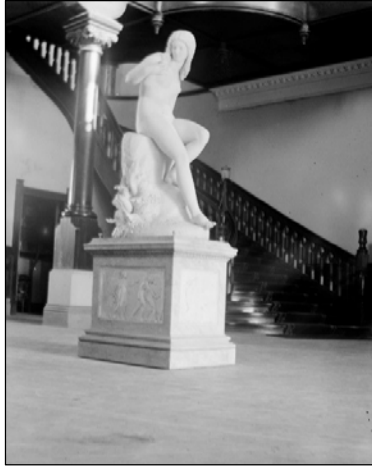
*Figure 52 - The original lighter coloured floor tiles in the central hall (Auckland Libraries Heritage Images)*

Within the central hall, the concrete floor slab was originally overlaid with light coloured tiles. These tiles were replaced at some point with the current darker terracotta versions. The upper floor is tongue and groove timber, believed to be matai.

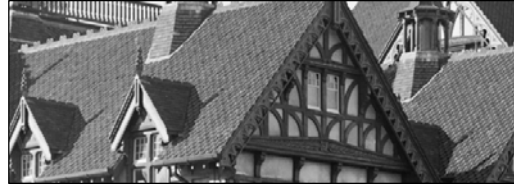
*Figure 10 - Bridgewater roof tiles 1908 (Turnbull Library)*

The present Marseille roof tiles are replacements from around 1952. According to the specification and from original tiles found in the basement, the roof was originally sheathed with a more ornate and darker coloured No.4 Bridgewater tile chosen and sourced specifically from Colthurst and Symons, England. These tiles can be seen in photographs of the building up until around 1950. Architect Corlett thought the Bridgewater tile preferable to the Marseille tile, more in harmony with the style of the building and “home made” – “home” being England.

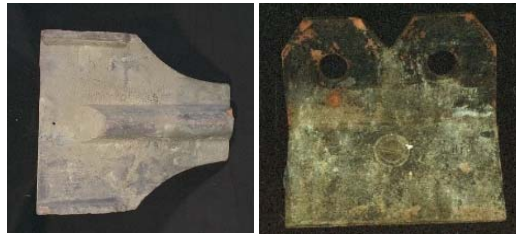
*Figure 11 - An original 'well burnt' Bridgewater roof tile from the Bath House building (Rotorua Museum)*

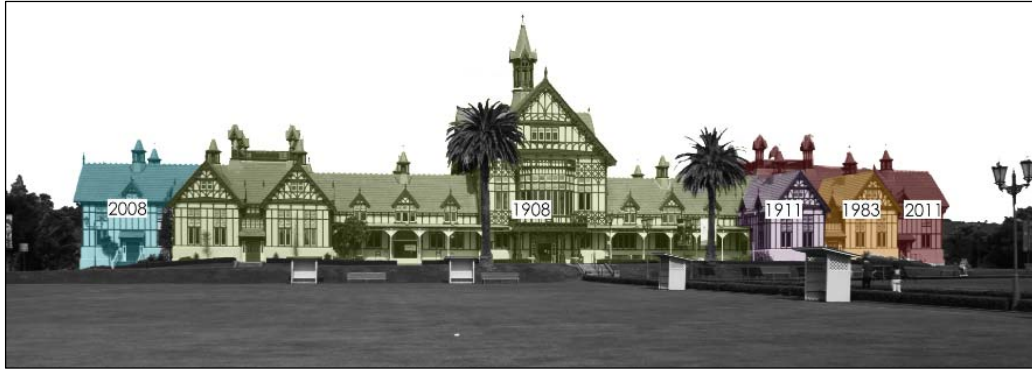
Figure 6 - the different stages in the realisation of the Bath House scheme

Budget restrictions had originally compelled the omission of the extreme north and south extensions, as well as the south wing. The first gable to the south wing was added in 1911 although the second gable was not completed until February 1983.

In 2008, the north wing was extended with an addition being built largely to the design envisaged by Wohlmann in 1908. In 2011, the south wing was similarly extended. Wohlmann's conception was now achieved, in plan at least, with the symmetry envisaged. These additions would provide further gallery space for the Rotorua Museum.
