## ROTORUA BATH HOUSE (FORMER) CONSERVATION PLAN

April 2019

## DPA Architects

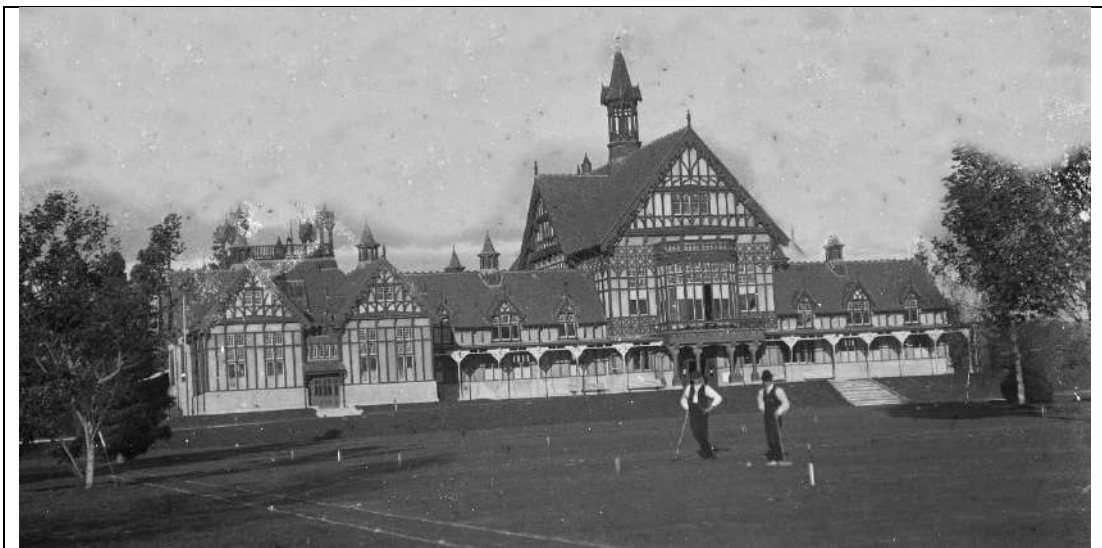
Figure 10 – The Rotorua Bath House as originally completed  
Source: Palmerston North Museum

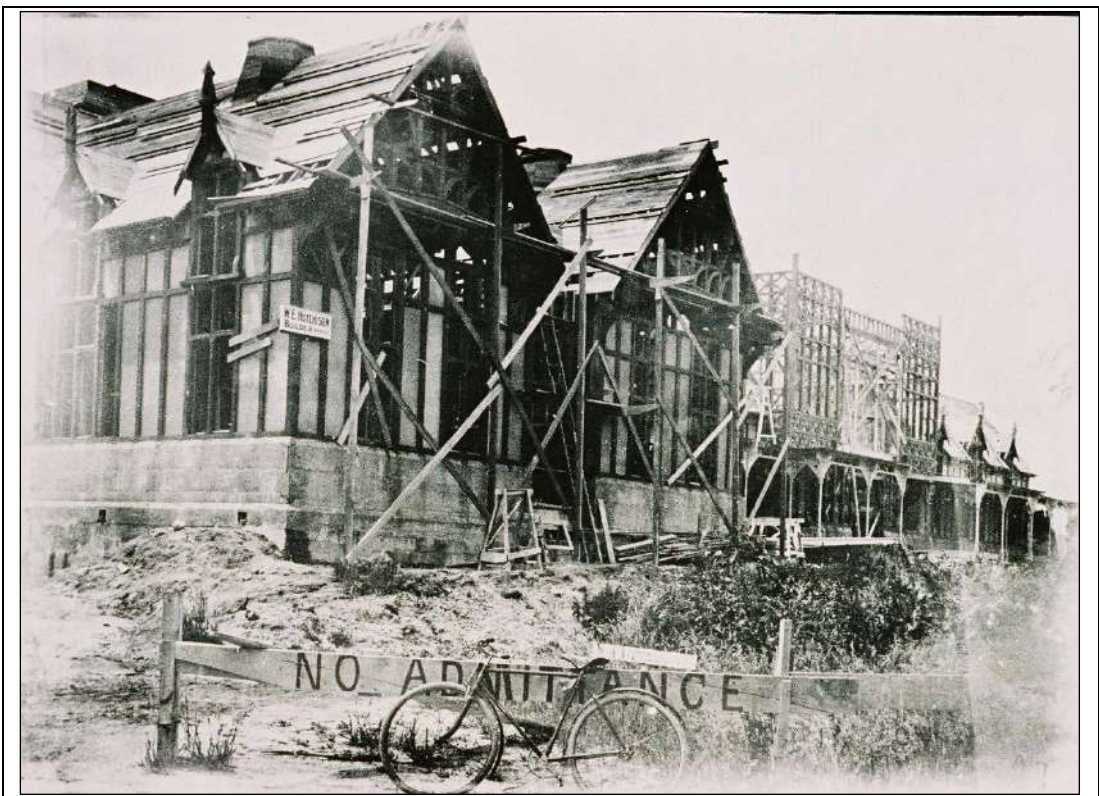
Figure 13 – The Bath House under construction (front elevation) showing roof sarking.  
Source: Rotorua Museum

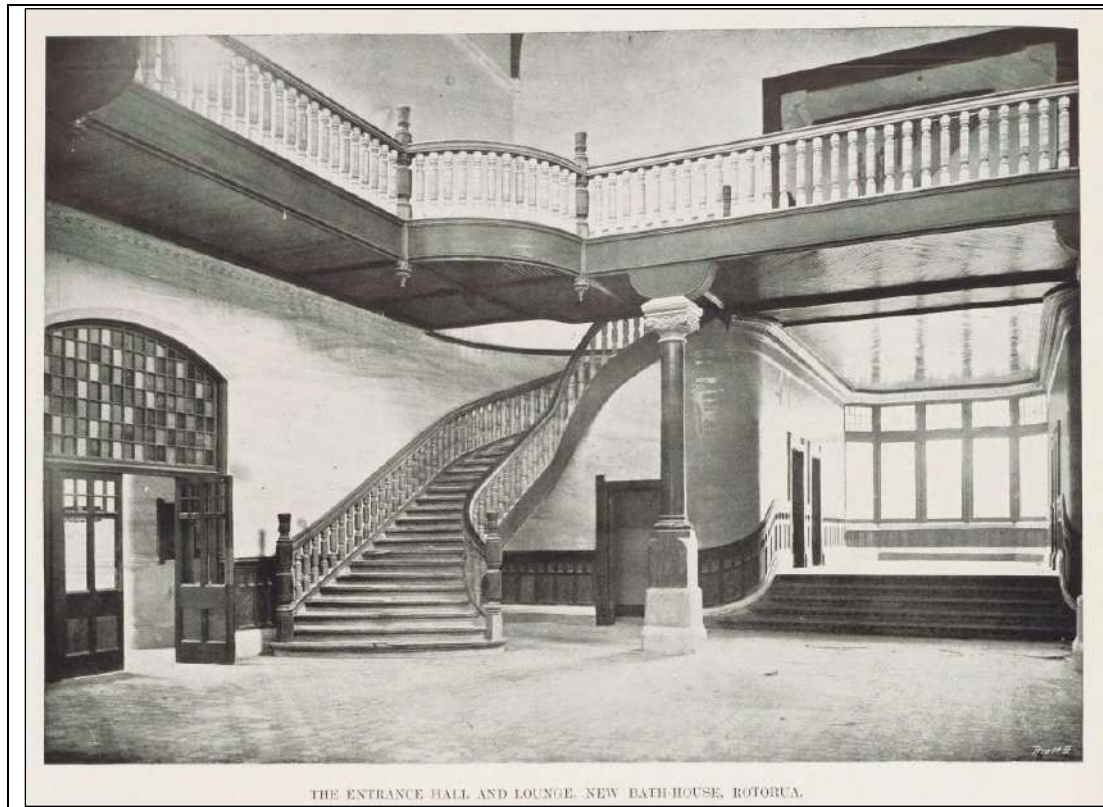
Figure 17 - The central hall nearing completion in 1908. Note the cornice between the roof trusses and the upper staircase which were removed during the 1960s.

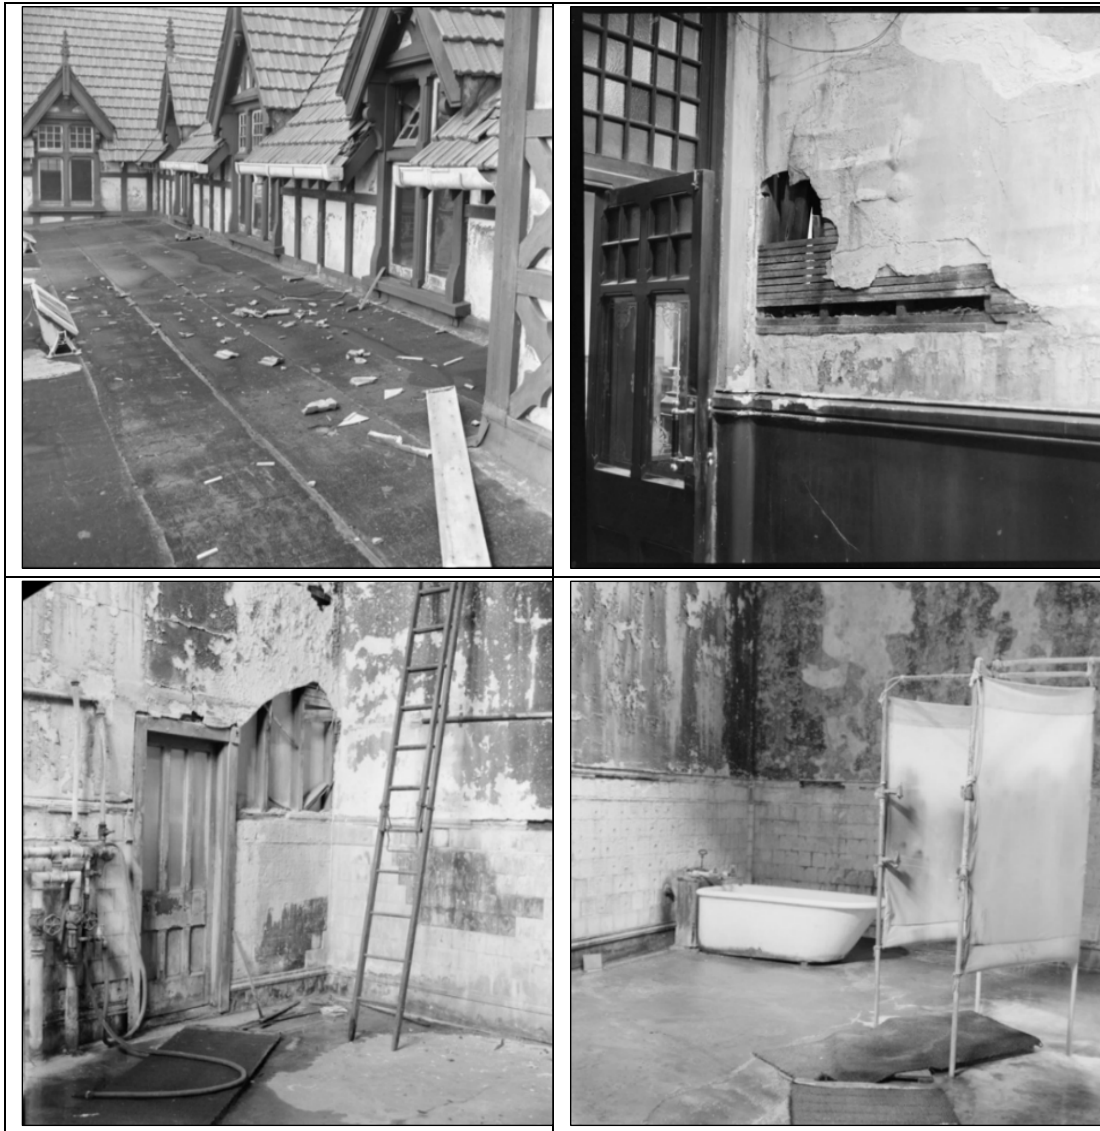
Figure 29 – Series of photographs showing the extent of deterioration in the building by 1960.  
Source: Alexander Turnbull Library

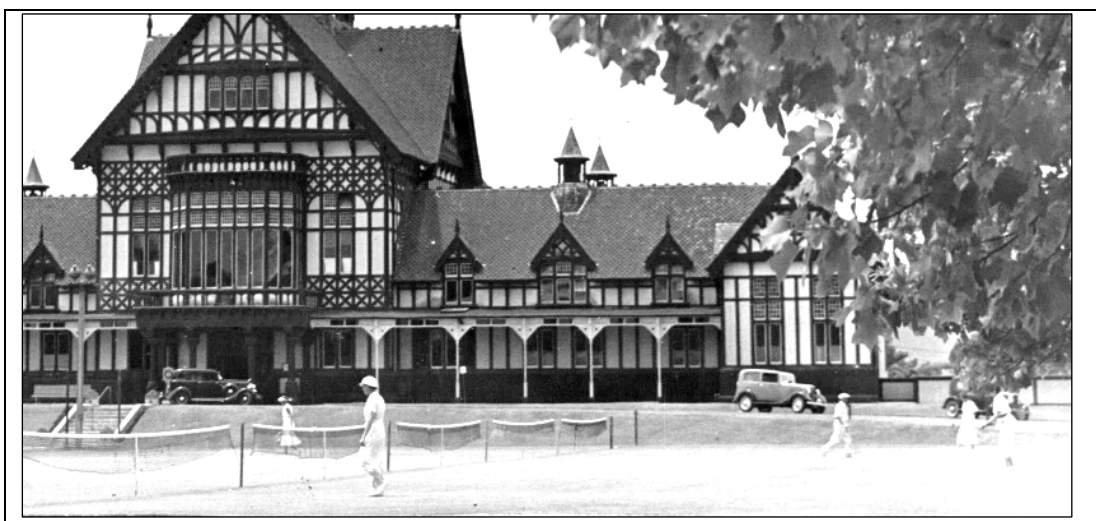
Figure 41 – The 1911 gabled addition (right) in 1930.

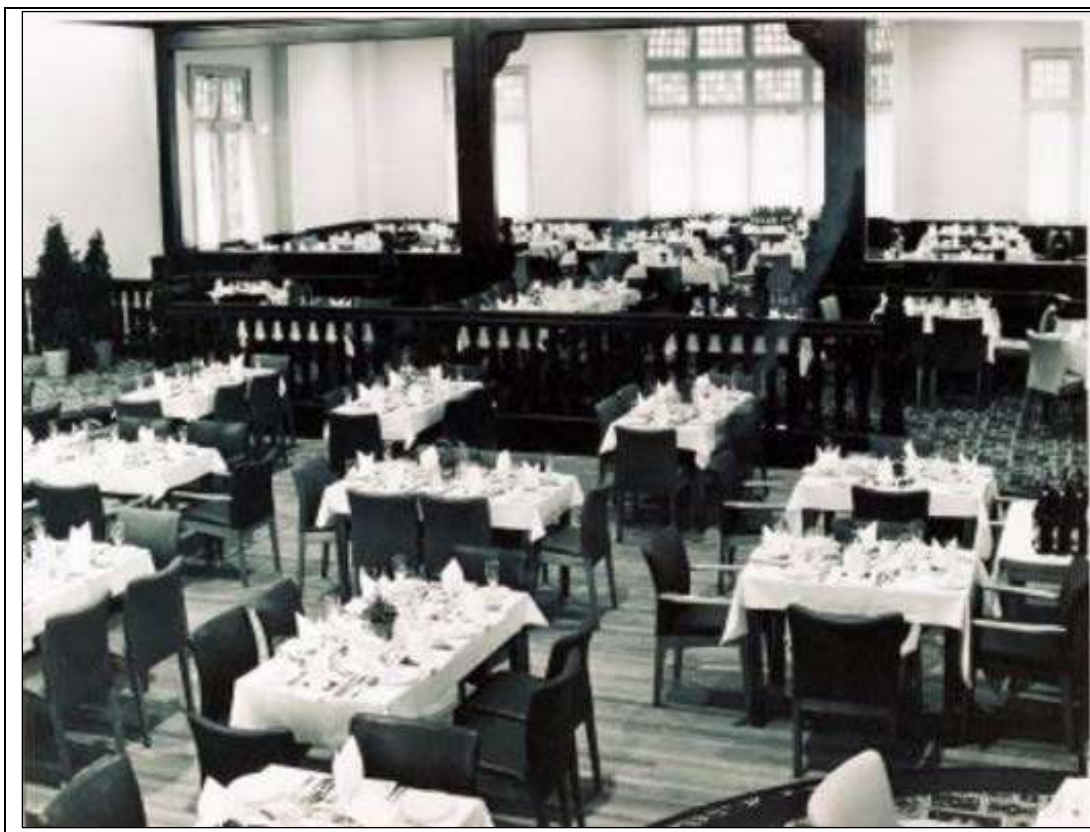
Figure 43 – The Tudor Towers Restaurant, showing the infilled void in the floor and clearance of the walls towards the rear of the mezzanine.

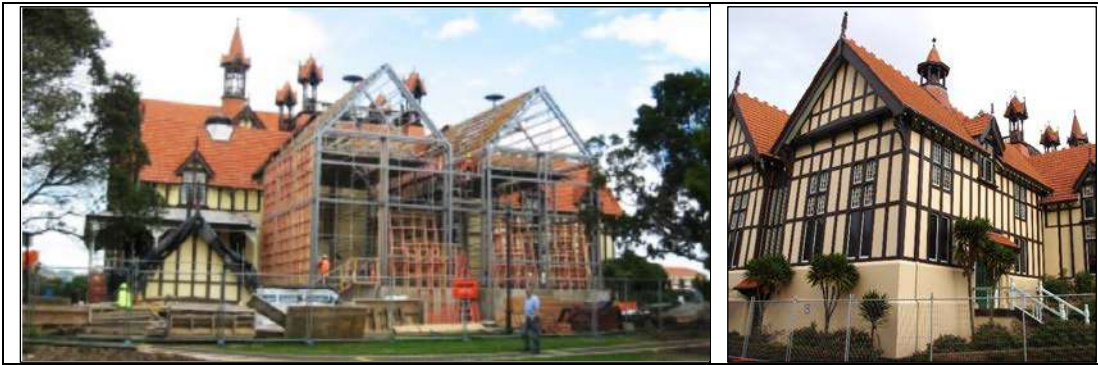
Figure 48 – The 2008 north wing addition under construction (left) and completed (right).  
Source: Rotorua Museum and DPA Architects

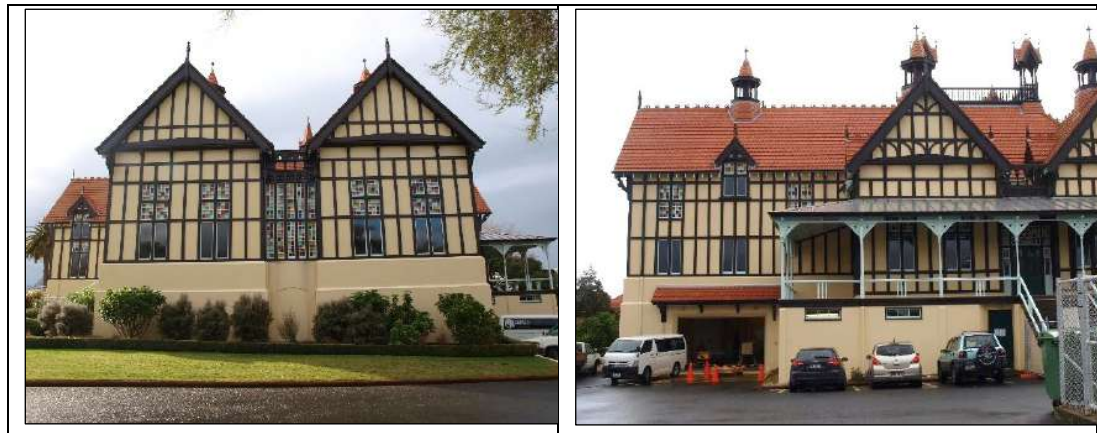
Figure 51 (left) – The completed south elevation of the 2011 addition. Note the inaccuracies of the detailing and colouring of the stained glass windows compared with the 1908 building, and Figure 52 (right) – The completed east elevation of the 2011 addition showing the loading dock which was not part of the original plans.  
Source: DPA Architects

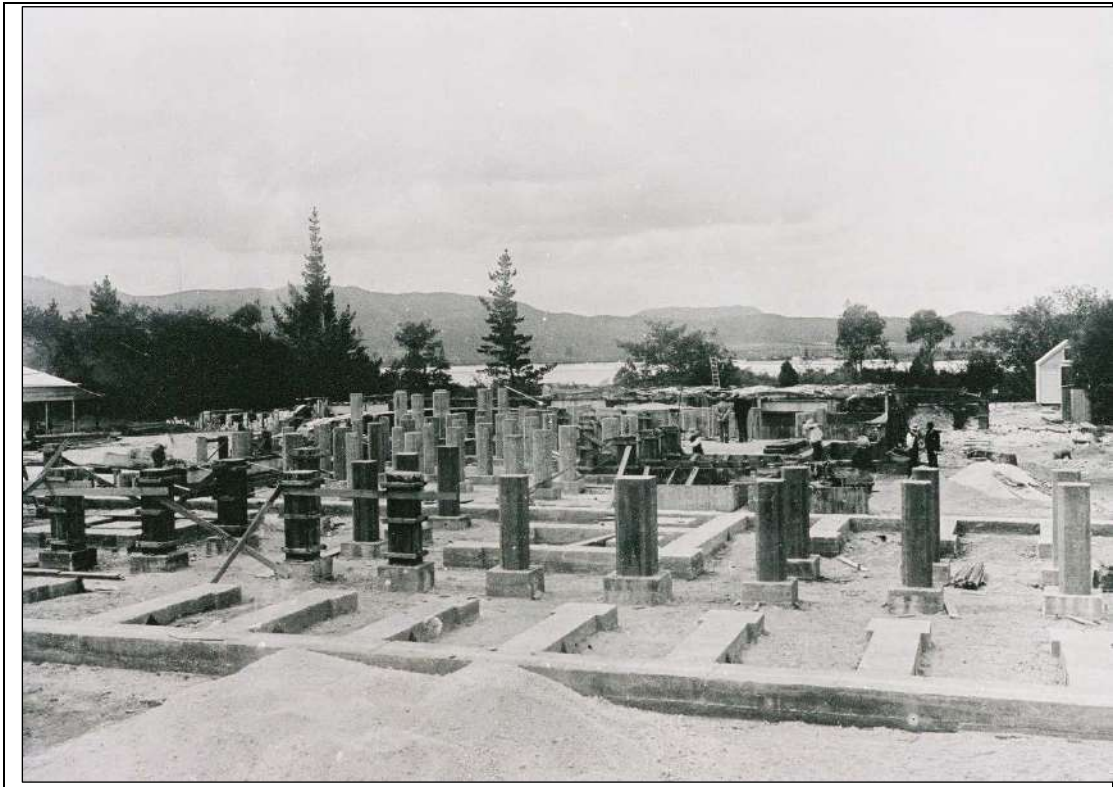
Figure 57 – The pumice concrete columns and vaulted ceiling structure under construction, 1906.  
Source: Rotorua Museum

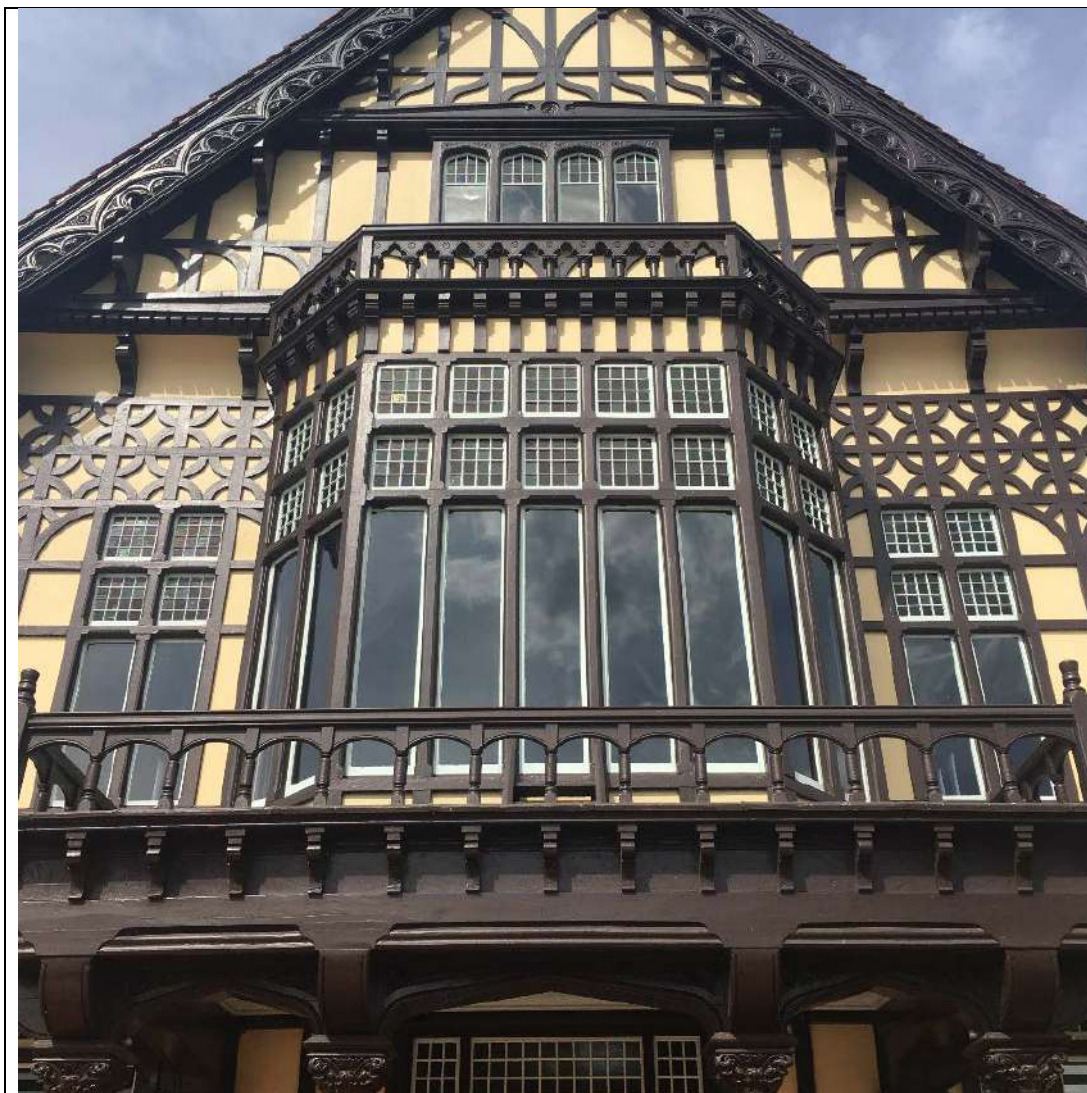
Figure 58 – The exposed timber framing with concrete panels on the west façade of the 1908 section of the building

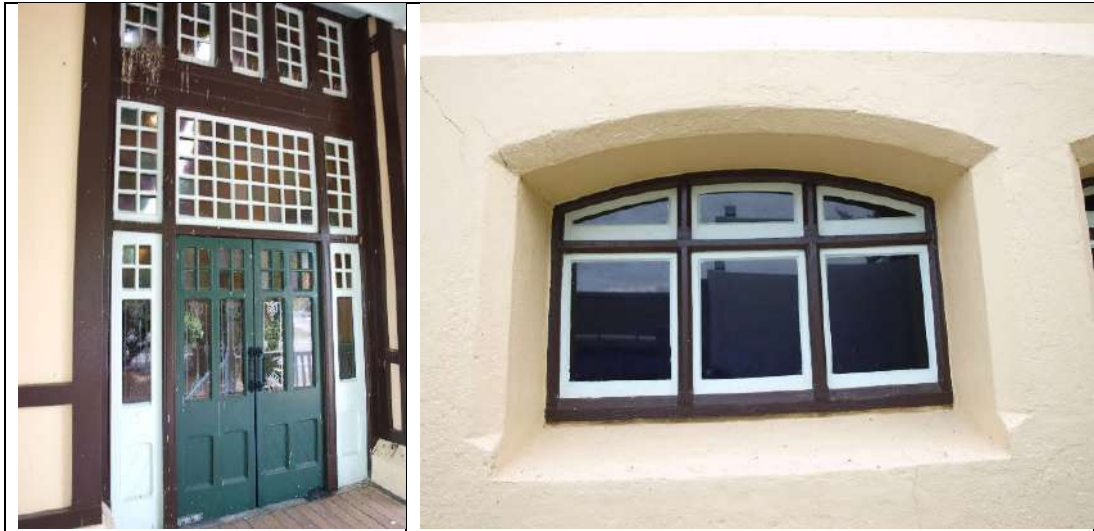
Figure 59 – Original timber joinery in north wing (left) and Mud Baths (right)  
Source: DPA Architects

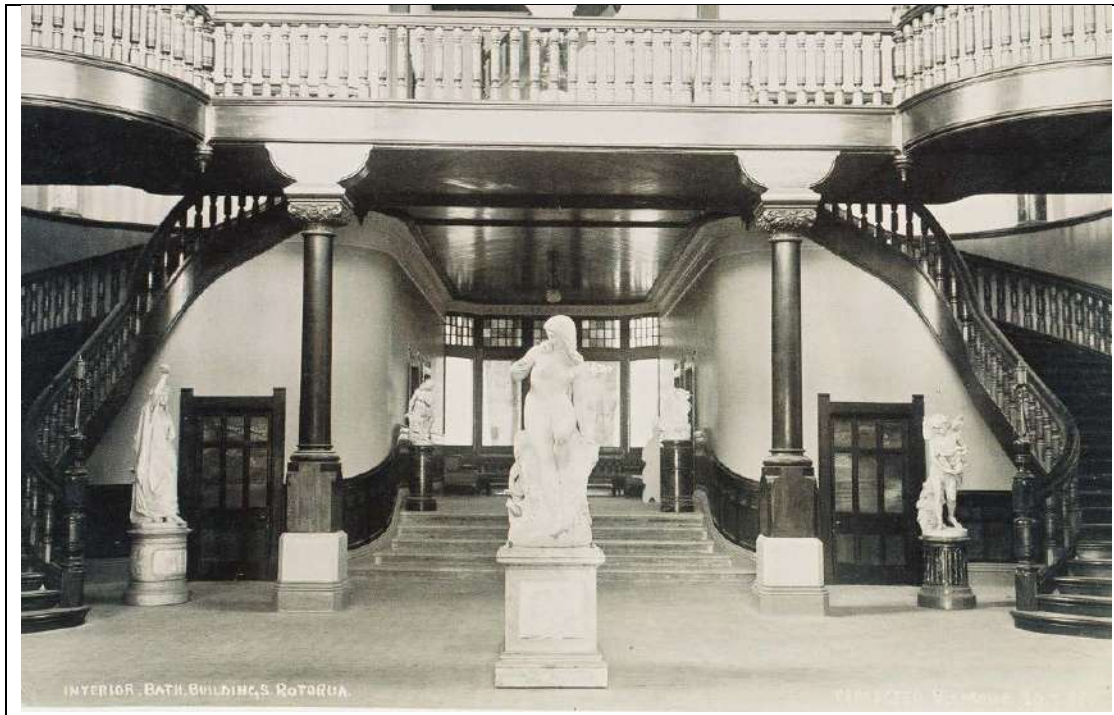
Figure 65 - The original light coloured floor tiles in the central hall and raised floor area.  
Source: Alexander Turnbull Library

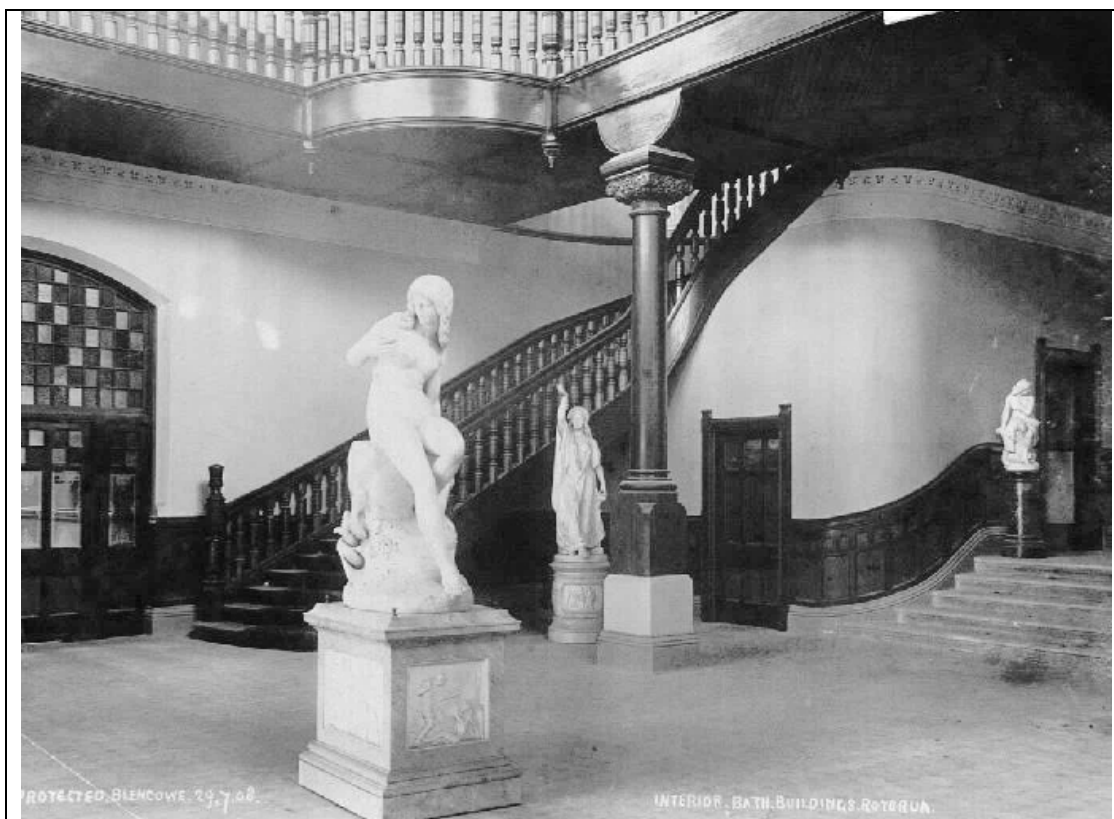
Figure 66 - The original light coloured floor tiles in the central hall and steps.  
Source: Rotorua Museum

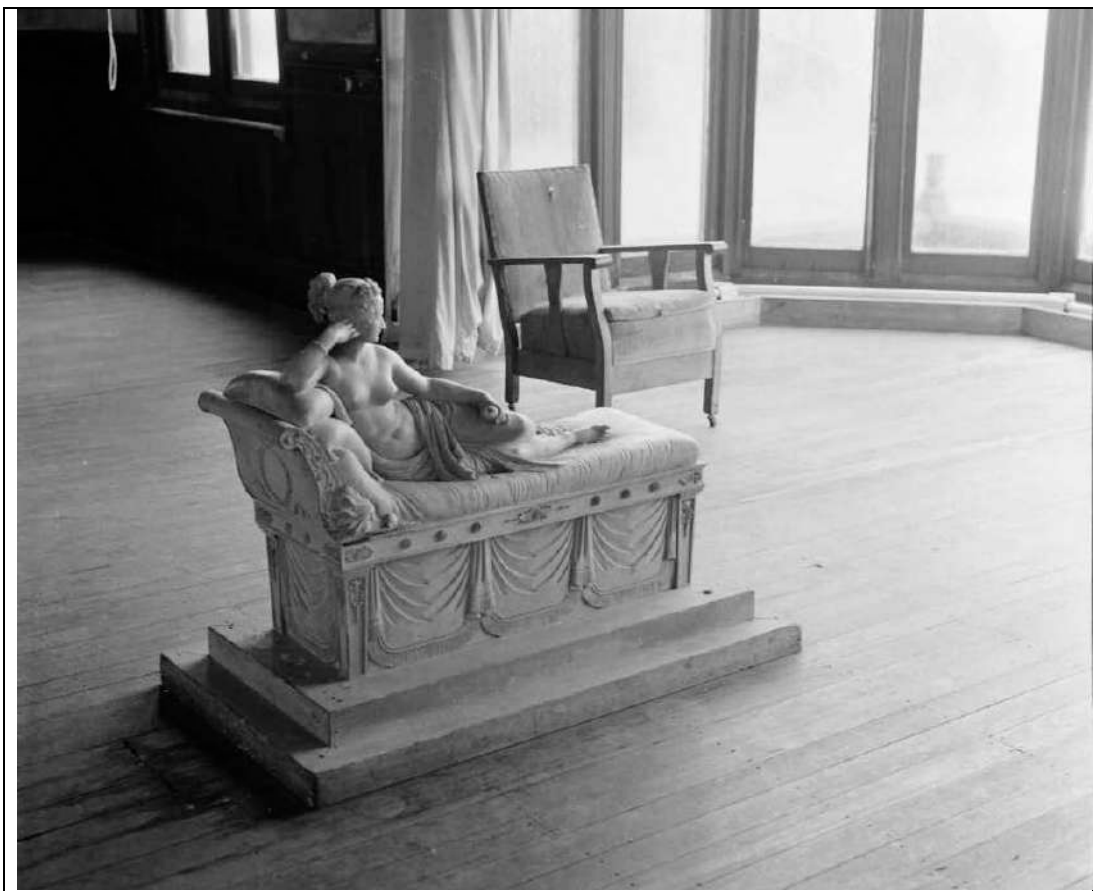
Figure 70 – The original floor treatment of the Central Hall Mezzanine.  
 Source: Alexander Turnbull Library

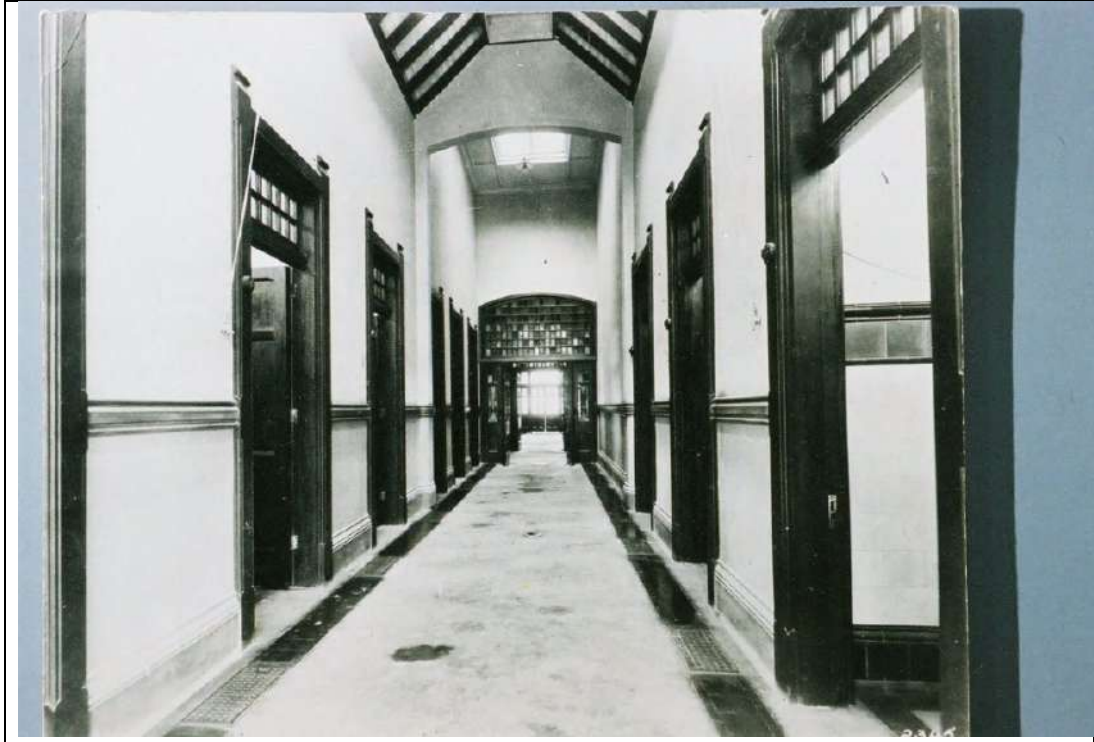
Figure 71 - The north wing corridor probably prior to the 1920s showing original dados.  
Source: Rotorua Museum

Walls are generally plaster, either over concrete or timber laths where walls are timber framed. Dado moulds and, in some instances skirtings, have also been formed in plaster. In the areas that originally housed baths, glazed tiles and skirtings were fixed to the walls to provide an impermeable surface. Remnants of these tiled surfaces can be seen in the north east corner. Within the main hall at the entry level is a fine timber panelled dado. At the upper level can be found remnants of a simpler tongue and groove dado.

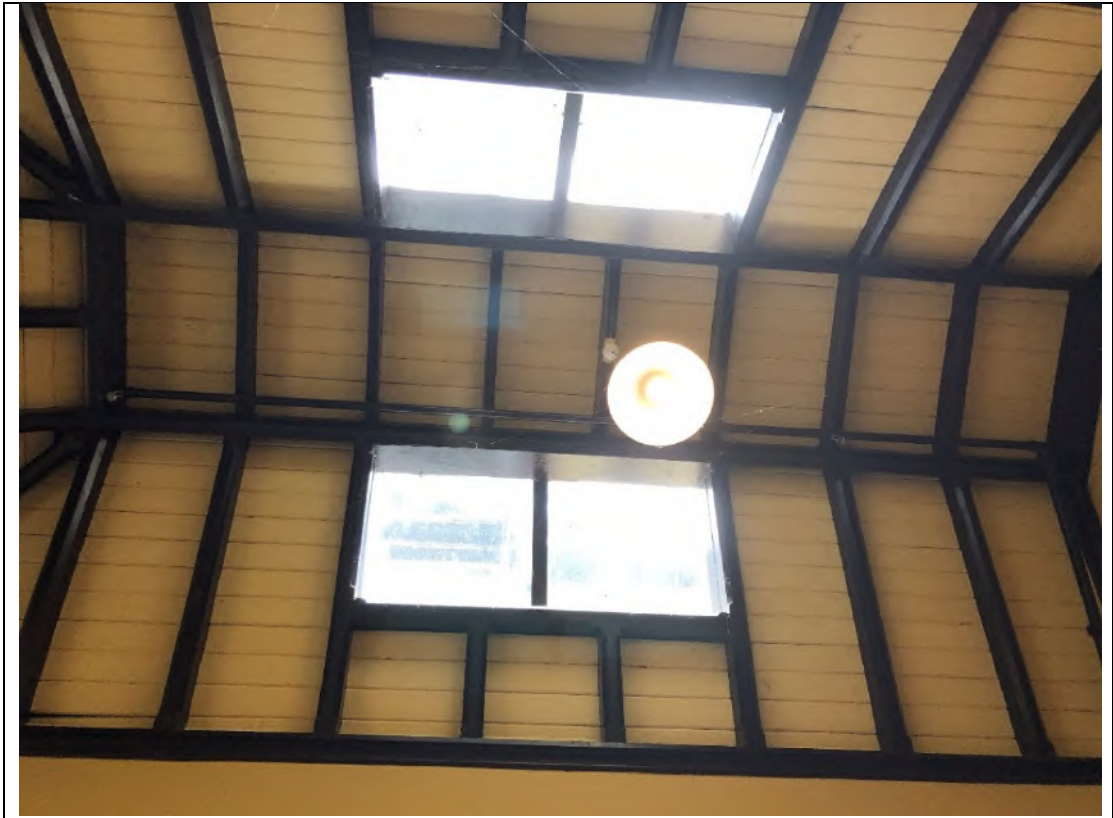
Figure 69 – Original coffered ceiling, north wing  
Source: DPA Architects

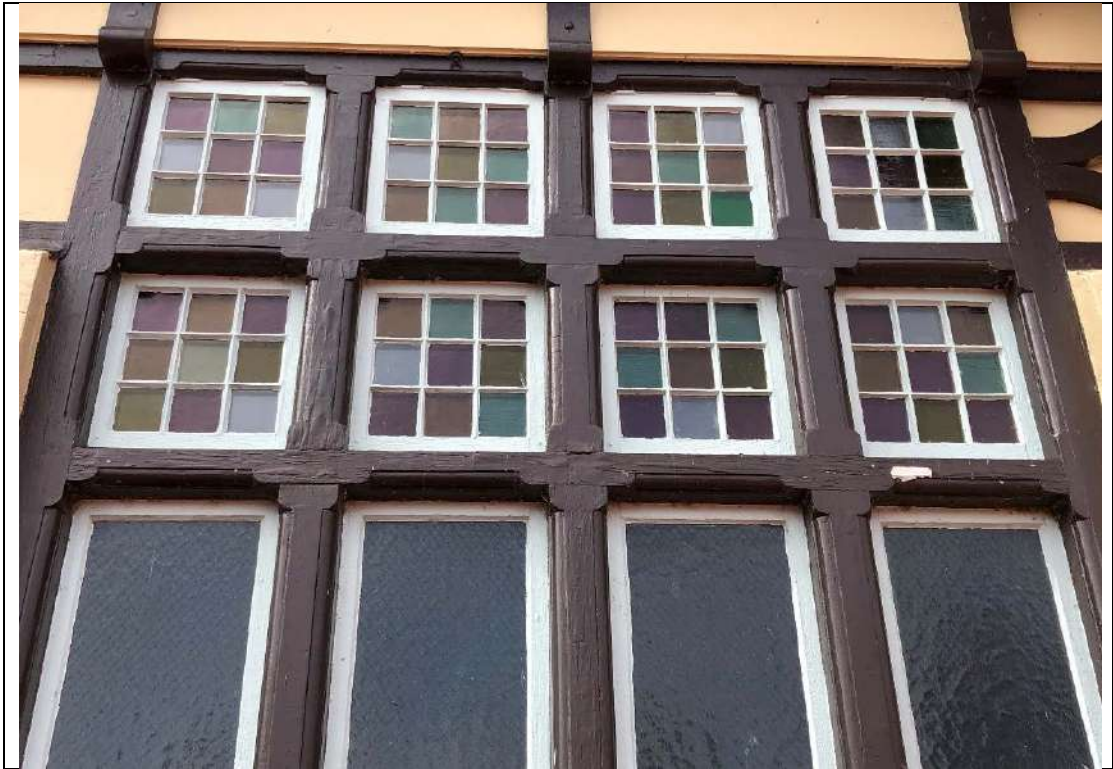
*Exterior view of windows to the 1908 central hall showing deteriorated paintwork.*

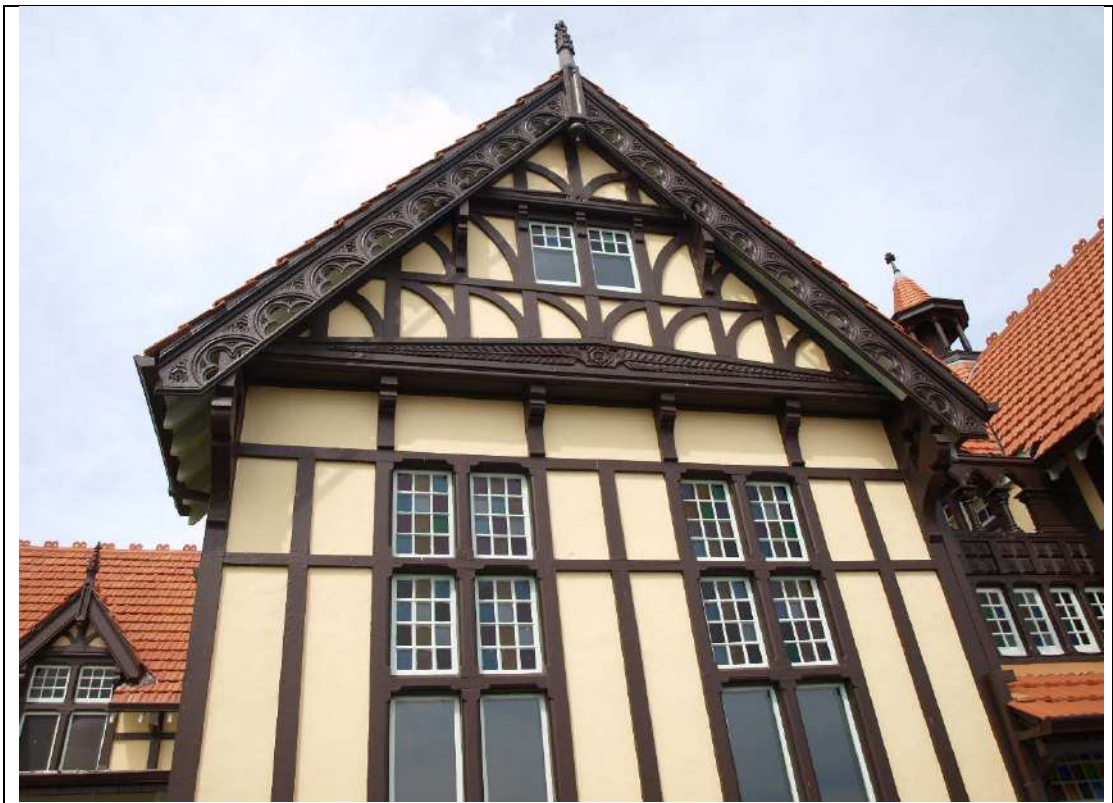
*The west façade of the 1908 building showing detail of a gable end and tower*

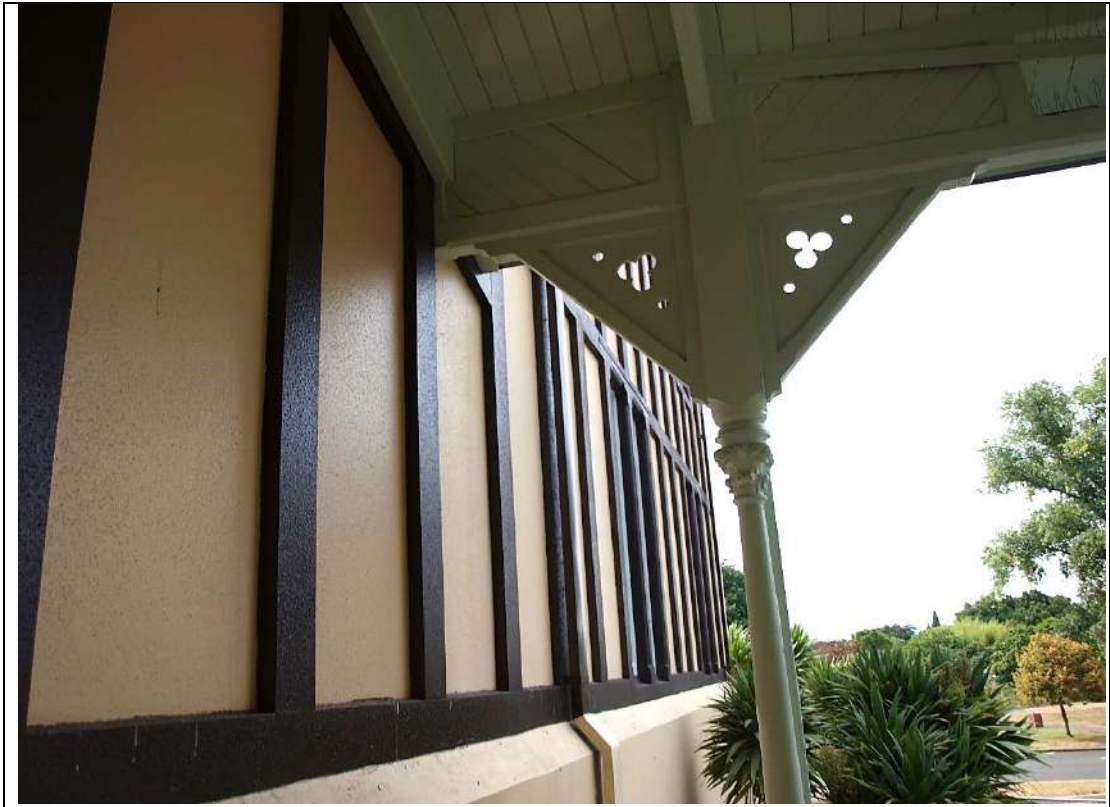
*Verandah detail on the 1908 north wing*

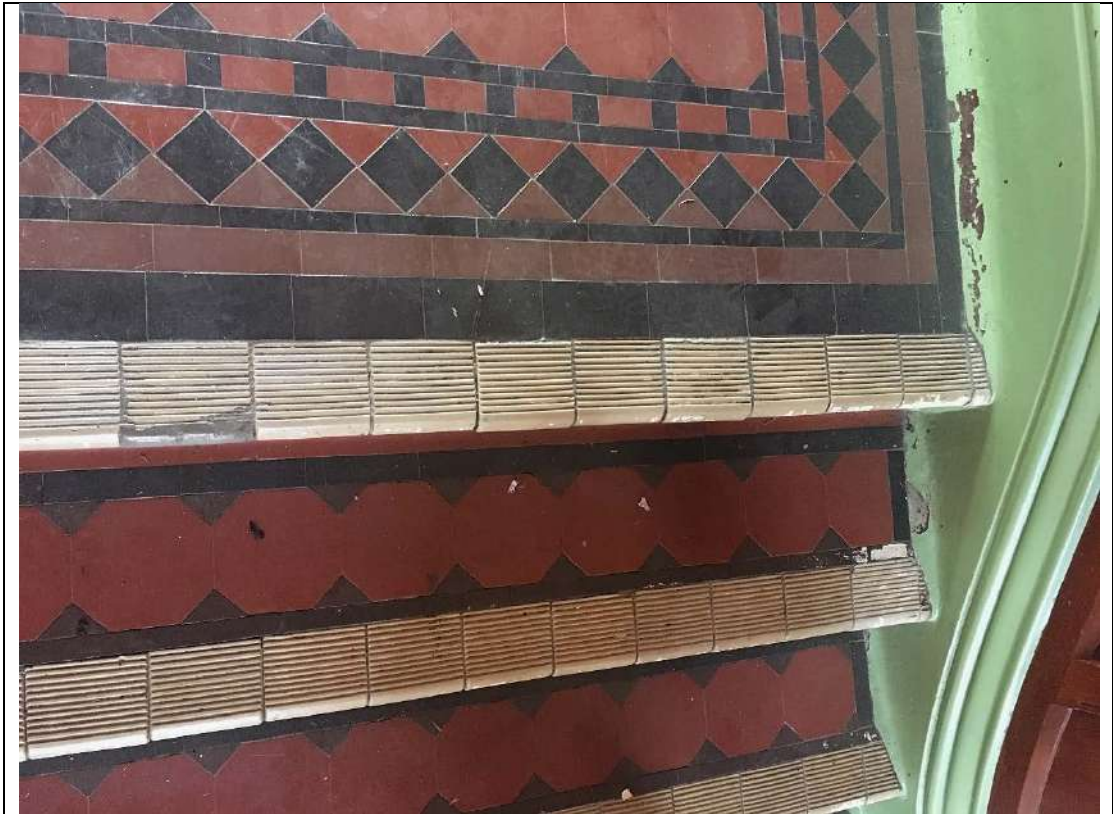
*Assumed 1920's tessellated tiles and step nosing tiles at rear of 1908 central hall.*

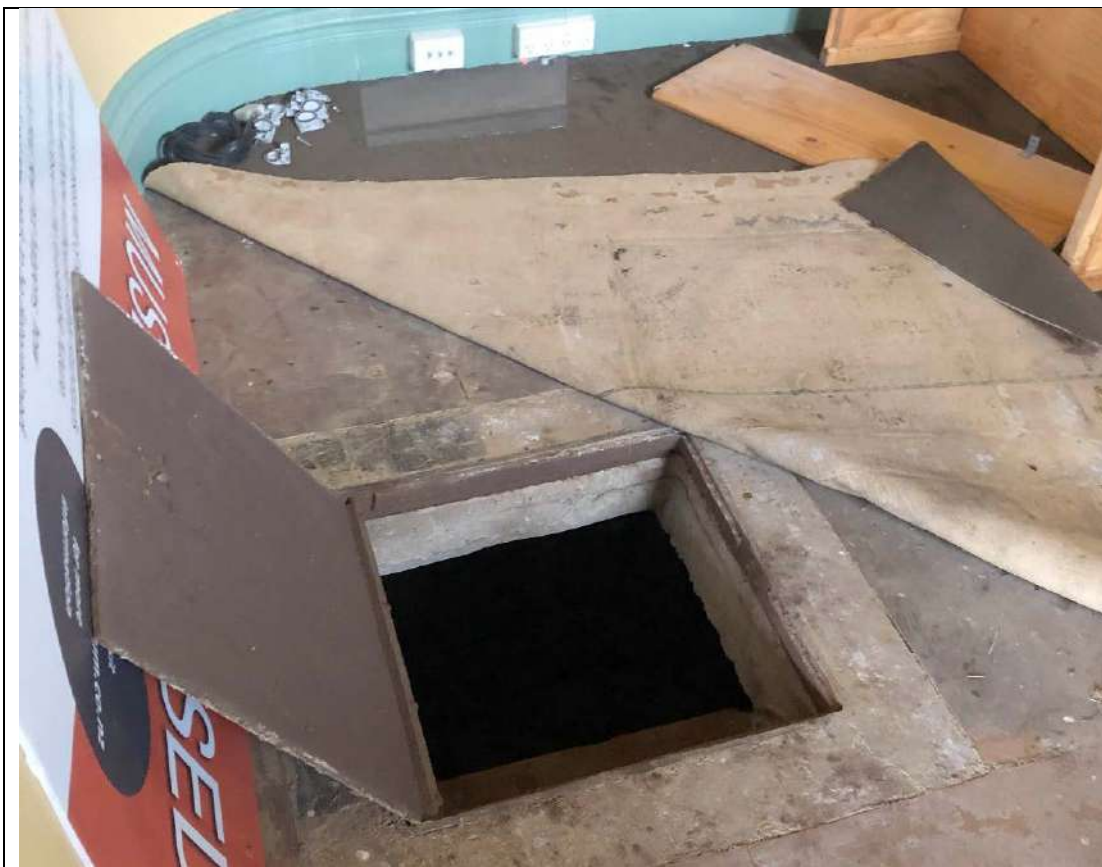
1908 hatch in the floor of room G 3K and ladder to strong room (B 3C)

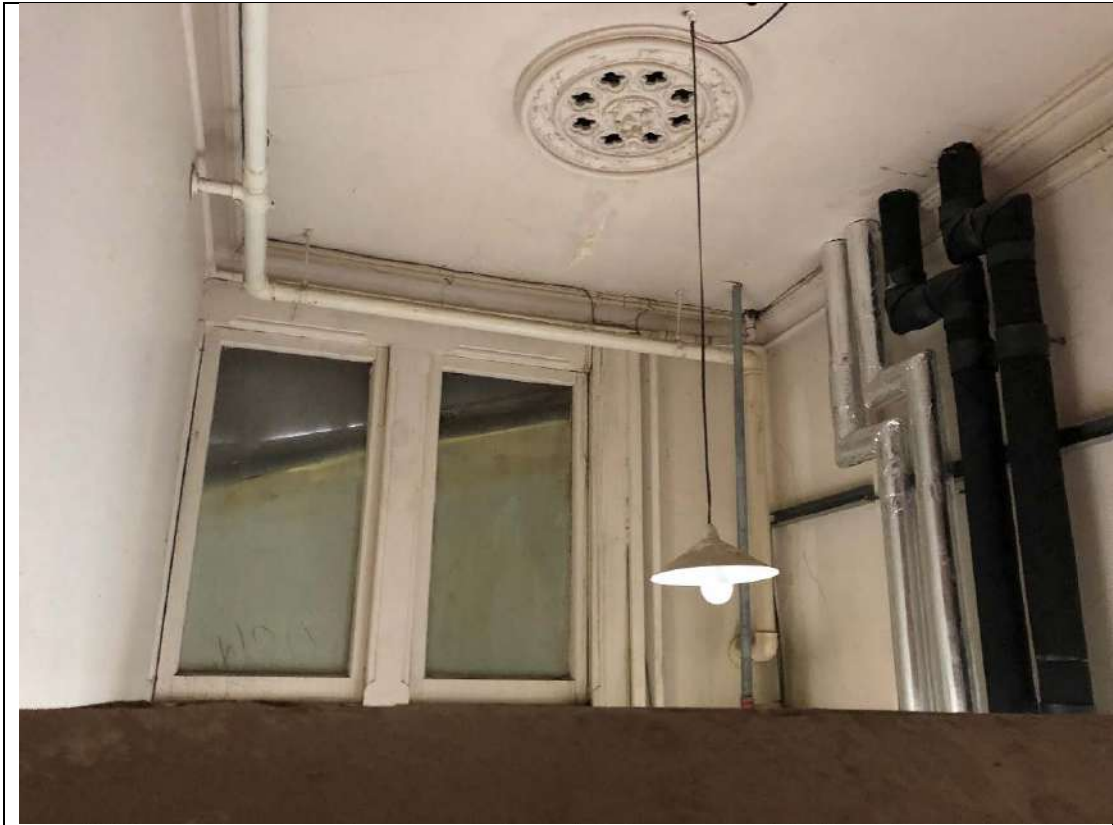
Original 1908 ceiling, window, architraves in office (G 3D) to rear of central hall

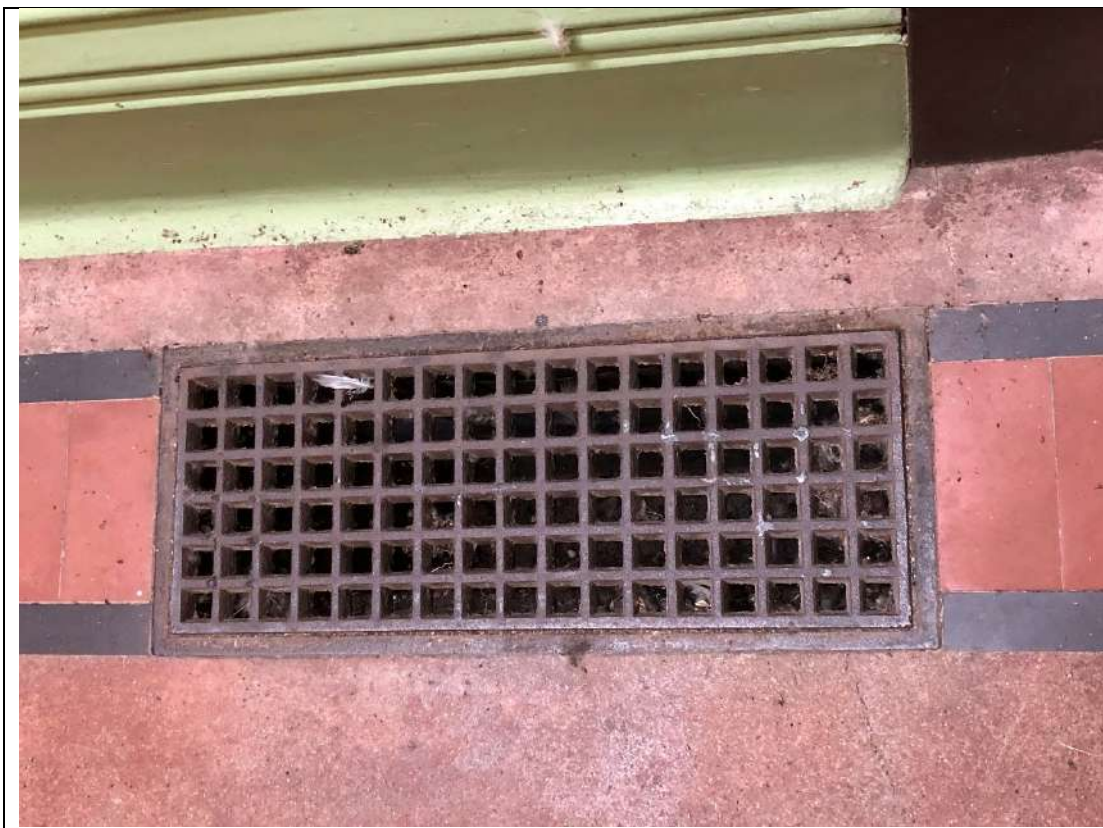
1908 north wing original floor grate (G 5G).

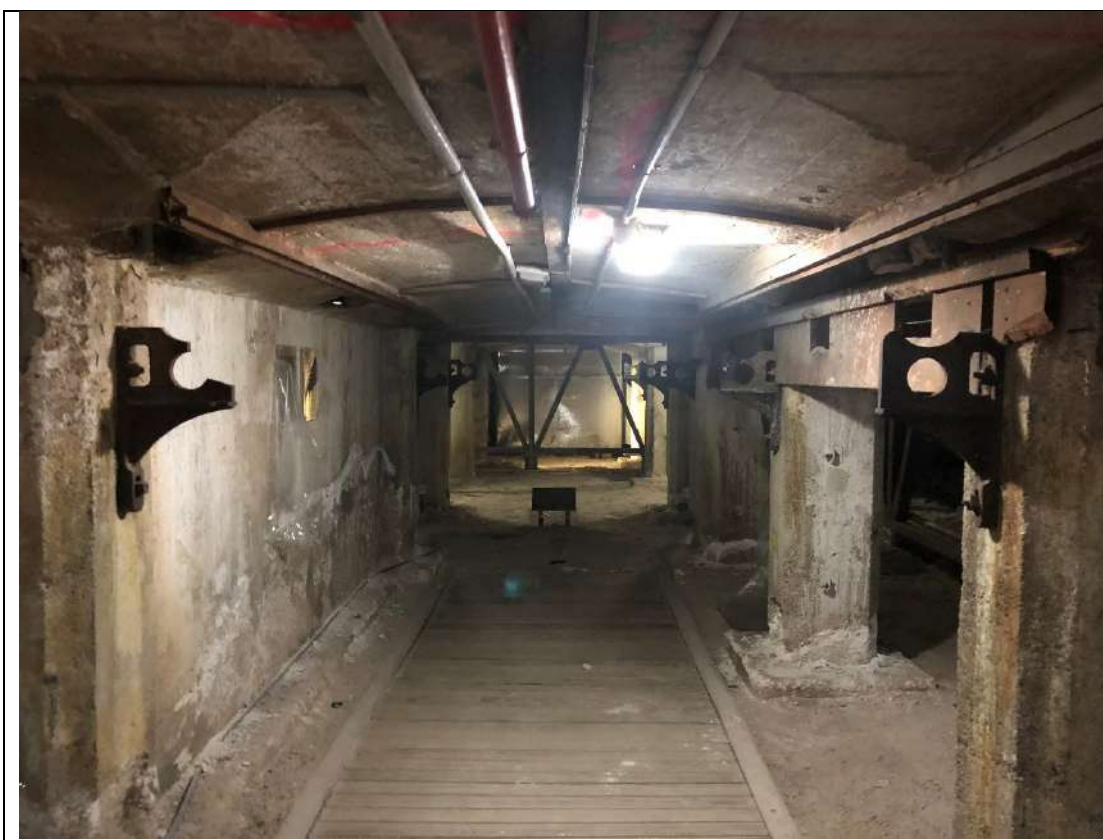
Original concrete columns, walls, ceiling and cast iron fixtures, 1908 north wing basement (B 4B)

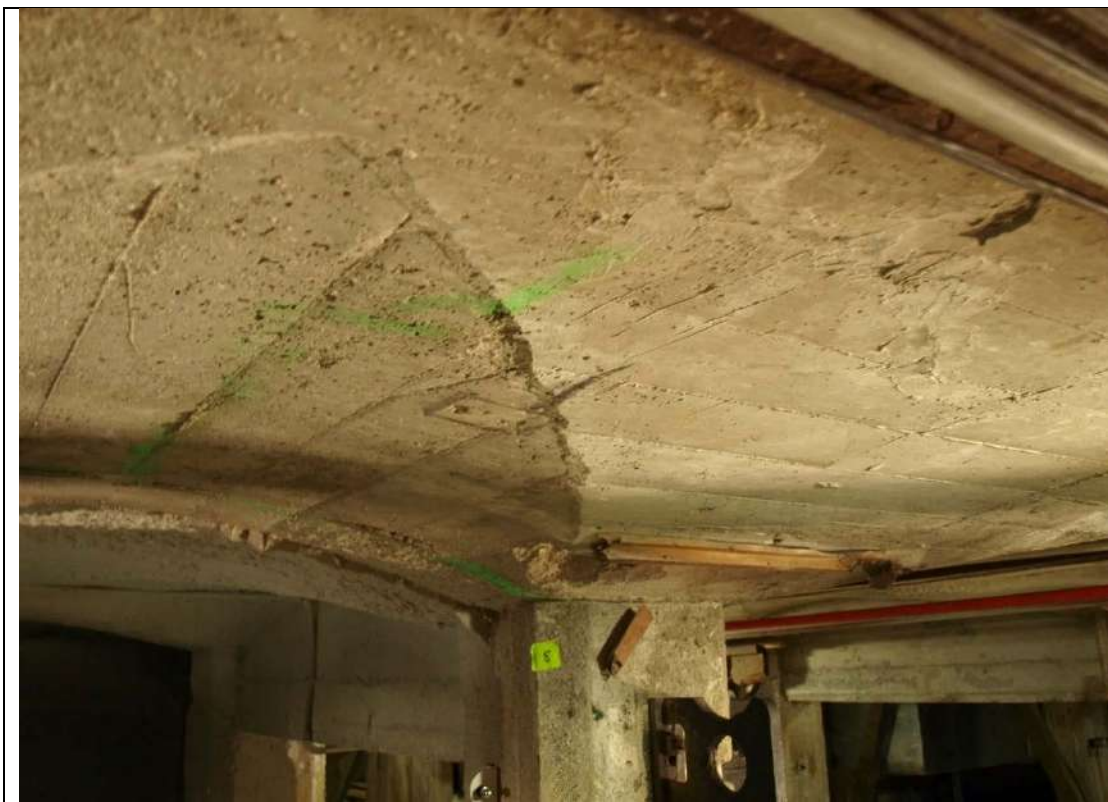
Vaulted ceiling, basement (B 4B)

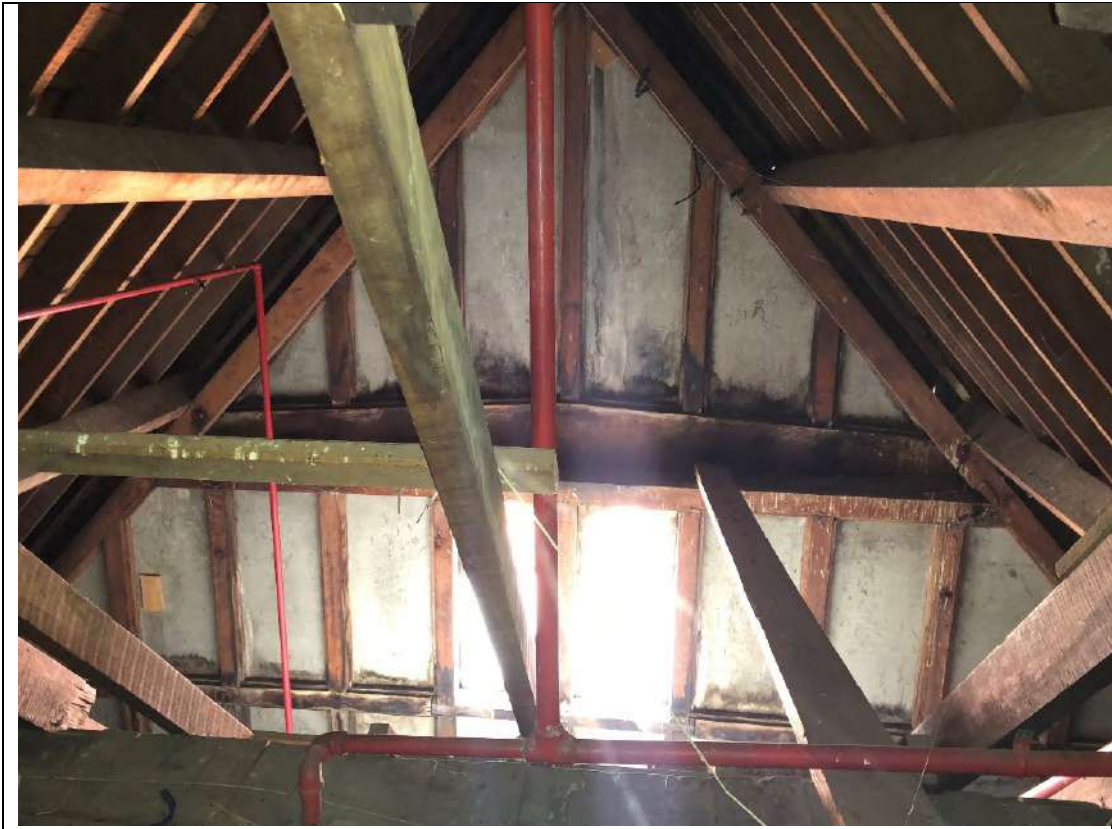
1908 roof space above the central hall. Inside face of timber wall framing and concrete infill panels. Note water staining.
