## ROTORUA BATH HOUSE (FORMER) CONSERVATION PLAN

April 2019

## DPA Architects

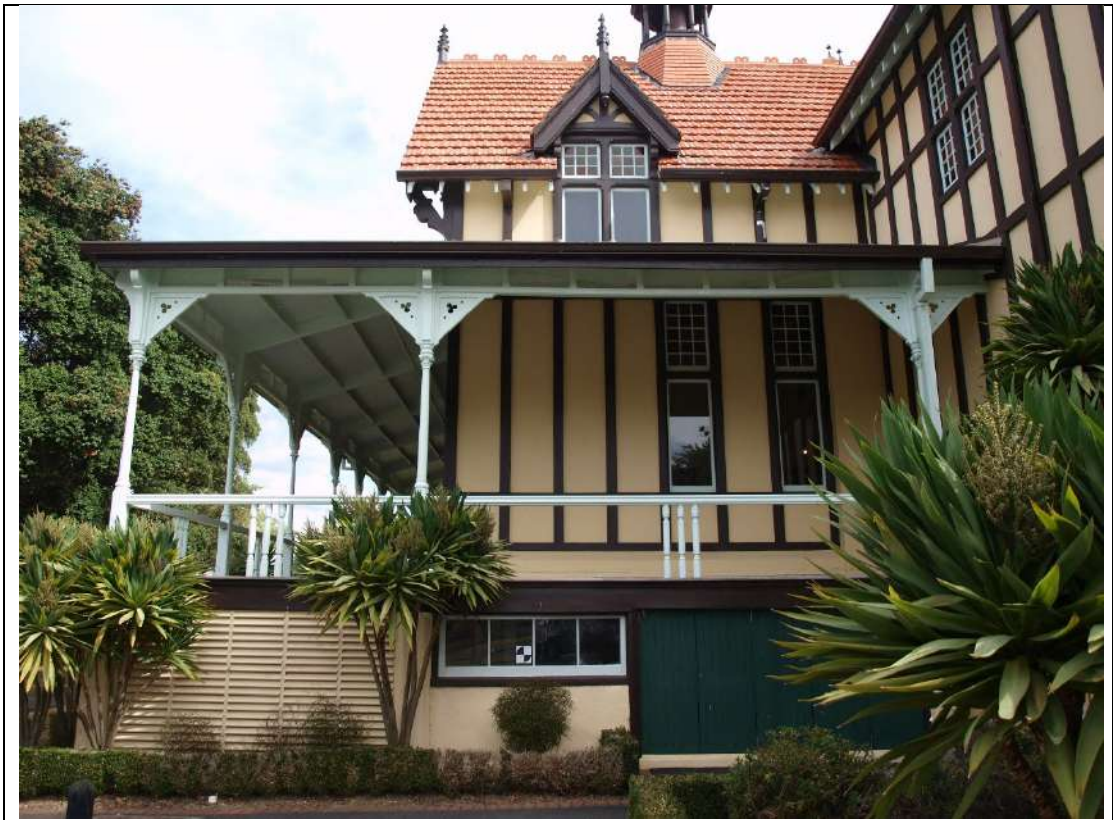
*Intrusive grilles in the infilled space of the north wing rear verandah*

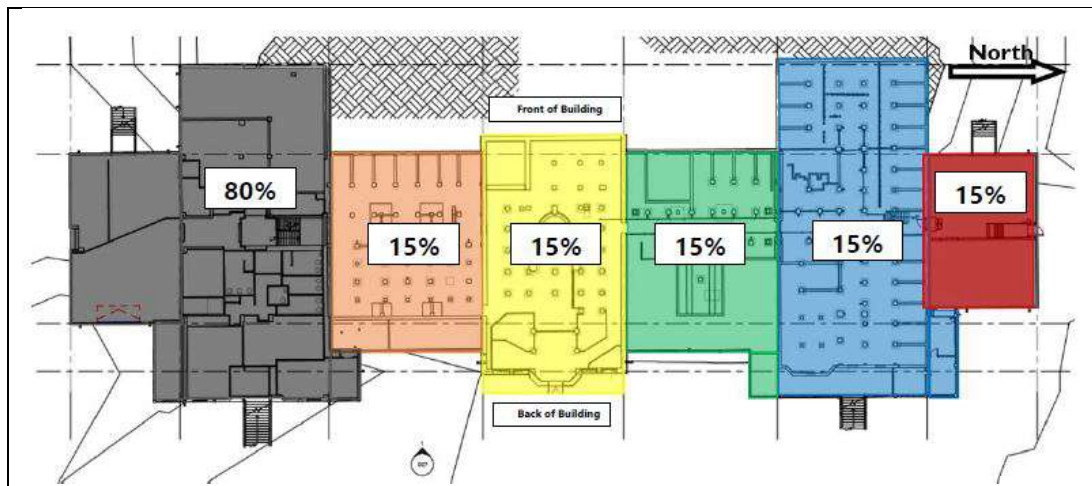
Diagram showing the seismic strength of the various sections of the building in NBS.

As such, a preferred option to strengthen and repair the building was adopted and in September 2018 DPA Architects of Auckland were appointed to carry out design work for the upgrading of the building in conjunction with Rotorua firm Carling Architects. Completion of the works is expected in 2021.
