# ROTORUA LAKES COUNCIL ROTORUA MUSEUM SEISMIC STRENGTHENING-STRUCTURAL ELEMENT DESCRIPTION

DEVELOPED DESIGN-J000949

GDC CONSULTANTS

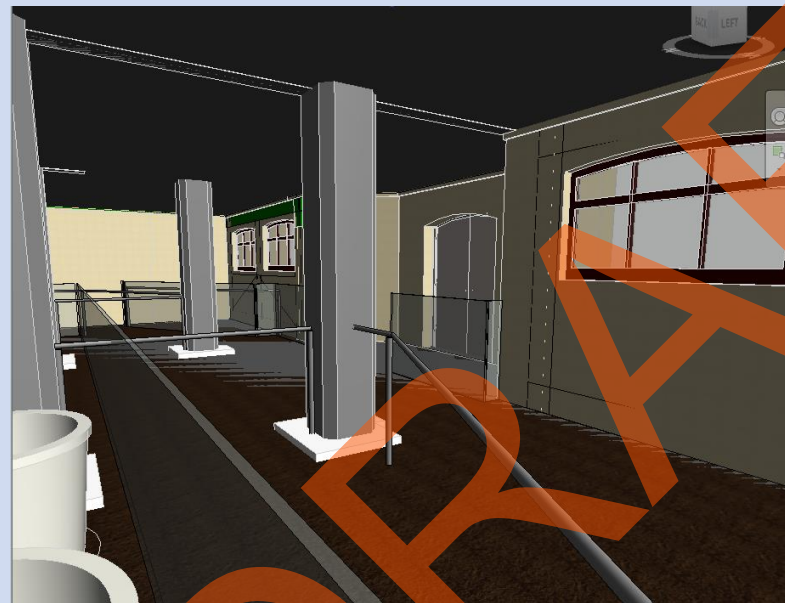
- For Vertical elements: A pad footing is to be designed which will pick up the residual axial load.
- Elements with diagonal struts: A ground beam is to be designed between the pad footing to pick up the residual shear.

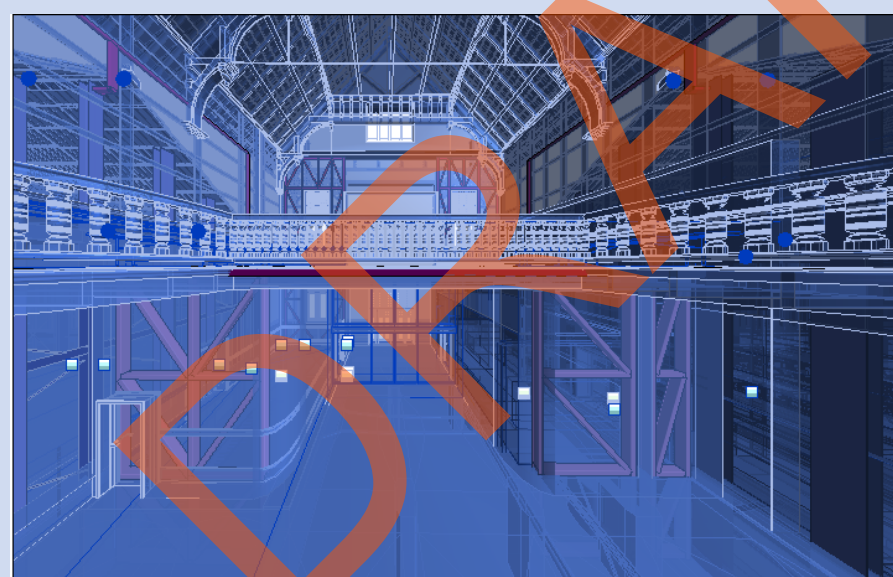
**Western Wall:** 125x6SHS vertical bracing will be exposed and offset from the wall to preserve the dado, cornice and skirting.

**Western Wall:** New 125X75mm SHS bracing is to be aligned and housed within the east exterior wall cavity and the linings reinstated.

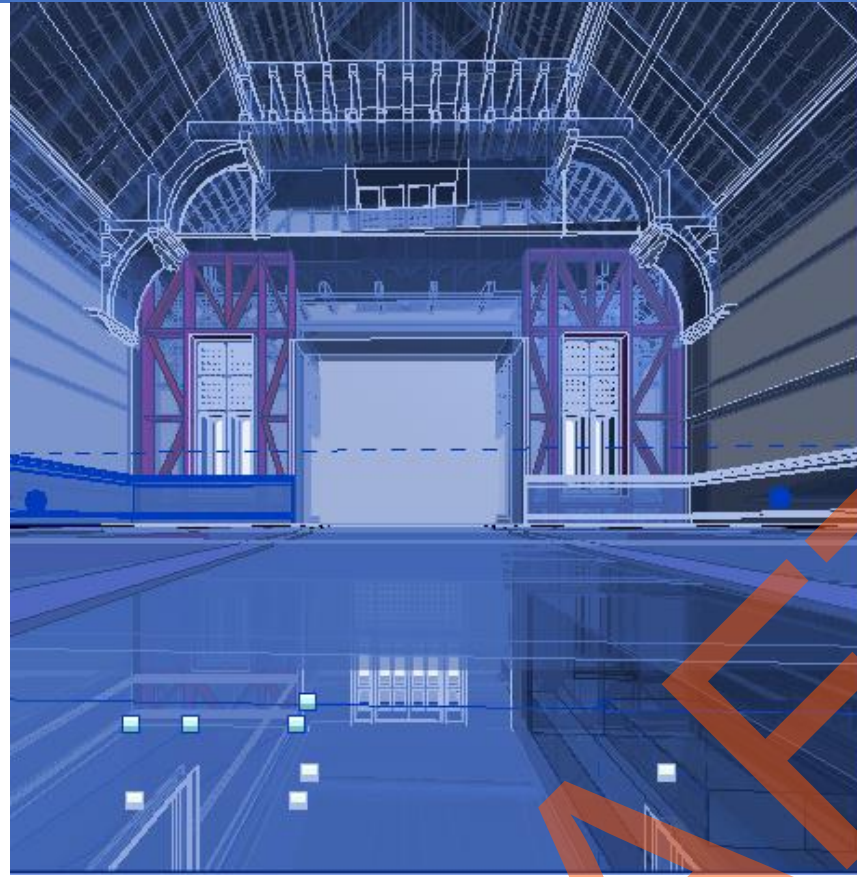
**Northern/Southern Wall:** 89 SHS vertical strongbacks (to brace the concrete pumice walls out of plane) are placed within the wall cavity.

**Mezzanine Floor:** A horizontal truss is designed using 150 SHS and the main members and 100x10 flats as the diagonal members. These are rebated into the top of the existing floor joist.

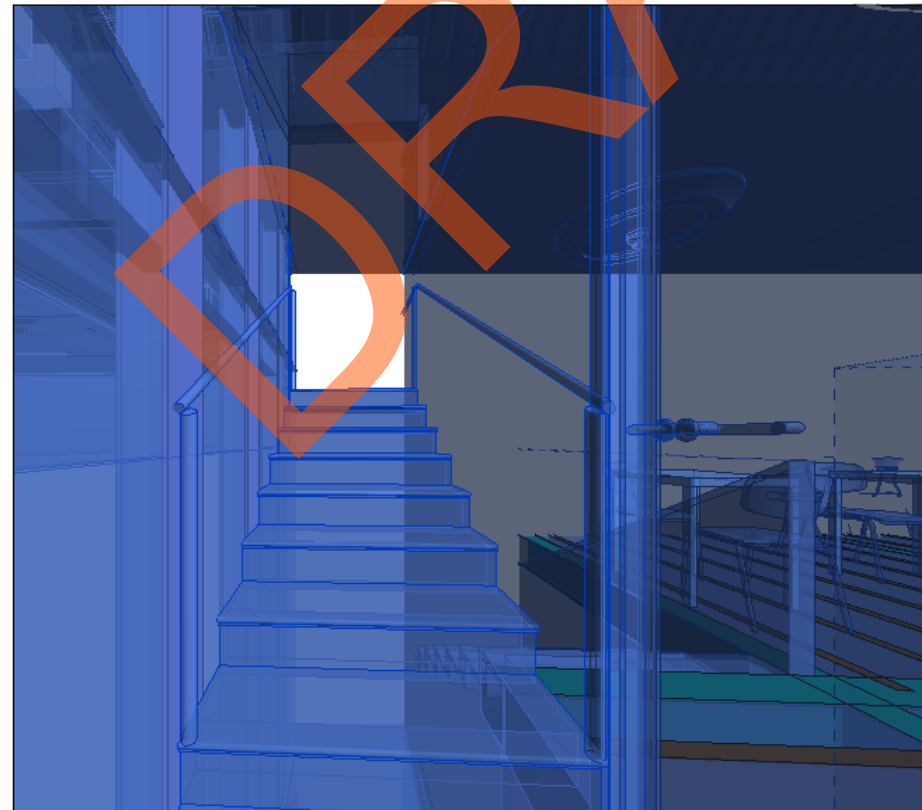
New 250 UC strongbacks are to be embedded 100mm into the north end full height concrete walls, grouted in place and lined over. In the area of fire egress a minimum of 1100mm length is to be attained of the steps. Hence specially designed 150UC is to be with 100mm embedment into the north end wall.

**Northern Wall:** 250 UC 89.5 at bottom and 150UC (specific design) Strongback to be embedded 100mm into the existing concrete pumice wall.
