# Te Whare Taonga o Te Arawa - Rotorua Museum Development

## Geotechnical Seismic Assessment Report

Prepared for  
Rotorua Lakes Council

Prepared by  
Tonkin & Taylor Ltd

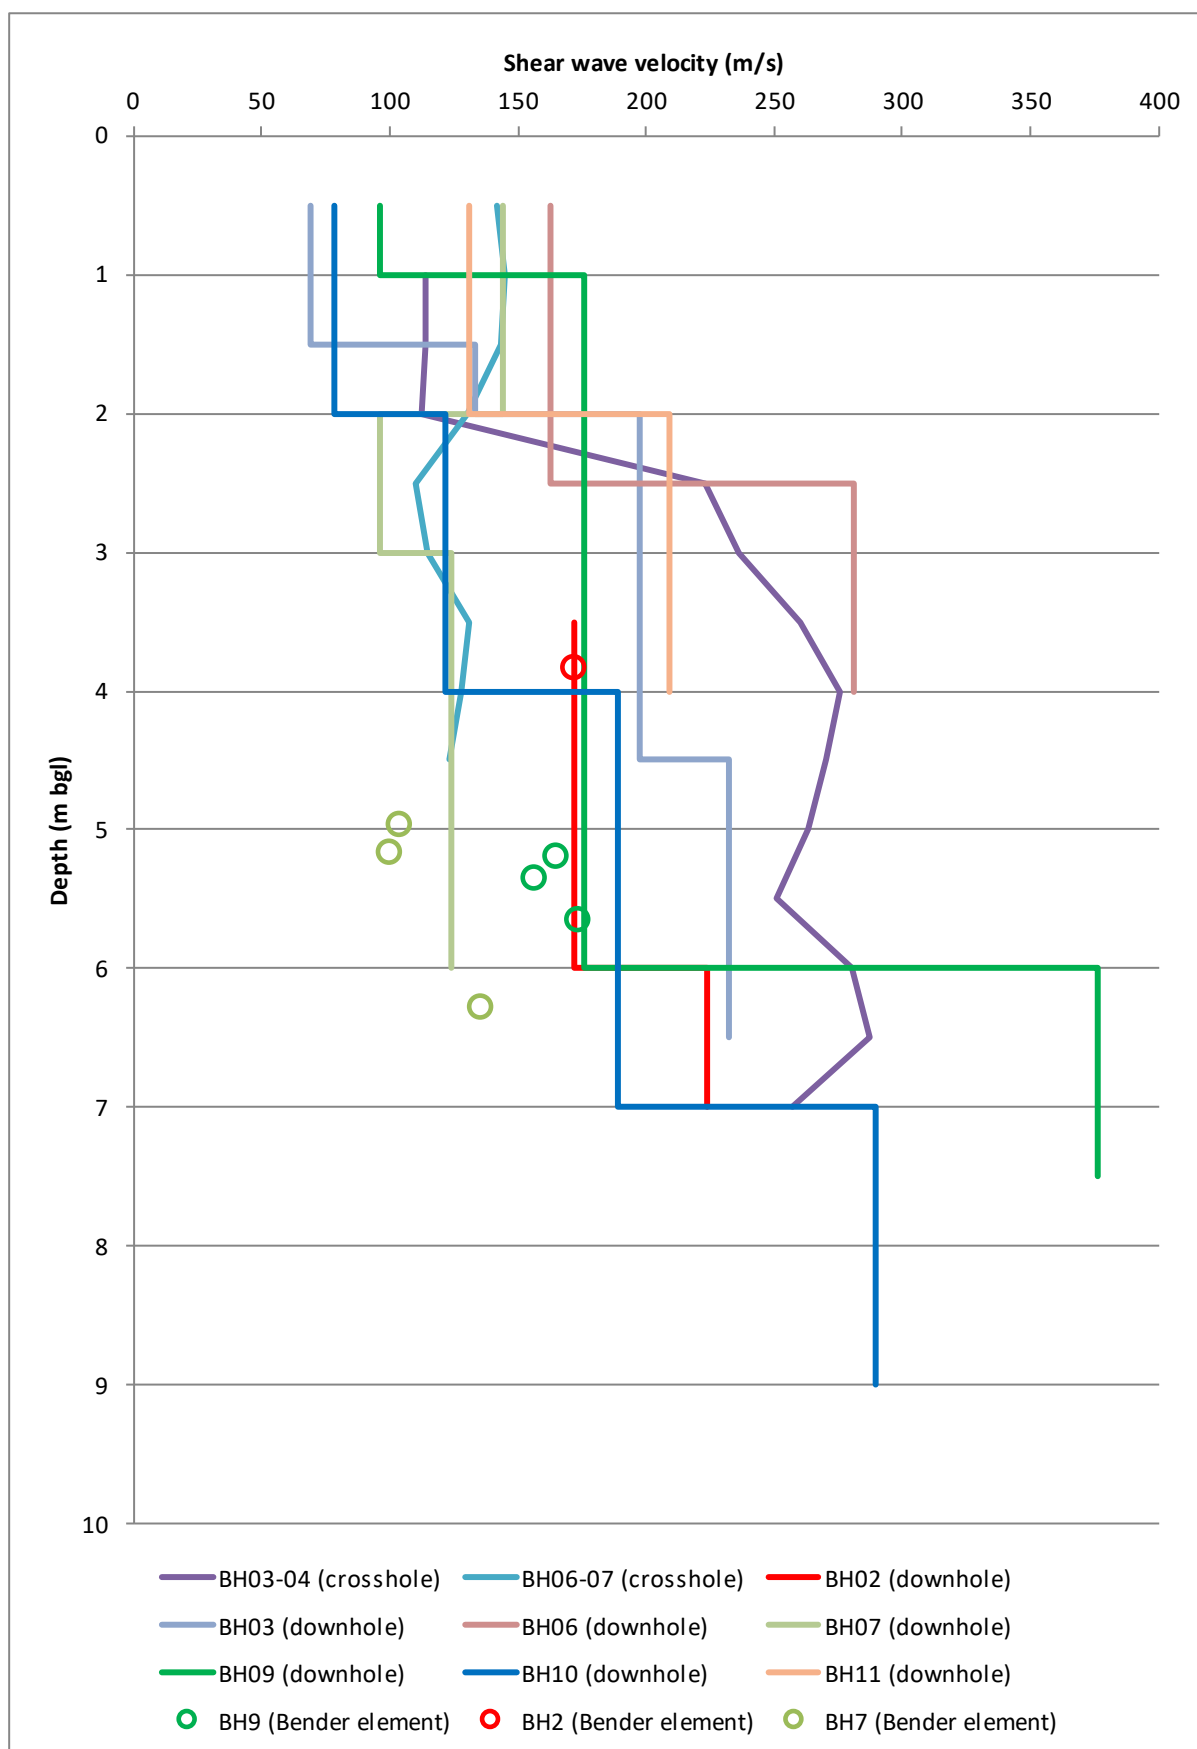
Shear wave velocity measurements were undertaken as part of the recent investigation, and the results are summarised in Figure 3.2. The raw data of the shear wave velocity measurements are included in Appendix C5. Laboratory Bender Element tests were carried out to provide indicative shear wave velocity of the samples that were tested for the cyclic triaxial tests. The indicative shear wave velocities of these sample are plotted in Figure 3.2 for comparison (shown as hollow circles). These show that the tested samples appear to be comparable to the field condition, which indicates that there is no obvious evidence of sample disturbance (loosening or densifying of the soil).

Figure 3.2: Summary of laboratory and field measured shear wave velocities

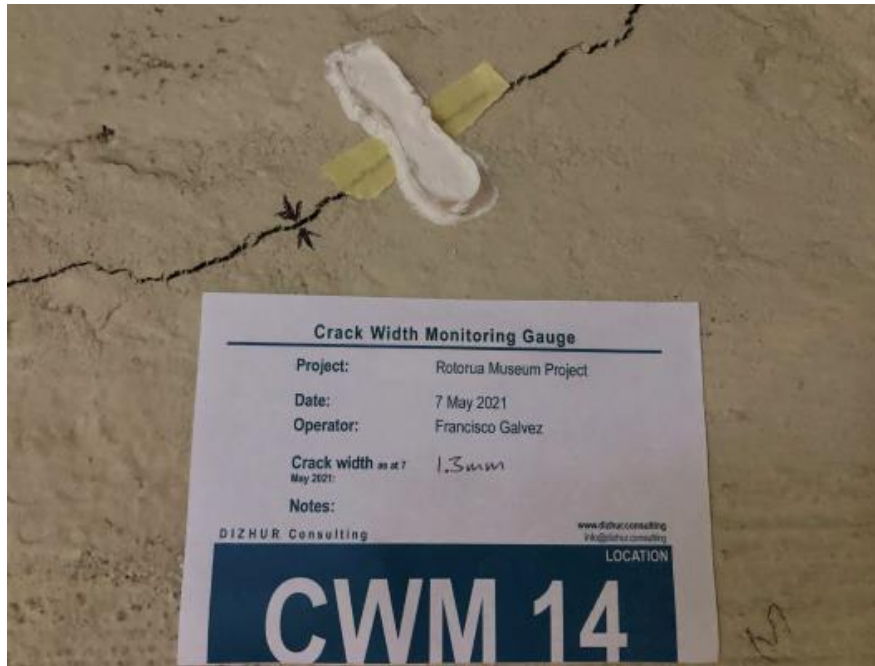
The structural engineer (Dizhur Consulting) carried out a building condition assessment in May 2021. During this assessment, a number of considerable sized cracks were observed in the building walls in zones 1 to 5. The structural engineer installed twenty plaster “dog-bone” gauges (Figure 6.1) in May 2021 over selected wall crack locations in zones 1 to 5 to monitor the crack width and determine whether or not the cracks are active (opening or closing). The structural engineer inspected and measured the crack width monitoring gauges in June and August 2021. Movements were observed in seven of the monitoring gauges installed in Zone 3 and one of the monitoring gauges installed in Zone 5. No movement was observed in the monitoring gauges installed in zones 1, 2 and 4.

Figure 6.1: One of the plaster “dog-bone” gauges installed by the structural engineer to monitor the crack width in the wall

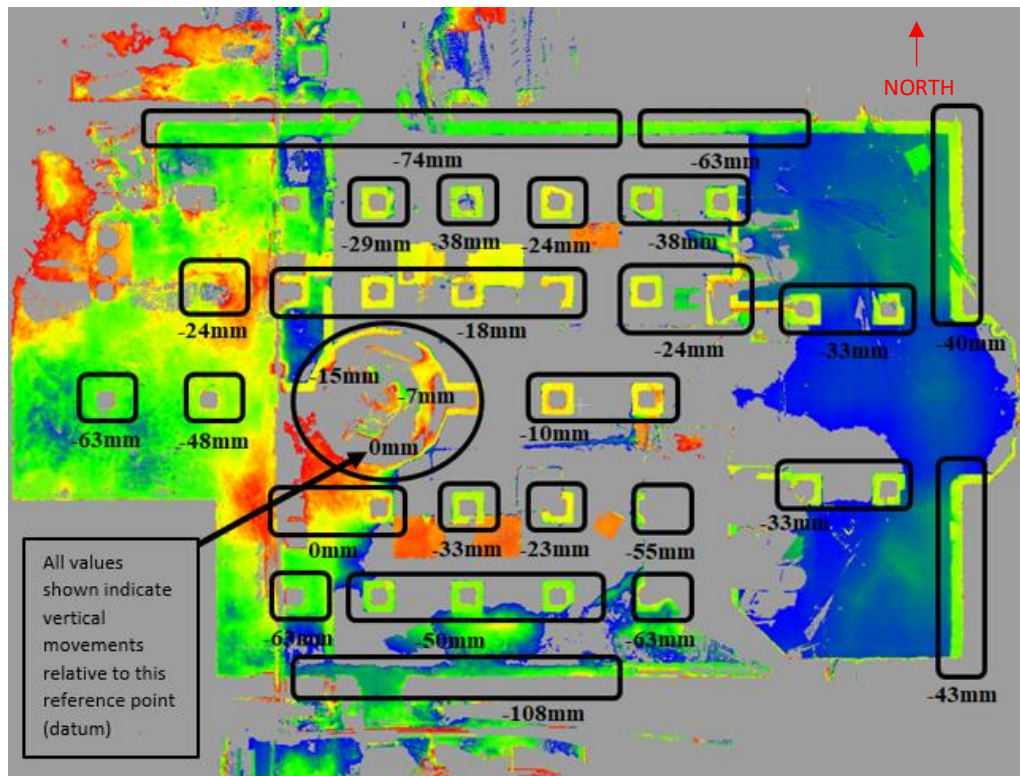
The structural engineer has produced contour plots showing differential in elevations of the foundations in zones 2 to 5 relative to the reference point in Zone 3 from the point cloud data. These plots are shown in Figure 6.2 to Figure 6.4. It is understood that, in assessing the elevation differential, the structural engineer has assumed that the foundations were level at the time when they were constructed. The contour plots seem to indicate a general trend of worsening differential in the elevations towards the locations of the large gable walls, where the heaviest loads from the building are imposed.

Figure 6.2: Differential in foundation elevations in Zone 3 relative to the reference point. Source: Dizhur Consulting<sup>9</sup>

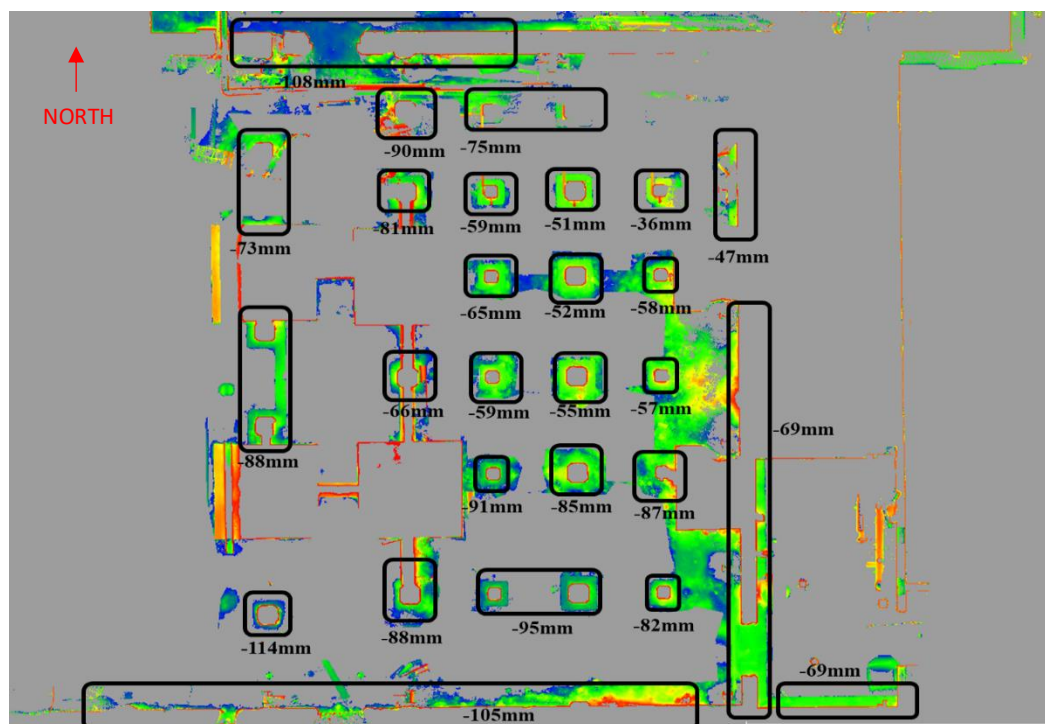
Figure 6.3: Differential in foundation elevations in Zone 2 relative to the reference point in Zone 3. Source: Dizhur Consulting<sup>9</sup>

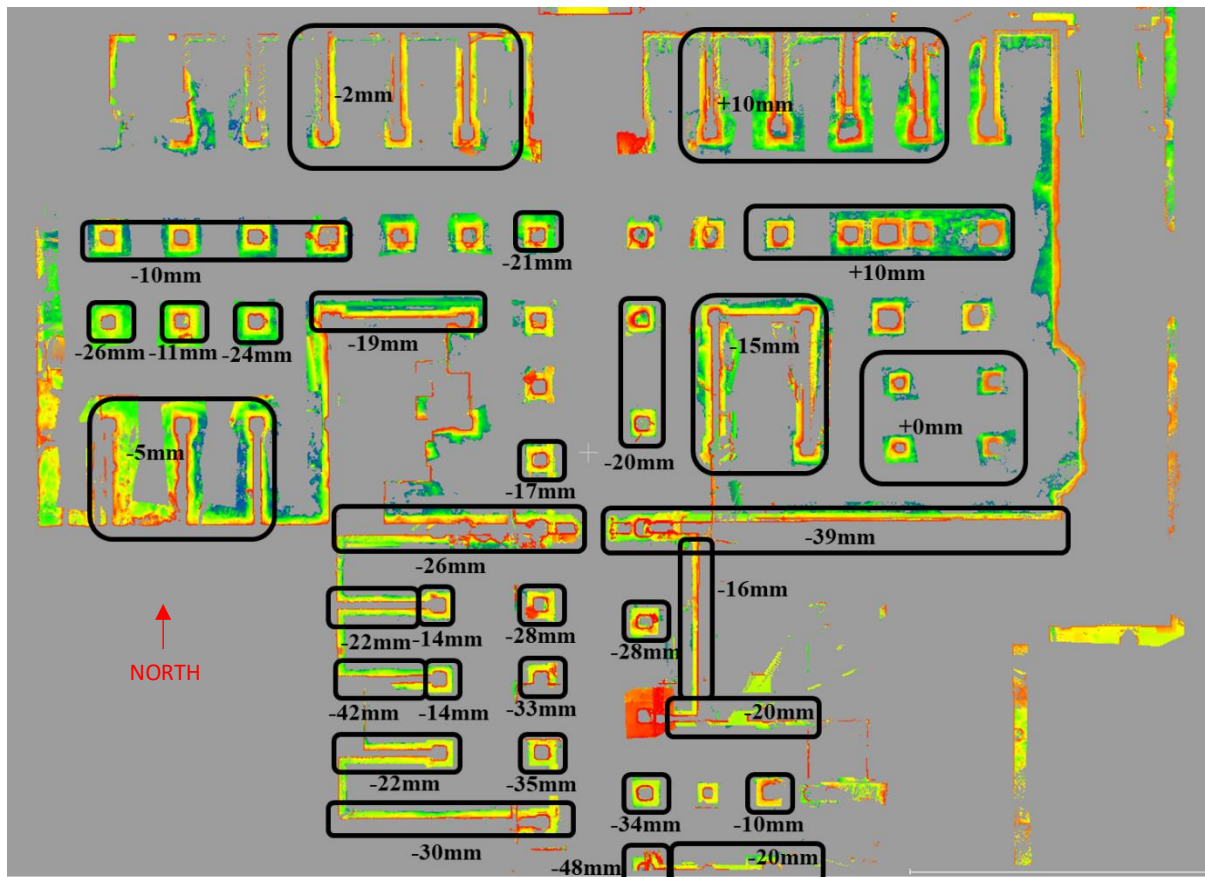
Figure 6.4: Differential in foundation elevations in Zone 4 & 5 relative to the reference point in Zone 3. Source: Dizhur Consulting<sup>9</sup>

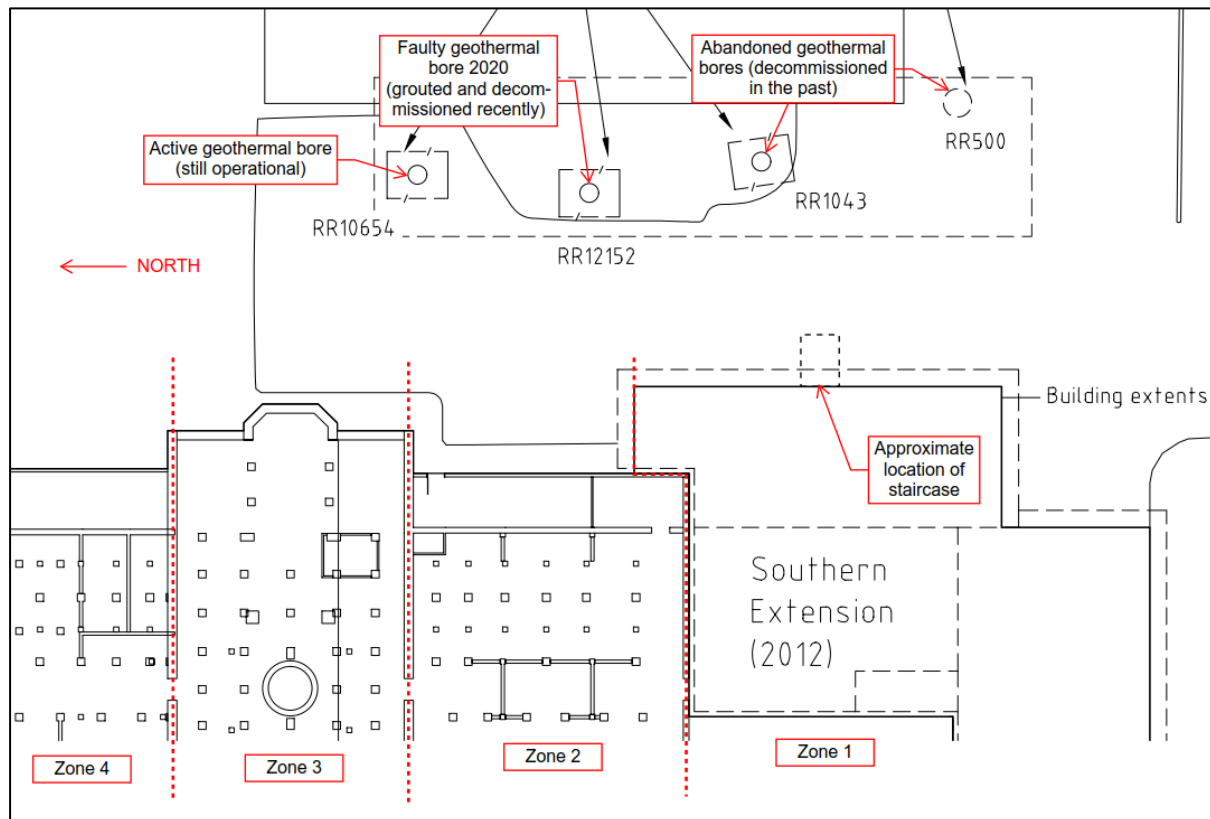
RLC identified that a geothermal bore failure was the prime cause following testing undertaken on the nearby geothermal bores. The approximate location of the faulty bore is shown on Figure 6.5.

Figure 6.5: Approximate location of the faulty geothermal bore

The faulty bore was decommissioned using pressurised grout. However, an elevated temperature level remains noticeable in some areas of Zone 1 and southern end of Zone 2, albeit it is understood that it is no longer as high as prior to the decommissioning of the faulty bore.

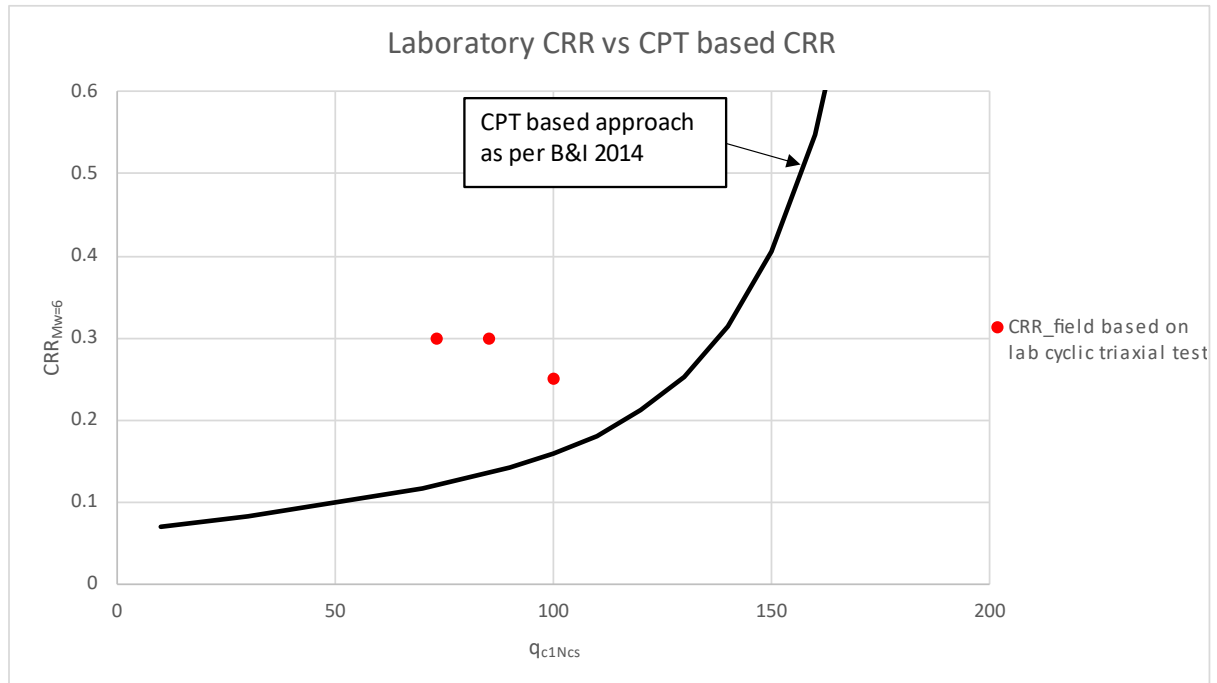
Figure 6.8: Comparison between laboratory and CPT-based estimates of cyclic resistance for a magnitude  $M_w=6$  earthquake. CPT-based triggering curve is based on Boulanger & Idriss (2014)<sup>18</sup> with a probability of liquefaction  $P_L=15\%$ , and lab-based results are interpolated from the cyclic resistance curves at 5 cycles.

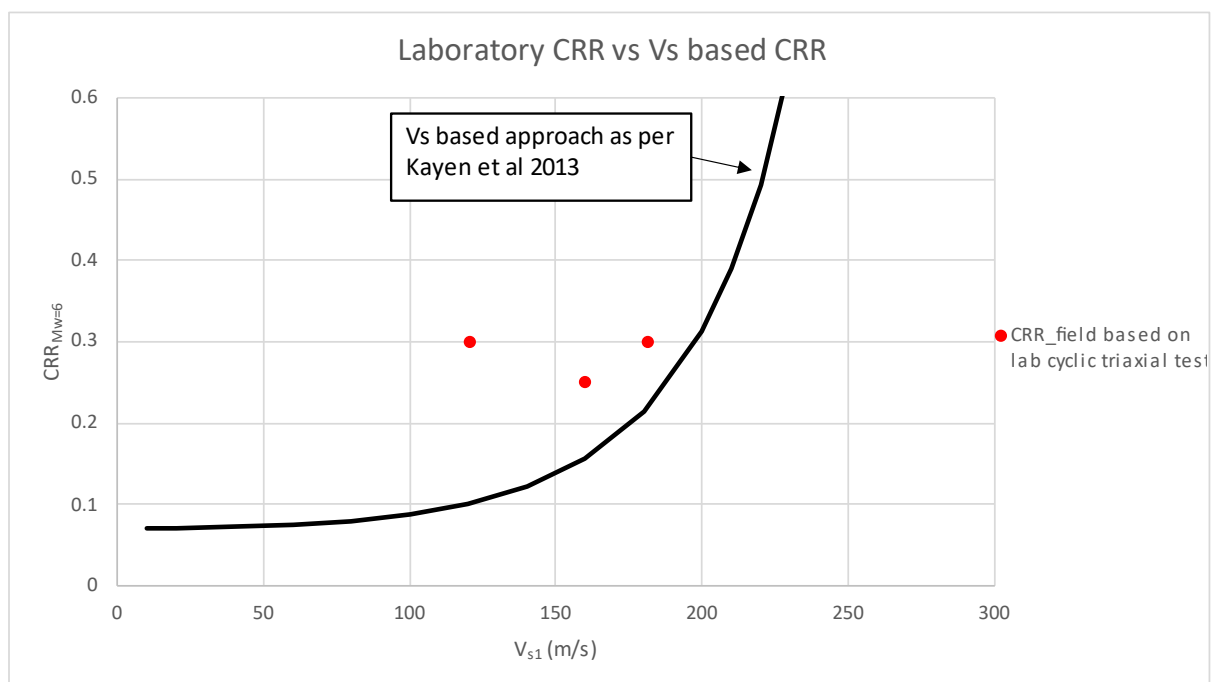
Figure 6.9: Comparison between laboratory and Vs based estimates of cyclic resistance for a magnitude  $M_w=6$  earthquake. Vs-based triggering curve is based on Kayen et al (2013)<sup>22</sup> with effective vertical overburden stress of  $\sigma'_{v0}=80\text{kPa}$ , fines content of  $FC=30\%$  and a probability of liquefaction  $P_L=15\%$ .

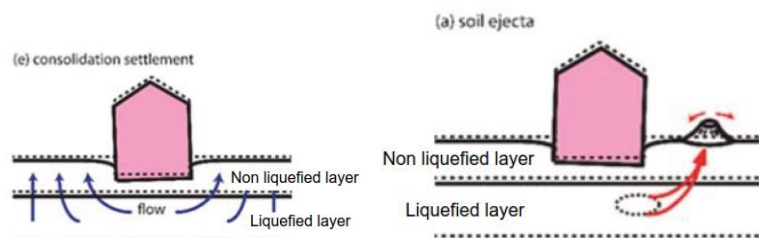
Figure 6.11: Schematic showing reconsolidation settlement (left) and ejecta (right). Source: Bray and Macedo<sup>25</sup>

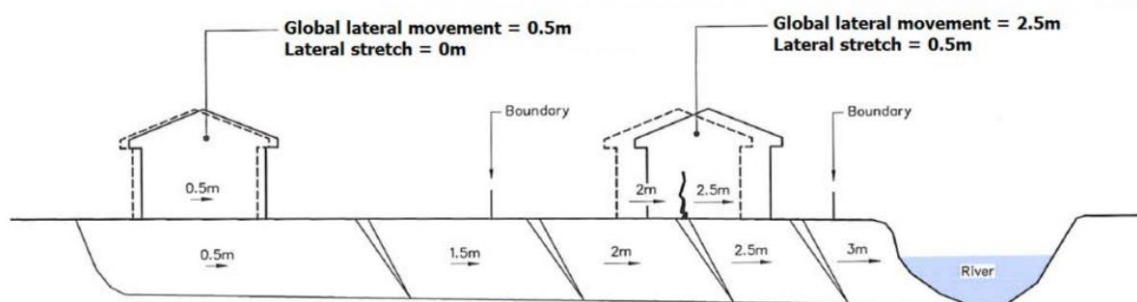
Lateral movement occurs when earthquake shaking causes a mass of soil to lose shear strength and move relative to the surrounding soil. Lateral movement can be entirely horizontal and occur on flat ground, but it is more likely to occur on or around sloping ground, such as adjacent to hillsides and waterways (due to the presence of a free face). When lateral spreading occurs, the ground tears and stretches causing cracks and fissures to form. In most cases the land located immediately adjacent to the free face is likely to experience the most severe cracking and stretching. These effects reduce as the distance from the free face increases. A schematic sketch for lateral spread phenomenon is shown in Figure 6.13. This ground movement can induce significant lateral force to the affected foundations and structures.

Figure 6.13: Schematic of lateral spread phenomenon (note: values of lateral movement and lateral stretch shown are illustrative only, and do not relate to the Rotorua Museum site). Source: Ministry of Business, Innovation & Employment (MBIE)<sup>26</sup>

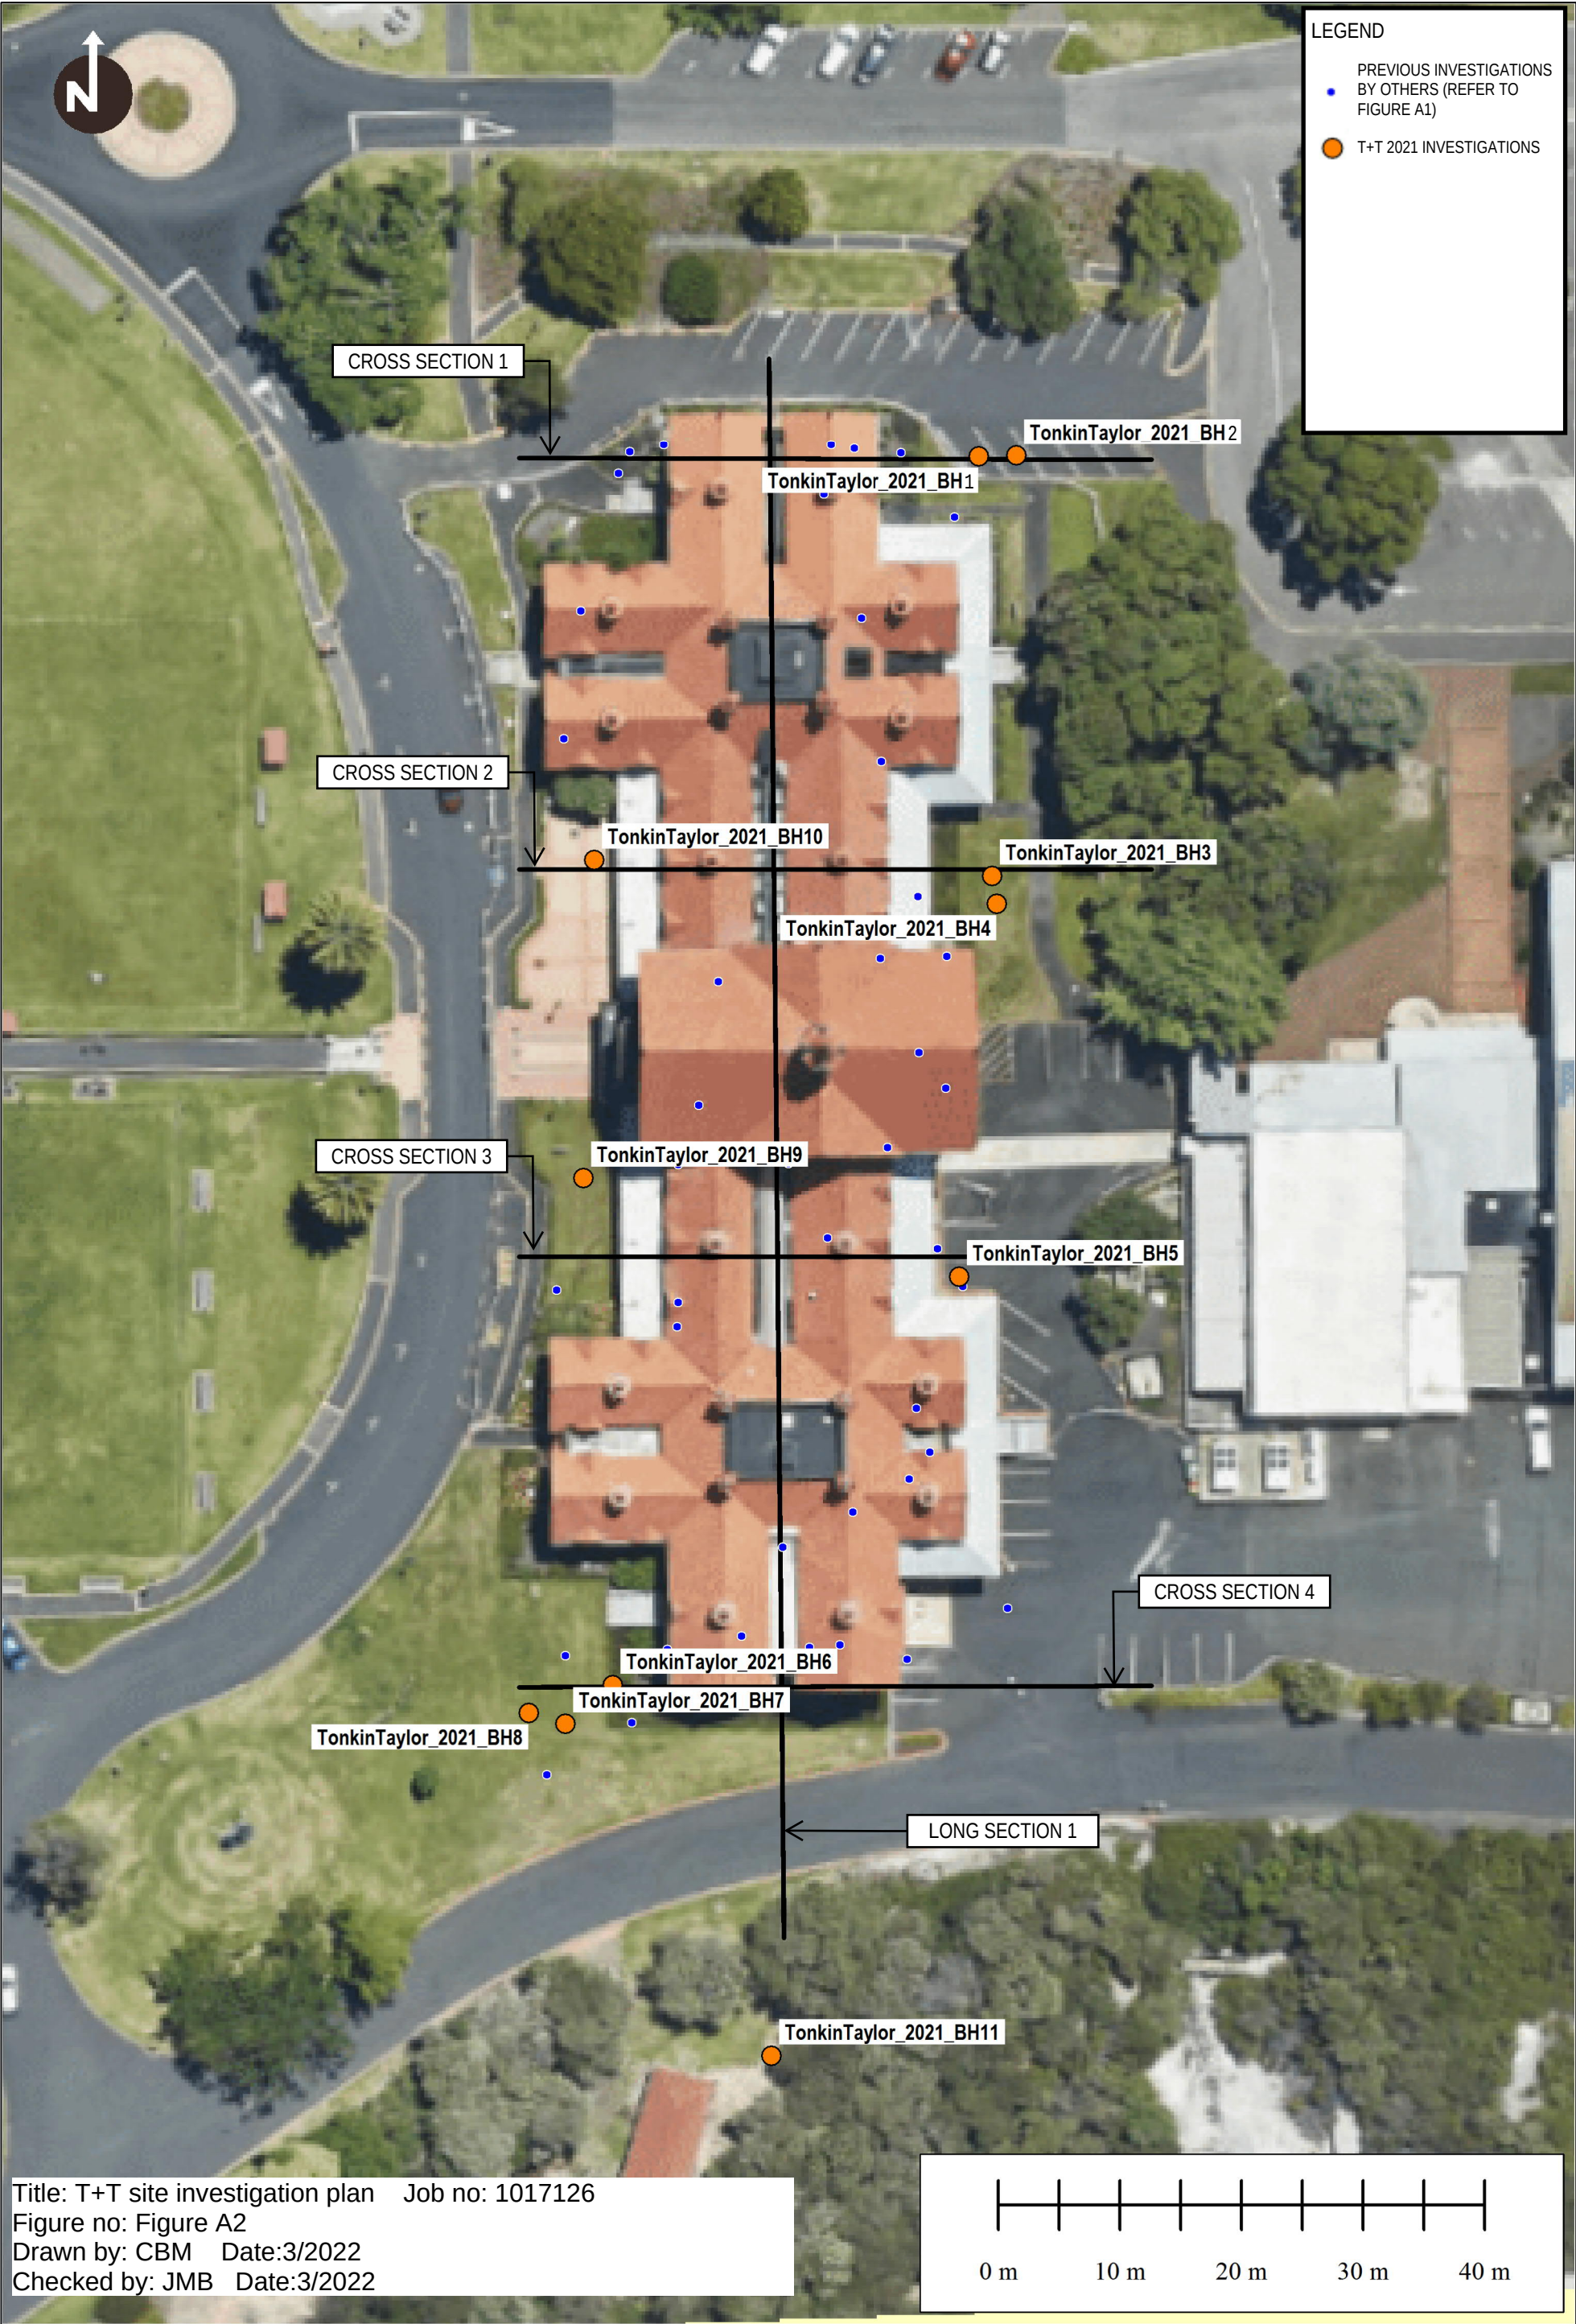
# Rotorua Museum Long Section 1 (N-S)

1. Ground model based on point historical investigation. The nature and continuity of the geology away from these locations may vary from those assumed in this figure.
2. Distance associated with investigation location represents offset from section.

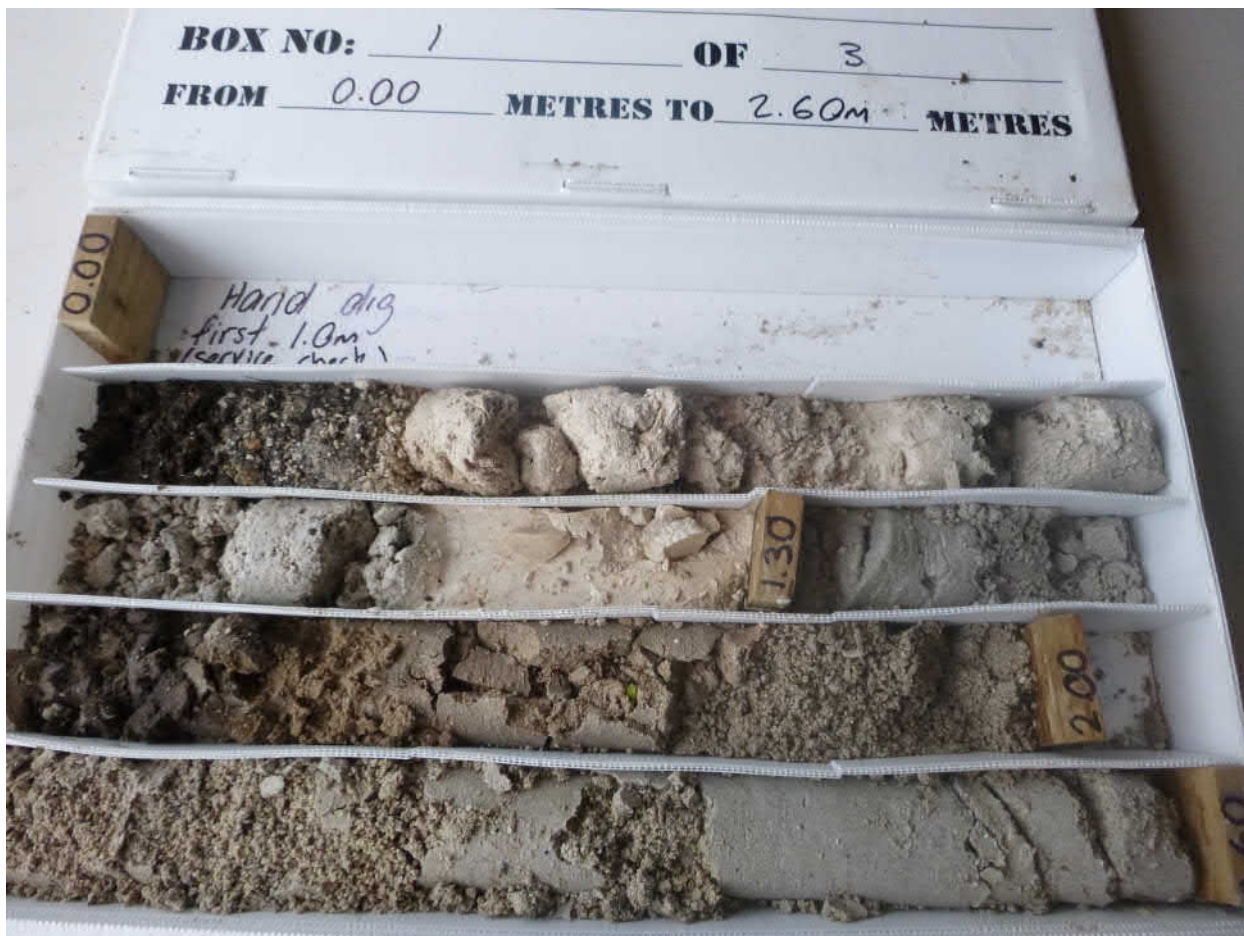
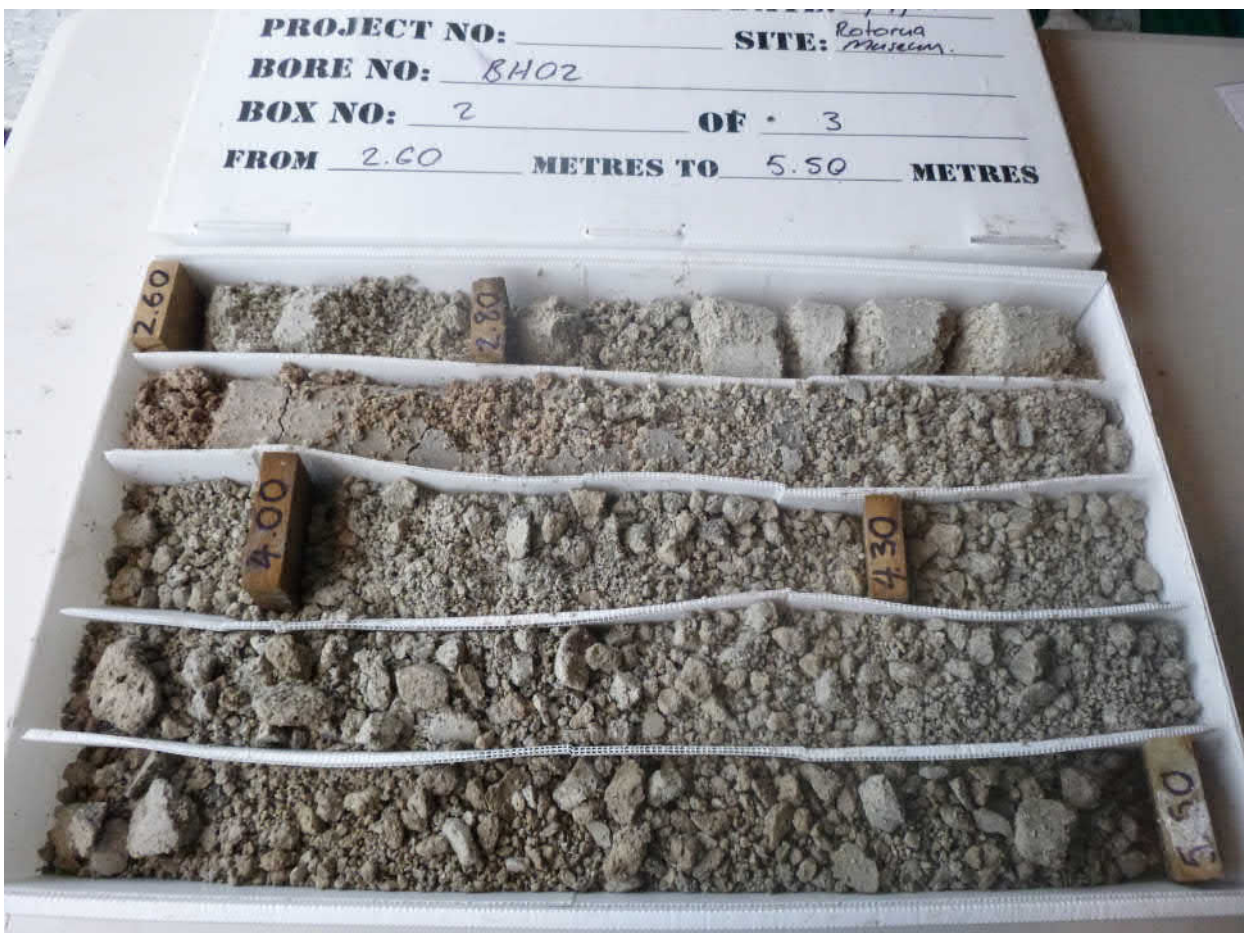
**BH02: Box01 (0-2.6m) and Box02 (2.6-5.5m)**

Borehole was drilled inclined  $30^\circ$  from vertical line

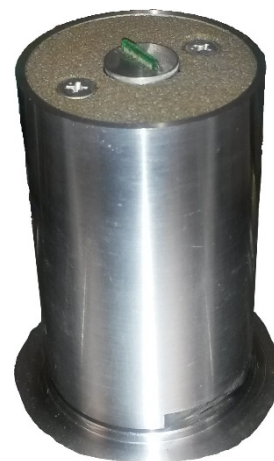
Figure 2: Bender element test system arrangement.

(b) Bender element platen

Shear wave velocity testing was performed on all specimens. When undertaking this testing, a sinusoid voltage pulse is sent to the 'source' bender element (mounted in a platen as shown in Figure 2b), which deflects under the voltage applied. This generates a horizontally-orientated shear wave which propagates vertically through the specimen. When the shear wave arrives at the 'receiver' bender element, it causes a small deflection of the bender element, which in turn generates a small voltage, which is monitored using an oscilloscope. This system arrangement is shown schematically in Figure 2a, along with a photo of one of the bender elements used in the CTX device. By considering the height of the specimen and the time difference between sending the voltage pulse and the first arrival of the shear wave, it is possible to estimate the shear wave velocity (Equation 2, where  $l_{tt}$  is the distance between the tips of the bender elements). It should be noted that the source wave is not directly measured, but is assumed to be the same shape and occur at the same time as the output from the signal generator. In practice, there is a delay between the output of the signal generator and the displacement of the source bender element. The 'system delay' is measured by holding the tips of the source and receiver elements together and measuring the time lag between the source signal and the received signal. For the testing presented in this report, the time delay is 10  $\mu\text{s}$ . This time delay was subtracted from the receiver signal prior to picking the arrival time.

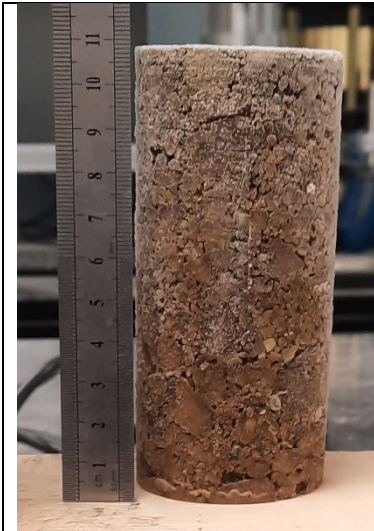
Pre-test

- Noticeable smell (Sulphur?) present on specimens
- Gel present all through the specimens

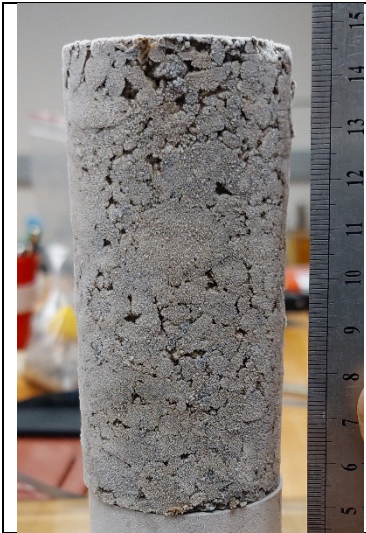
Pre test

- Noticeable smell (Sulphur?) present on specimens
- Gel present all through the specimens
- Sample fell apart when removed from membrane at end of test.
