# Te Whare Taonga o Te Arawa - Rotorua Museum Development

## Geotechnical Seismic Assessment Report

Prepared for  
Rotorua Lakes Council

Prepared by  
Tonkin & Taylor Ltd

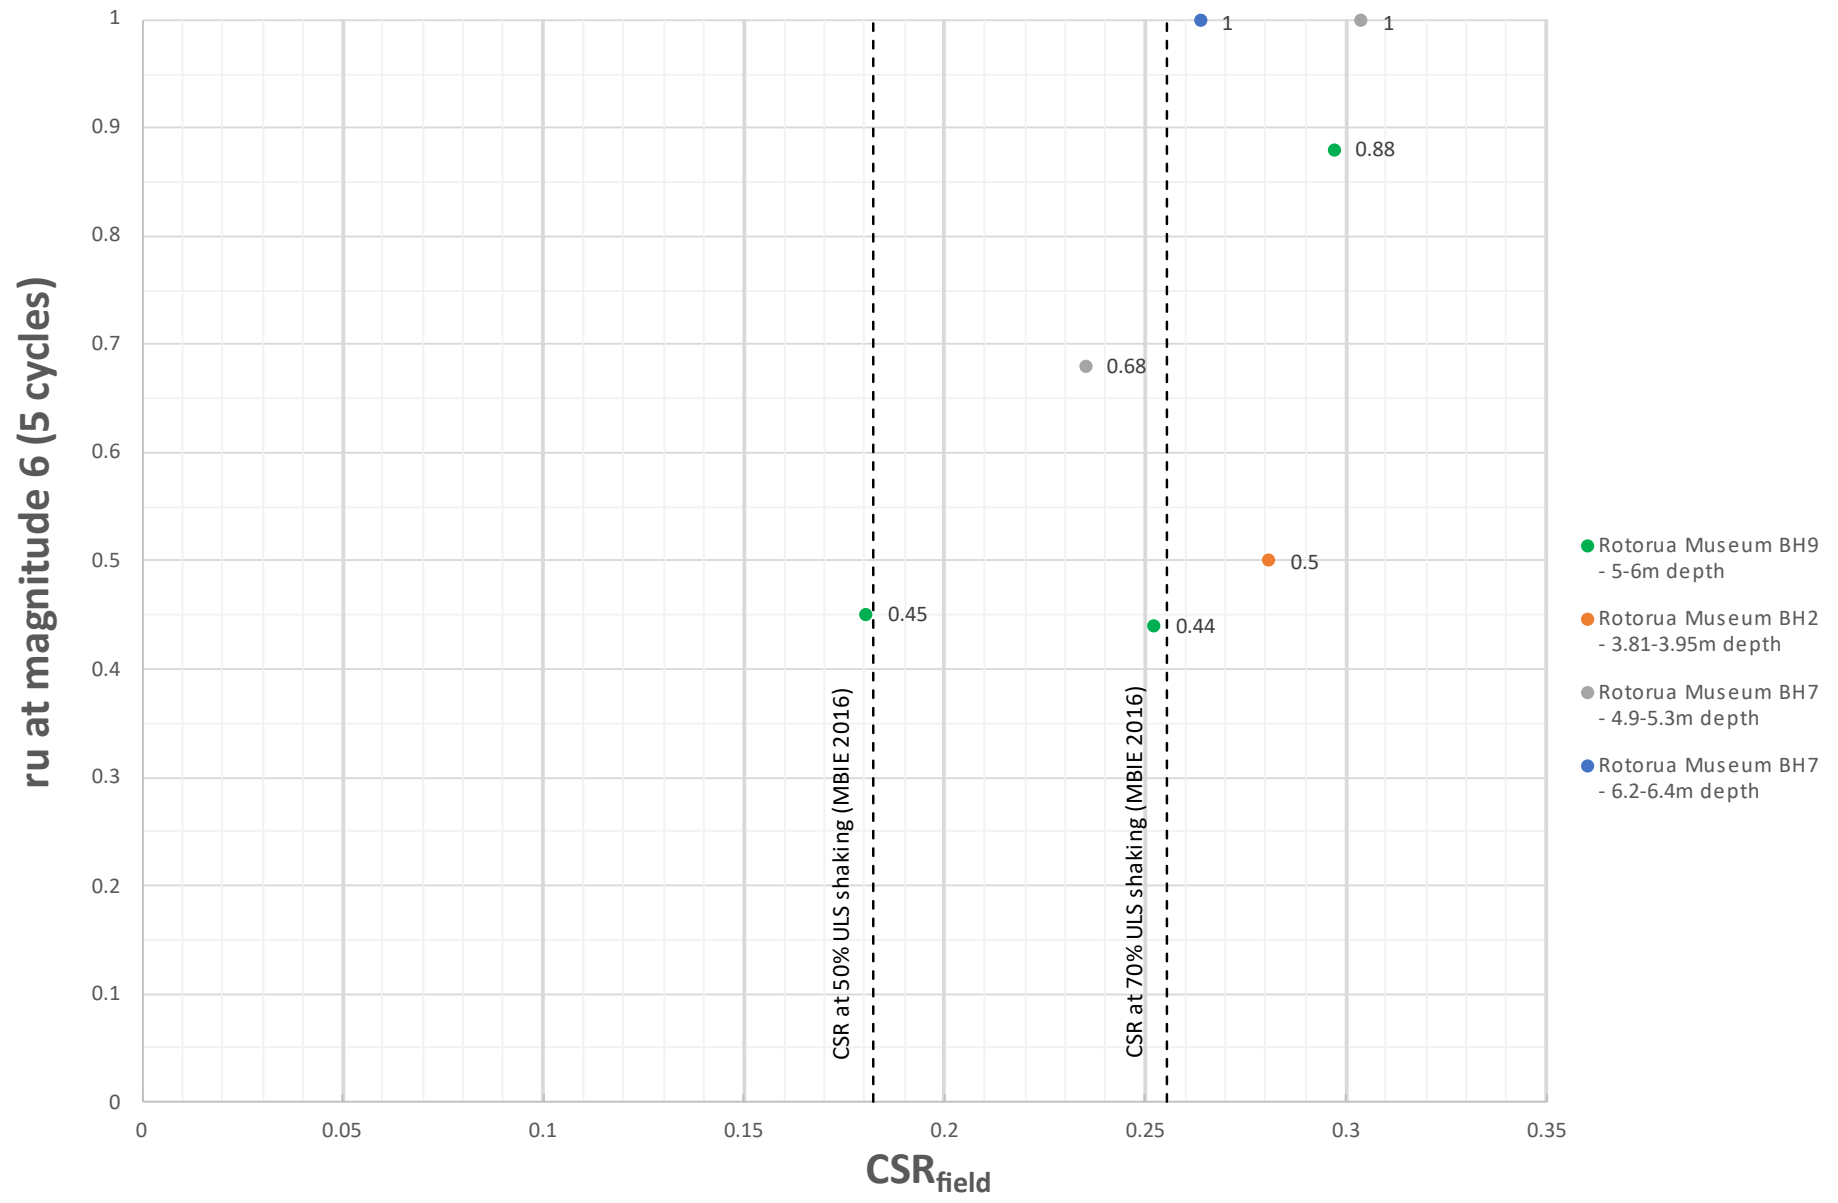
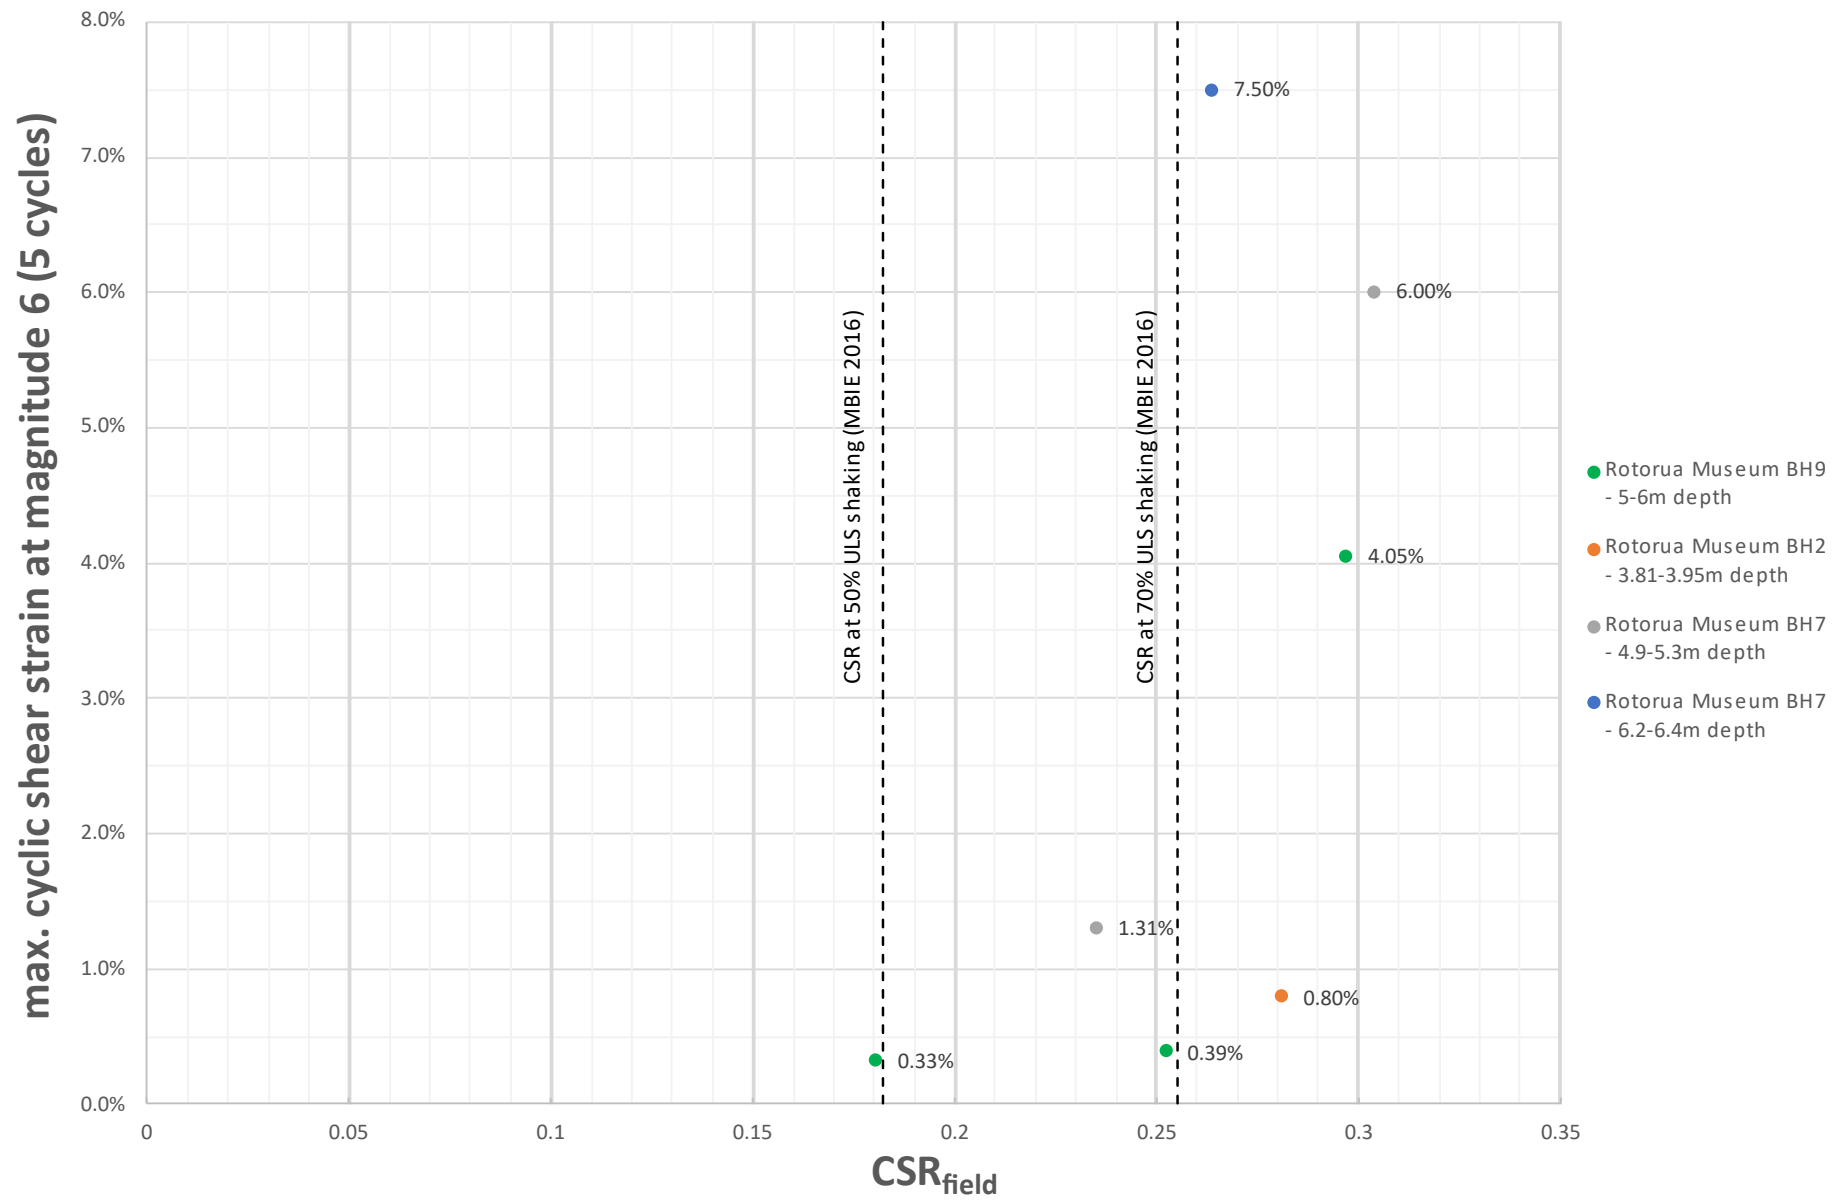
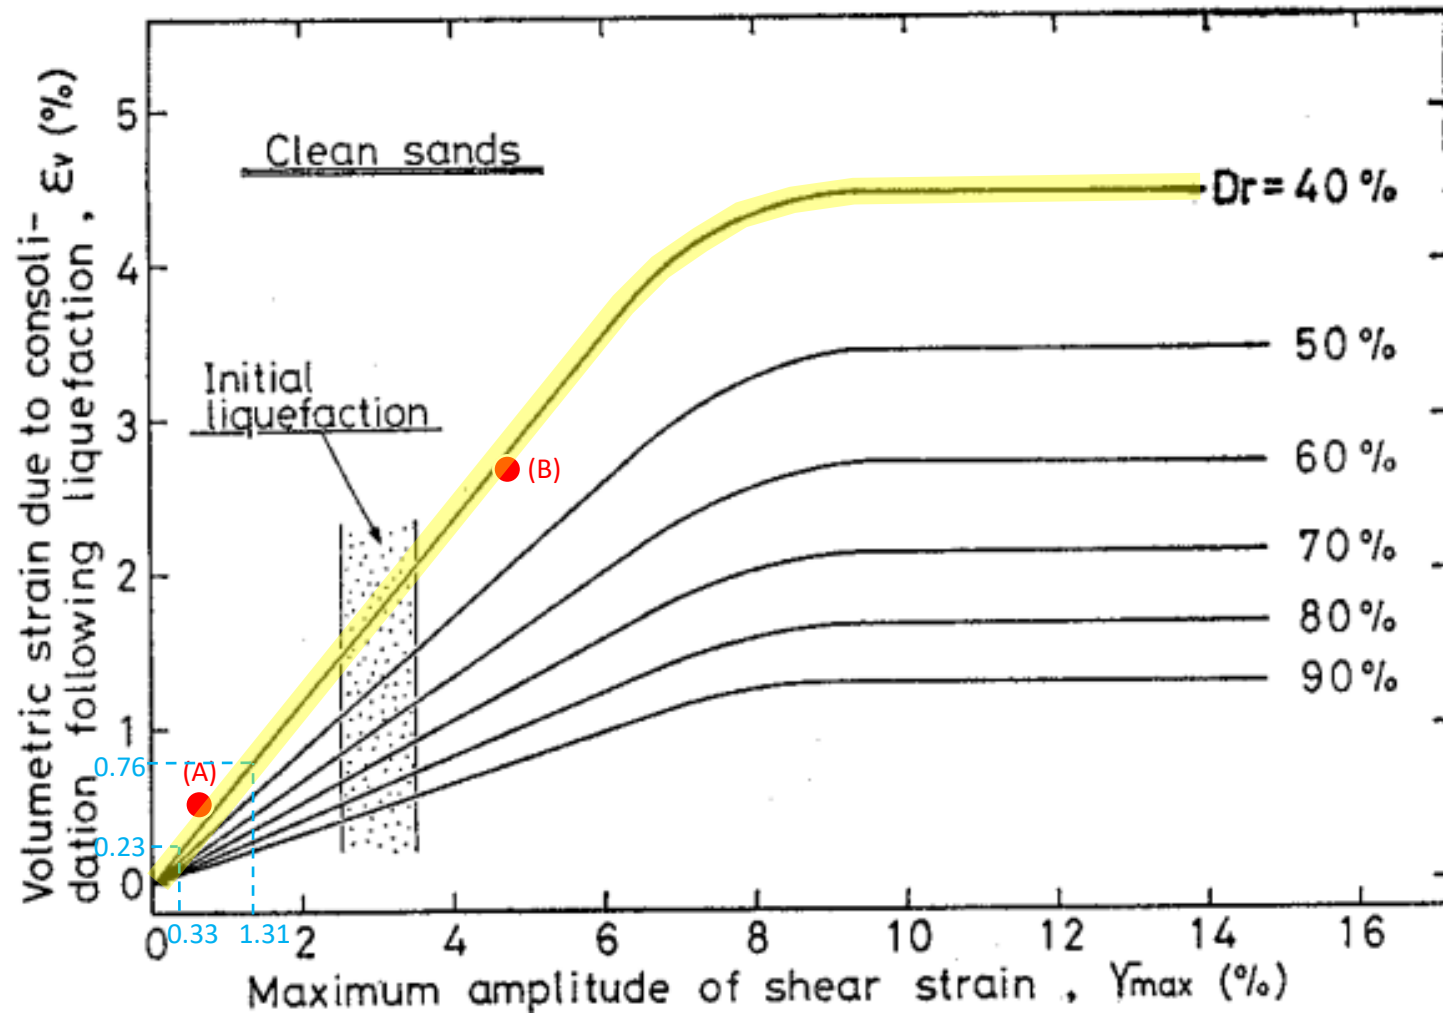
Page 3 shows that for the cyclic triaxial tests where the shear strains remained stable for 50 – 70% of ULS (IL3) shaking, the excess pore pressure ranged from  $r_u = 0.44$  to 0.68, with a representative average value of approximately  $r_u = 0.5$ . This excess pore pressure reduces the frictional contribution to the shear strength of Layer 2b by 50%, resulting in an equivalent shear strength ratio of  $s_u/\sigma'_{v0} = 0.27$  (this compares to a value of 0.09 adopted for the fully liquefied condition). This reduced shear strength was included in the Meyerhof punching shear bearing capacity calculations summarised in Appendix E of this report.

(A) Rotorua Museum BH9,  
5-9m depth  
 $CSR_{field} = 0.18$   
failure not reached  
 $\gamma_{max} = 0.6\%$ ,  $\varepsilon_v = 0.5\%$
