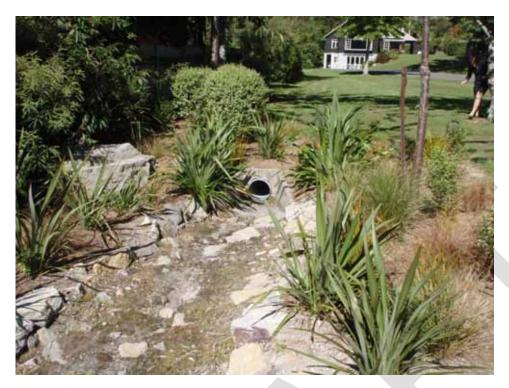
Discharge Point 1 (DP1) drains a small catchment approximately 0.7 ha in size at the northern end of the Lake Okareka Settlement. Most of this catchment runoff is concentrated into a number of catchpits located on the northern end of a steep street where they are concentrated and piped to the discharge point at DP1. The stormwater generated on the properties on the lake edge generally drain directly to the lake via overland flow. Figure 5 shows the outlet pipe for PD1 where stormwater then enters a short, armoured channel (approximately 5 m long) before discharging to the lake.

Figure 5: DP1 discharge point on the edge of Lake Okareka.

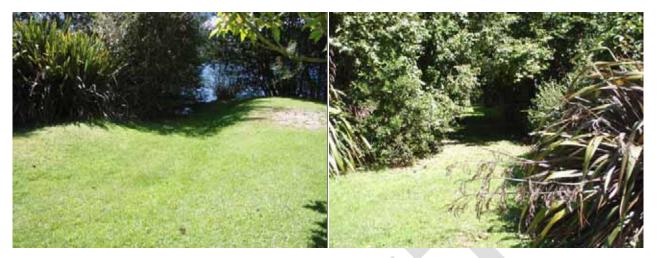
The Wash's main channel bisects properties numbered 9 and 11 Steep Street to discharge into the lake at Discharge Point 2 (DP2). Here water leaves The Wash's lined channel and spills into the lake via a poorly confined channel over the grassed reserve for approximately 20 m. The Wash drains approximately 167 ha of which only a small portion is within the Lake Okareka Settlement. Figure 6 shows The Wash channel and where it enters the lake. The Wash outlet appears to drain onto a small headland, possibly formed by the deposition of silt carried as bedload when The Wash is in flood.

Figure 6: DP2 (The Wash) discharge point to Lake Okareka. The photo on the left shows the overland flow path to the lake whereas the photo on the right shows the outlet from the confined channel.

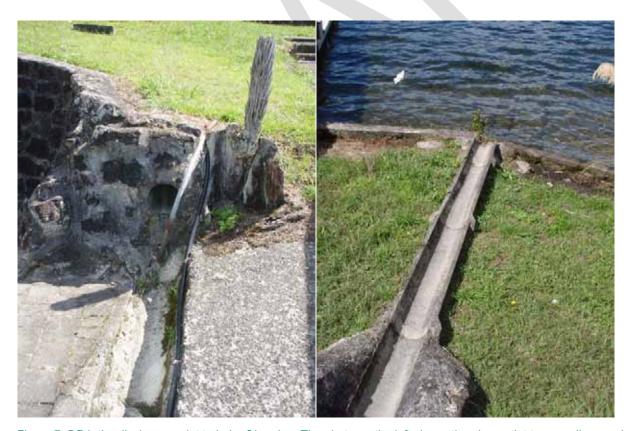
Discharge Point 4 (DP4) drains a small portion of the Lake Okareka Settlement of around 0.8 ha and is located below the properties of number 47 and 49 Okareka Loop Road. Figure 7 shows the DP4 outlet to Lake Okareka.

Figure 7: DP4, the discharge point to Lake Okareka. The photo on the left shows the pipe outlet to a small open channel that spills to the lake as shown in the photo to the right.

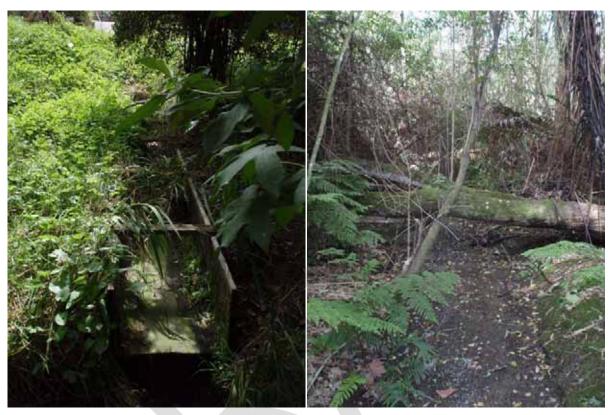
Discharge Point 5 (DP5) is located adjacent to property number 1 on the Okareka Loop Road. A catchpit collects runoff and discharges into an open drain/channel around 30 m upstream from the lake margin. The channel is lined with a wooden outfall before it flows into an unlined shallow drain approximately 10 to 15 m from the lake edge. Figure 8 shows the discharge point to Lake Okareka.

Figure 8: DP5, the discharge point to Lake Okareka. The photo on the left shows the wooden outfall to a small open channel that flows to the lake shown in the photo to the right.

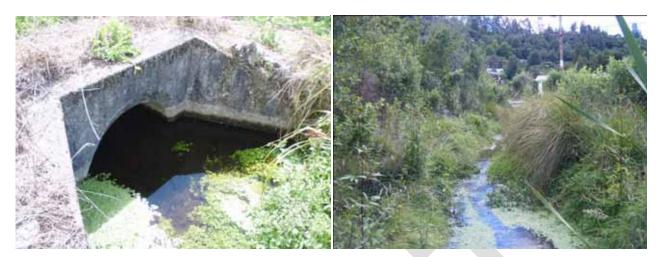
Discharge Point 6 and 7 (DP6 and 7) combine at the intersection of Okareka Loop Road and Acacia Roads and each discharges into an open drain/channel around 30 m upstream from the lake margin. DP6 drains around 11 ha of the Lake Okareka Settlement and DP7 drains around 123 ha of predominantly native bush and pasture. Figure 9 shows the discharge point to Lake Okareka.

Figure 9: DP6 and 7, the discharge point to Lake Okareka. The photo on the left shows the pipe outlet to an open channel/drain that flows to the lake. The drain is shown in the photo to the right looking from the lake edge.

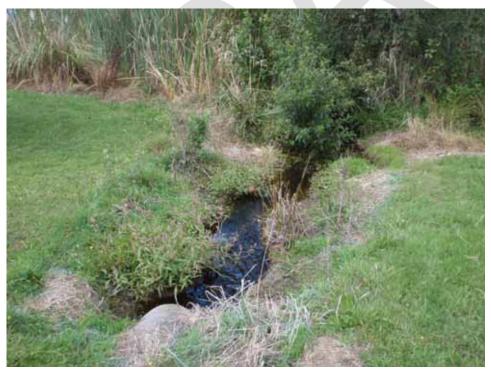
Discharge Point 8 (DP8) is located adjacent to the intersection of Acacia Road and Benn Road. DP8 drains two shallow roadside drains on Benn Road that extend between Wattle Grove Road and Acacia Road. DP8 discharges spring water from an unknown source into an open channel 5 to 10 m upstream from the lake margin on a grassed reserve next to the public toilets. Figure 10 shows DP8 discharge location on the edge of Lake Okareka.

Figure 10: DP8 discharge point on the edge of Lake Okareka.

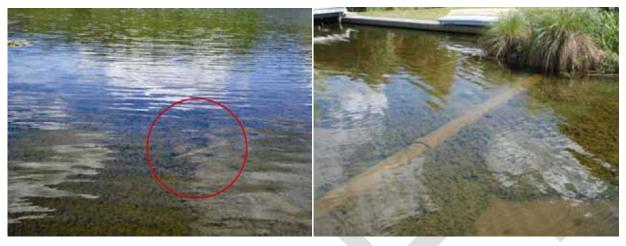
Discharge Point 9 (DP9) drains a small portion (approximately 0.6 ha) of the Lake Okareka Settlement on the Acacia peninsula. The outlet is located below the properties of number 69 and 71 Okareka Loop Road. Here runoff from the catchment discharges directly to Lake Okareka via a submerged pipe extending into the water for approximately 5 to 10 m. Figure 11 shows DP9 discharge location on the edge of Lake Okareka.

Figure 11: DP9 discharge point on the edge of Lake Okareka. The photo to the left shows the submerged pipe end and the photo on the right shows the submerged pipe leaving landfall.

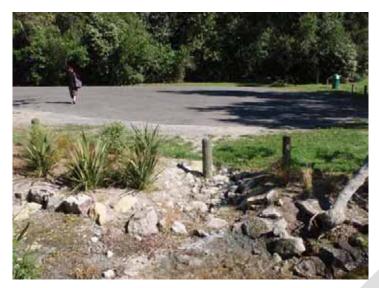
Similarly the majority of driveways are sealed. Figure 12 shows an example of stormwater drainage from the road edge and a simple silt/gravel diversion practice. The settlement area also includes a local fire station (designated within the RDC District Plan), a community hall and two tennis courts providing for recreational activity use. None of these uses are anticipated to produce any contaminants different to those generated from residential areas.

Figure 12: Left – Turnaround point with a discharge to lake. Sediment on road margins drain to lake without treatment. Right – Gravel driveway next to catchpit with silt/gravel diversion bags around grate.

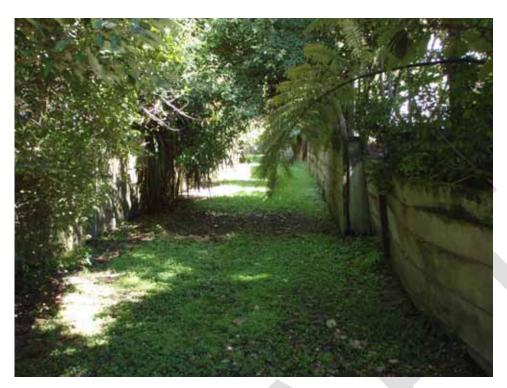
During the site visit for this CSCA on 9 March 2011 very little existing erosion within the Lake Okareka Settlement was observed. The majority of the waterways are effectively ephemeral and well vegetated or lined in most places, hence, the potential for erosion is limited. The Wash, between the start of the channelised section approximately 20 m upstream of Millar Road and the lake outlet at DP2 is an ephemeral water way that has been channelised. The Wash banks are lined in most places with either wooden retaining walls or rock filled gabion baskets. In the vicinity of Millar Road some of The Wash stream banks are contoured and vegetated. The Wash channel bottom contains established vegetation and at the time of the field visit there was between 150 and 200 mm of sediment on the bottom. Figure 13 shows the lower reaches of The Wash its channelised nature and the vegetated channel bottom.

Figure 13: Lower reaches of The Wash.

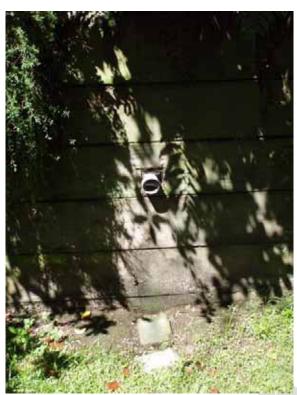
During the field visit, some minor erosion was observed at the upper reaches of The Wash around the Millar Road Bridge where the bank edges are not lined and some minor slumping has occurred. Additionally, stormwater piped into The Wash from surrounding properties or road margins discharge directly to The Wash and cause some minor localised erosion when the pipes are discharging. The majority of these discharges have some rudimentary measures to reduce the localised erosion, such as bricks or rock riprap. Figure 14 presents one such stormwater inflow that has rudimentary erosion control in place. Minor erosion was also present in the open drains on Benn Road, leading to the DP8 discharge point. At this point the open drains have spring water entering the drain. These springs appear to be located at the corner of Wattle Grove Road and the Benn Road intersection. The drains on either side of the road at this location appear to have spring water running in them causing some minor erosion, and they are potentially a source for sediment during heavy rain. Figure 15 shows the open drain and minor erosion (particularly on the right bank) on the bank edges.

Figure 14: Minor erosion around a private stormwater connection pipe flowing into The Wash and the rudimentary measures to control erosion.

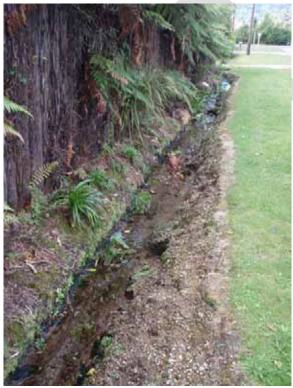
Figure 15: Benn Road open drain and minor erosion of main channel.
