FILE NOTE – SPA LODGE

RE: Spa Backpackers Lodge – 1221 & 1215 Amohau St Rotorua

**HEALTH ACT 1956 – SECTION 29 – HEALTH NUISANCE
HOUSING IMPROVEMENT REGULATIONS 1947 – MINIMUM STANDARD OF FITNESS FOR HOUSES
ROTORUA LAKES COUNCIL GENRAL BYLAW 2017**

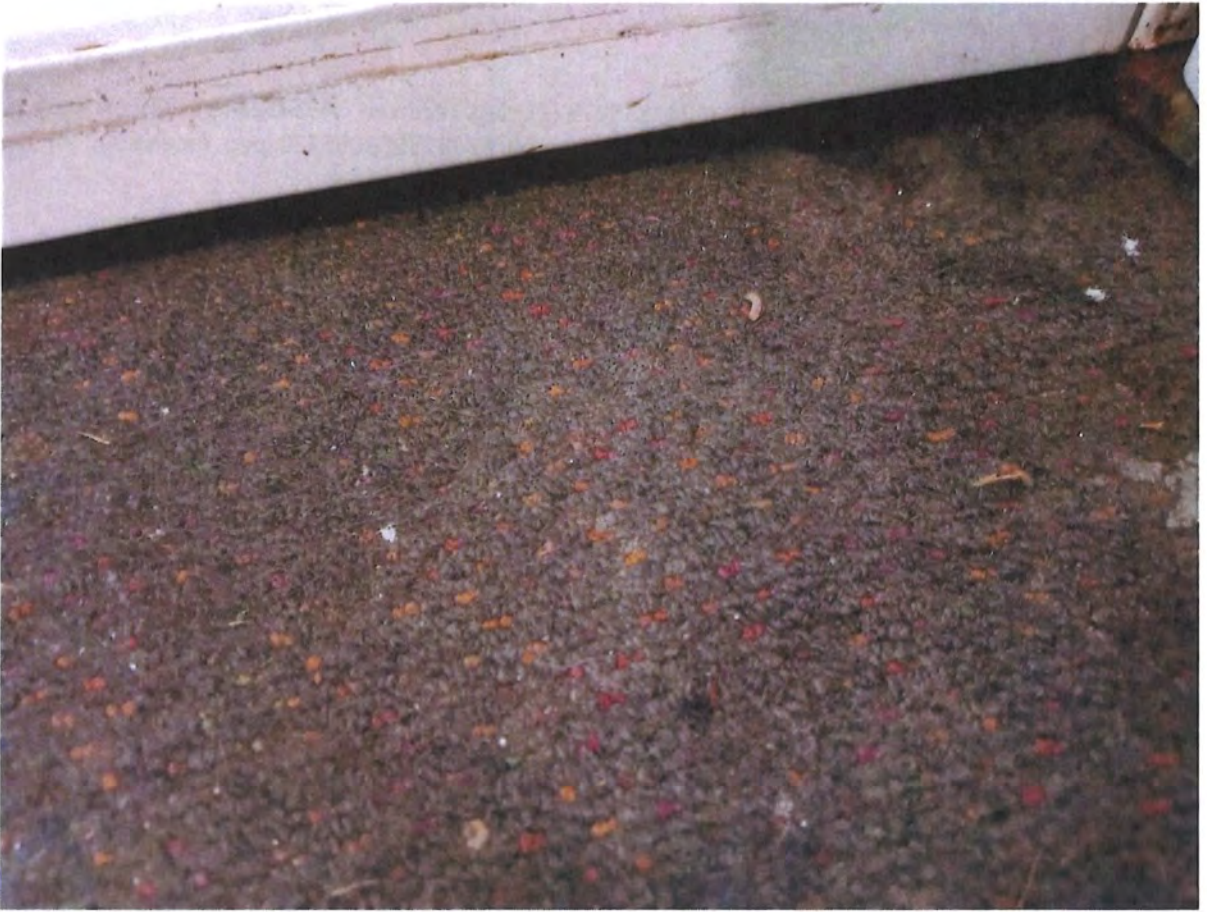
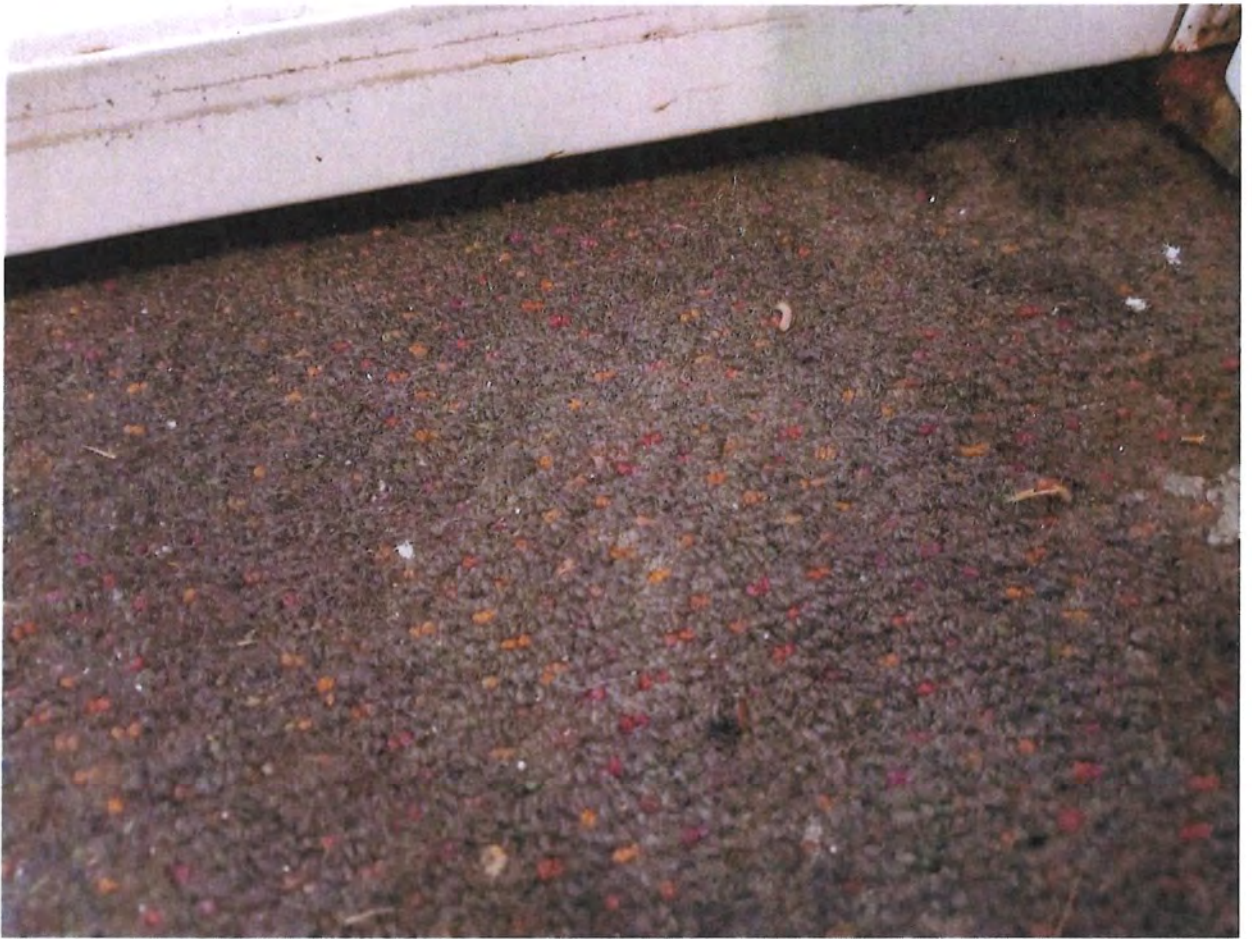
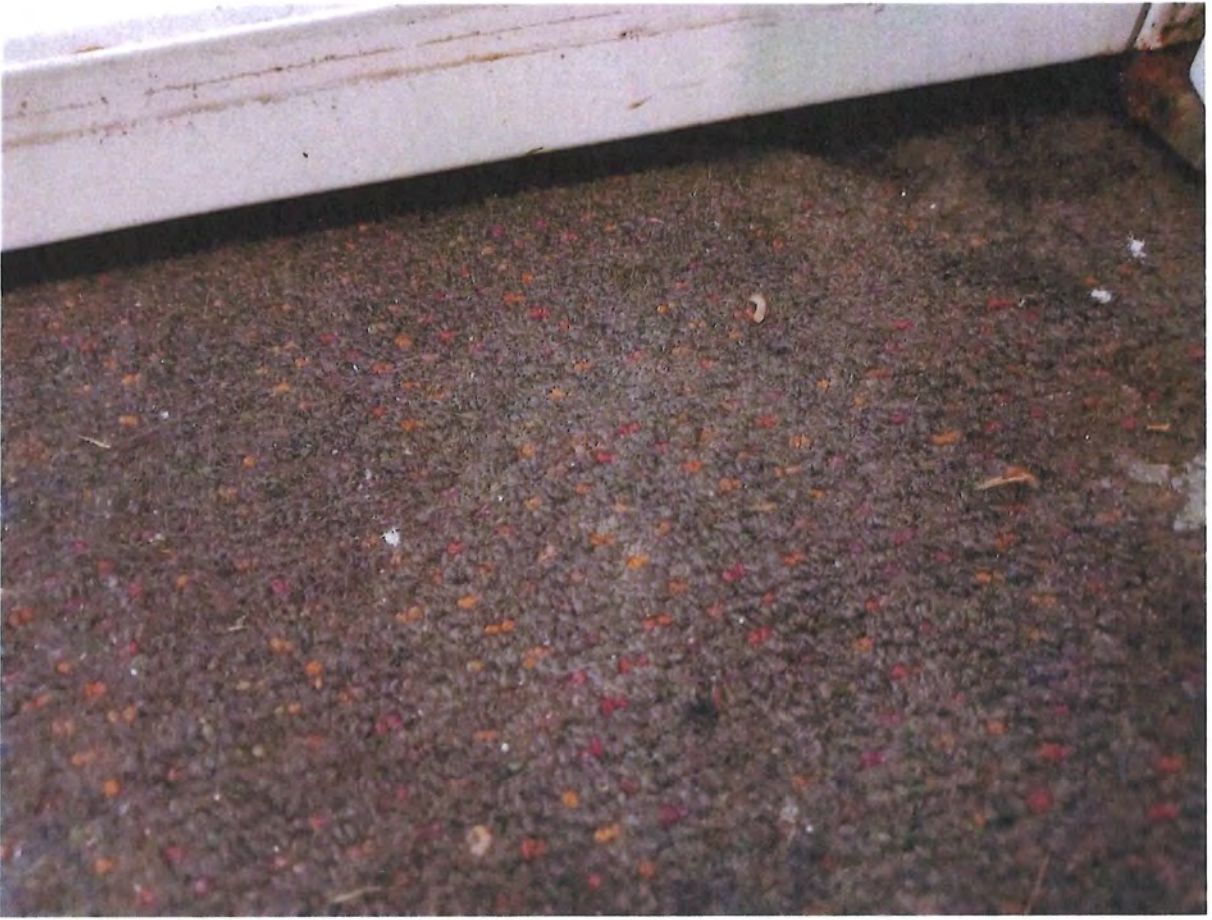
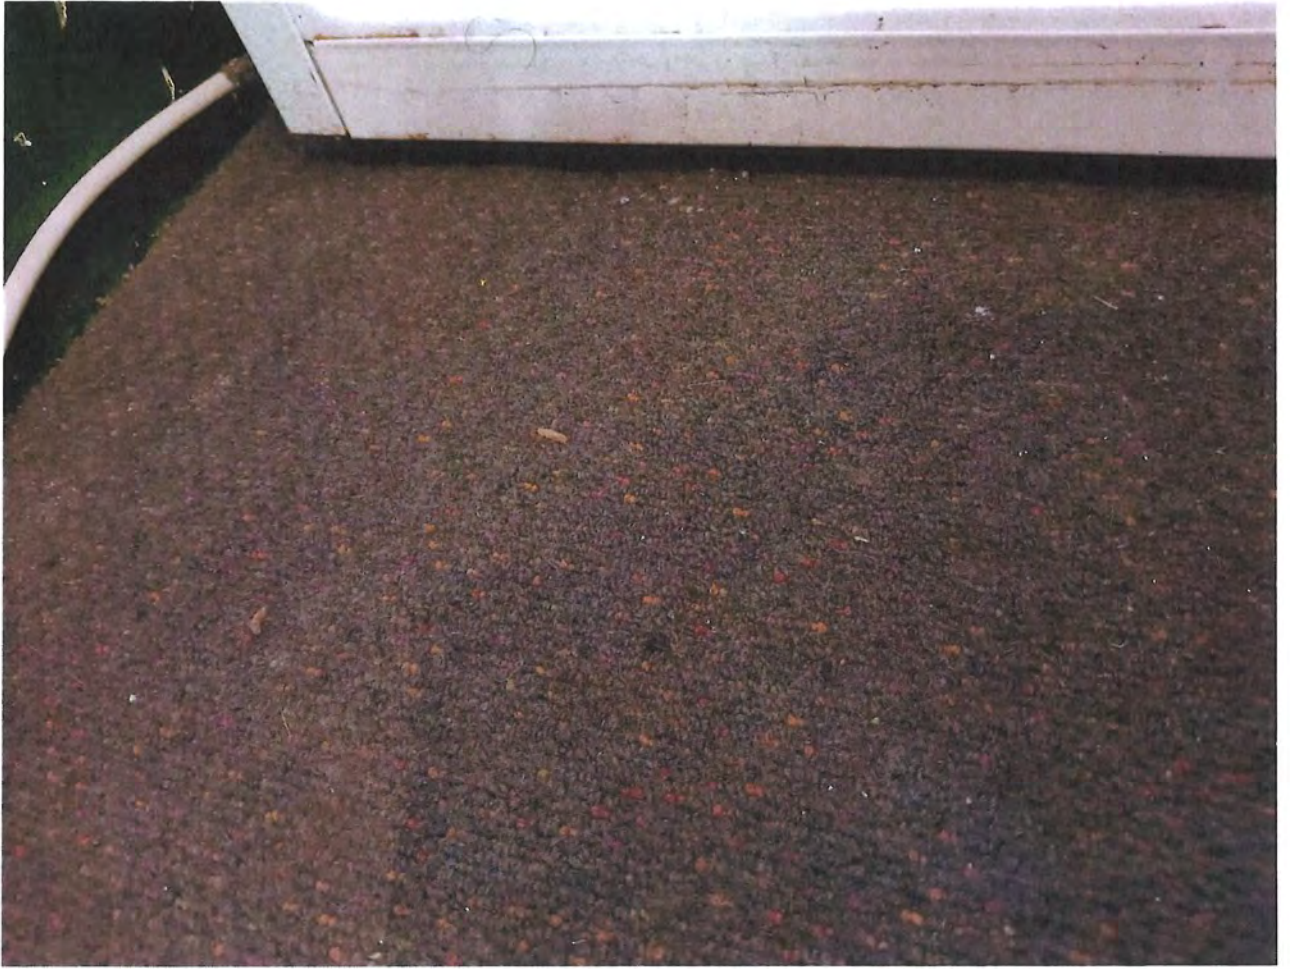
Hello my name is [REDACTED] I'm sending some photos of spr lodge i stay at [REDACTED] [REDACTED] rotorua [REDACTED] and gf have been staying at spr lodge for 2weeks now and nothing has been done about any thing my ph number is [REDACTED] please ring me when ever..I have seen young bbys running around mums with p pipes and beer bong il send tho the photos of the Miggots

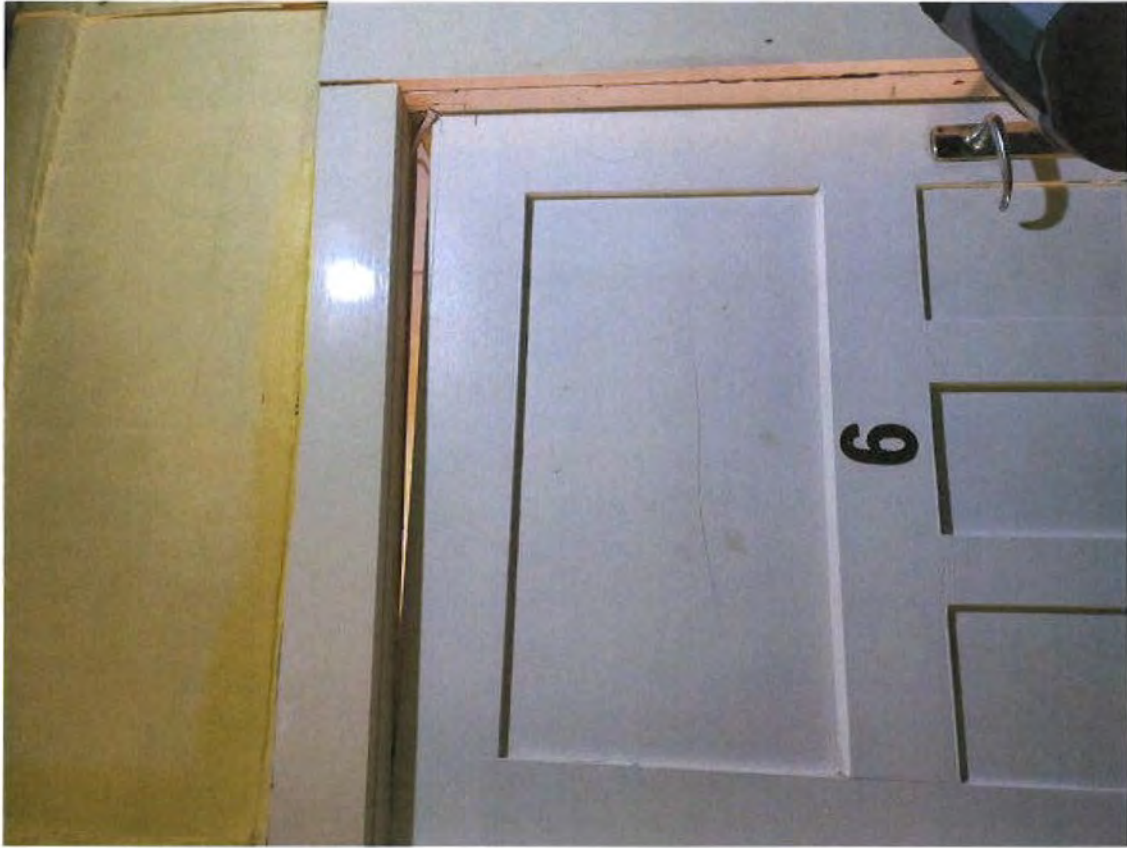
SPL 1	Door to room 6 fully closed and locked. Has a big gap in the top and nothing to stop draft coming through.
SPL 2	Inside room 1 where we were informed the male staying in this room was detained by police not long before arriving and the women and 2 children that were meant to be staying this room were apparently trespassed from spa lodge however were still on-site.
SPL 3	Food all over the 2 drawers inside room 1
SPL 4	Same as SPL3
SPL 5	Underneath the drawers pictured in SPL 3 & 4 with visible rodent faeces and jib that has broken up on the carpet.
SPL 6	Same as SPL 5
SPL 7	Hole in the wall of Room 1 which shows no insulation in the walls (this wall is between room 1 & 2)
SPL 8	Tagging and further hole in the wall of room 1
SPL 9	Broken window in room 1 that appears to be historic as there was dust on the broken part of the window and no glass shards inside or outside of the window.
SPL 10	Bars on the window fram that can't be removed and no glass stopping wind or inspects from getting in. Just the piece of wood seen turned on an angle.

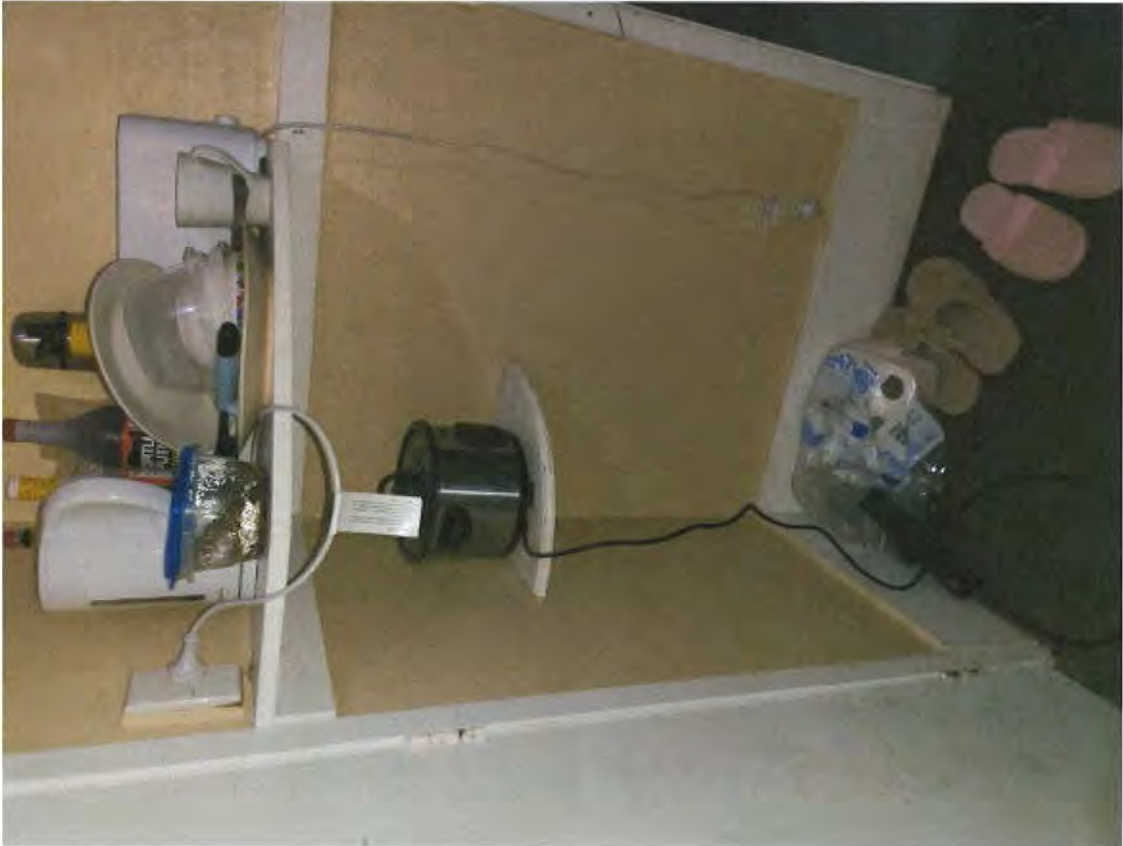
SPL 11	Mold on the curtains of room 3
SPL 12	Cooking appliances inside one of the rooms
SPL 13	Further cooking appliances etc in same room as pictured in SPL 12
SPL 14	Old rice left inside rice cooker from same room pictured in SPL 12 & 13
SPL 15	Fridge in same room pictured in SPL 12 & 13 fridge was leaking and had some type of cardboard layed underneath to stop these. We were adevised by the "manager" that the fridge is supplied with this room.

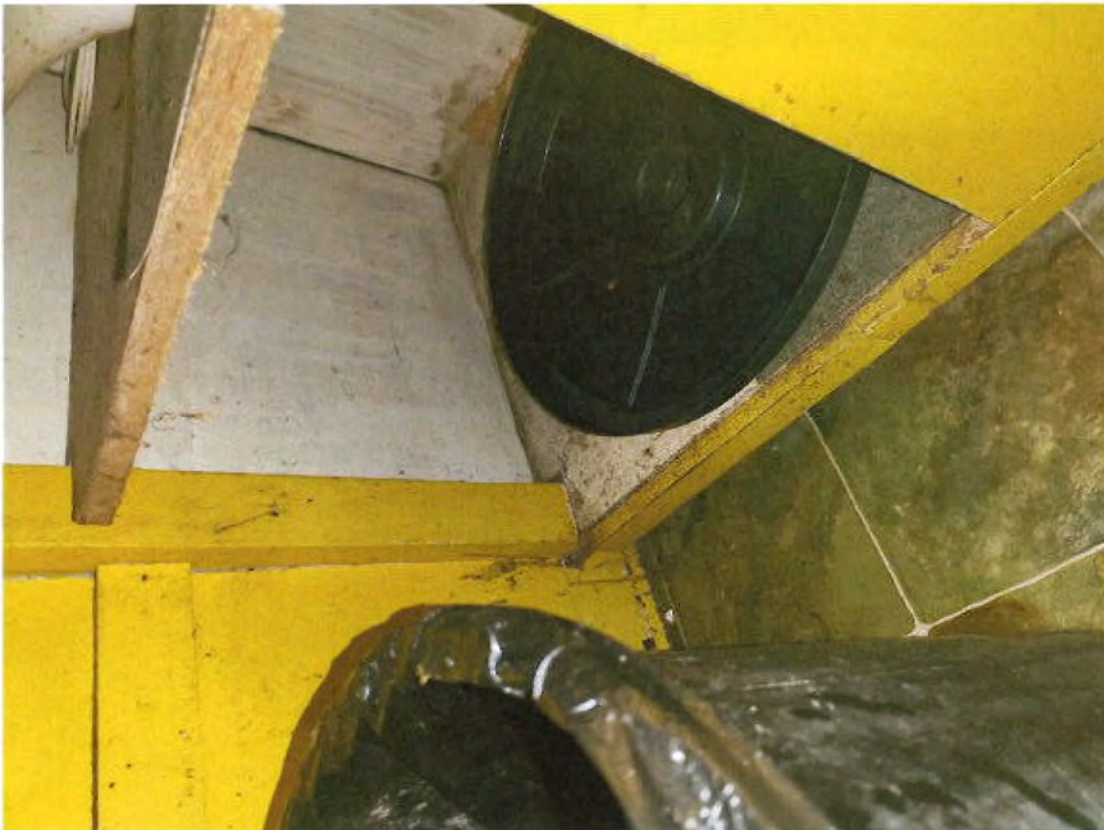
SPL 29	Photo of the oven we were told the cleaner had cleaned moments before.
SPL 30	Underneath a kitchen bench covered in mould and food grime.
SPL 31	Closer look at picture SPL 30 with mould and damp walls visible
SPL 32	Underneath rubbish bin lid pictured in SPL 31 where more mould and deteriorating cabinetry.
SPL 33	Dirt and mould down the side of the fridge in kitchen
SPL 34	Mould all over the wall above the oven
SPL 35	Mould and grime on window sill in common area
SPL 36	Missing window in common area
SPL 37	Broken and lifting lino in shared shower room mould covered over the holes
SPL 38	Mould all over the roof in the same shared shower room from SPL 37 and piece of perspex like material covering the top of the shower.
SPL 39	Peeling and water/steam damaged ceiling in same shared bathroom pictured in SPL 37
SPL 40	Additional photo of ceiling above shower in shared bathroom from SPL 37 as well as the rest of the perspex slid over the top of the shower.

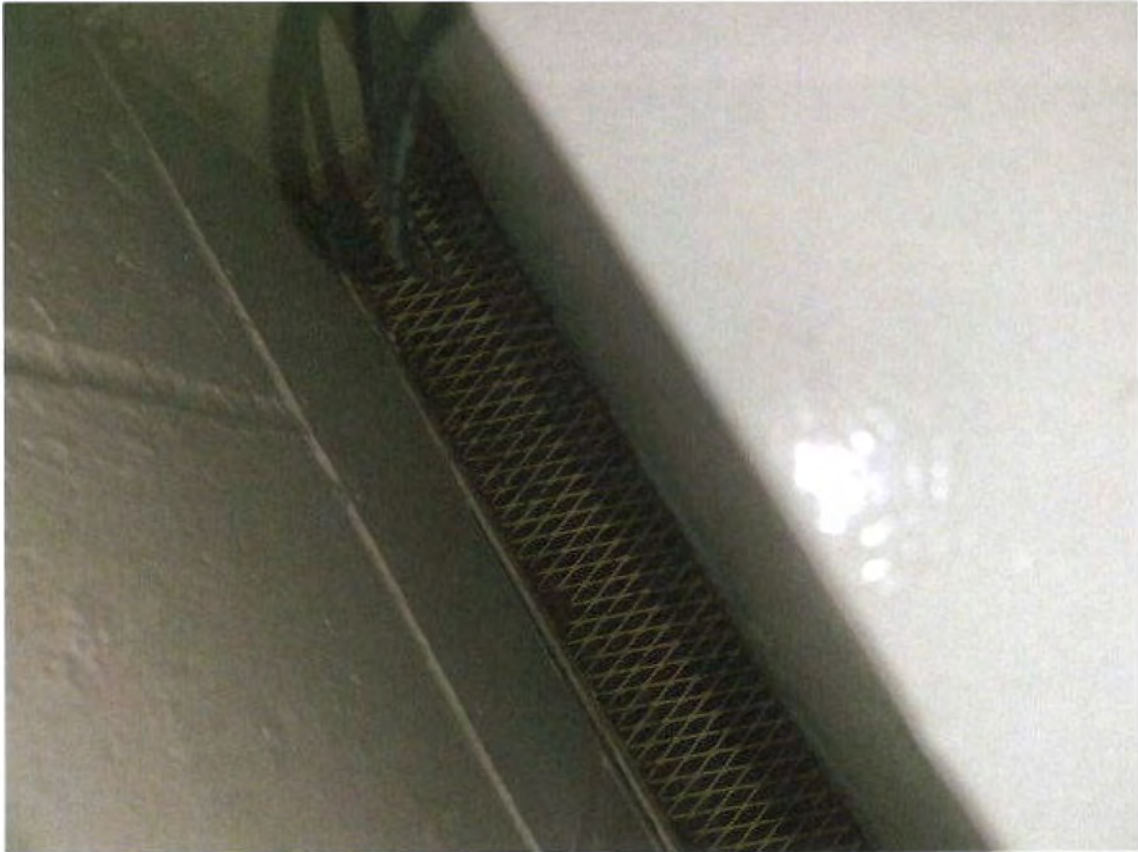
SPL 56	Mould painted over on walls, ceiling and skirting in room 9
SPL 57	Cage covering radiator/heater covered in grime and mould behind a drawer in room 9

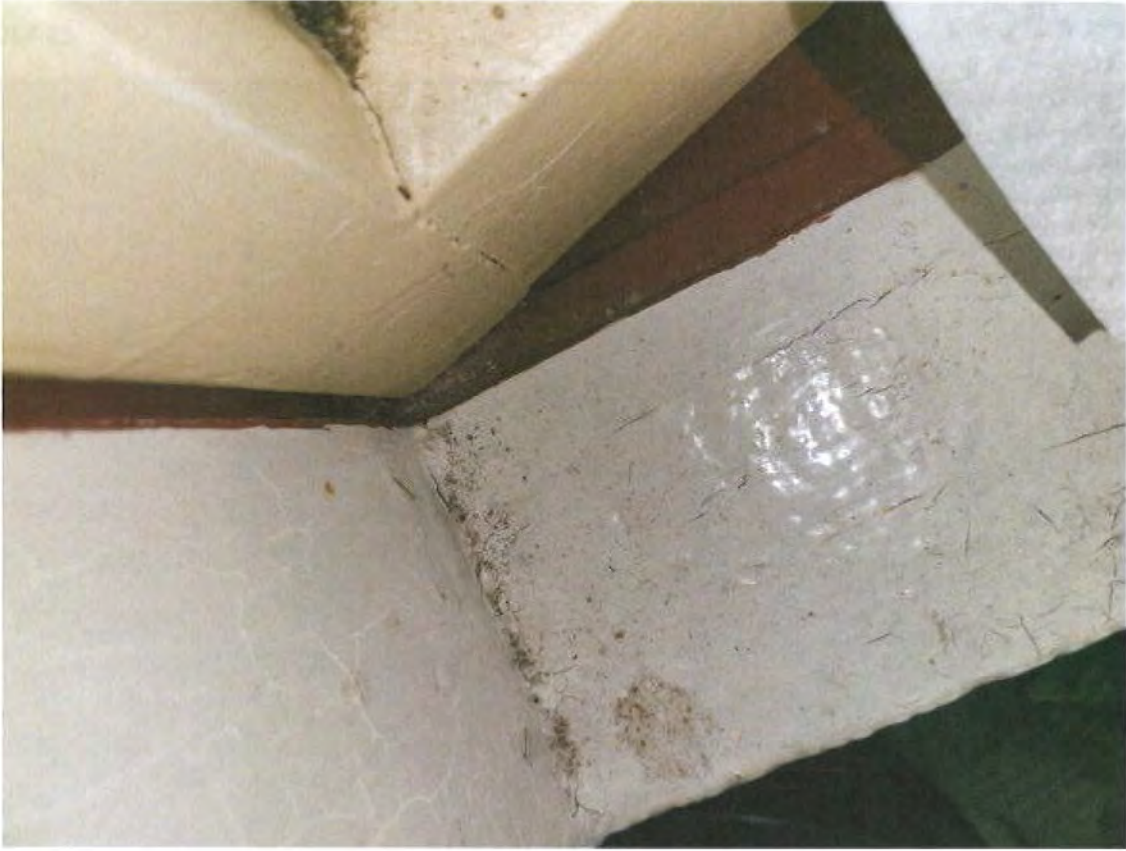
SPL 58	Bits of mould on window sill room 9
SPL 59	Doorway of room 15 door serverly rotton, damp and mouldy
SPL 60	Carpet of room 15 that was completely wet and the odour was very strong of wet carpet and mould
SPL 61	Additional picture of the extent of rotting to the door of room 15
SPL 62	Extremely wet carpet and occupants belongs stacked up to the door but enough room left to open door
SPL 63	Photo of mould all over the ceiling in room 15
SPL 64	Window and curtain of room 15 which has green mould/slime on the window sills, between the window and window frame and all over the curtain
SPL 65	2nd photo showing mould on room 15 curtain and window
SPL 66	Some of the occupant of room 15's belongings that are showing signs of mould
SPL 67	Further belongings of room 15 occupant's belongs demonstrating mould growth
SPL 68	Missing hinge off door to room 15 plus rotting wood in the door
SPL 69	Back end of room 15 ceiling which shows mould on ceiling

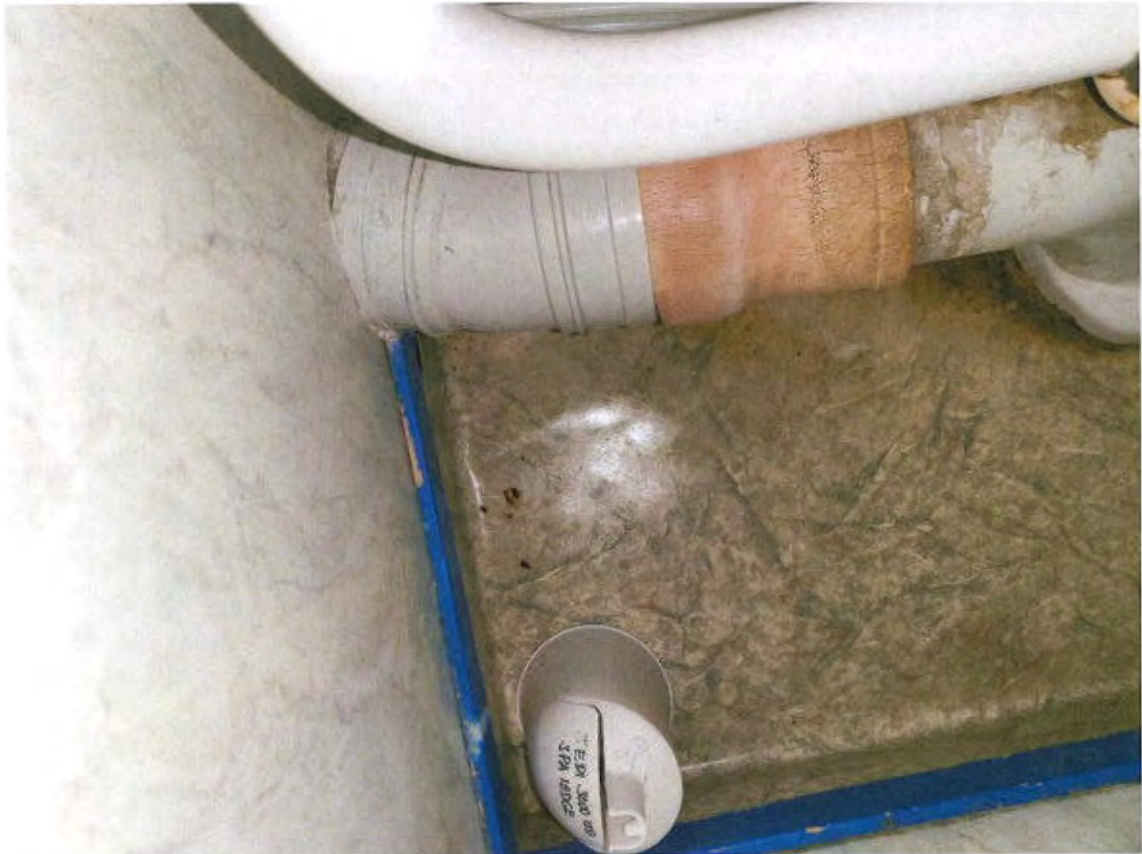
SPL 85	2nd phot of toilet mentioned above with further mould grown into the lino
SPL 86	Room 21 empty and ready for new tenant, foul odour coming from room and mould that appears to be painted over
SPL 87	Window of room 21 with mould that appears to be growing in between the window and frame

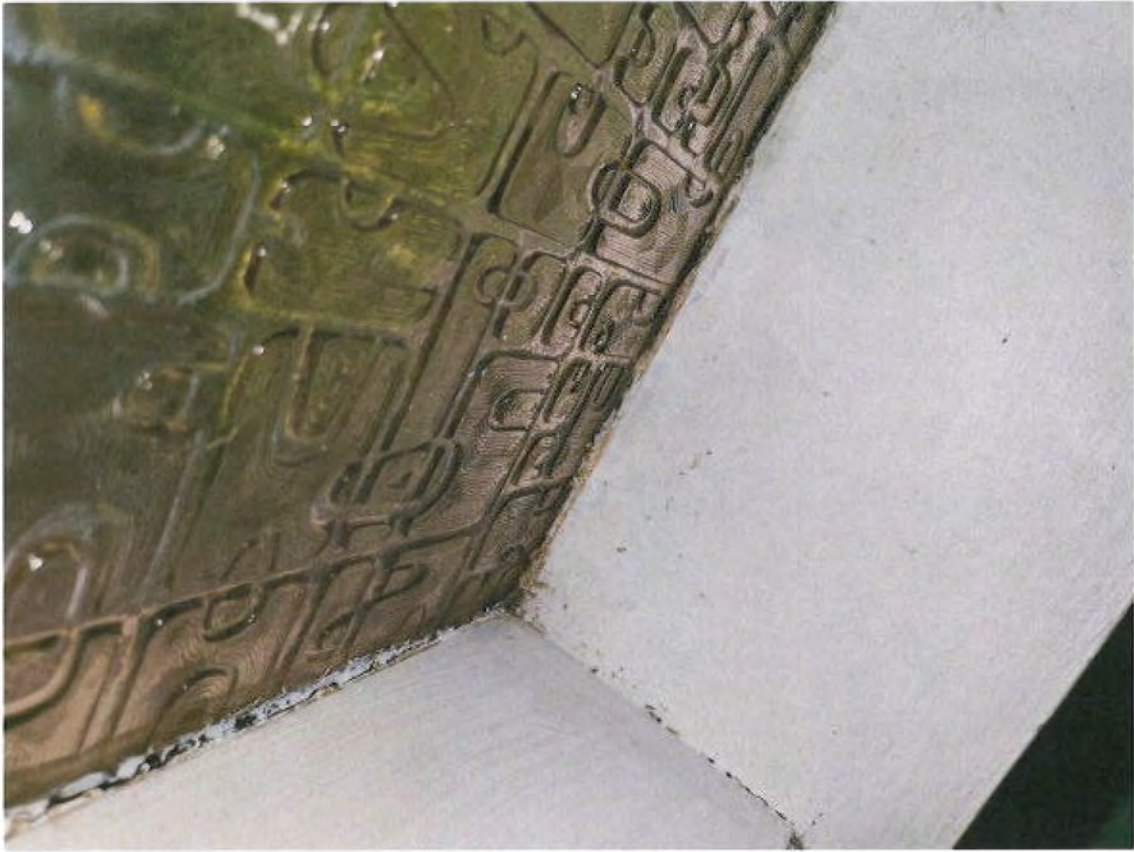
SPL 88	Further to above SPL 87
SPL 89	Down the side of the bed of "clean room ready for next tenant"
SPL 90	2nd kitchen with rotting and broken skirting boards, tagging on all walls
SPL 91	Further to SPL 90 old cavity for cupboard
SPL 92	Further to SPL 90 mould on ceilings and warped cupboards and flooring
SPL 93	Further to SPL 90 plus stove top with no extractor fan/ventilation method
SPL 94	Further to SPL 90
SPL 95	Further to SPL 90
SPL 96	Further to SPL 90
SPL 97	Further to SPL 90
SPL 98	Wet lumpy carpet outside 2nd kitchen area
SPL 99	Inside room 21 from the door way. Extreme odour big crack down middle of left-hand side wall and paint cracked and peeling
SPL 100	Items of clothes in room 21 and bubbled paint on wall on left hand side next to doorway
SPL 101	White substance all over floor in room 21

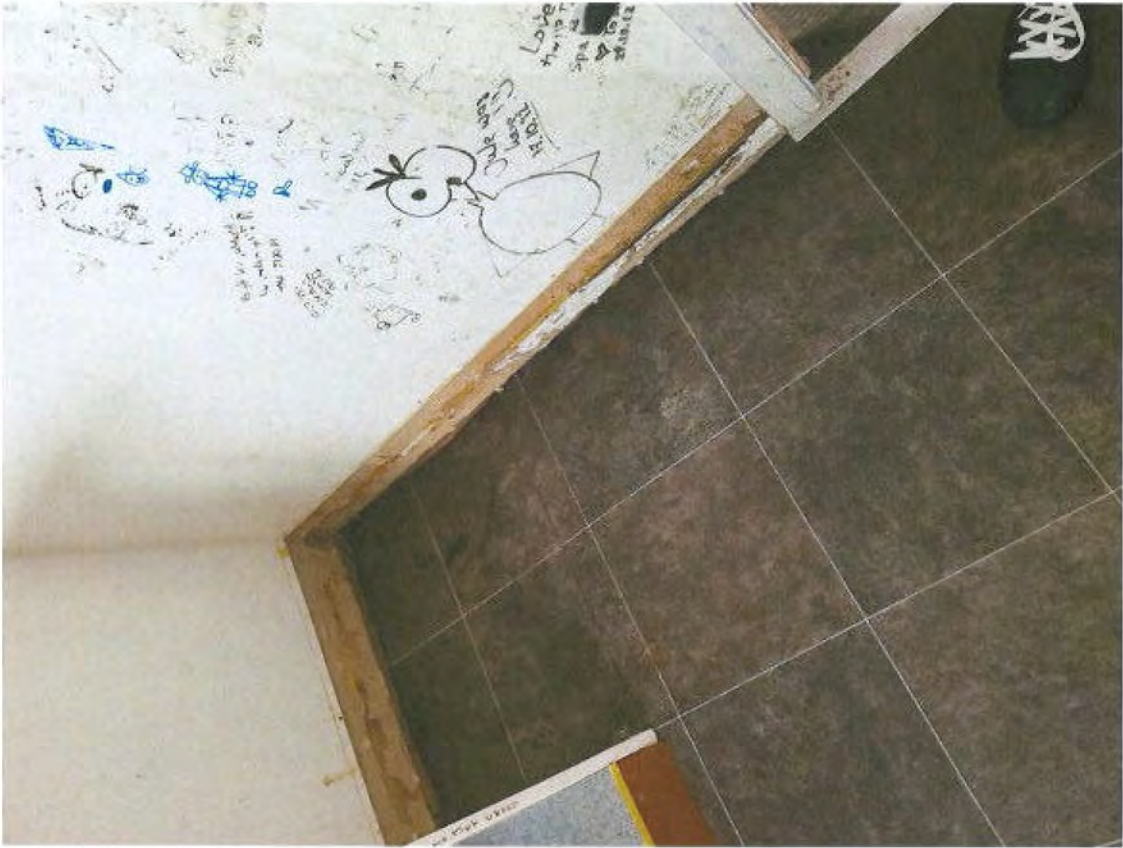
SPL 90

There are two kitchens and except for the stainless steel bench they were un-kept and not suitable for food storage, preparation or cooking as the floors, lower walls, skirting boards, ceilings, cupboards, benches had thick layers of dirt, grim and leftover waste in some of the storage areas. The walls above the fridge and oven had black and white mould patches. There was a noticeable odour coming from the fridge before opening the small bar fridge which is not fit for purpose for the amount of occupants this site has. The flooring is spongy in places, the lino had worn or ripped over time, in these areas the flooring was black with dirt build-up.

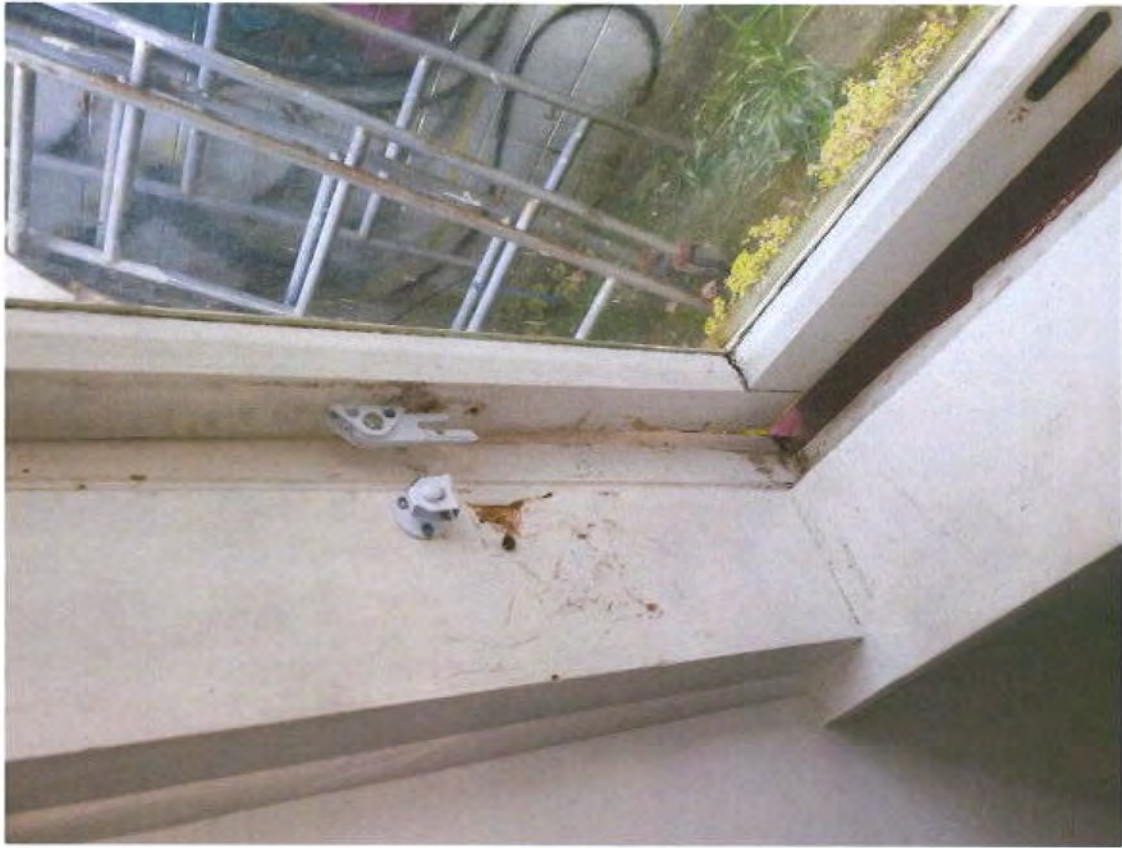
SPL 102	Window and window sill of room 21 with broken latch and wet wood in window frame
SPL 103	Refuse in room 21 on the floor in a corner
SPL 104	Door of room 21 completely rundown and not at all clean mould around door frame
SPL 105	Back of room 21 curtain
SPL 106	Mould on beam, walls and ceiling in room 24
SPL 107	Door pushed open as far as possible in room 24, visible cooking facilities and overcrowded with furniture/belongings
SPL 108	Heavily Mouldy curtain in room 24 food items stacked by window
SPL 109	Cooking facilities set up and being used with no ventilation
SPL 110	Photo of room 25 from the doorway
SPL 111	Container used to clean frying pan behind the door of room 25
SPL 112	Old dirty dishes and food on top of fridge in room 25
SPL 113	Open rubbish bag of rubbish with food scraps etc next to fridge in room 25
SPL 114	Broken radiator panel heater in room 25
SPL 115	Behind broken radiator heater in room 25

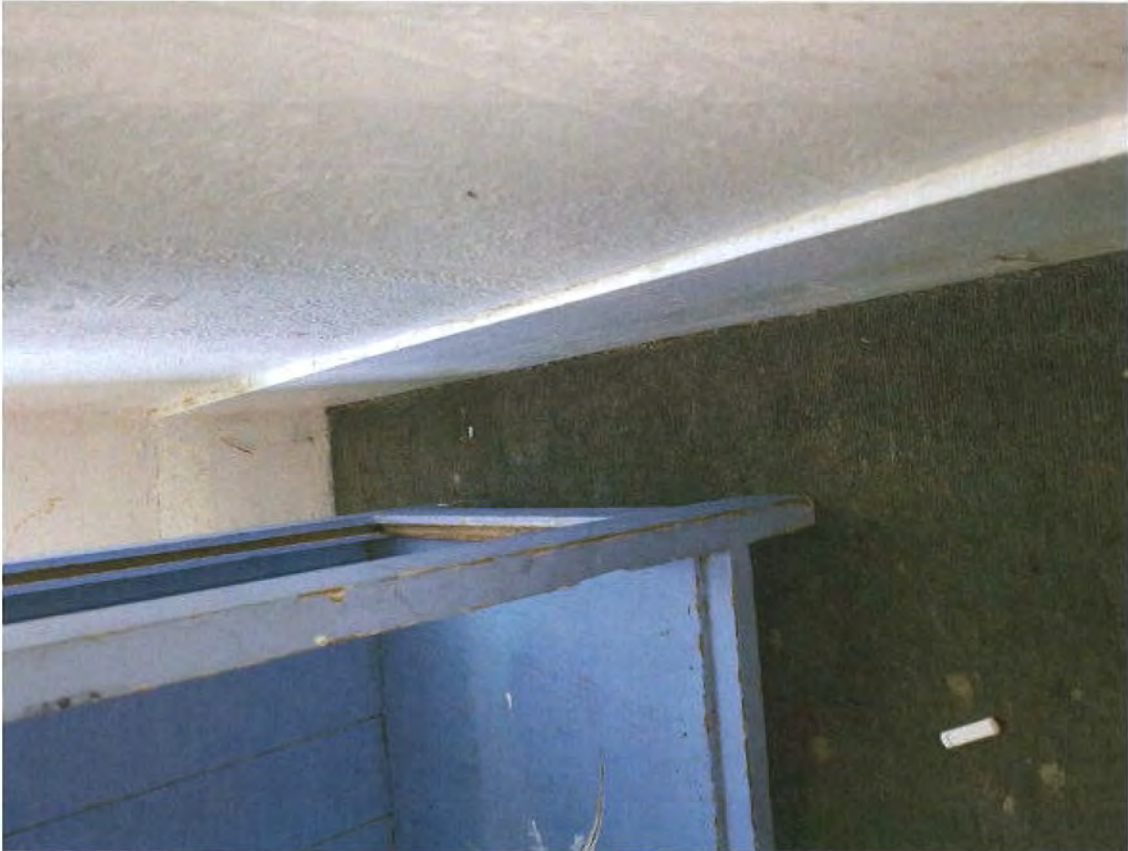
SPL 116	Painted over rotting wood on window sill in room 25
SPL 117	Mould down the side of the wall and between the carpet in room 24 plus dark spots that look like they could be mould
SPL 118	Closer look at dark spots on the carpet that resemble mould in room 24
SPL 119	Additional photo of carpet and wall in room 24
SPL 120	Fire hose tap outside in corridor leaking with mould on the wall behind the pipe and visible damp spot on carpet
SPL 121	Leaking fire hose tap as pictured above
SPL 122	Room 28 which appears to be an additional room added on as the cladding/exterior of the building has been built around to form a room
SPL 123	Closer look at cladding inside room 28
SPL 124	Ceiling in room 27 with visible mould
SPL 125	Room 28 photo taken from the doorway further additional room using the outside of the building
SPL 126	Closer photo of room 28's cladding on the inside of the room
SPL 127	Wall above the door in room 28 that appears to paint sagging due to water damage

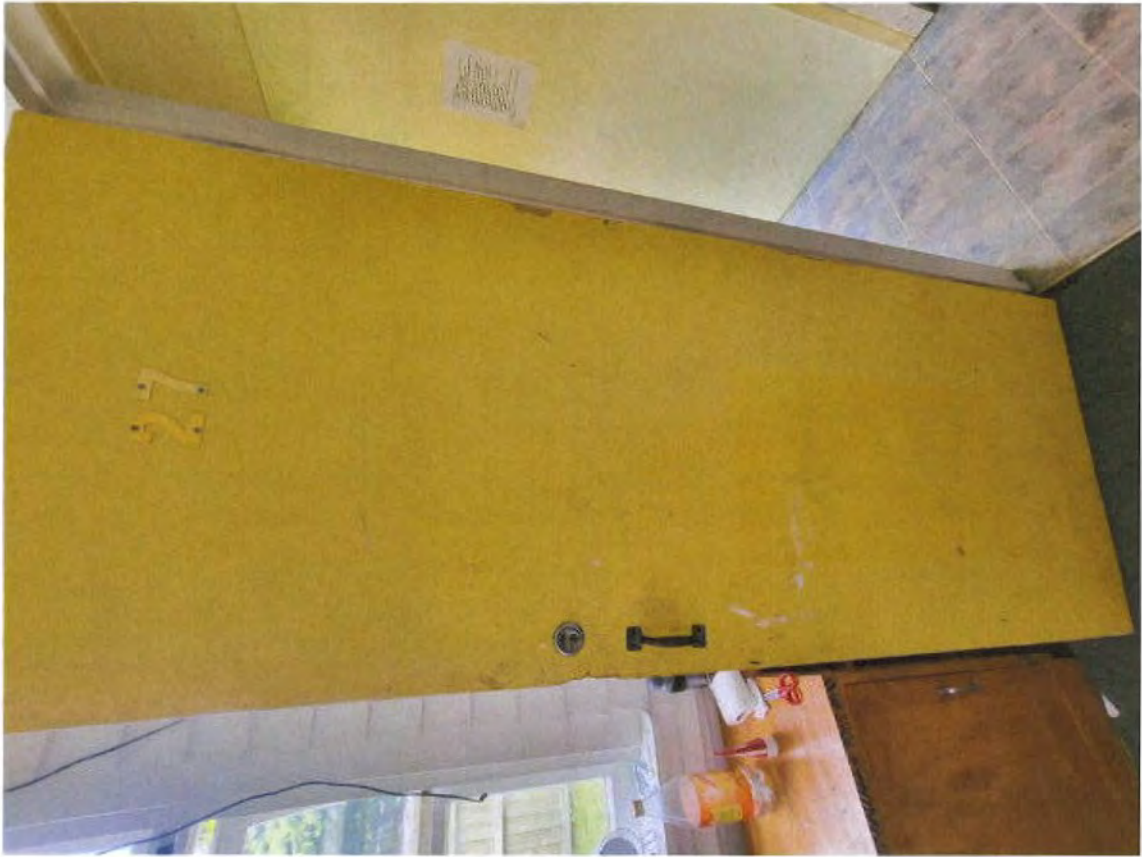
SPL 128	Grubby door of room 27
SPL 129	Grime and mould on the bottom wall under the window of room 27
SPL 130	Closer look at ceiling in room 27 that appears to have mould/dirt painted over top of
SPL 131	The outside of the door frame of room 27
