On-Site Wastewater Capability at Lake Tarawera

Bay of Plenty Regional Council

October 2017

louise feathers planning

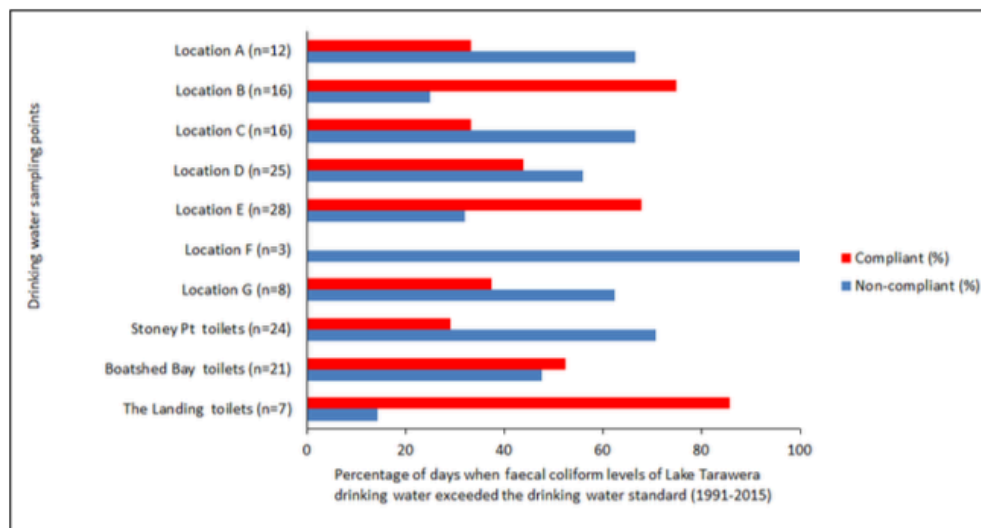
Figure 2: Microbiological compliance and non-compliance levels of drinking water at Lake Tarawera (1991-2016).

The study utilised a mass balance approach for nutrient loads and also investigated *E. coli* concentrations from tap water samples collected from public toilet sites around the lake. In terms of the public health findings the report noted:

The counts of faecal coliforms recorded from water samples collected from selected locations within the catchment, indicate some faecal contamination of drinking water source or distribution system.

The study noted there were some issues with aspects of the data used in the analysis however it stated that it is quite clear that the majority of drinking water samples analysed during the 15-year period at Lake Tarawera catchment were non-compliant (see Figure 2 below), warranting the need for efforts aimed at reducing potential sources of faecal contamination within the catchment, including considerations for sewage reticulation.

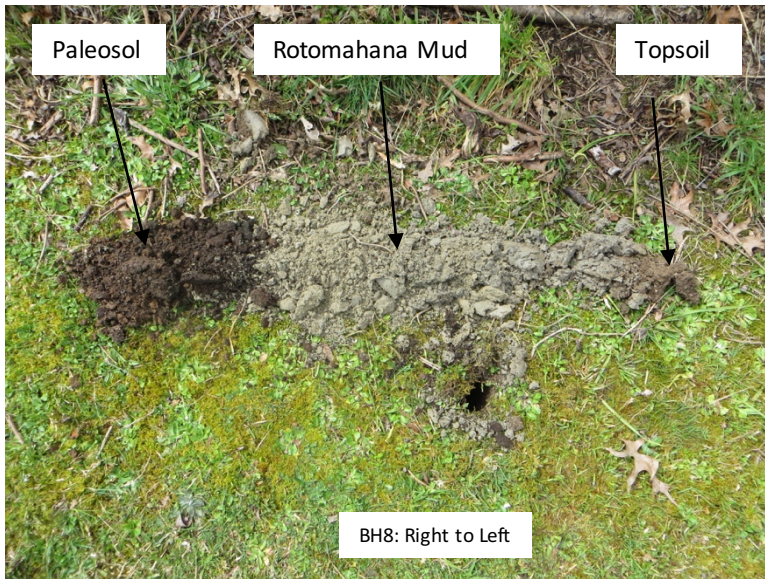
Figure 5: Borehole showing Rotomahana Mud and paleosol.

Based on the literature review outlined in section 5.2.2, the Rotomahana Mud was identified in 9 of the 11 boreholes drilled. One borehole intersected the Tarawera tephra unit only and could not be progressed beyond 500mm depth due to large volcanic clasts or erupted blocks. A further borehole did not intercept the Rotomahana Mud unit on the lake shore reserve, instead encountering coarse washed sands.

Where intersected, the Rotomahana Mud comprised a light brownish grey slightly clayey silt, and was overlain by a thin topsoil of 50-100mm. The unit varied in thickness from 400mm to 900mm and was often underlain by a paleosol or relic topsoil layer covered by the eruptive material. The paleosol was also observed in a road cutting on Spencer Road. See Figures 5 and 6.

On the basis of the borehole testing, soil characterisation and percolation tests, it is apparent that the Rotomahana Mud unit has poor soakage characteristics, and hence a revision to the required area for wastewater disposal was appropriate. On the basis of a 4-bedroom dwelling using lake water supply, a design daily flow of 1,200 litres per day would be generated per dwelling. Using the recommended loading rate of 2 mm/day, this equates to a required disposal area of 600m² per site. While this is considered a conservative scenario as not all dwellings will be four-bedroom houses, this is countered by the fact that no reserve area has been factored into the required disposal area.

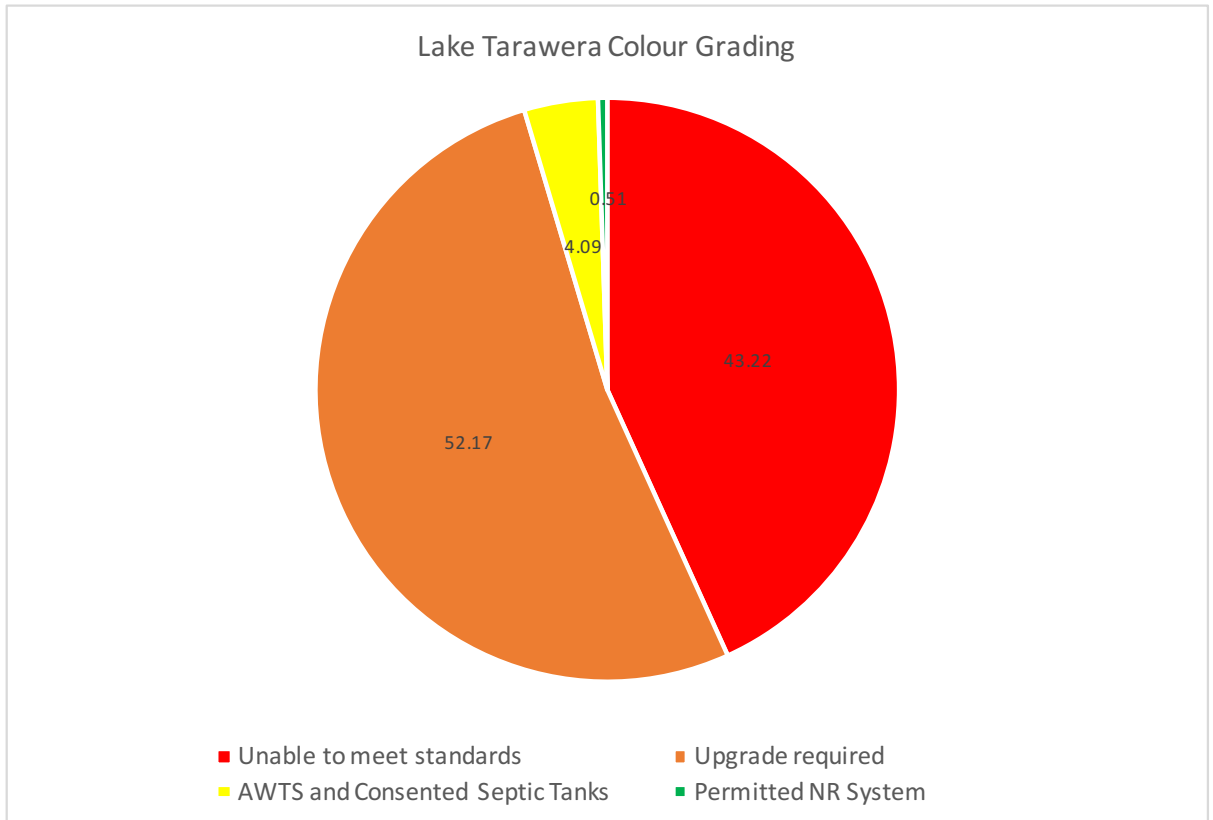
The pie chart below shows the total number of Lake Tarawera properties assigned to each colour category.
