Address of the property:
1221 Amohau Street, Rotorua

Report completed by:
Lynda McHugh, Person deemed competent
Fire and Emergency New Zealand, Nga tai ki te Puku

Section 121(1)(a) Building Act 2004 advice on: 1221 Amohau Street Rotorua Central Rotorua [Spa Lodge]

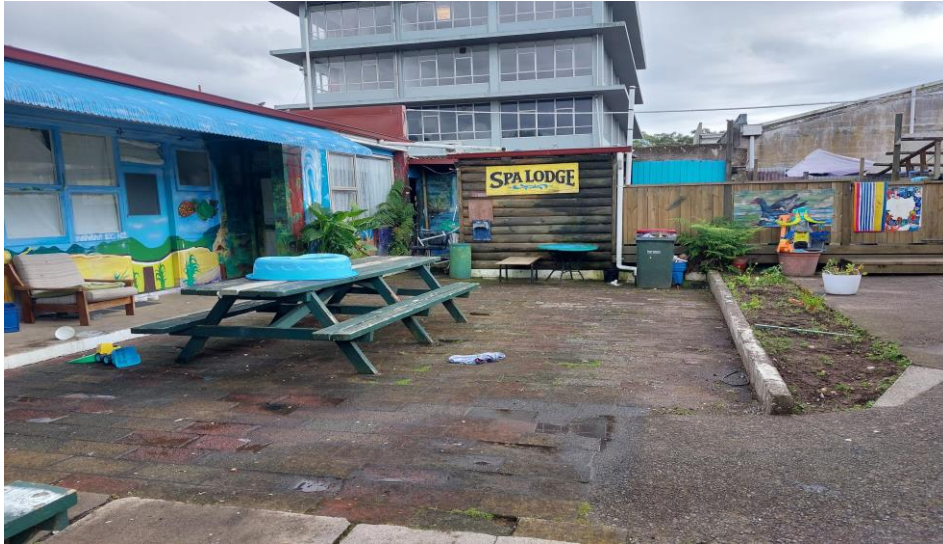
Image 3: View of the courtyard.

The building presented as untidy, with rubbish and clothes scattered around the property.

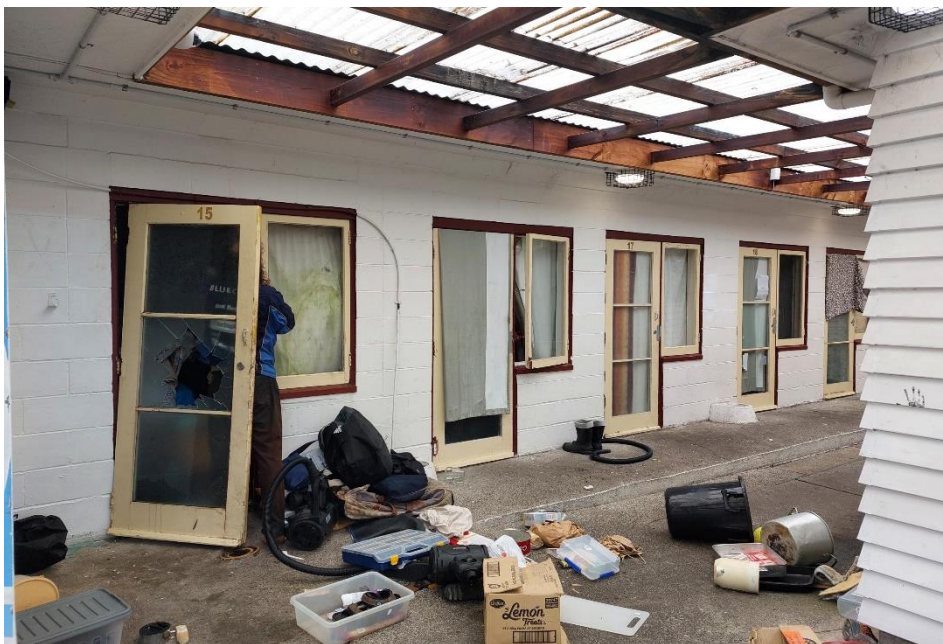
Image 4: Outside rooms 15, 16 and 17.

The building appeared to be run down, with windows and doors broken, holes in the walls, and damage to the external cladding.

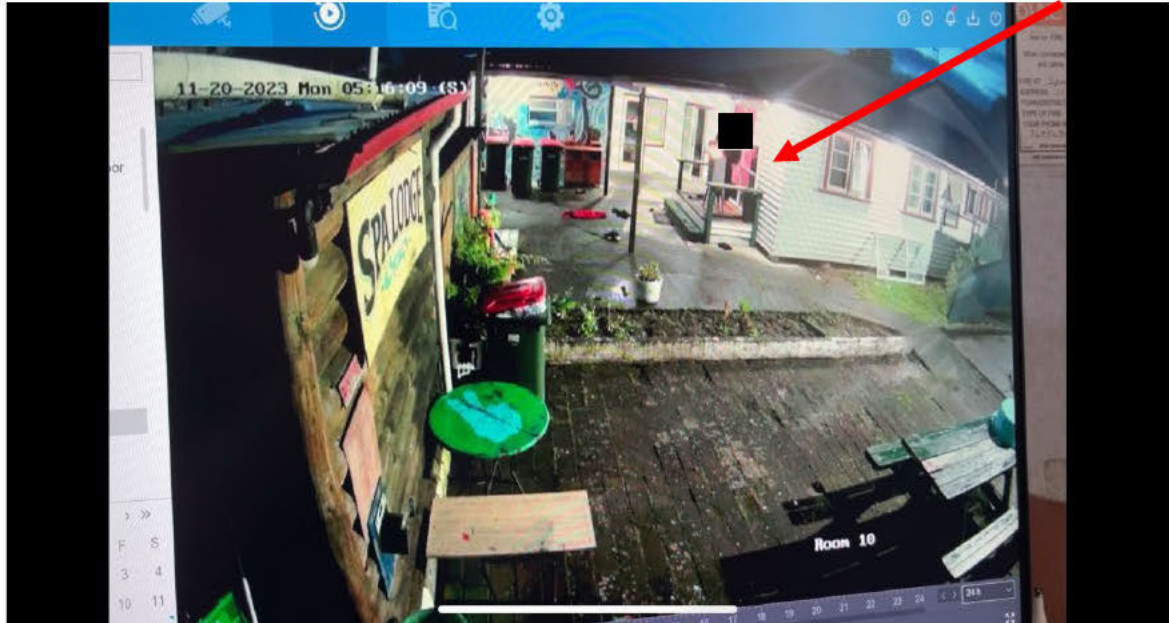
Image 6: At 5:16 a.m. an occupant on the deck of Room 12 set a rubbish bin on fire.

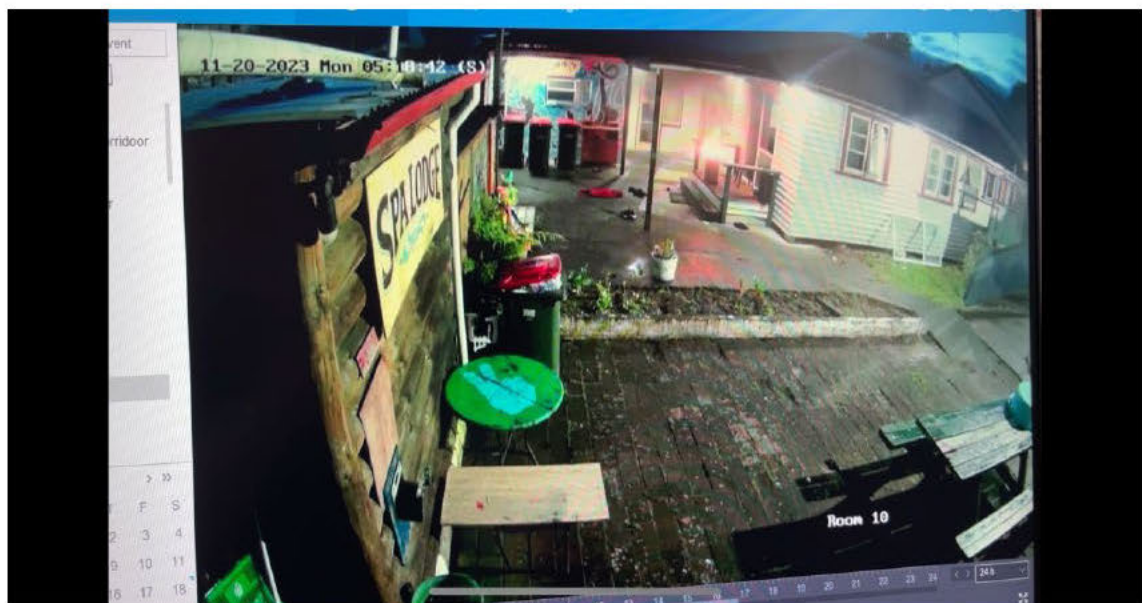
Image 7: The fire reached the roof at 5:18 a.m.

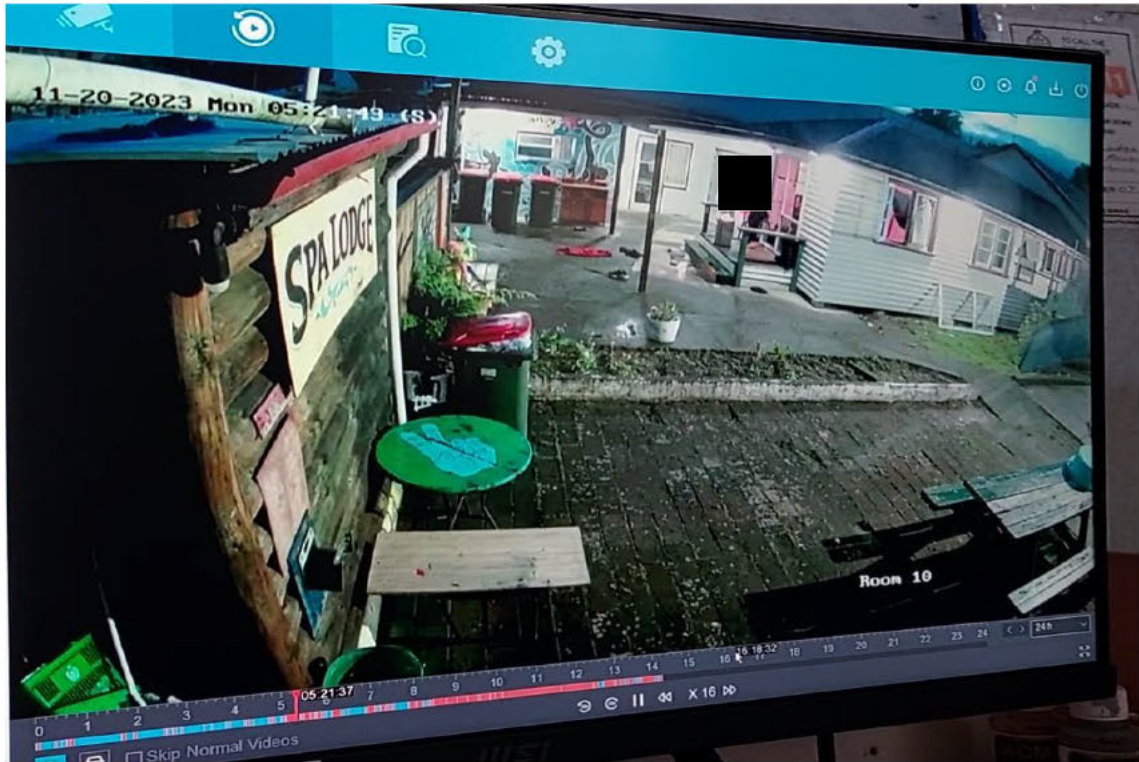
Image 8: At 5:24 a.m. an occupant at his door notices the fire and goes back inside.

This behaviour of the occupants is very concerning. At one stage, this fire was left alone, burning for approximately 20 minutes.

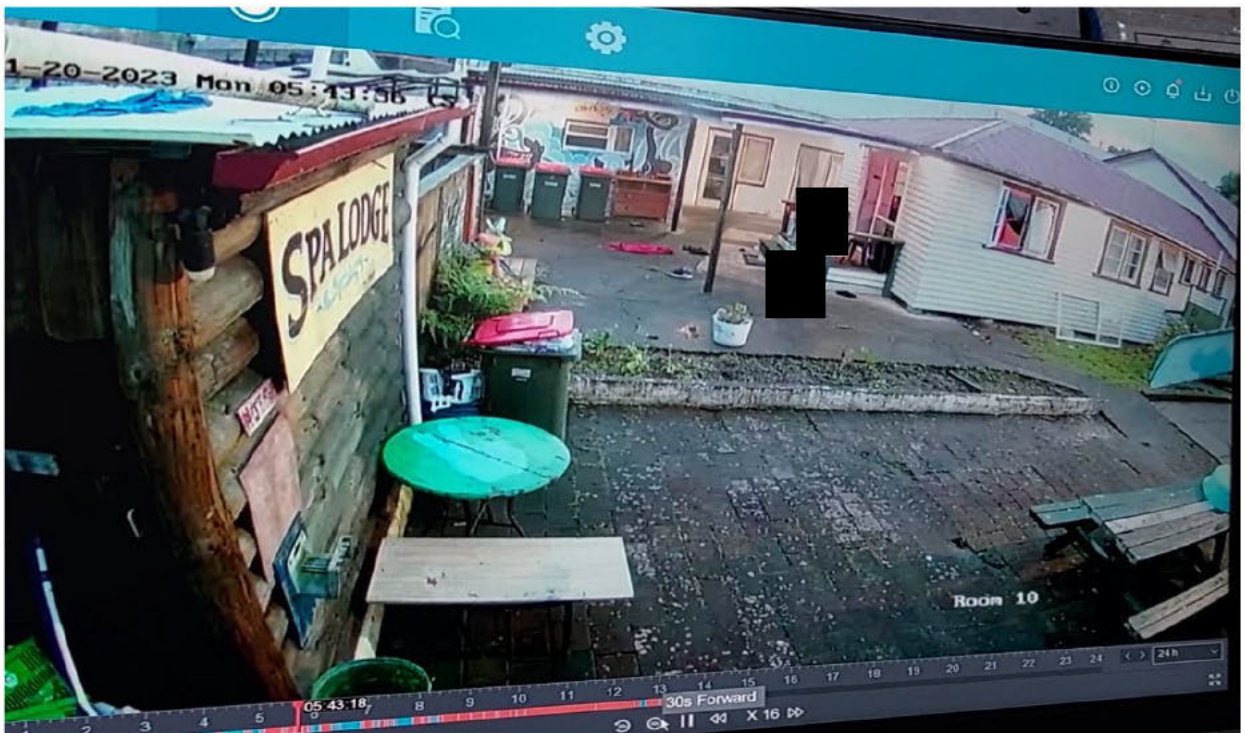
Image 9: AT 5:43 A.M. a different occupant walks by and notices the fire.

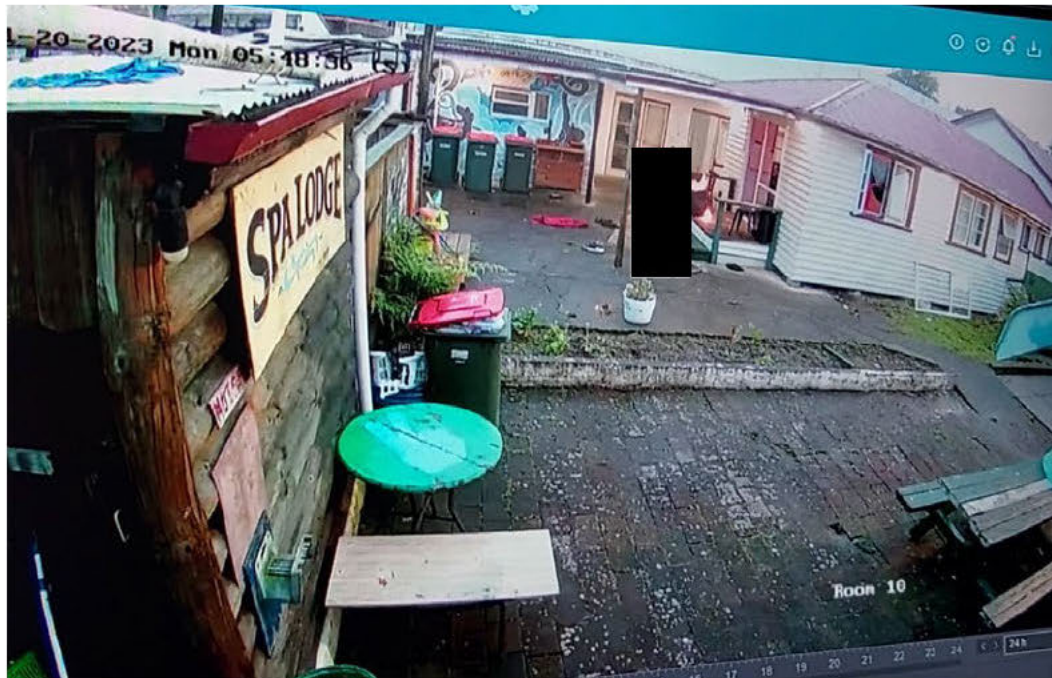
Image 10: At 5:48 a.m. another occupant walks by past the fire that has now burnt through the decking.

No one activated the fire alarm system, called 111, alerted other occupants of the fire, alerted management of the fire, or extinguished the fire until approximately 7 a.m. Then, it smouldered until I fully extinguished the fire at 11 a.m.

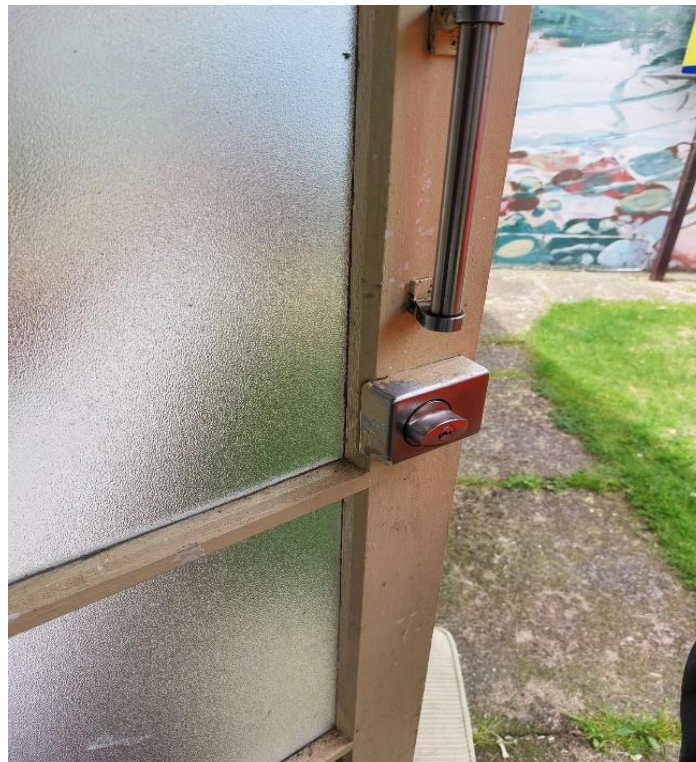
Image 11: Front door to Spa Lodge

When I arrived on Thursday, November 16, 2023, the key deadlocks on the doors were highlighted to me. The site manager explained that the night manager locks both the front exit doors with a key so no one can leave or enter the premises during the night.

Building occupants must be able to easily open the doors in the direction of travel to a protected path, safe path, or a safe place [except as permitted by the Building Code]. I identified that the locking devices on two fire exit doors may not meet C/AS2 3.15.2[a], which requires:

It is unacceptable practice to lock people into a building and remove the key. In the event of smoke and or fire, the occupants will become trapped and disorientated, likely resulting in smoke inhalation-related deaths or fire-related deaths.

I understand that both deadlocks have now been replaced by complying locks that can be easily opened from the inside, day or night. This occurred between my visits on 16 November 2023 and 22 November.

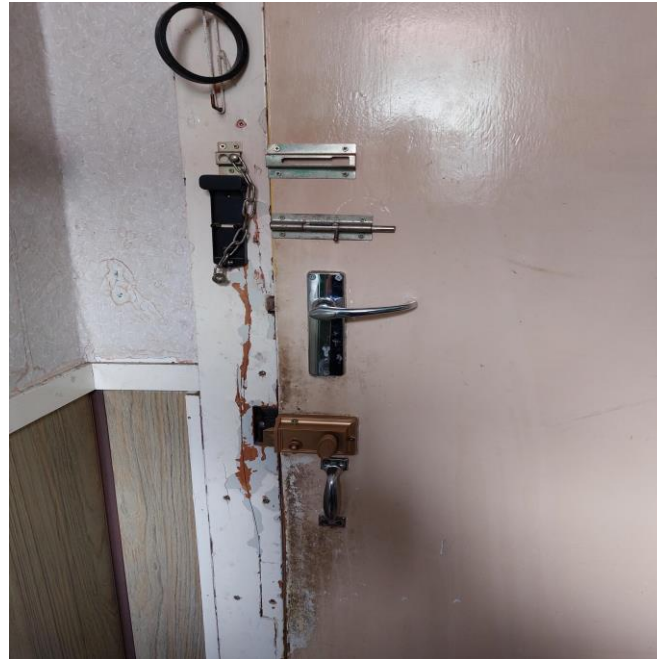
Image 12: Exit door from manager's office

As I left the manager's office on the day of the recent fire, 20 November 2023, I noticed the door had four separate locking devices installed. Again, I have concerns that in the event of smoke or fire, with limited visibility, a person would be able to find and unlock all of these locks, enabling them to escape to a place of safety.

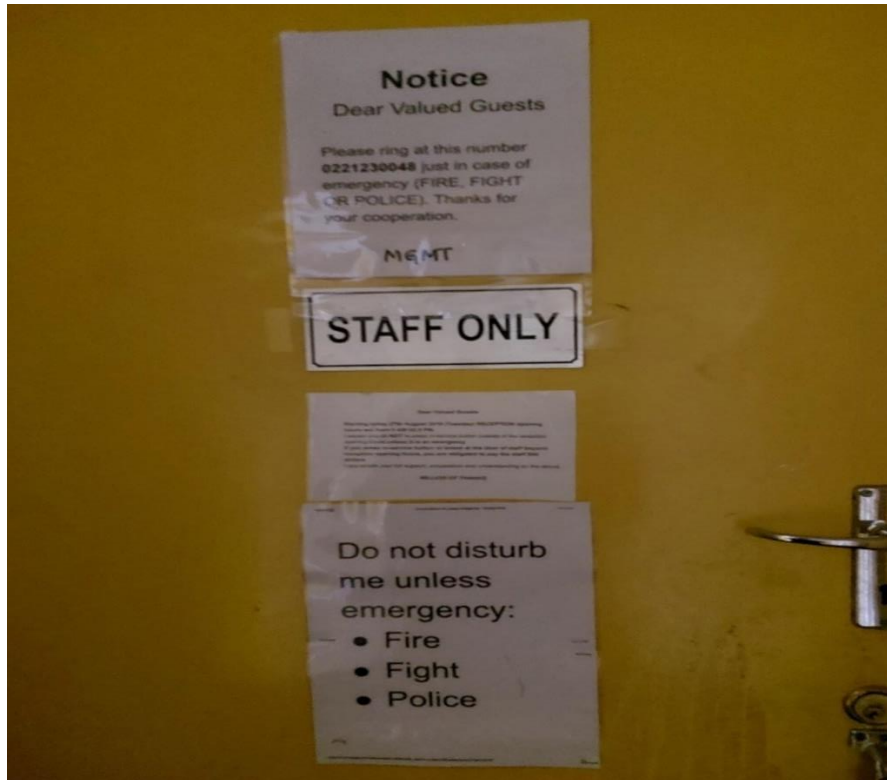
Image 13: Notice on the outside wall of the manager's office

I noted a sign on the front door to the manager's office. It states, "Please ring this number [REDACTED] just in case of emergency [FIRE, FIGHT OR POLICE]." However, nowhere on the notice does it mention first calling 111 for police, fire, or ambulance.

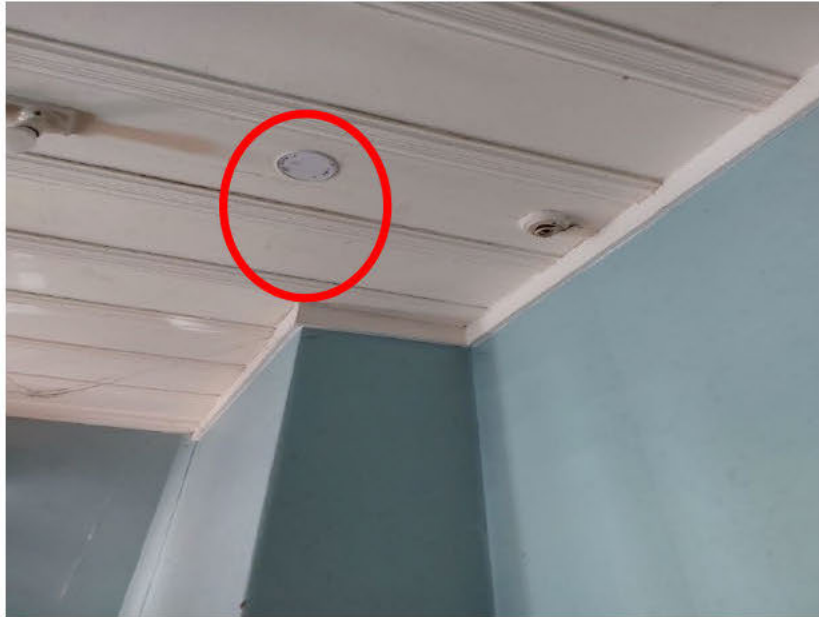
Image 14: Smoke alarm plate with smoke alarm removed.

A number of the occupants smoke cigarettes, and by [REDACTED] admission, the occupants are not permitted to smoke inside their units; however, they have extreme difficulty controlling this behaviour. I observed many cigarette butts on the ground around the units. The risk of this ending in a tragic event poses a very high risk should an occupant be under the influence of drugs and alcohol or medication [prescribed or self-induced] and fall asleep with a lit cigarette. To provide all occupants in this building with the best chance of surviving a serious fire in these circumstances is to have smoke detection and sprinklers installed throughout the building. I was informed that domestic Type 1 smoke alarms are installed in every bedroom.

However, every bedroom I was provided permission to have a look in had the alarm from the ceiling removed, presumably so they could smoke cigarettes inside their bedroom without activating the smoke detector. Research states that "discarded cigarettes and smoking materials have consistently been identified as the leading cause of unintentional residential fires within the international based literature".¹

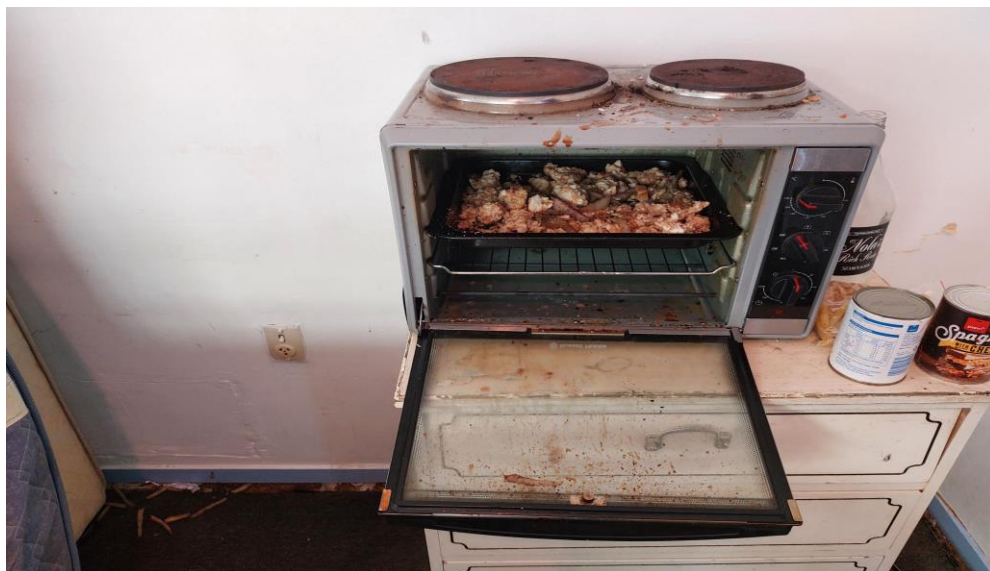
Image 16: Mini kitchen bench-top for cooking in one of the rooms.

A mini kitchen bench-top oven was seen in room 12 with food remaining.

Given that this room had the smoke alarm removed, it compounds the fire risk to the occupants in the bedrooms.

I recommend that there be no cooking facilities in the bedroom as they are not set up to have this. It would be too easy for someone to fall asleep, leaving the oven or pot to heat up until a fire occurs.

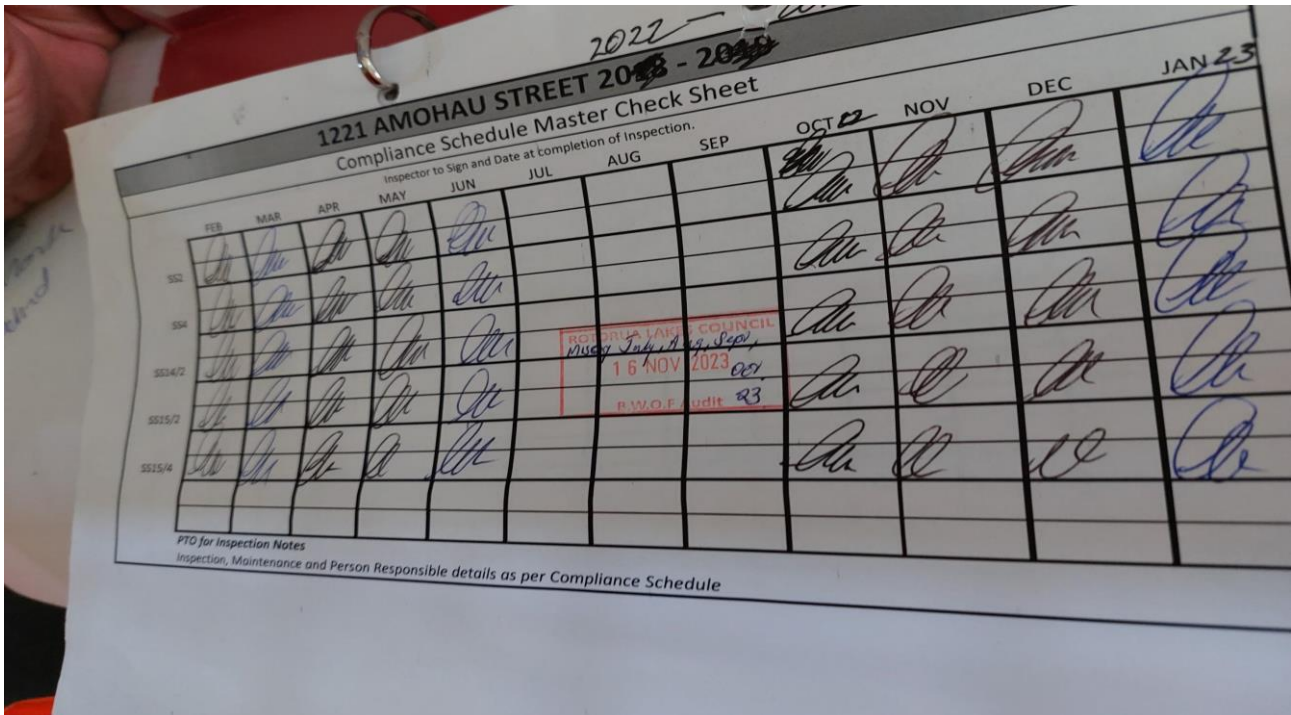
Image 17: Compliance Schedule for 1221 Amohau Street Rotorua

The building has a current BWOFF that expires on 27 January 2024. However, the compliance schedule indicated that the specified system checks for a period of three months were not carried out as required by the Building Act.

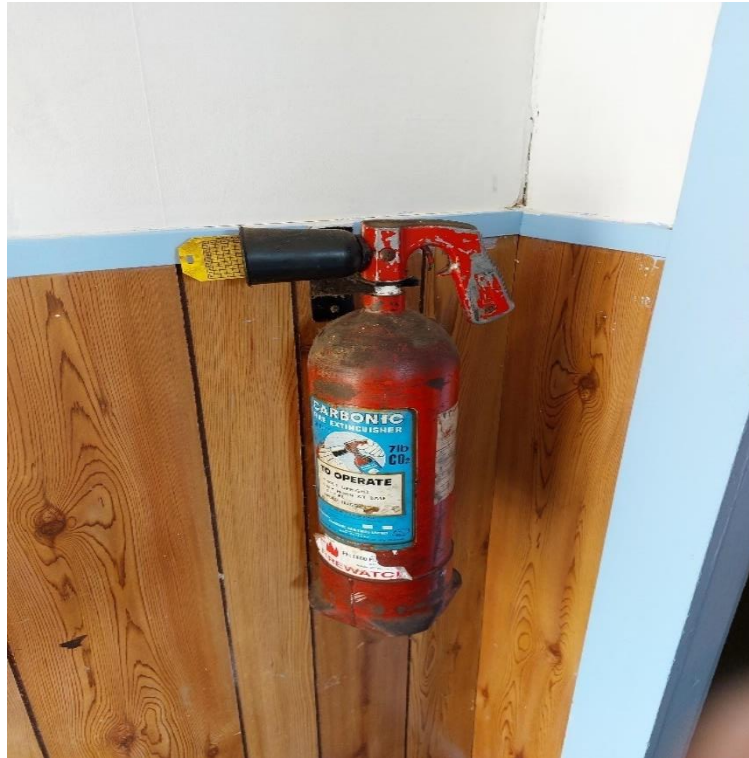
Image 18: Fire extinguishers on the wall in the escape route.

I observed fire extinguishers and firehoses throughout the building. Records indicated that no hand-held firefighting equipment had been tested and maintained for a long time.

Fire extinguishers must be checked to ensure they are operable and ready for use in an emergency. The on the wall in the escape route extinguisher was covered in rust, the release pin had been removed, and the yellow tag had been stuffed into the extinguisher's nozzle. I have significant doubts that this fire extinguisher will work. This extinguisher will need to be replaced with a new fire extinguisher immediately.

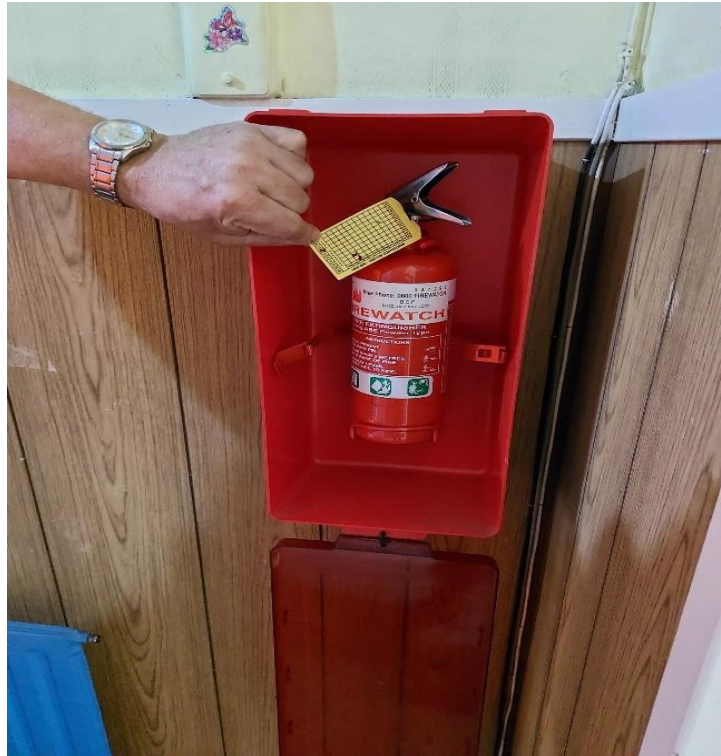
Image 19: Fire extinguisher near manager's office

A second fire extinguisher is located on the wall in the escape route. The yellow tag contains the testing and maintenance record, and demonstrates that this extinguisher has not been tested and maintained. There was no pin in the extinguisher, and it was nearly empty.

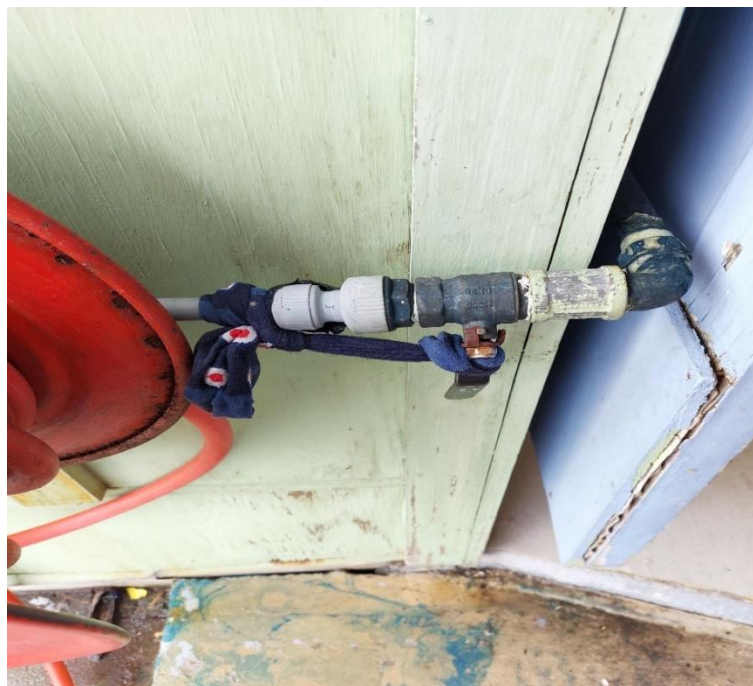
Image 20: Defect fire hose

Records on the hose indicated that this fire hose has not been tested and maintained. The metal reel showed some signs of rust, and the handle was tied closed by a sock. The hose nozzle had been removed from the end of the hose.

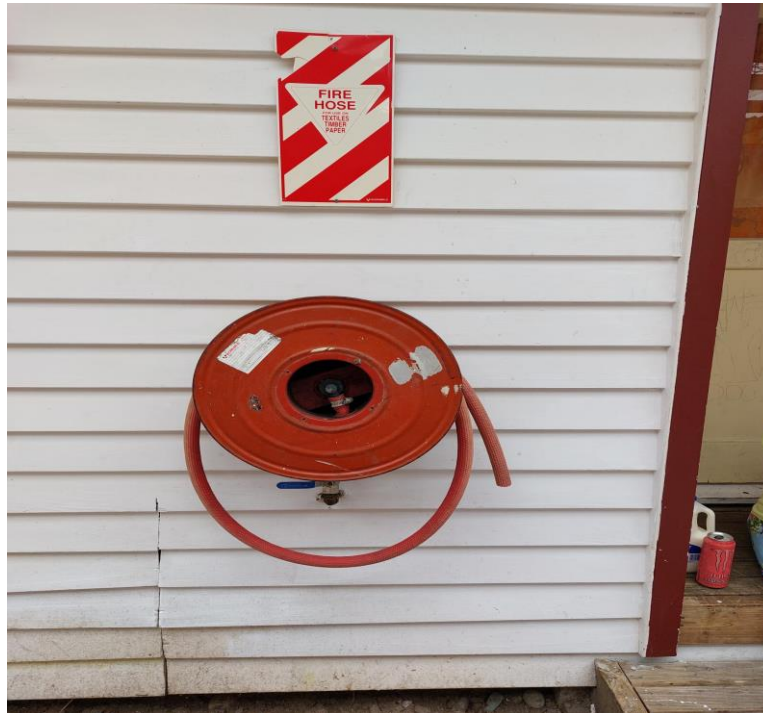
Image 21: Second fire hose located in the courtyard.

A hose reel showed some signs of rust to the rear of the reel; there was no nozzle on the end of the hose and no records indicating when it was last tested and maintained.

An overview of the handheld firefighting equipment in the building shows they are in a significant state of disrepair. I do not consider they would operate for their intended purpose.

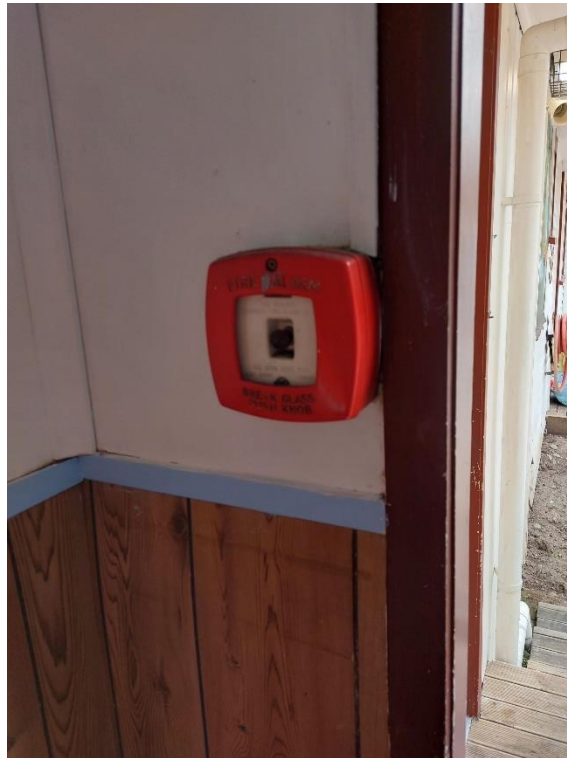
I identified no fire action notices around the building.

Image 22: Fire Action notice needs to be above all manual call points.
