# On-Site Wastewater Capability at Lake Tarawera

for

Bay of Plenty Regional Council

October 2017

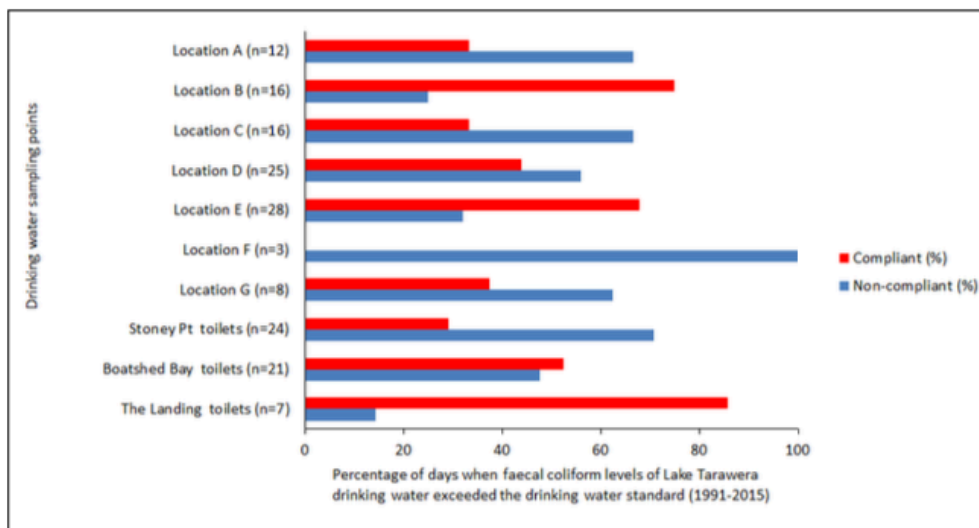
Figure 2: Microbiological compliance and non-compliance levels of drinking water at Lake Tarawera (1991-2016).

The study noted there were some issues with aspects of the data used in the analysis however it stated that it is quite clear that the majority of drinking water samples analysed during the 15-year period at Lake Tarawera catchment were non-compliant (see Figure 2 below), warranting the need for efforts aimed at reducing potential sources of faecal contamination within the catchment, including considerations for sewage reticulation.

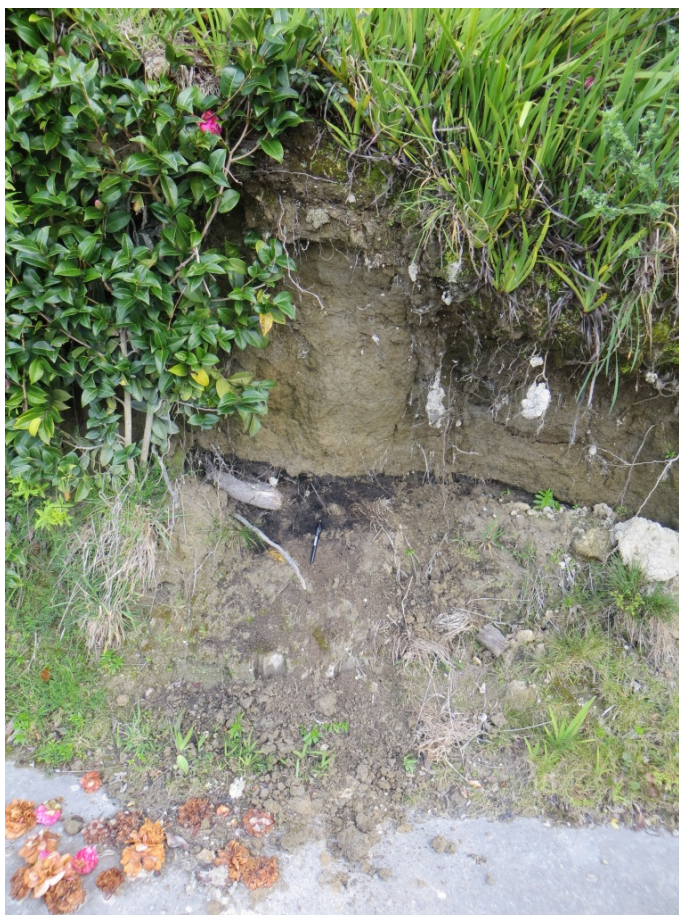
Where intersected, the Rotomahana Mud comprised a light brownish grey slightly clayey silt, and was overlain by a thin topsoil of 50-100mm. The unit varied in thickness from 400mm to 900mm and was often underlain by a paleosol or relic topsoil layer covered by the eruptive material. The paleosol was also observed in a road cutting on Spencer Road. See Figures 5 and 6.

Figure 6: Rotomahana mud and paleosol in Spencer Road

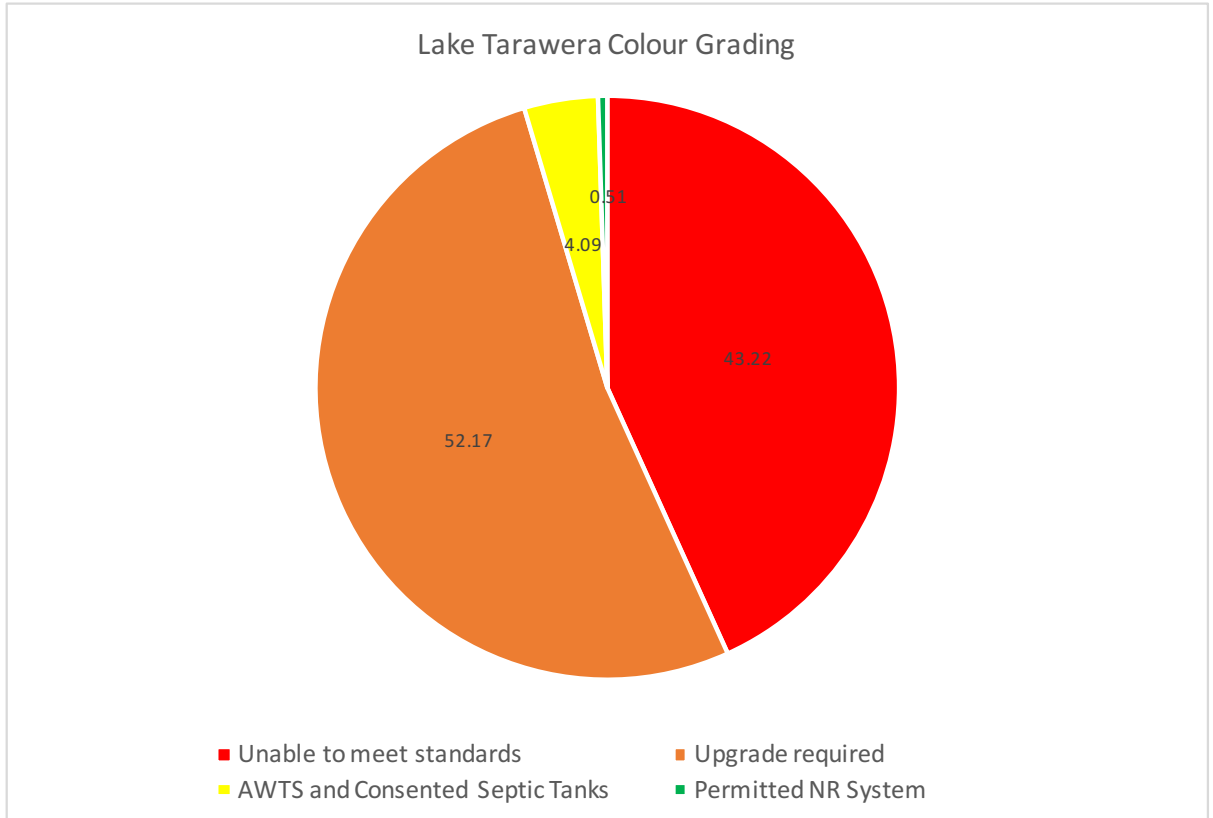
The pie chart below shows the total number of Lake Tarawera properties assigned to each colour category.

- 0.5 percent of sites are permitted (green);
- 4 percent of sites are currently authorised via resource consent or have a secondary treatment system in place, however both of these only provide short term solution and will require upgrades in the future (yellow);
- 52 percent of sites would require upgrades including new wastewater treatment systems to be authorised or permitted (orange);
- 43 percent of sites are likely to be unable to meet the required standards for on-site wastewater, due to the soil type and steep slopes limiting available disposal area (red).
