**CAPTION SHEET AND SUMMARY OF FACTS**

**CRI-2017-063-3196**

**Bay of Plenty  
Regional Council**

**Rotorua District Council  
1061 Haupapa Street  
Rotorua**

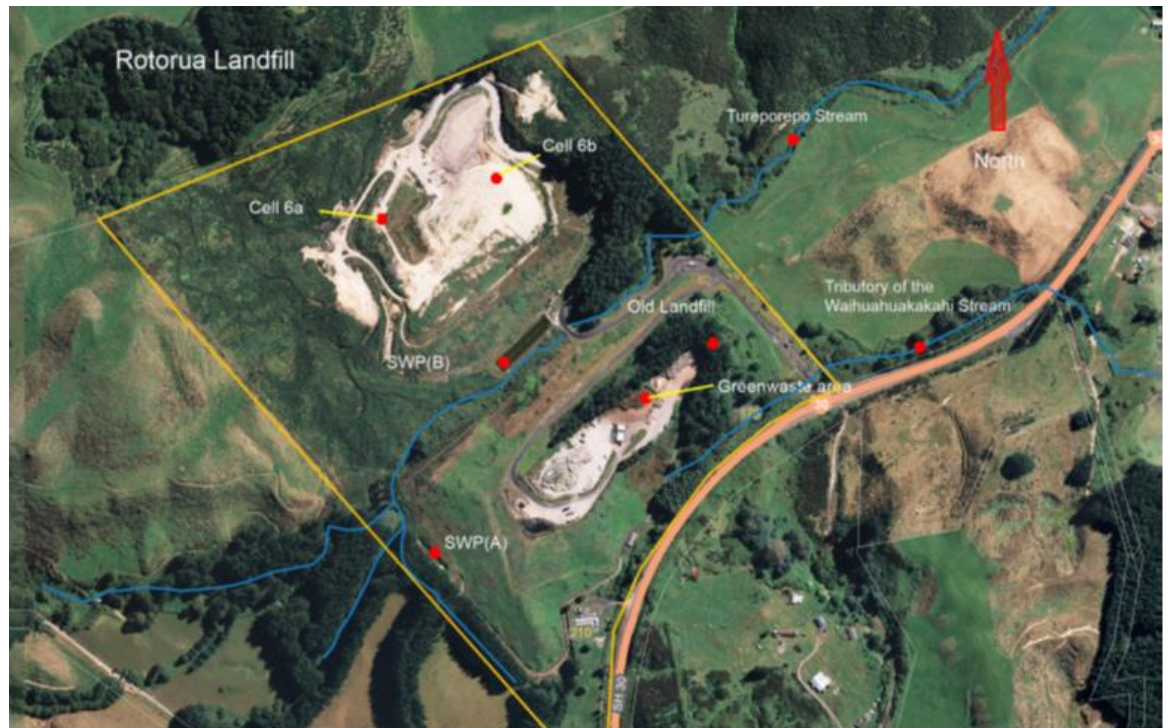
4. The landfill site is 45 hectares in size and is approximately 6 km south of Rotorua.<sup>1</sup> It has been used as a municipal and commercial landfill by RDC since 1970.
5. The landfill site has been developed in stages. Stage 1 was the original landfill but has subsequently been capped and converted into a greenwaste
