## **Te Whare Taonga o Te Arawa - Rotorua Museum Geothermal Investigation in the Building's South Wing**

### **1 Introduction and background**

### 3 CCTV inspection of the vent pipes

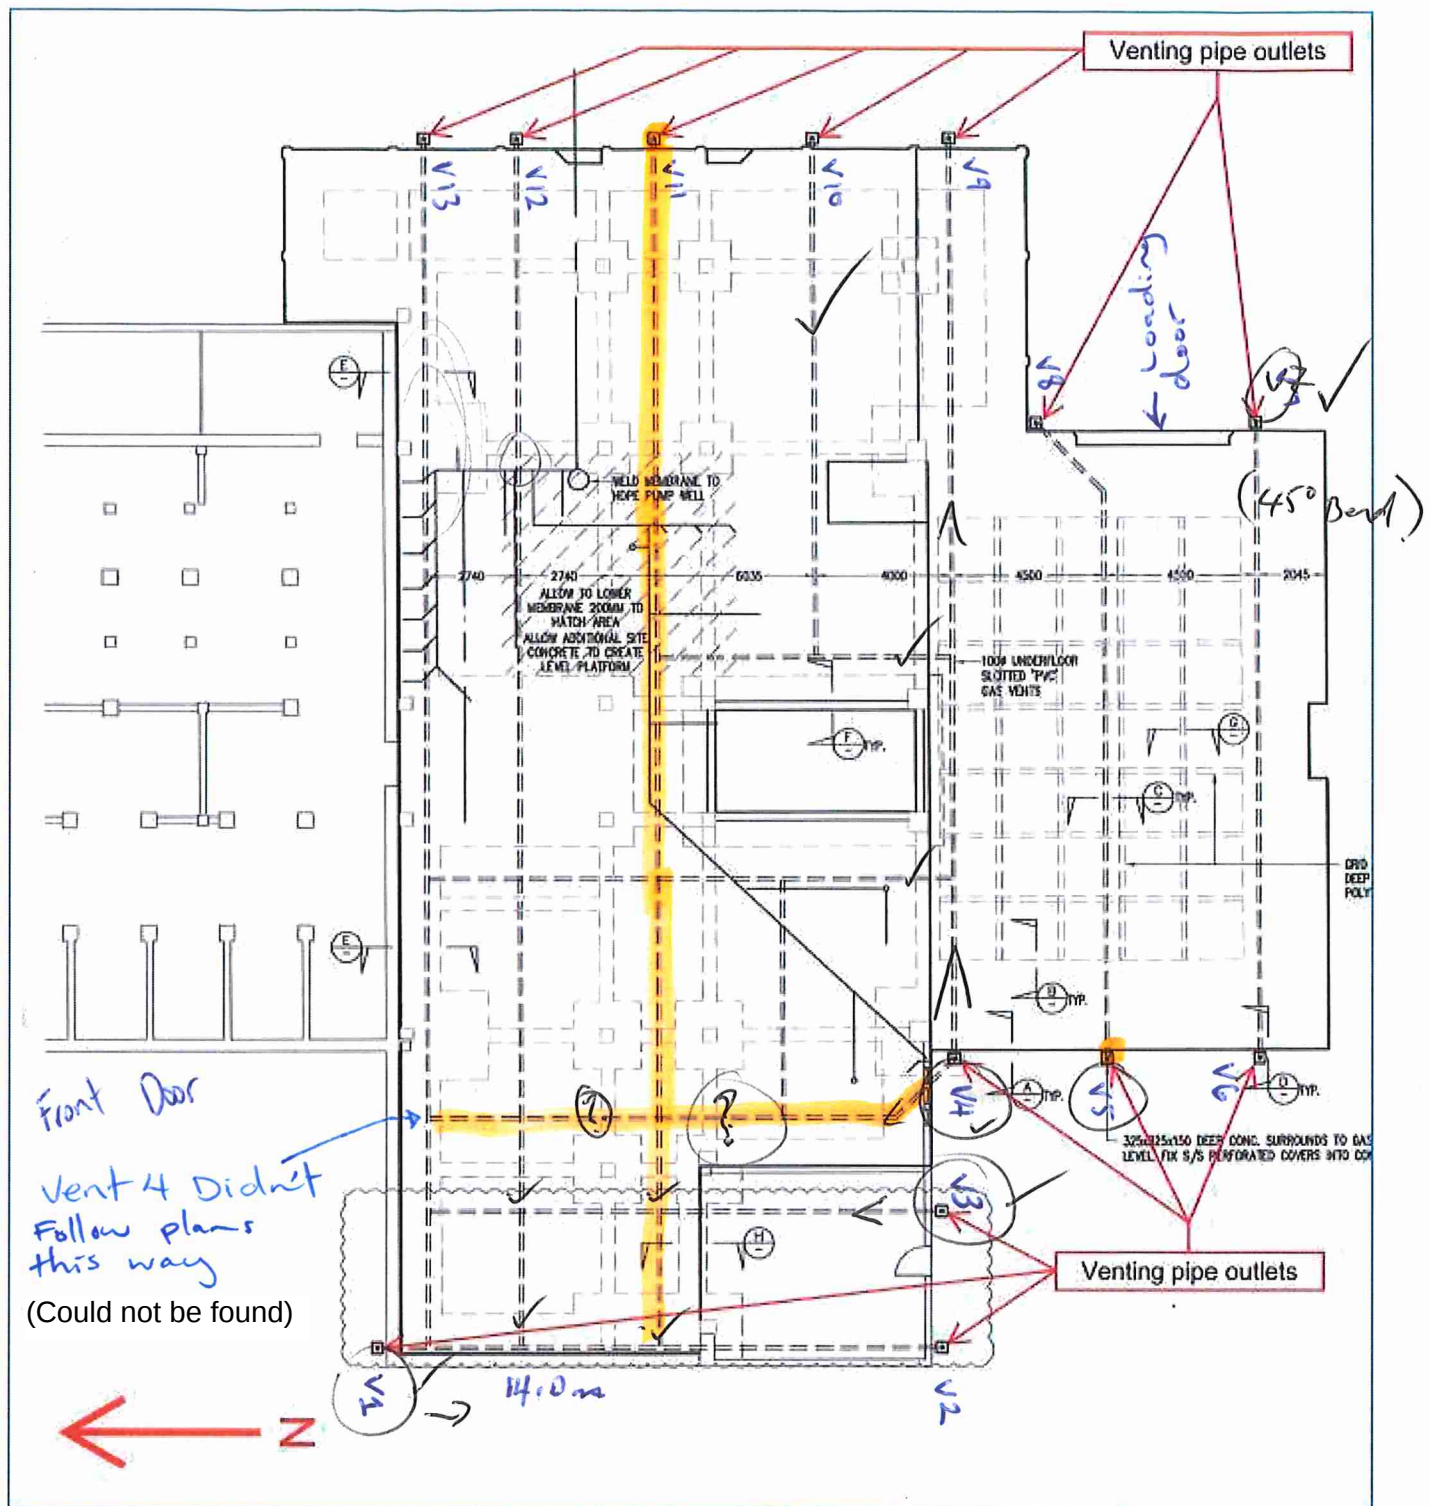
\* V1 to V2. ✓

\* V3 to End ✓

V4 North WA? (Could not be found)

V4 to V9 ✓

(V5 - unable to find. (under stairs)?)

V6 to V7 ? ✓ → V5-to-V8. ? ✓

V7 to 6V ✓

V8 to V5 ✓

V10 to End ✓

V11 - <sup>under</sup> Stairs ?

V12 to End (Disjoint 10.6m)

V13 to End.

Abandoned Due to Steam  
1.8m

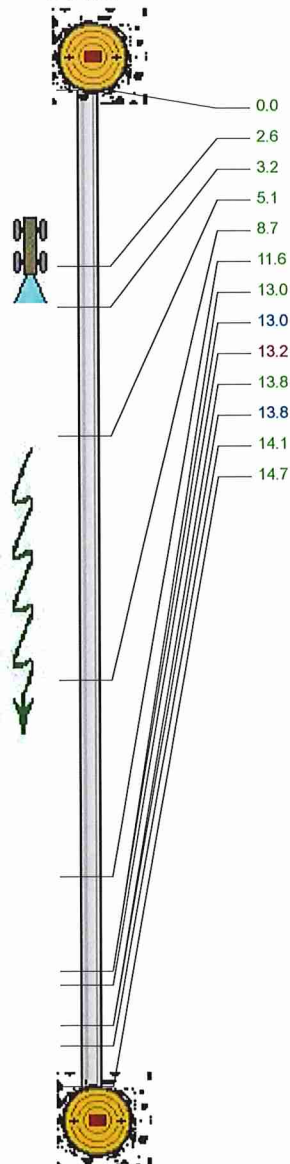
V1 to V2

| 13.0 | General Comment, (Geothermal build up at vent cuts) | 0 |
| 13.0 | Debris - Silty, Small, (Gravel and dirt) | 8 |
| 13.2 | Joint Faulty, Small, at 4 o'clock, (Joint faulty pipe split) | 1 |
| 13.8 | General Comment, (staining on pipe wall) | 0 |
| 13.8 | Debris - Silty, Small, (Dirt) | 8 |

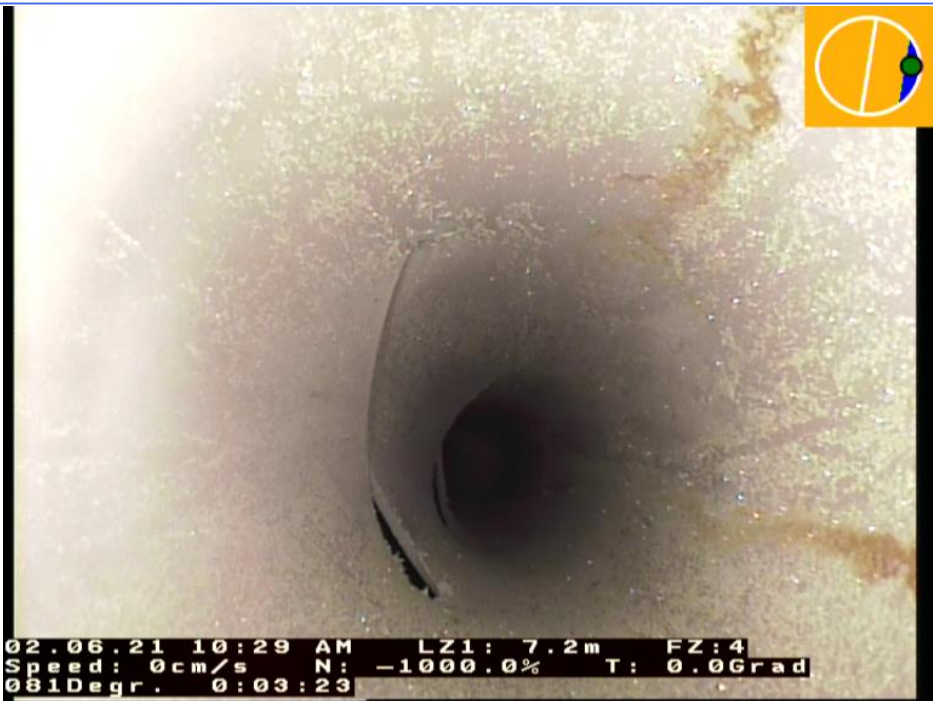
Picture 004

- Line V3 – pipe deviates down at approximately 6.8 m from the V3 vent outlet, indicating the pipes were potentially laid at different levels and connected via a vertical connecting pipe. The CCTV operator indicated that they could not continue further as it could cause the equipment to become stuck and non-retrievable.
- Line V12 – pipe is disjointed and out of alignment at approximately 10.6 m from the V12 vent outlet, preventing further access for the CCTV equipment.
- Line V13 – inspection had to be abandoned early due to poor visibility. Visibility was lost from 3.4 m onward, which appears to be caused by the presence of heavy steam/mist within the pipe.

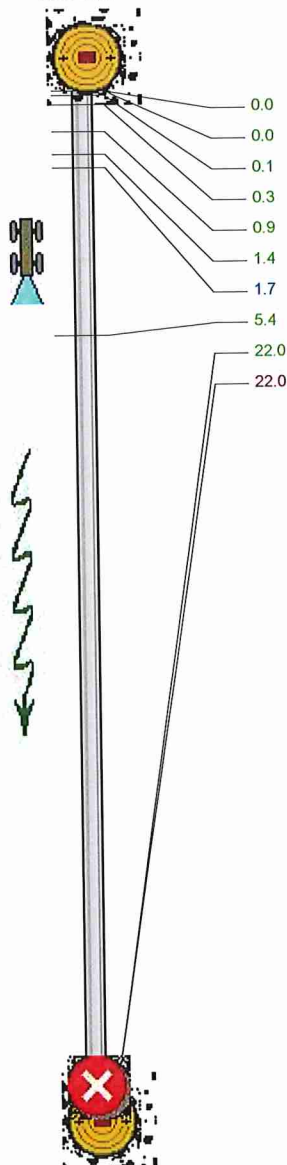
Line Deviates Right  
Inspection Starts, (V7)  
Line Deviates Down  
Line Deviates Right  
Line Deviates Down  
Line Deviates Right  
Obstruction Temporary, Small, at 6 o'clock, (Rocks in pipe)  
Line Deviates Left  
Inspection Abandoned, (couldnt continue)  
Obstruction Permanent, Small, at 6 o'clock, (Rocks in pipe)

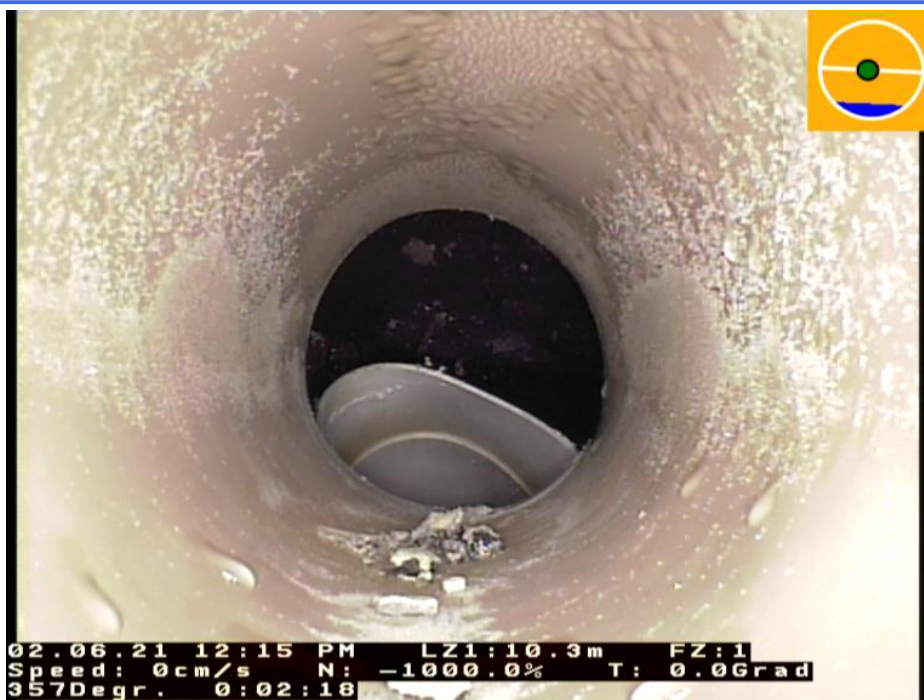
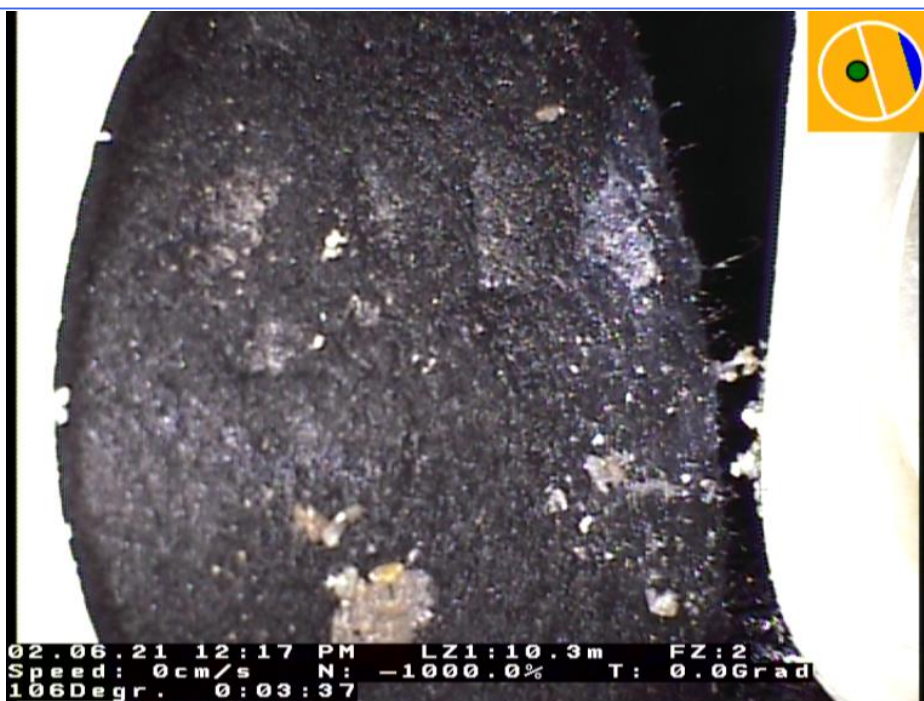
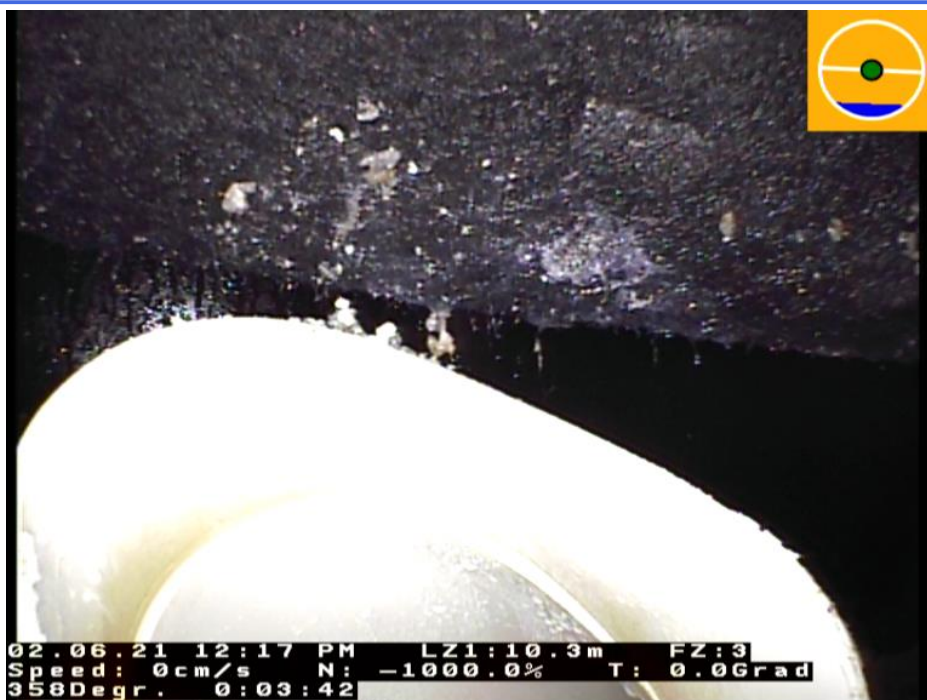
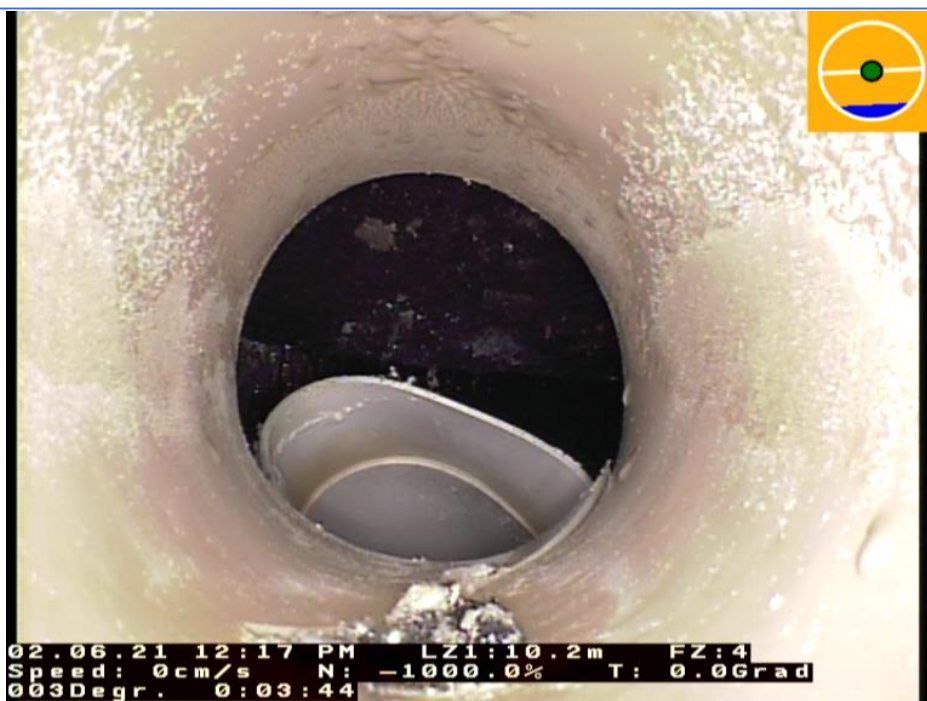
V12 to END

- 2 The location of the gap in Line V12 appears to coincide with the area where the elevated temperature is currently experienced in the building's south wing. However, with the information we have available to date, there is not enough evidence to suggest that the gap is the cause of the elevated temperature in the building. The gap may have caused a movement to the gas membrane somewhere, which potentially may lead to the slab being exposed to the ground and the heat. However, to investigate this, the gas membrane will need to be exposed so it can be inspected (i.e. requires removal of the concrete slab). This may not be practical and is likely to attract high cost.
