# Hemo Gorge Sculpture As Built Inner Tube Connection Test

GU7231-802 A

27<sup>th</sup> November 2020

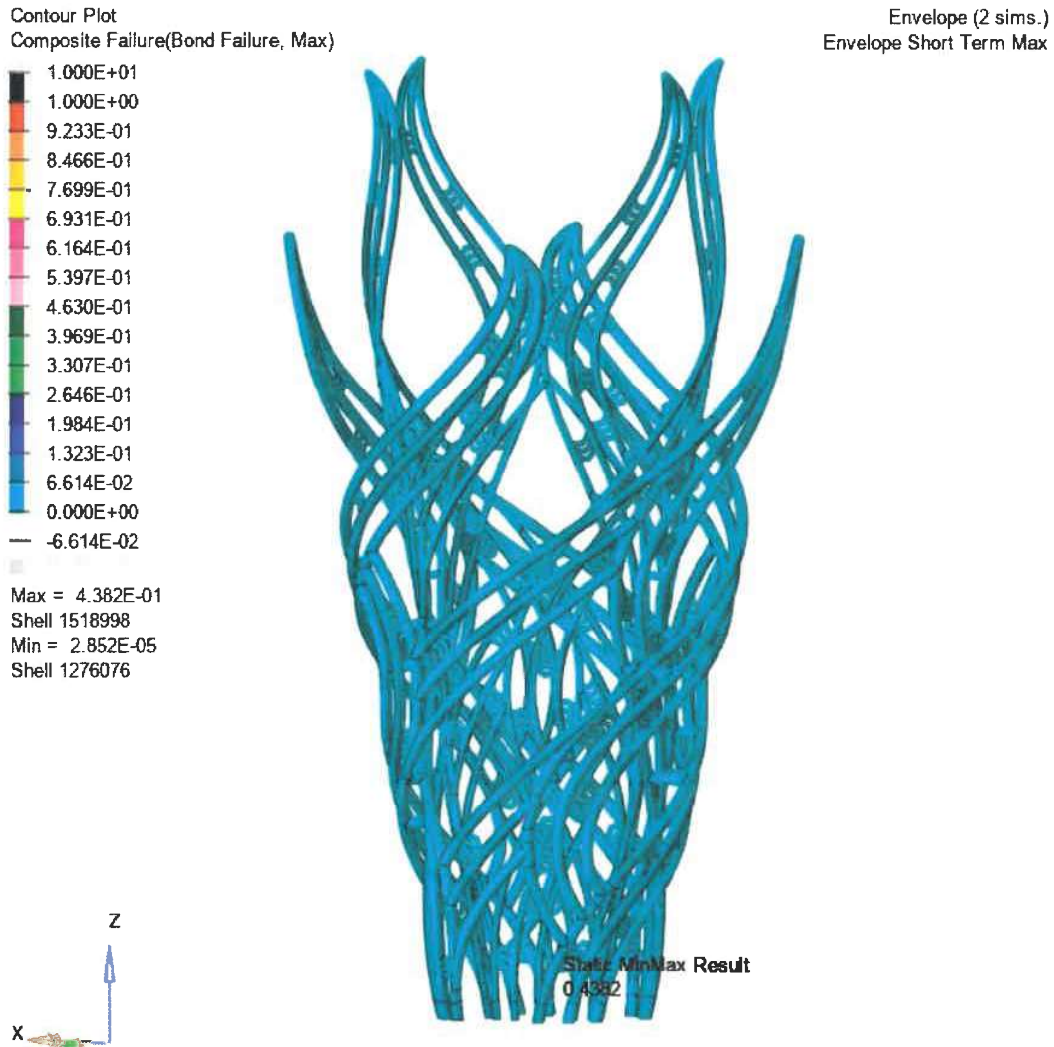
Figure 1. Bond failure index, as designed, prior to test result

The structural design phase showed that there was no issue with interlaminar shear with the analysis model showing all elements being below the target failure index of 0.4630. The highest element had a failure index of 0.4382, meaning there was a reserve factor of  $0.4630/0.4382 = 1.06$ . This is shown in Figure 1, below.

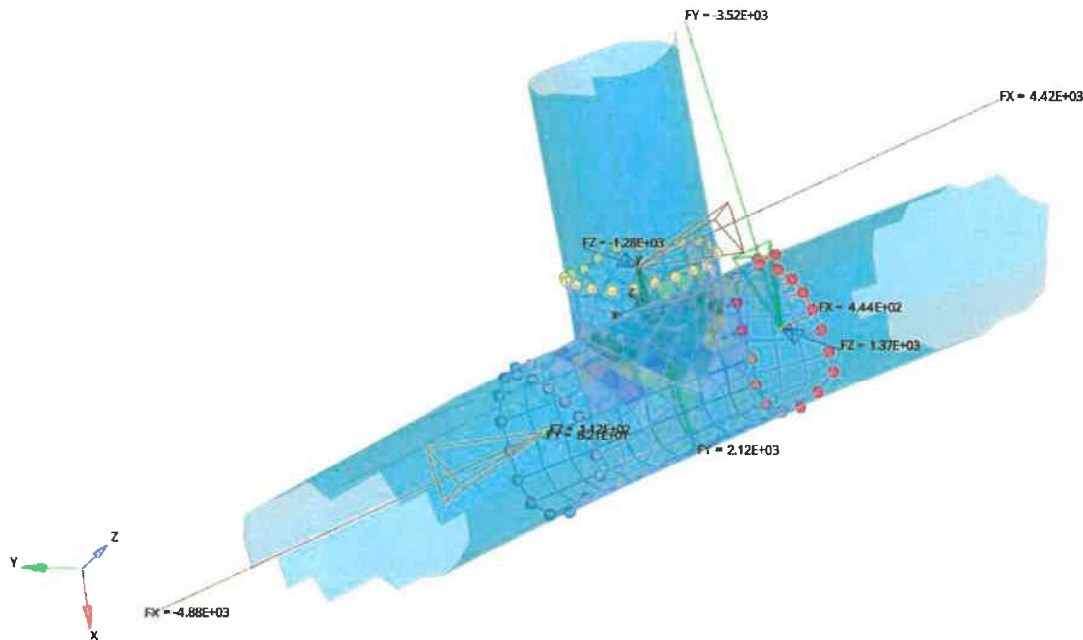
**Figure 4. Extraction of free body forces from model (moment vectors not shown for clarity)**

Using the free body tool available in the analysis software the forces and moments were extracted from about the inner tube connection identified above as having the highest ILSS.

The loads were extracted relative to a local co-ordinate system aligned with the axis of the joiner tube and the inner tube. Out of plane loads, relative to this co-ordinate system, were small and were not considered as part of the testing.

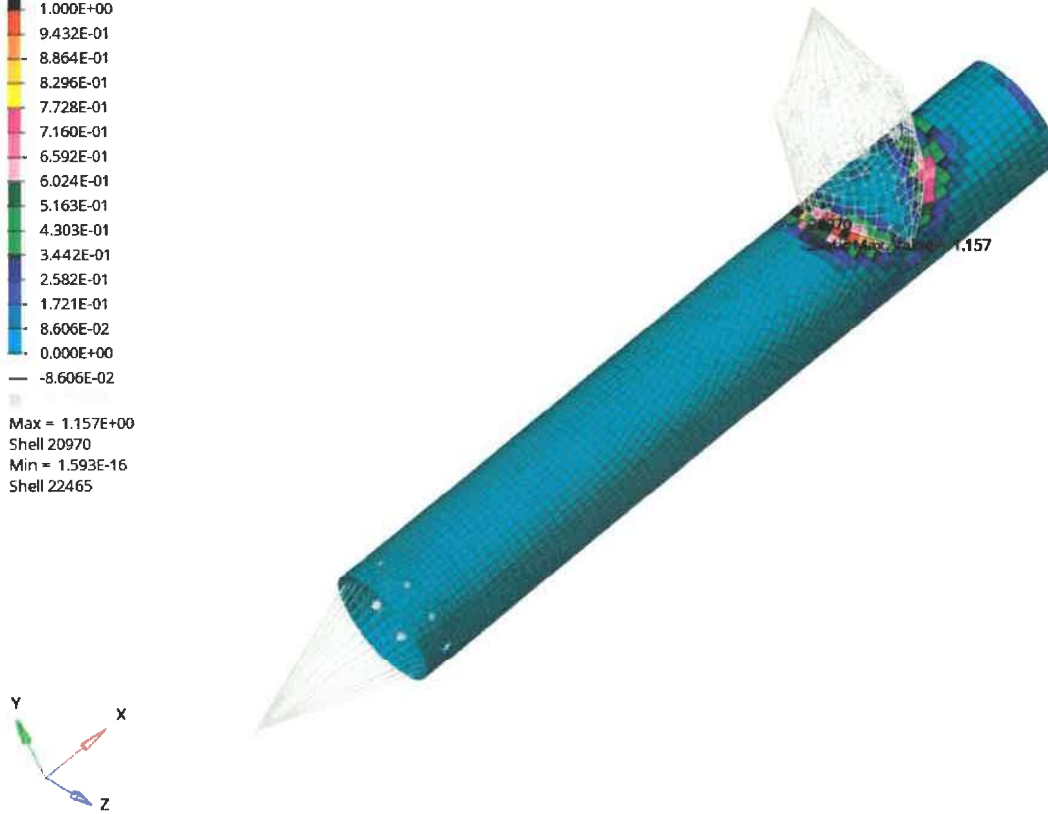
Figure 5. Test model bond failure index

By adjusting the geometry of the test model, a compressive force vector was found that produced the same level of interlaminar stress in the inner tube as the full model. See Figure 5 on the following page.

The applied load to generate this stress state was 11,606N, which represents an equivalent to the ULS stress state in the full model.

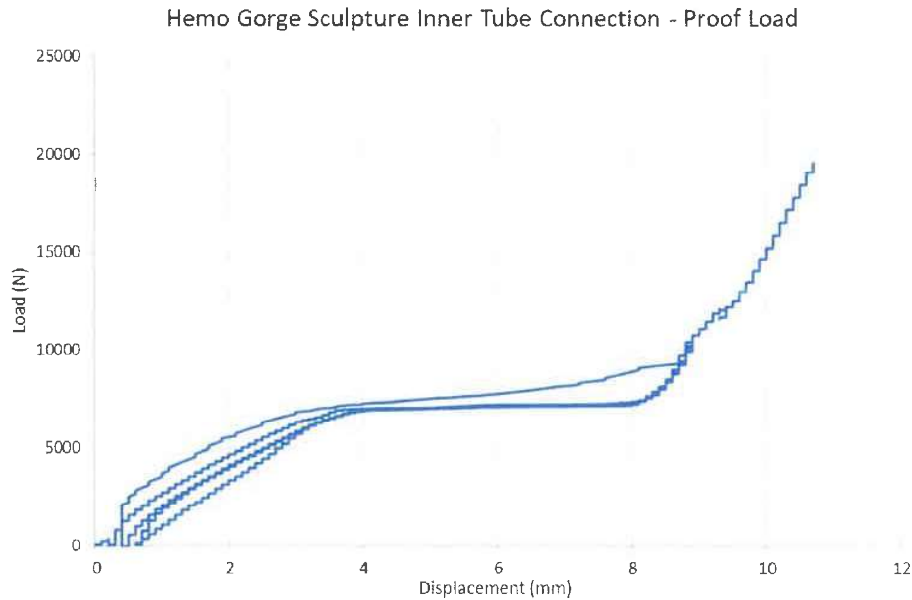
**Figure 7. Proof load test, load vs displacement**

The increase in displacement at approximately 7,500N was attributed to settling of the fixtures. This feature was observed each time the load passed through this range.

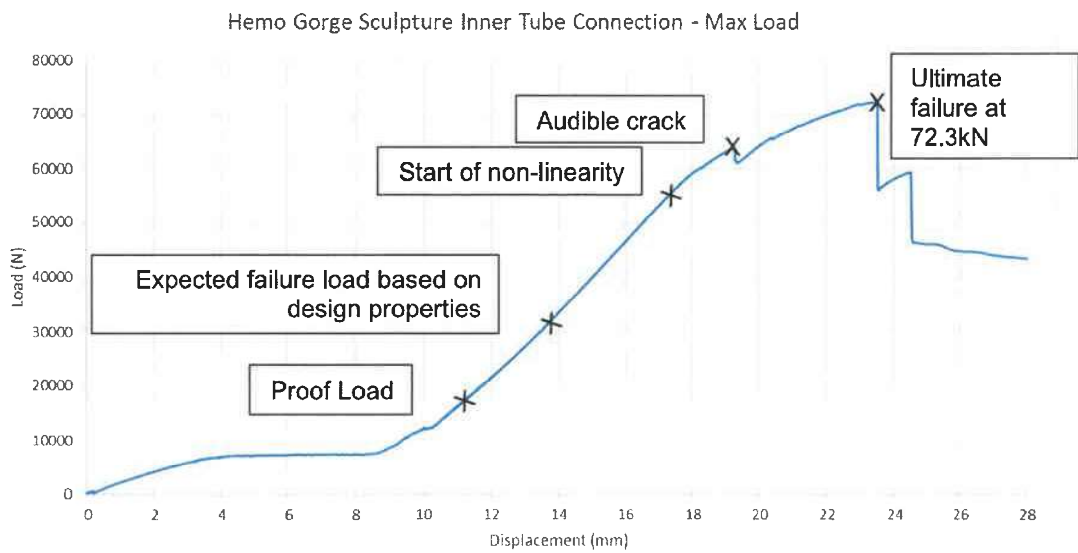
Figure 9. Max load test, load vs displacement

The max load graph shows a relatively linear increase in load to around 55,000N, after which it starts to taper off. There was an audible crack at 63,000N, which corresponded to the slight drop in load seen at this point on the graph. The connection continued to hold load up to a maximum of 72,357N at which point explosive cracking was heard and the main tube was visibly seen to have failed in compression just outside the extents of the joiner tube taping, as shown in Figure 10 on page 14.
