# Rotorua Museum Seismic Upgrade Stage 1A – Data Collection Geotechnical Desk Study

Dr Frantisek Havel  
13 January 2017

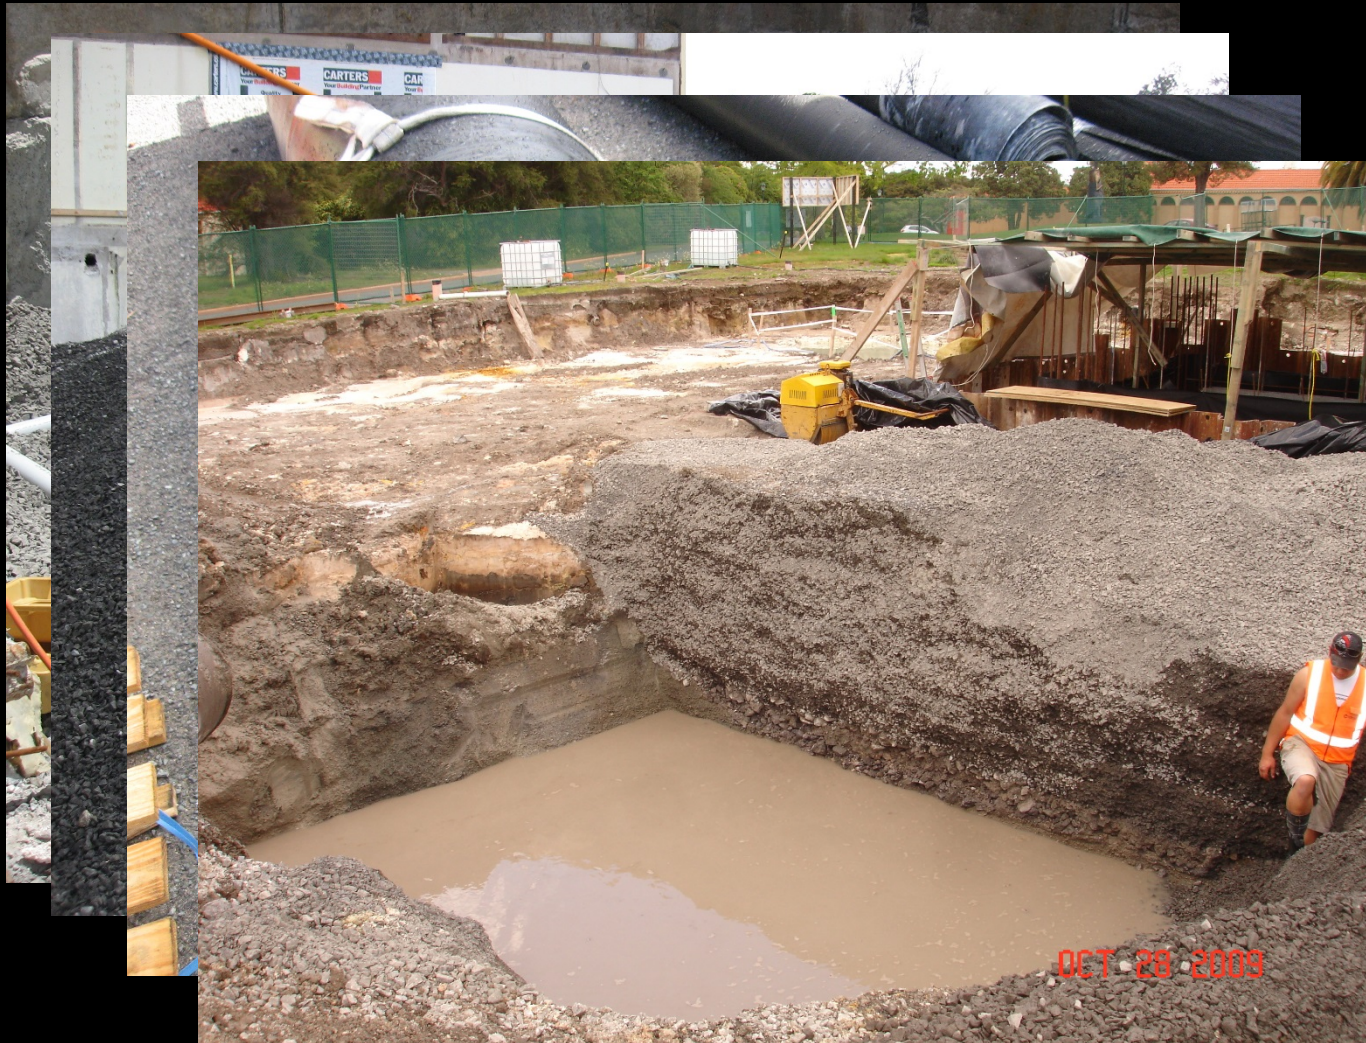
# South Wing Extension 2007-2011/12

## - detail design and construction

- Foundation on concrete slab with soil replacement up to 2.2m below concrete basement slab (1.9m hard fill + 0.3m crushed dust) and up to 0.8m below lift shafts (0.5m hard fill + 0.3m crushed dust) was proposed and (following limited information as photos and transmittal to Sigma from Terrane during construction) constructed
- A basement level is approximately 1.5m below existing ground level and a lift shaft is approximately 3.5m below existing ground level
- Sub-floor venting system and a membrane underneath the concrete slab was designed by Terrain and constructed
