# ROTORUA BATH HOUSE HERITAGE IMPACT ASSESSMENT

FOR REVIEW

October 2022

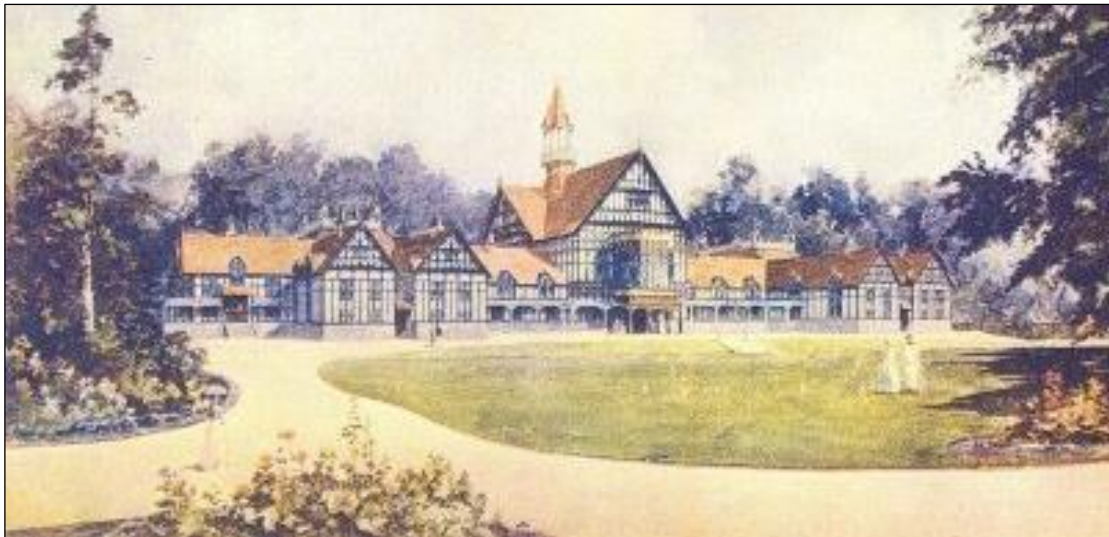
*Bath House original concept. A “homely timbered building.” Source: Rotorua Museum Te Whare Taonga o Te Arawa.*

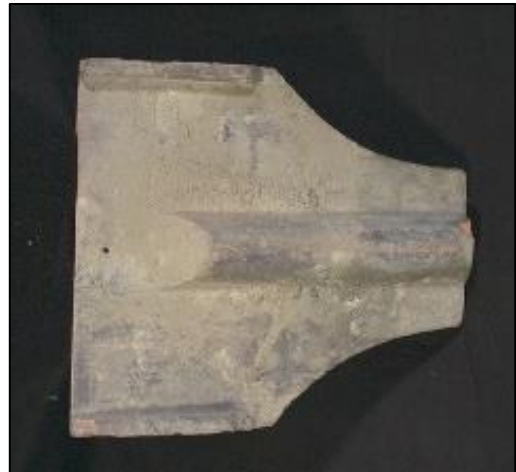
*An original 'well burnt' Bridgewater roof tile from the Bath House. Source: Rotorua Museum Te Whare Taonga o Te Arawa.*

According to the specification - and from original tiles found in the basement - the roof was originally clad with a more ornate and darker coloured no.4 Bridgewater 'well burnt' tile, sourced from Colthurst and Symons in England. These tiles can be seen in photographs of the building up until around 1950. Architect Corlett thought the Bridgewater tile preferable to the Marseille tile, believing it to be more harmonious with the style of the building and 'homemade' – 'home' being England. The present Marseille roof tiles on the central sections of the building date to c.1952.

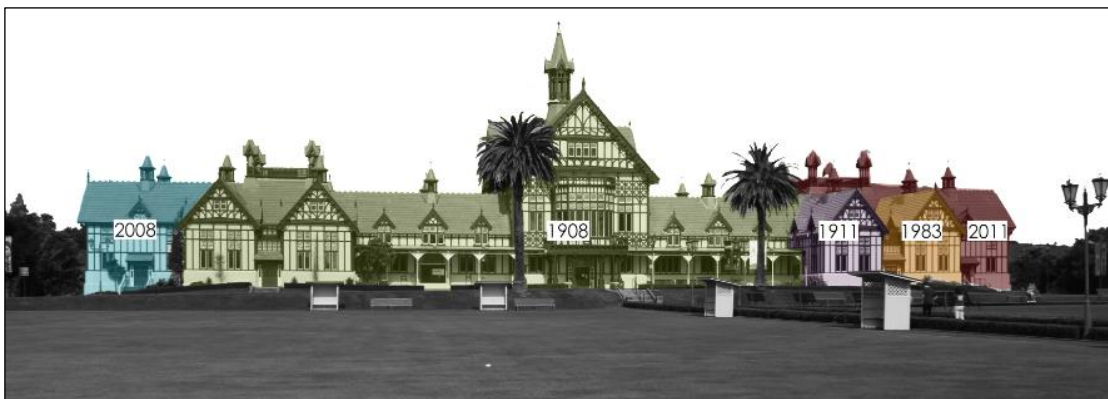
Diagram showing chronological realisation of the Bath House building. Source: DPA Architects.

Anticipating the building's centenary, it was proposed to fulfil the original design of the building as conceived by Wohlmann. During the original construction period, budget restrictions had led to the omission of the northern-most section of the north wing and most of the southern wing. One more gable was added to the south wing in 1911, and a second gable added alongside this in 1983. Extensions to the north wing were completed in 2008; those to the south wing were finished in 2011. These latest additions provided additional gallery space for the Rotorua Museum and completed the symmetry of the front elevation.

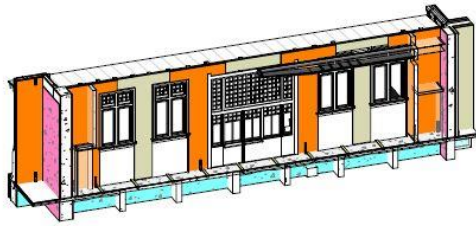
*CLT panels (shaded orange) in Zone 4.*

CLT panels will reinforce the original timber-framed walls at the east and west of zones 3 and 4. The panels provide a practical solution to reinforcing the gable end walls which contain large glazed areas.

The panels will be 90 mm thick and will likely be strapped and lined, adding additional depth. This will impact skirtings, dados, cornices and window openings. The panels will be detailed to allow a small space around the window openings, with chamfered reveals.

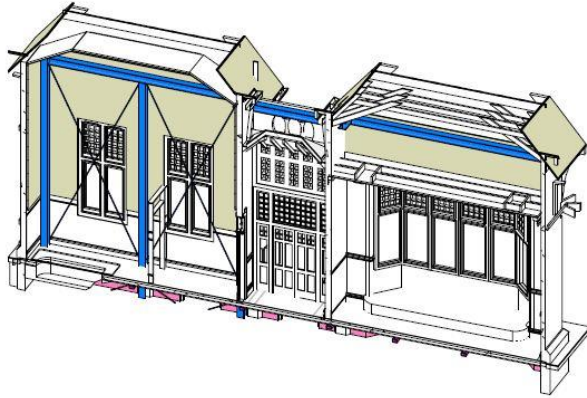
*Steel frame applied to eastern gable end wall of Zone 5.*

New steel framing will also be visible at the eastern gable end wall of Zone 5 along gridline AD. A specific steel structure has been designed for this wall, with three legs protruding from the basement in G 5H and G 5K to form a frame with a horizontal member at gutter-level extending above the corridor and into the ceiling of G 5A. The frame will be clearly visible in G 5H and G 5K but not in the corridor or G 5A. The horizontal steel member above the cooling room G 5A will be concealed in the ceiling.
