5 Geology

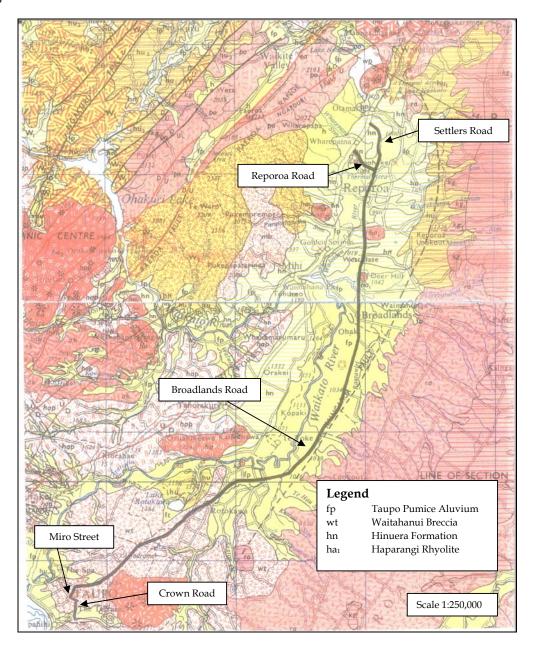
The geology of the area generally comprises volcanic rocks and sedimentary soils of the Pliestocene era (1.8 million years to recent). The distribution of these materials is shown in Figure 25 (taken from the DSIR Geological Map of New Zealand 1:250,000 series, Sheet 5 - Rotorua and Sheet 8 – Taupo (Healy et. al 1964)) and described below in order of increasing age.

Figure 25. Geology of the study route

The descriptions of the materials the route traverses (largely taken from the Geological Maps (Healy et. al 1964)) are as follows.

- (a) Taupo Pumice Alluvium: Pumice alluvium lahar and glowing avalanche deposits. Typically forming flat terrain, infilling the valleys (valley confined) in the Hinuera Formation at this locality
- (b) Waitahanui Breccia: Pumice breccia, lapilli tuff and glowing avalanche deposits. Low hummocky and gently sloping terrain
- (c) Hinuera Formation: Fluvatile pumice rhyolite and ignimbrite sands and gravels. Typically low rolling terrain with shallow slope angles
- (d) Haparangi Rhyolite: Lithoidal rhyolite, dissected domes and flow. Proximally bounded by younger Hinuera Formation deposits.
