DETAILED SEISMIC ASSESSMENT & CONCEPT RETROFIT REPORT

## ROTORUA MUSEUM

GOVERNMENT GARDENS ORUAWHATA DRIVE, ROTORUA

February 2022

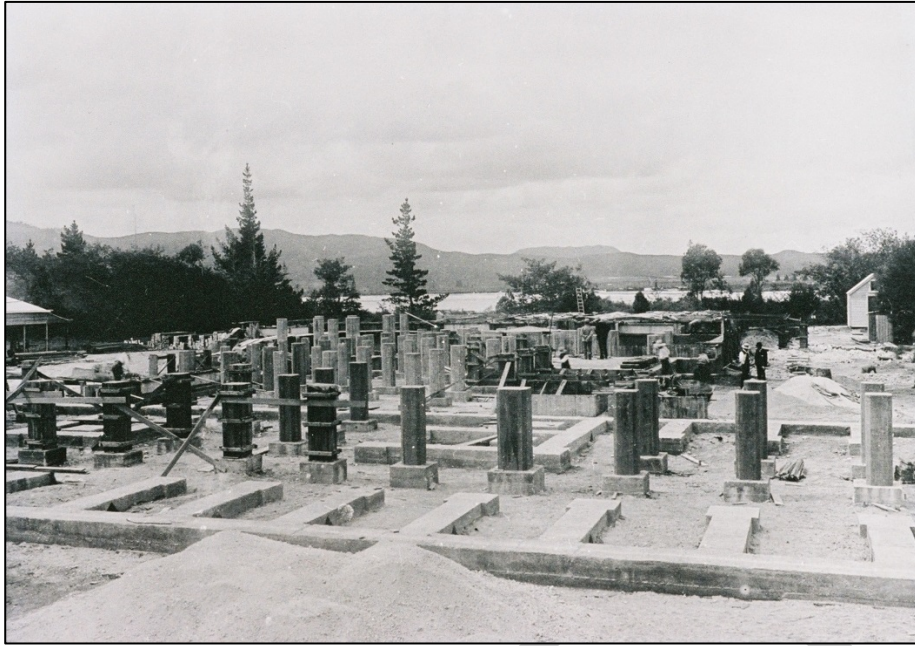
(c) Construction of bath house foundations showing wall strip footings, columns and column pad footings c. 1907 (photo provided by DPA Architects)

As can be seen in **Figure 3-1c**, it appears that the basement columns were constructed prior to the vaulted floor, which likely resulted in cold joints between the columns and the floor. Although the large, unreinforced concrete gable walls will have had some structural stability provided from the vaulted geometry of the floor structure, it is unlikely that they had any significant connections to the floor. Based on the assumption that the original foundations were constructed with a reasonable level of consistency in elevation, and by observing the consistency in displacements measured at the ground floor level and at the top of the footings, it is seen that the north and south concrete gable walls (A4 and A5 walls) of Zone 3 have experienced significant settlements relative to the foundation of the historic fountain, which appears minimal. Given that the only 'pathway' between these two points is the vaulted floor structure, it is hypothesised that the stress concentrations from the high level of movement between the two points have been released in the form of damage to the vaulted floor. In addition, the change in cross sectional area from the vaulted floor to the basement columns results in high stress concentrations at this interface, which when coupled with the presence of cold joints between the columns and the floor (due to possibly being constructed at different times), may explain the resulting cracks that are observed at the tops of the columns where they meet with the vaulted floor.

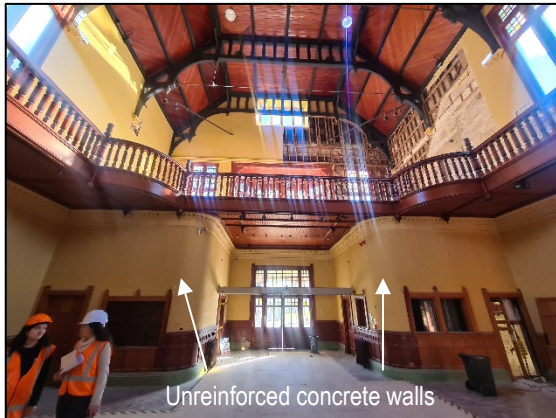
- Partition walls at the ground floor level are approx. 150mm thick unreinforced pumice concrete walls which extend to the soffit of the mezzanine floor. The walls comprising the rooms at the west side of the building and supporting the mezzanine floor were approx. 180mm thick, see [Figure 4-3a](#).

(a) General view of west (front) wall of Zone 3

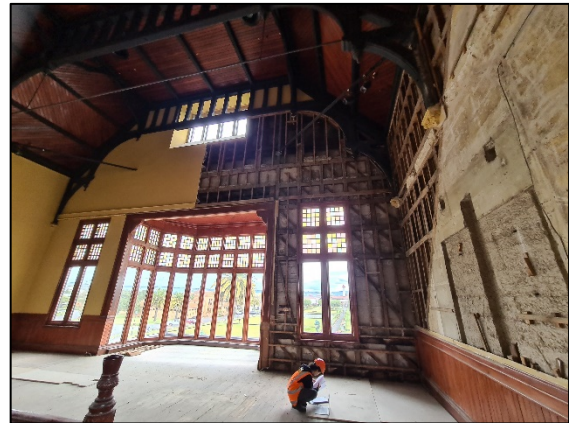
- The west wall (front wall) of the structure was observed to be a jetty structure, wherein the wall juts out above the main bay window, see [Figure 4-3f-h](#). Note that the jettying structure is local only to the west wall of Zone 3. Based on visual observations and existing documentation, this wall has leaned inwards at the top, resulting in the placement of diagonal steel sections just above the top of the bay window (undertaken c. 1996) and anchored from the west wall back to the north and south walls to brace the wall against further inward movement, see [Figure 4-3b, c](#).

(b) View of west (front) wall at mezzanine level showing wall framing

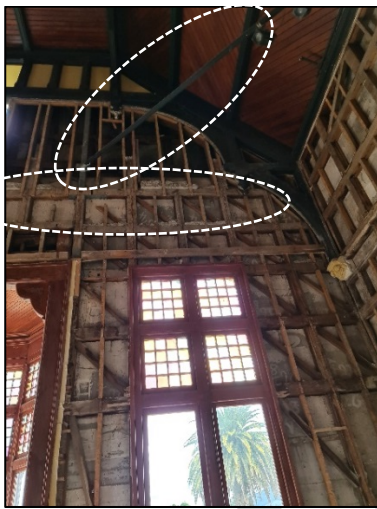
(c) Diagonal steel elements bracing west wall + curved panels indicating jetty wall structure – see also (e) and (f)

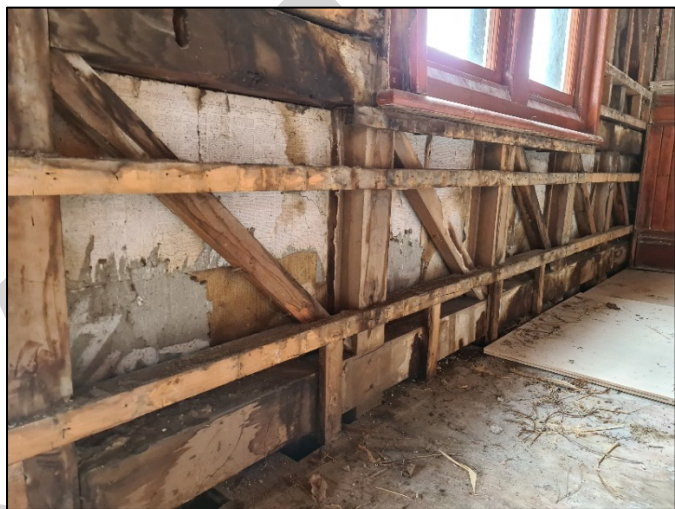
(d) Diagonal bracing elements (nailed connections only) along west wall, see also (c)

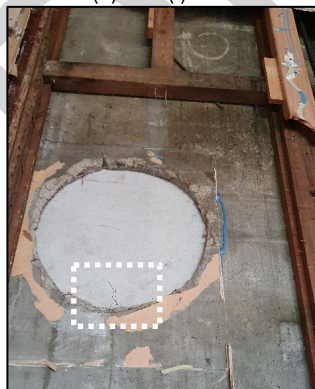
- The infill panels contain a layer of 'chicken wire' reinforcing (see [Figure 4-3e](#)), which has appeared to largely hold the infill panels together despite cracking/localised deterioration of the panels. The panels are secured within the framing via rebates in the horizontal and vertical timber members, and timber beading around the perimeter of each panel (see [Figure 4-3n, o](#)).

(e) 'Chicken' wire reinforcing within infill panels (note photo taken in Zone 4)

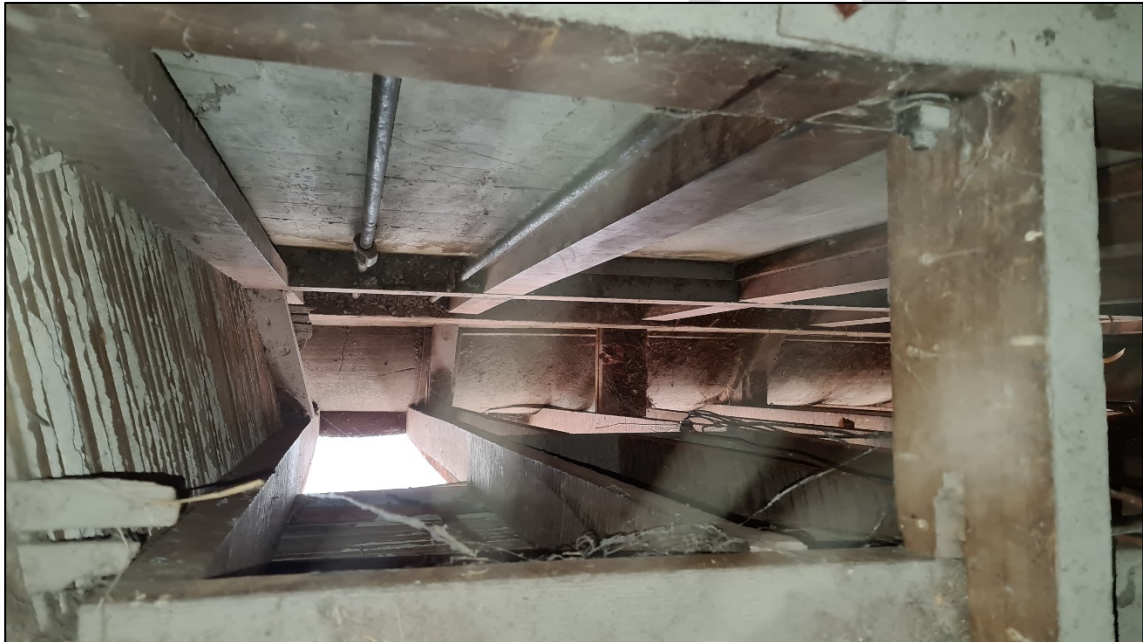
(h) View from within roof space looking down west wall showing curved panels. Approx 24mm diameter metal rods with turnbuckles supporting abutting wall

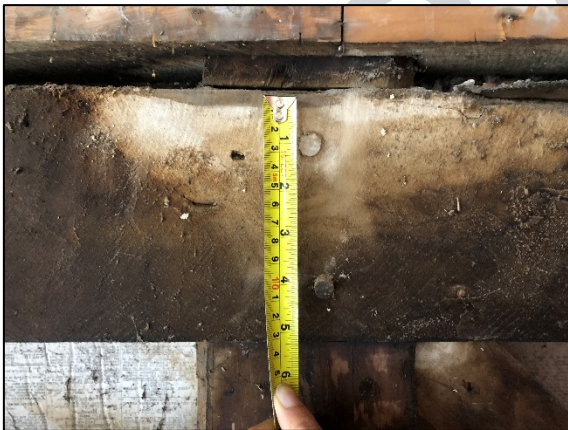
- The timber framing is constructed such that the horizontal members are continuous, and the vertical members are interrupted (see [Figure 4-3m](#)). Horizontal and vertical primary members are connected via mortise-tenon joints and wooden pegs, see [Figure 4-3j, k](#). Secondary vertical and horizontal members are connected to the primary members via simple nailed connections. For Zone 3 only, the east and west walls contained diagonal members which were connected to the primary members via simple nailed (i.e., compression only) connections, see [Figure 4-3c, d, q](#). See [Figure 4-3i, n, r](#) for typical measurements and details of the timber framing members.

(j) Closeup of mortise-tenon joint connecting primary horizontal and vertical members. Two wooden pegs also used to connect members

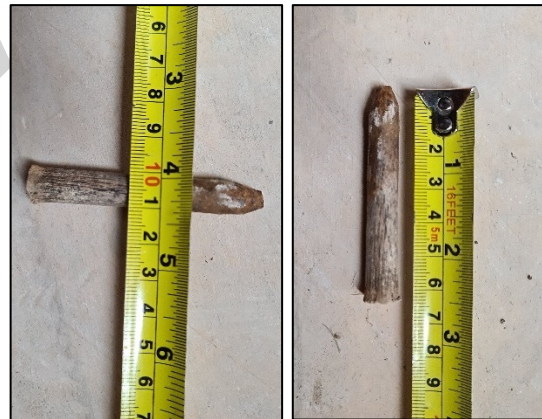
(k) Dimensions of wooden peg in mortise-tenon joint – approx. 9mm diameter, 65mm length

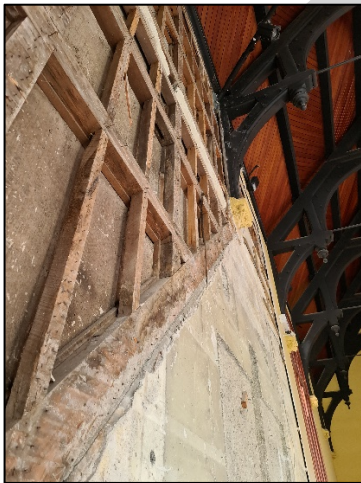
- No significant mechanical connection was observed between the tops of the concrete gable walls and the timber framed walls atop them, see [Figure 4-3u](#).

(u) No visible mechanical connection between diagonal timber baseplate of timber framed wall and the concrete gable wall

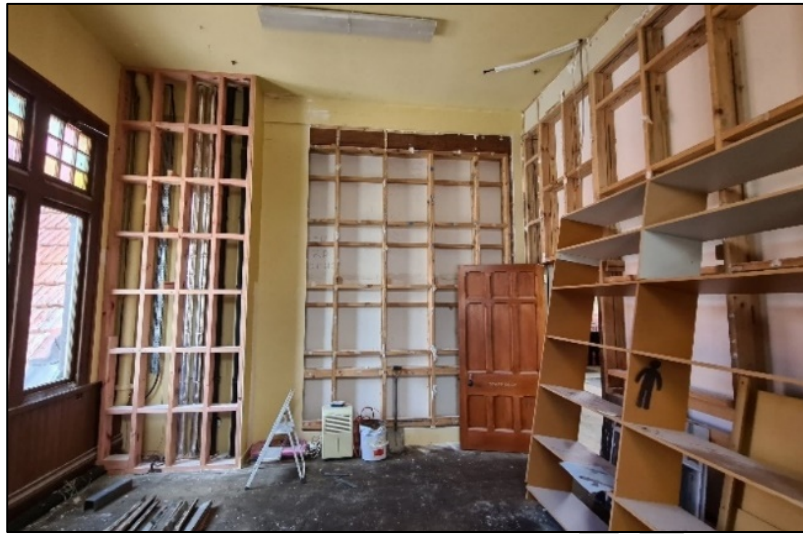
- Partition walls at the rear of Zone 3 at mezzanine level were found to be newer, timber framed walls, see [Figure 4-3w](#).
- At the northeast corner at ground floor (room G3N), a steel beam was found to be supporting a portion of concrete wall above, which had otherwise been removed.

(w) Newer timber framed partition walls at rear rooms (east perimeter wall is to the left of image)

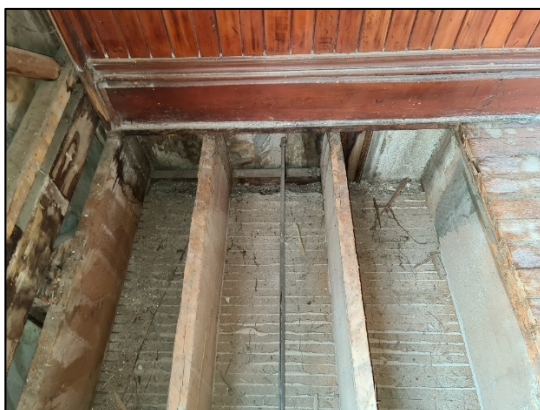
(g) Northwest corner of mezzanine floor showing joists pocketed into concrete gable wall – no plates identified

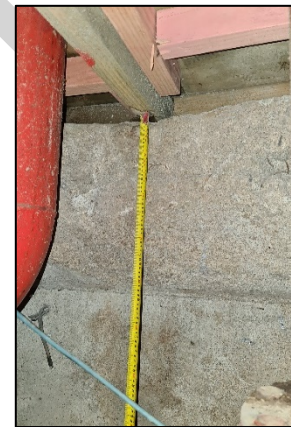
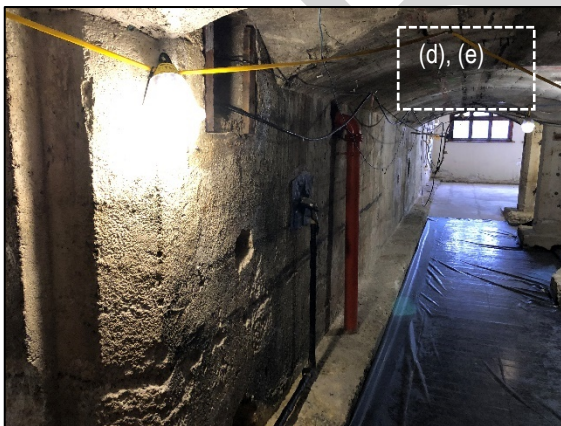
- A detailed investigation was made regarding the extensive level of cracking (see for example [Figure 4-5d-g](#)) of the vaulted floor slab in Zone 3 and other original zones (Zones 2, 4 and 5). For a detailed analysis of the slab cracking and associated deformations, please refer to [§5](#).

(d) Walkway along north wall, close up of slab soffit in (d) and (e)

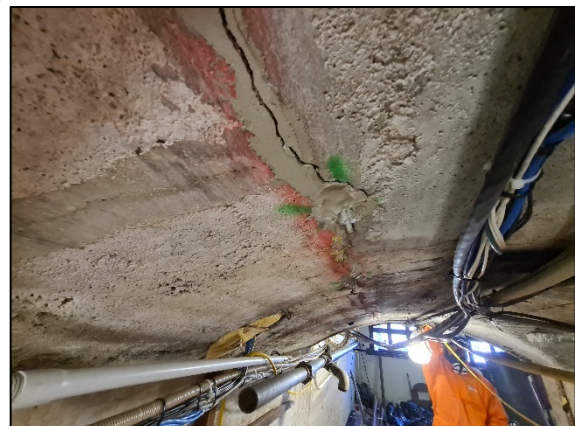
- At the underside of the vaulted floor slab in Zone 3, localised areas were identified where previous attempts were undertaken to remediate the slab cracking via injection of a resin material to try and seal the cracks. This has not appeared to have been successful due to the cracks having opened further, see [Figure 4-5d-f](#).

(e) Closeup of slab soffit showing cracking along apex of arch

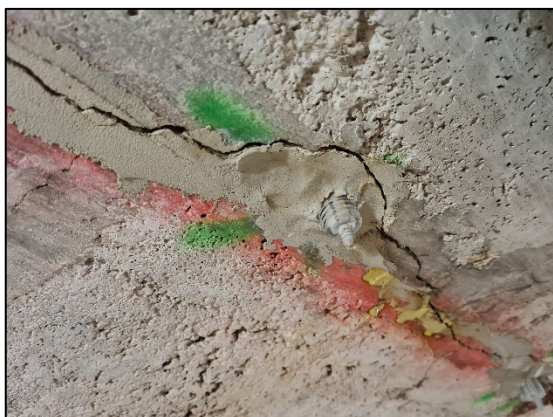
(f) Evidence of past attempts to repair cracks via resin material injections

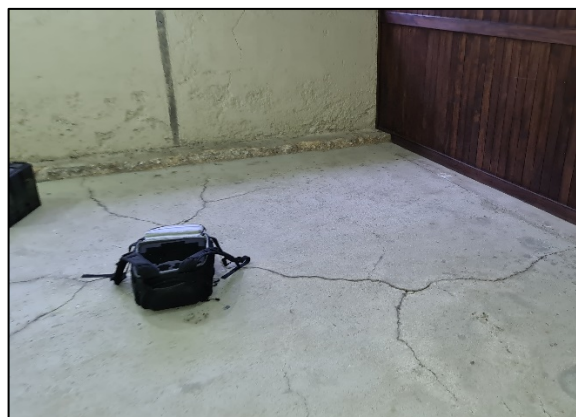
(g) Cracking of concrete at east end of basement – upward movement of ground

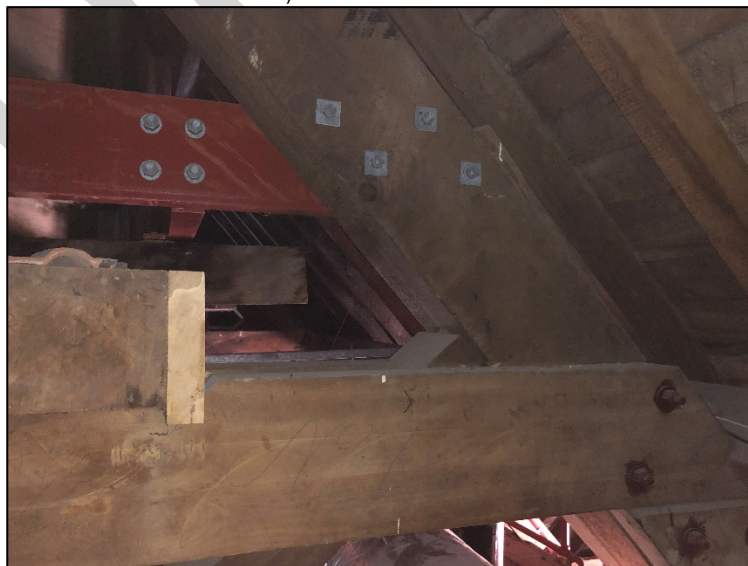
- The sarking is connected to the trusses via nailed connections. The timber trusses have pinned bolt and plate connections at the member joints, see **Figure 4-6c-e**. At some point over the life of the structure, some of the trusses appear to have been strengthened with the addition of steel members, see **Figure 4-6f**.

(f) Addition of steel member to strengthen truss

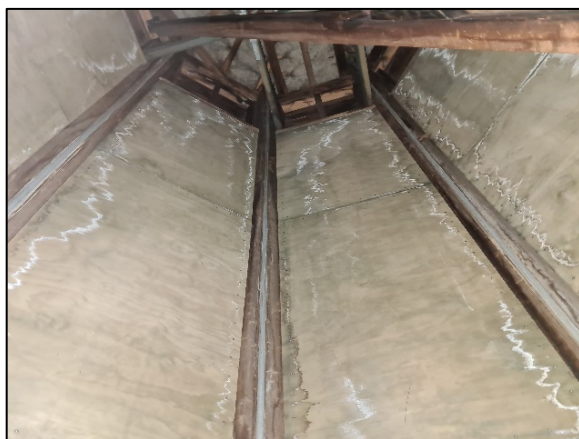
- A large turret is located at the approximate centre of the roof structure. The turret has been strengthened via the use of eight steel rods which have been tensioned at each end and fixed down into the beams which support the turret, see **Figure 4-6g, h**.

(g) View inside main turret showing steel tensioned rods

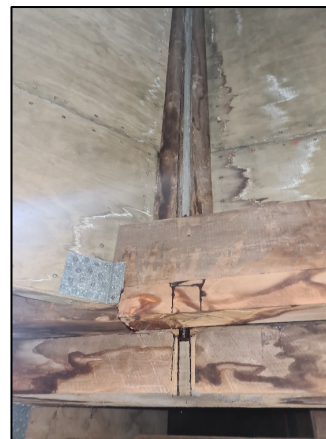
(h) Rods bolted into beams at base of turret structure

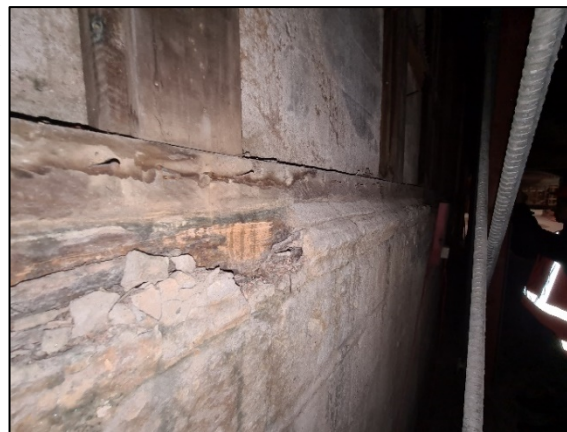
- The bottom plate of the timber framed wall is bolted to the concrete nib wall using approx. 12mm bolts and 30mm washers at approx. 1800mm centres. Localised deterioration of this baseplate was observed in some locations, see [Figure 4-7d](#).

(d) Localised deterioration of timber baseplate of historic timber framed wall

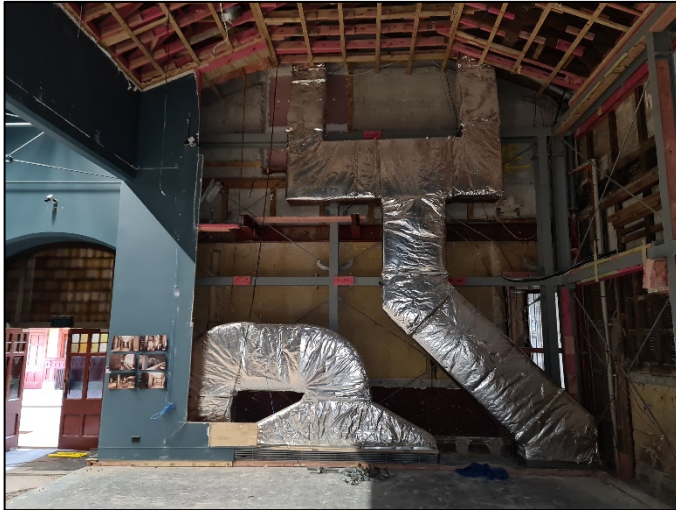
- The north wall of Zone 2 is shared with Zone 3 and is an approx. 500mm thick (at GF level) unreinforced pumice concrete gable wall extending to a height of approx. 10m and topped by a timber framed wall with infill panels, see [Figure 4-7e](#).

(e) East side of north wall of Zone 2 (shared with Zone 3)

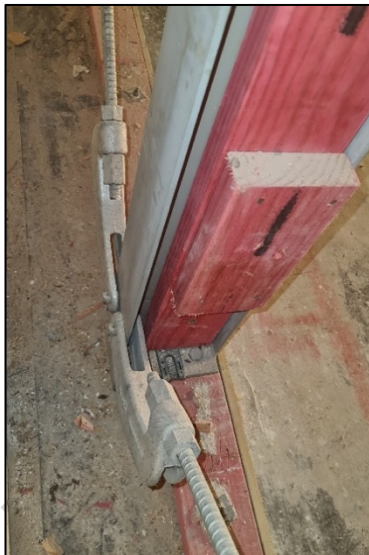
- The end connections are typically connected to the flanges of the columns, resulting in an eccentric connection, see [Figure 4-7g](#). In some locations, it was observed that the brace on one side of the column was connected to the outer flange, whereas the brace on the other side of the column was connected to the inner flange, resulting in a torsional action on the column should both braces be stressed, see [Figure 4-7i](#).

(g) Reidbrace end connections eccentrically connected to I-section column flanges

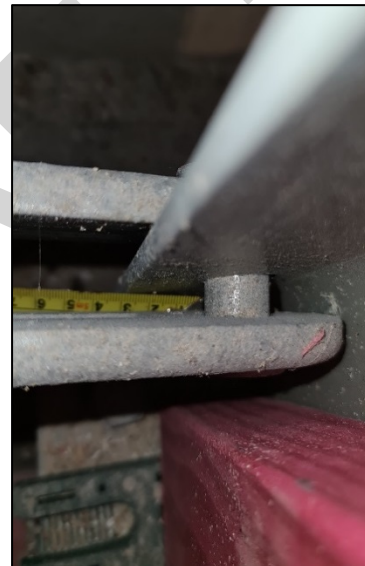
- The Reidbrace end connections were observed to be poorly installed, with significant gaps between the plates of the end connection and the column flange, see [Figure 4-7h](#). The gaps were deemed large enough to cause the connecting pin to undergo partial bending under seismic action, instead of solely shear.

- The end connections were considered to have insufficient edge distance from the pin to the end of the column flange in multiple locations, see [Figure 4-7h, j](#).

(h) Gap between flange and end connection causing pin to bend under load. Approx. 20mm edge distance of connection

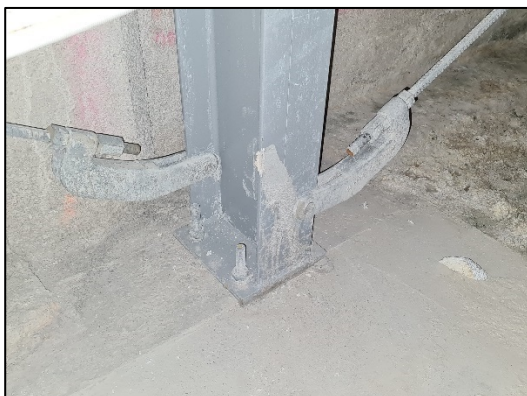
(i) Reidbrace end connections on opposite flanges, creating effect of torsion of column under load

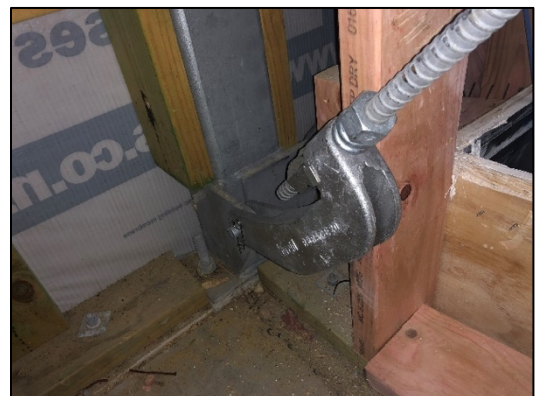
(j) Reidbrace end connection to corner column

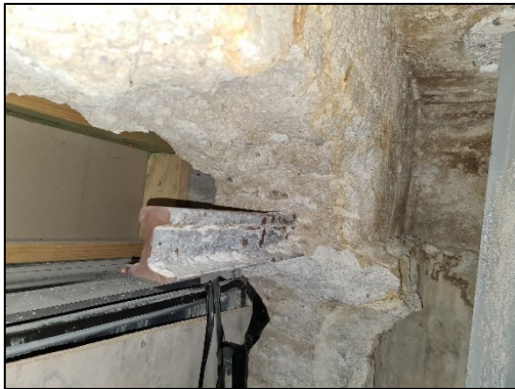
(k) Exposed railway line at south basement wall of Zone 2. Also identified via SPR in north and south basement walls of Zone 3

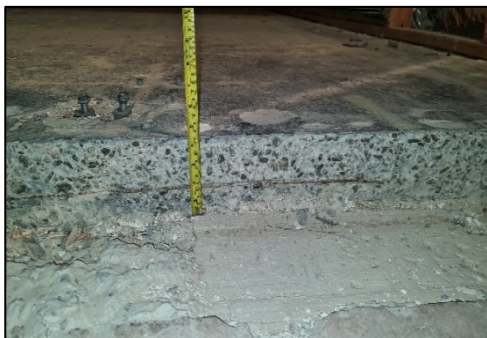
(b) View of Zone 2 basement adjacent to north wall with steel frame columns with newer footings in front of historic foundation wall

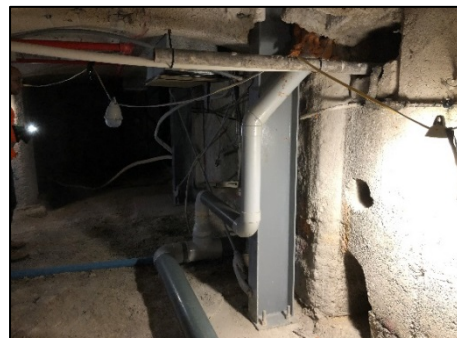
(c) Typical historic column and footing with evidence of slab cracking just above

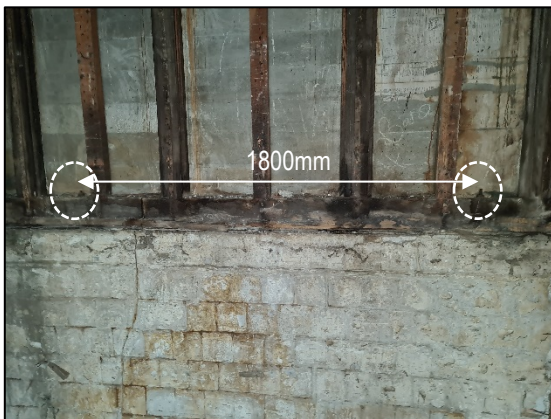
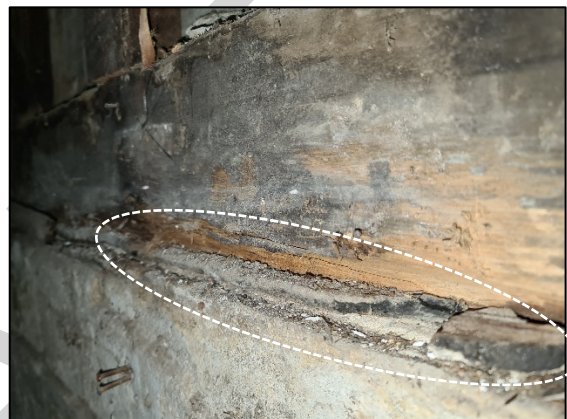
- Due to the linings largely being removed in this zone, a black layer of material was identified between the top of the concrete nib and the bottom plate of the timber framed wall, likely an effort to create a damp proof course between the concrete (which would have been more regularly exposed to moisture as a result of the building's original use), and the timber framing, see [Figure 4-10d](#).

(c) Bolts connecting baseplate to concrete nib spaced at approx. 1800mm centres

(d) Evidence of black layer between baseplate and concrete nib as a possible waterproofing layer

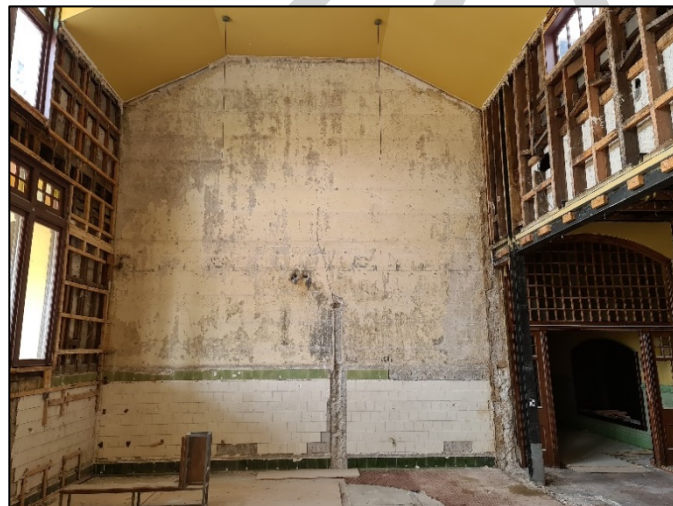
- The north wall of Zone 4 is shared with Zone 5 and is an approx. 300mm thick (at GF level) unreinforced pumice concrete gable wall extending to a height of approx. 10m, see [Figure 4-10e](#). There is no timber framed section of wall atop this wall.

(e) View of north (A6) wall (west side of Zone 4) – shared with Zone 5. Wall is approx. 300mm thick at GF

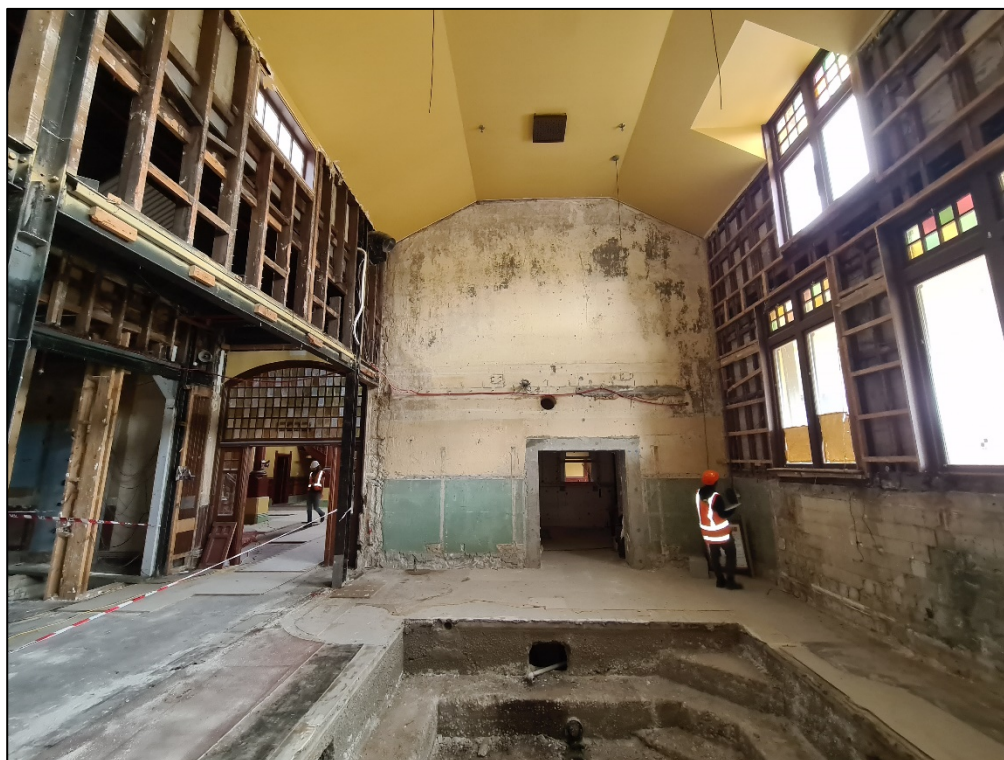
- The south wall of Zone 4 is shared with Zone 3 and is the approx. 500mm thick (at GF level) unreinforced pumice concrete gable wall that extends to a height of approx. 10m and topped by a timber framed wall with infill panels, see [Figure 4-10g](#).

(g) South wall of Zone 4 (A5 wall) – shared with Zone 3

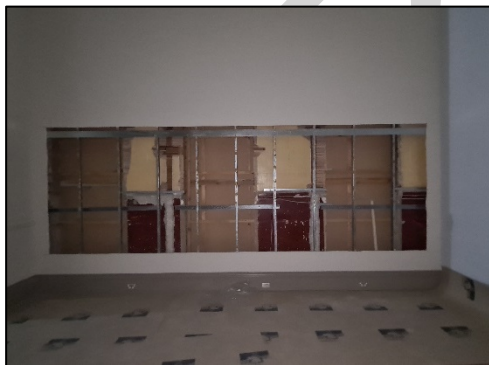
(c) West wall of main corridor running N-S (photo taken on west side), showing 3 door openings filled with timber framing

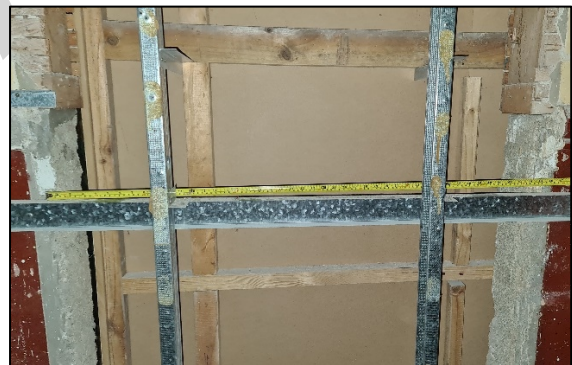
(d) Door openings approx. 1200mm wide

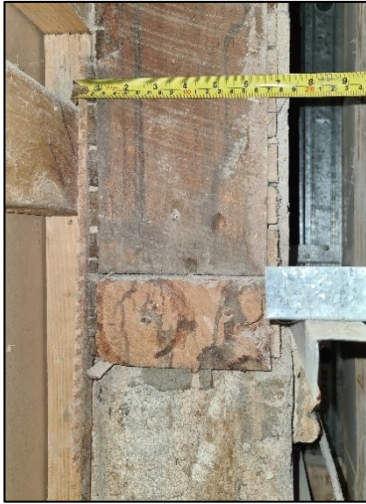
(e) Approx. 150mm thick timber wall studs, approx. 18-20mm thick lath and plaster linings. Baseplate approx. 80mm thick

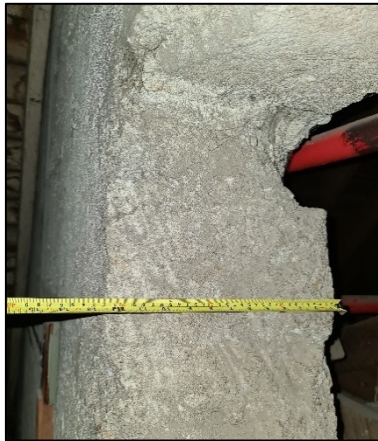
zones. Both walls are thinner than the A4 and A5 walls (north and south walls of Zone 3), measuring approx. 350mm at ground floor (see [Figure 4-13g](#)).

(g) South wall of Zone 5 measured approx. 320-330mm thick (from roof space)

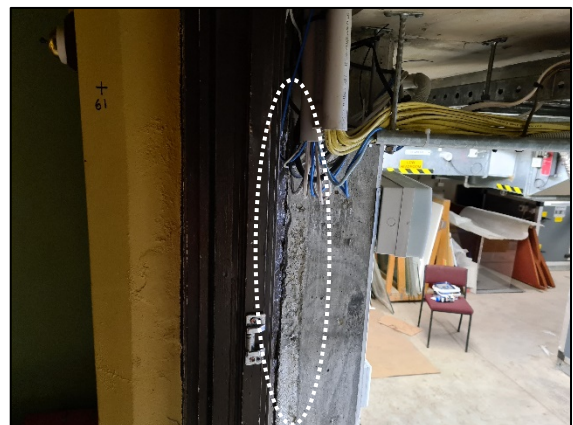
- Internal full height walls are composed of a concrete nib wall topped with timber framing and lined with lath and plaster, see [Figure 4-13c](#).
- Several partition walls on the east side of the gallery are not to full height and consist of an approx. 1.5m tall concrete nib with a short timber framed section above, see [Figure 4-13i](#).
- The main corridor running North-South and the corridor on the eastern side running East-West both contain approx. 1.2m wide doorways which have later been filled, see [Figure 4-13c, d, h](#).
- On the west side of the gallery, load bearing walls which likely will have formed a corridor (i.e., mirroring the east side), have been removed and replaced with steel trusses, see [Figure 4-13a](#).
- The north wall of Zone 5 was observed to have a separation with the south wall of Zone 6, see [Figure 4-13j](#).

(j) Polystyrene identified between Zone 5 and Zone 6 walls

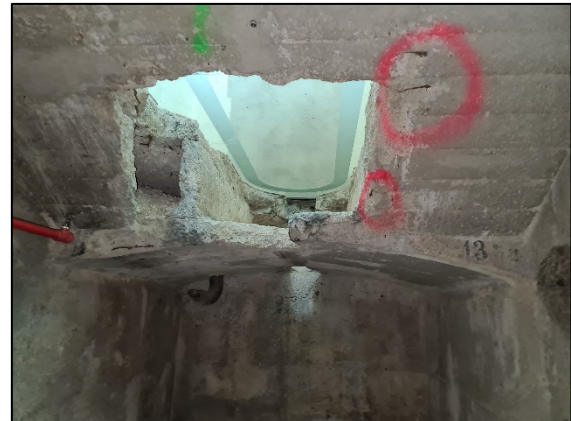
- The slab in Zone 5 contains three voids at the eastern end against the north wall, belonging to three historic bath rooms, see [Figure 4-14c](#).
- In several locations (including other zone basements), the presence of a fibrous, cementitious material (resembling gannite or sprayed concrete) was observed on the vaulted floor slab soffit, see [Figure 4-14a, b](#). The layer is approx. 10-20mm thick and is believed to have been added during the 1990s, possibly to mitigate further propagation of the slab cracking (though it has not succeeded).

(c) Void in vaulted floor slab at east side of Zone 5 for historic baths (two more adjacent to this one)

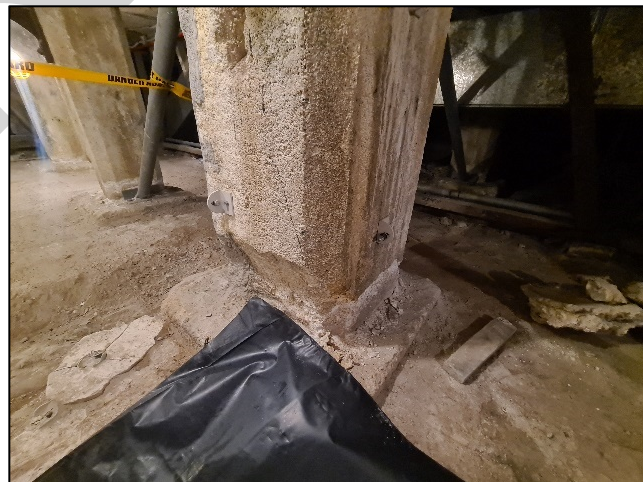
- The foundations typically consist of unreinforced pumice concrete walls at the perimeter of the Zone 4 structure and columns of the same material to support the internal region of the vaulted floor slab.
- Localised areas of the Zone 5 basement contain various braces and/or steel elements to strengthen the historic foundations, such as timber supports and circular hollow section diagonal members. It is unclear how effective the pipe sections are due to their end connections, see [Figure 4-14d-f](#).
- It was observed that a significant number of columns have experienced deterioration and loss in cross section over the years (see [Figure 4-14g](#)) due to the continual ingress of geothermal gases through the ground. This observation was made largely throughout the original basement area.

(g) Example of column cross section deterioration, likely due to ingress of geothermal gases from ground

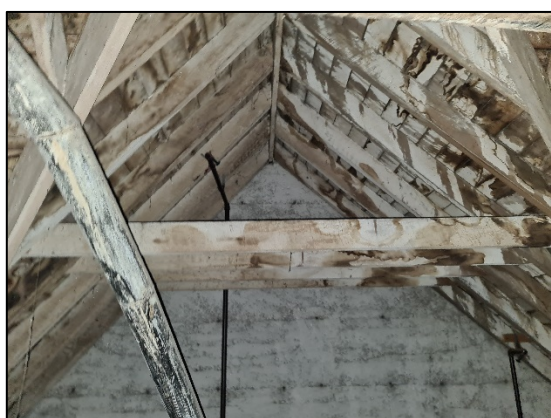
- It was observed that the sarking and rafters have experienced some decay due to moisture ingress and some nailed connections have corroded, see [Figure 4-15a](#). This observation is supported by previous timber assessments within the roof structure (see Prendos timber deterioration assessment report dated 20 June 2017, ref: 023908003).

(a) Truss structure at south gable wall of Zone 5, showing some moisture ingress and deterioration of timber members

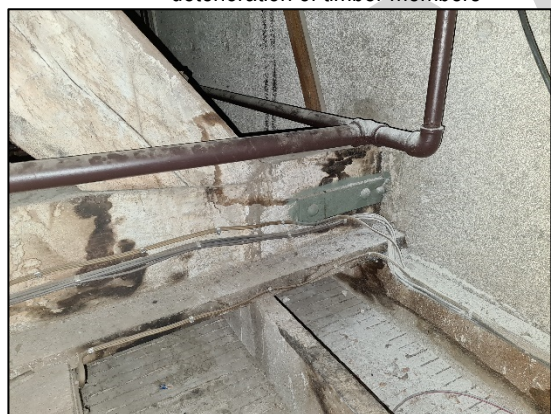
- The central section of the Zone 5 roof contains queen post trusses. The ends of the truss chords are pocketed into the concrete gable walls at north and south ends and the trusses are supported inter-span by internal timber walls at ground floor. Bolted plate connections were observed for the bottom chords of the trusses and strengthening of the rafter connection to the bottom chord was observed for some trusses (see [Figure 4-15c, d](#)).

(c) Bolted plate connections on truss chord pocketed into gable wall

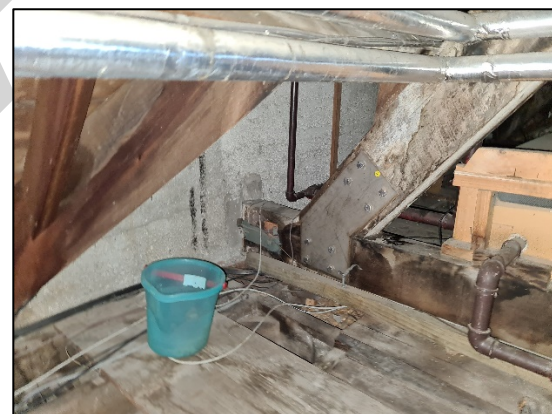
(d) Steel plates to strengthen rafter to bottom chord truss connection

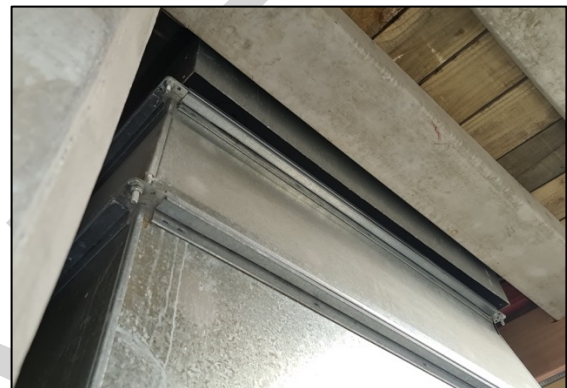
- Several columns were observed to have insufficient baseplate connections, see [Figure 4-16j](#). Some of the Reidbrace end connections were also observed to be connected to the columns via a cantilevered plate, which by inspection appeared to be inadequately detailed, see [Figure 4-16i](#).

(j) Reidbrace end connected to cantilevered welded plate on column

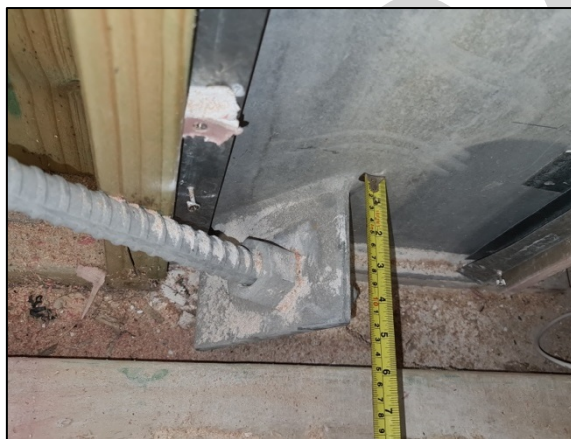
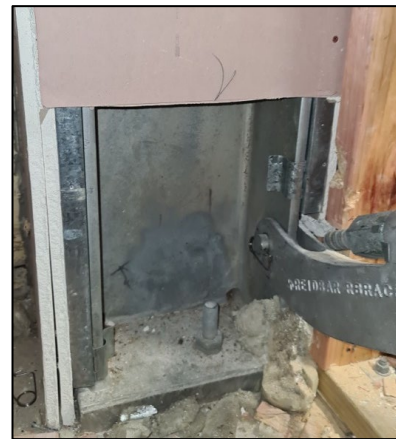
(k) Column baseplate with insufficient number of bolts

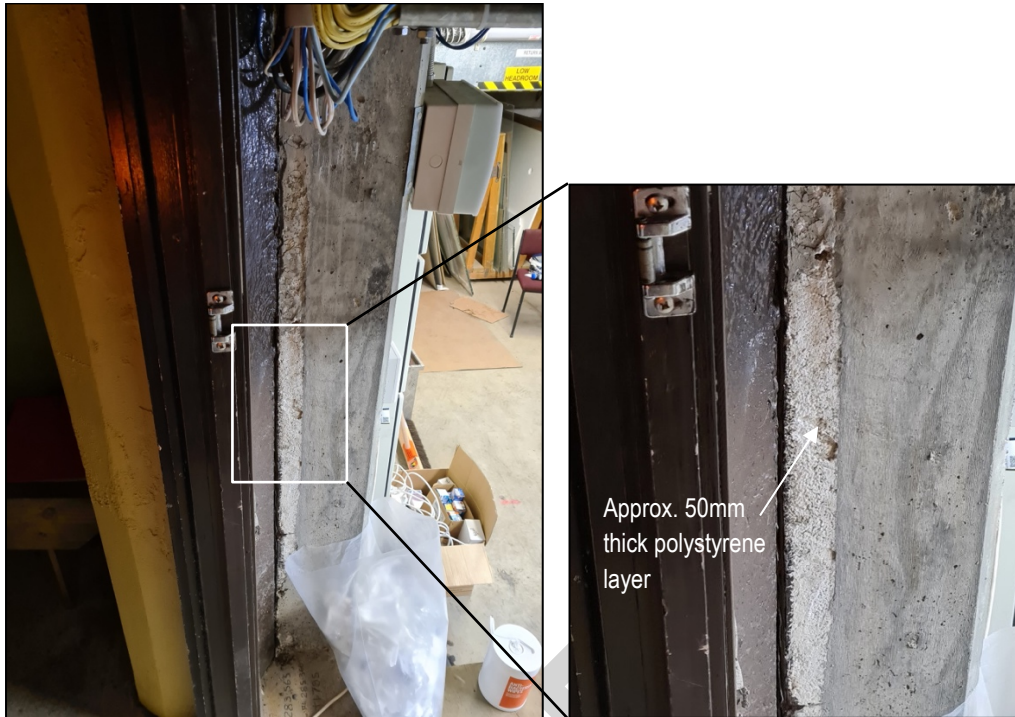
- The foundations for the perimeter walls are approx. 2.5m wide by 400mm deep reinforced concrete strip footings.
- The interface between Zones 5 and 6 was observed to have a gap filled with polystyrene, indicating a seismic separation between the two zones, see [Figure 4-17j](#).

(i) Basement entry to Zone 6, showing polystyrene between Zone 5 and 6 interface

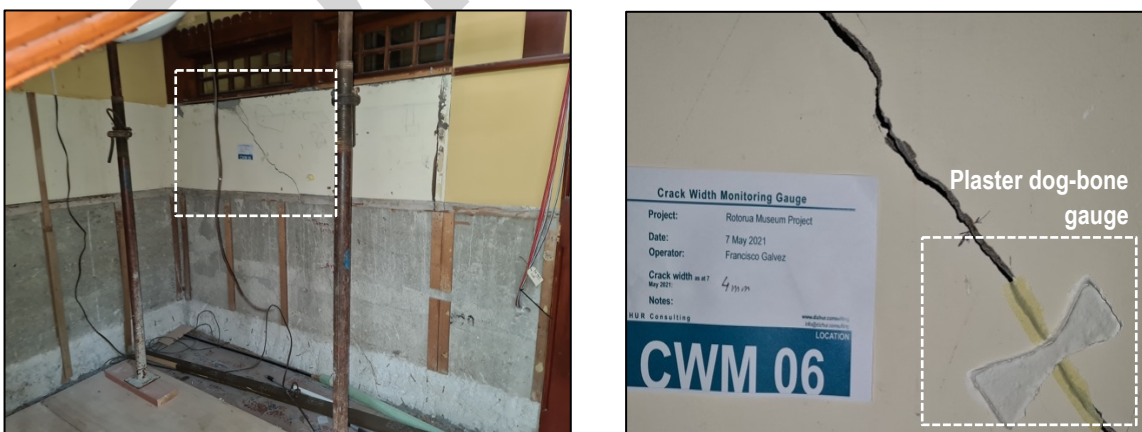
(b) Typical example of wall crack monitoring (CWM 6)

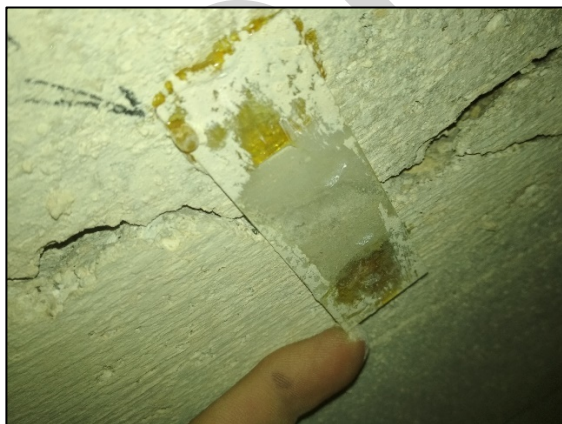
(c) 2 – not cracked (one side detached from wall)

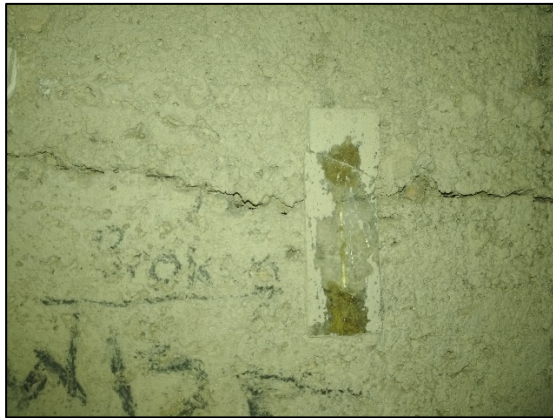
At gauge 4, approx. 2.5mm of relative displacement between the two sides of the crack had occurred, which describes the relative movement that occurred between the southern wall of Zone 2 and the perpendicular wall that the gauge was placed on (see [Figure 5-5a](#)).

(e) 4 – Cracked

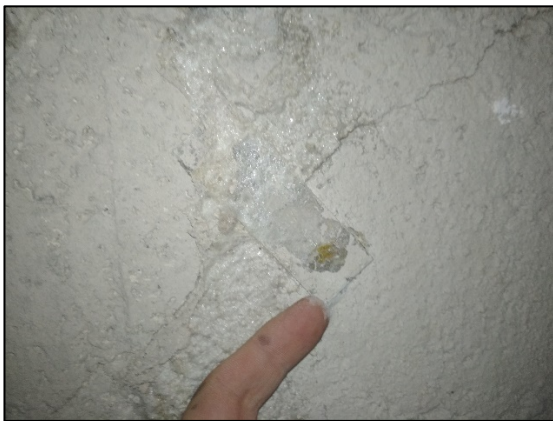
Gauge 6 was placed in the same crack as gauge 4, but on the opposite side of the wall. This gauge had detached from the wall on one side of the crack, however considering the significant relative movement experienced by gauge 4, it is hypothesised that this detachment could have been caused by wall movement. Gauges 1, 3, 5 and 7 did not exhibit any type of failure.

(g) 6 – not cracked (one side detached from wall)

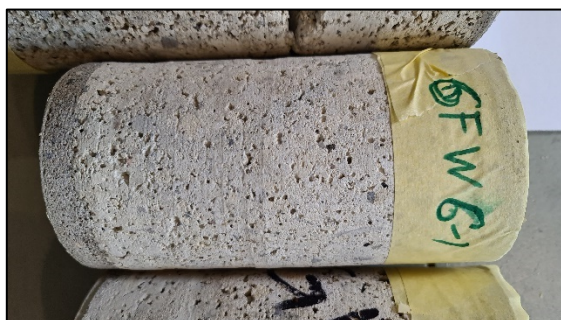
(a) B-S-1 – showing reasonably well compacted concrete

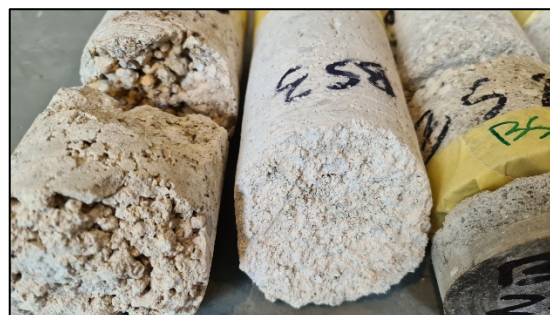
(d) Core samples showing large variability in compactness of material

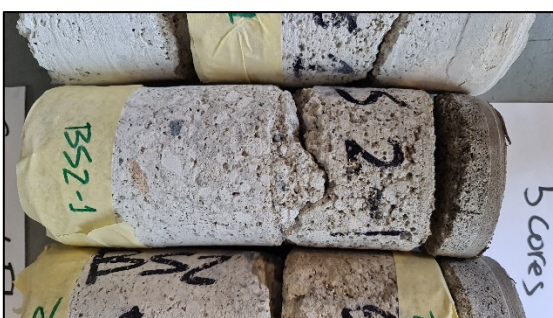
(e) Cores BS-2-1 and BS-1 (floor slab cores from Zones 4 and 5, respectively) showing 'layers' of poorly compacted concrete causing core to break apart

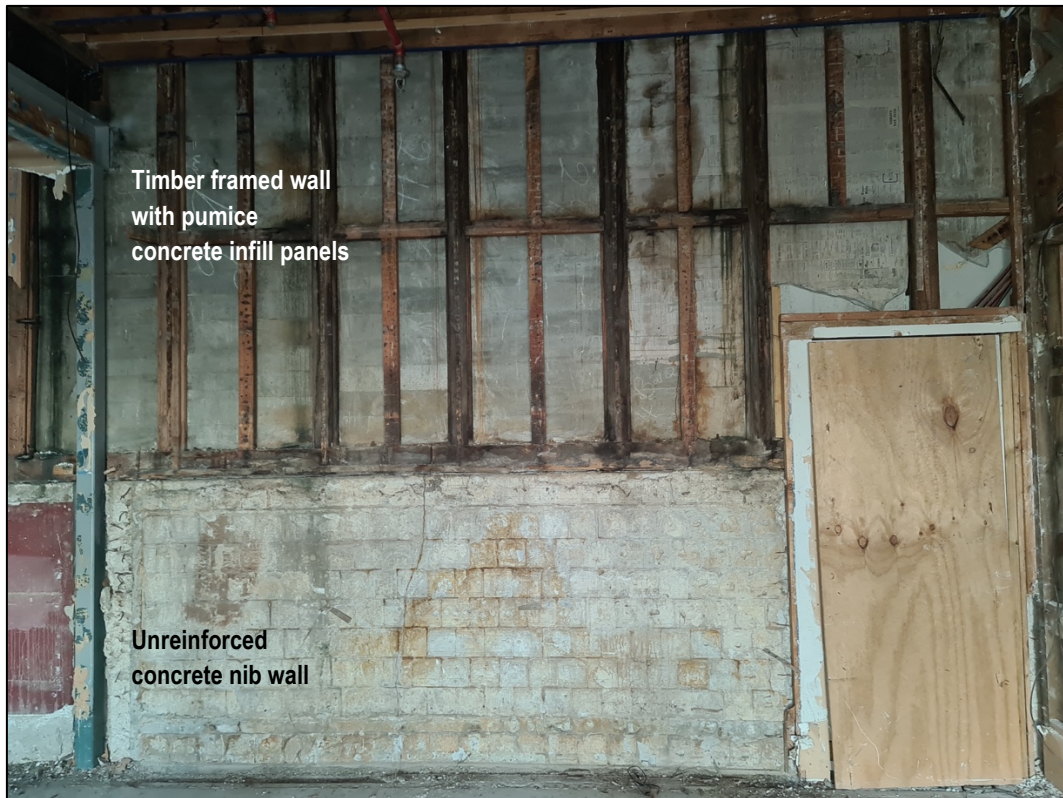
The building has been constructed with timber framing with approx. 40-50mm thick infill panels consisting of a more lightweight mix of concrete made using pumice. The infill panels were found to contain chicken wire mesh at approx. mid-section of the panels, which has assisted in holding the panels together despite cracking/localised deterioration.

a) General construction of east & west perimeter walls with concrete nib wall at base and timber frame wall above with pumice concrete infill panels

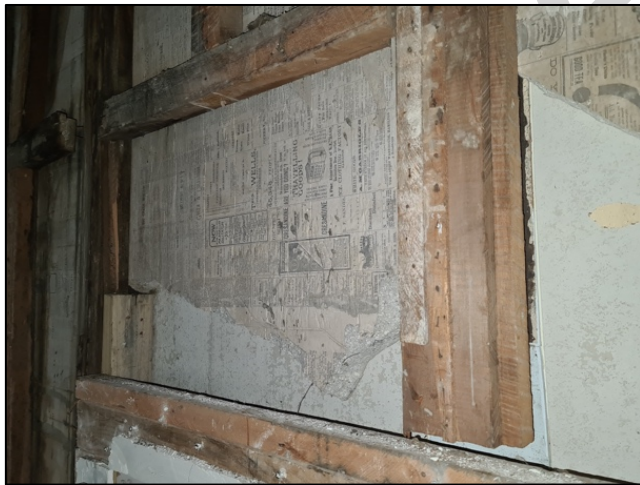
Aside from localised cracks observed in some infill panels, they were generally observed to be in good condition. Small voids were observed in the cross section of the infill panels, as well as small pieces of pumice concrete. The aggregate was generally small sized, as was expected considering the geometry of the panels.

b) Closeup of infill panels

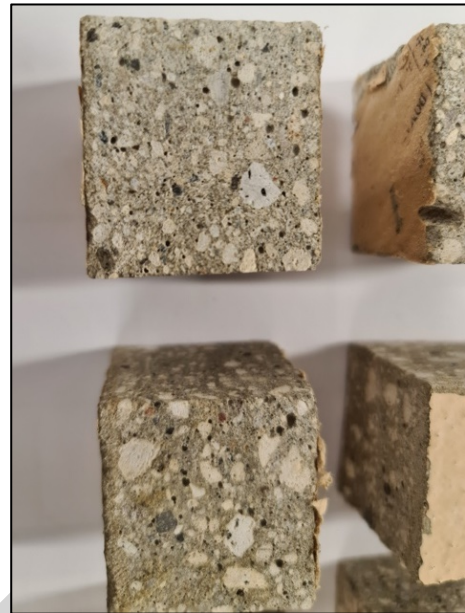
(e) Closeup of infill samples for testing showing small voids and pumice material in concrete mix

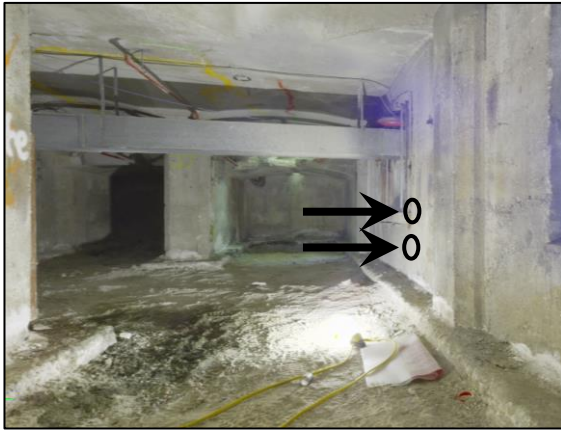
B-W-1-1, B-W-1-2 – Zone 5 east basement wall (2 cores extracted)

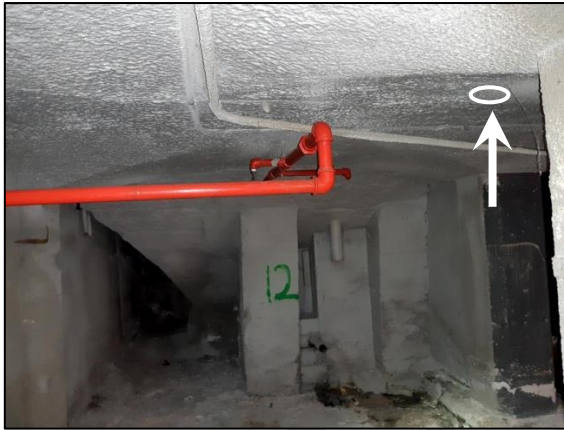
B-S-1 – Floor slab, Zone 5 south side (within G5P zone) (done from below, closer to column to avoid penetrating timber floor overlay)

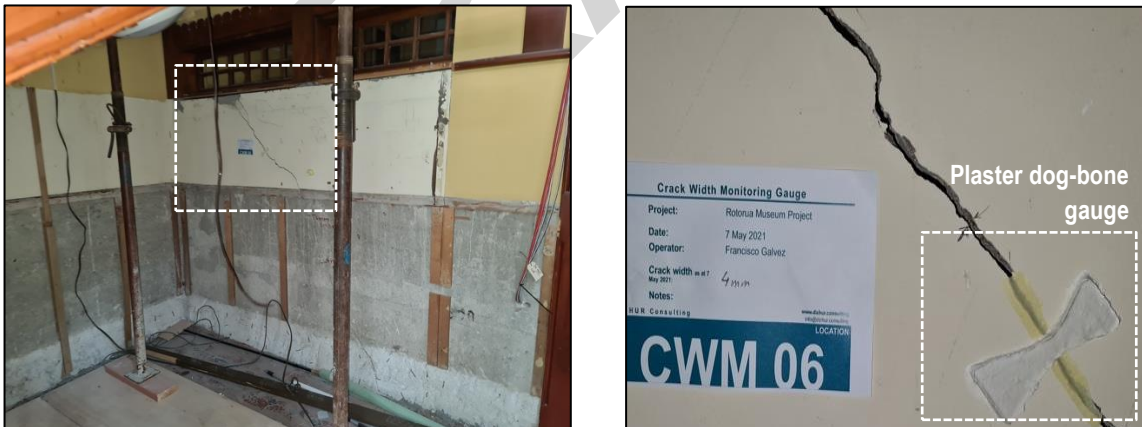
(b) Typical example of wall crack monitoring (CWM 6)

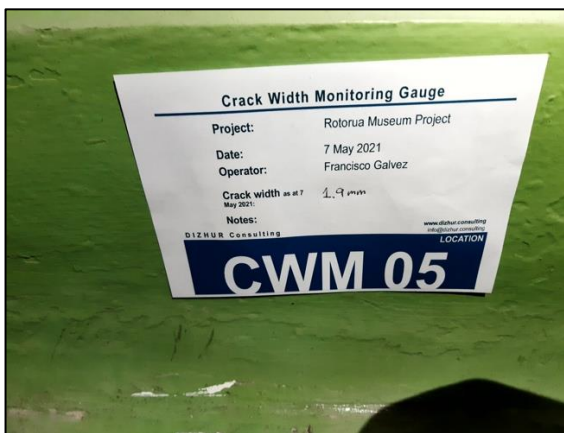
(b) CWM 05 –  $0.1\text{mm}$  crack identified in plaster, new total crack width = approx.  $2.0\text{mm}$

CWM 5 which exhibited a crack in the plaster of approx. 0.1mm in the May inspection, was observed to have increased in width to approx. 0.2mm. All other gauges which had previously exhibited cracks (CWM 1, 6, 13 and 15, all located in Zone 3) remained immeasurable (i.e., <0.1mm width) or exhibited approx. 0.1mm crack width. Refer to [Appendix 5](#) for all photos of gauges taken on 17 August 2021.

| ID | Zone | Location description | Existing crack width (mm) measured on: 7 May 2021 | Dog-bone crackwidth inspected and measured on: 14 June 2021 | Dog-bone crackwidth inspected and measured on: 17 August 2021 | Dog-bone crack width inspected and measured on: 21 November 2021 |
|---|---|---|---|---|---|---|
| CWM 5 | Zone 3 | GF – floor next to south wall doorway | 1.9 | Crack, +0.1mm = 2.0mm new width | Crack, 0.2mm crack in plaster = 2.1mm new width | Crack, 0.2mm |

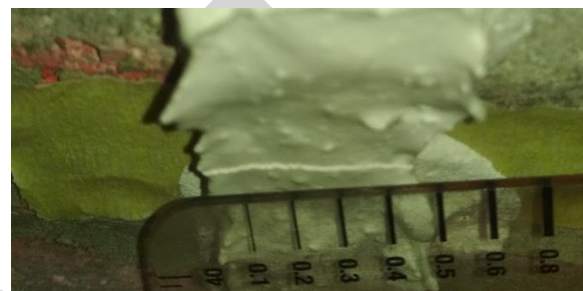
CWM 13 which exhibited a hairline crack in the plaster in the August inspection, was observed to have increased in width to approx. 0.2mm and the vertical displacement was estimated as 0.3mm. A new hairline crack was observed parallel to the existing 0.2mm crack coinciding with the width of the crack in the concrete ceiling. CMW 15 was measured to have moved vertically 0.4mm, which was not detected before. Refer to [Appendix 6](#) for all photos of gauges taken on 17 November 2021.

CWM 13 – 0.2mm crack opening + 0.3mm vertical movement detected. Parallel double crack.

| ID | Zone | Location description | Existing crack width (mm) measured on: 7 May 2021 | Dog-bone crackwidth inspected and measured on: 14 June 2021 | Dog-bone crackwidth inspected and measured on: 17 August 2021 | Dog-bone crack width inspected and measured on: 21 November 2021 |
|---|---|---|---|---|---|---|
| CWM 13 | Zone 3 | Basement – floor slab (overhead) near north gable wall | 1.6 | Hairline crack <0.1mm | Hairline crack + evidence of vertical displacement | Crack 0.2mm (2 <sup>nd</sup> hairline crack parallel) Vertical offset 0.3mm |
