DETAILED SEISMIC ASSESSMENT & CONCEPT RETROFIT REPORT

## ROTORUA MUSEUM

GOVERNMENT GARDENS ORUAWHATA DRIVE, ROTORUA

February 2022

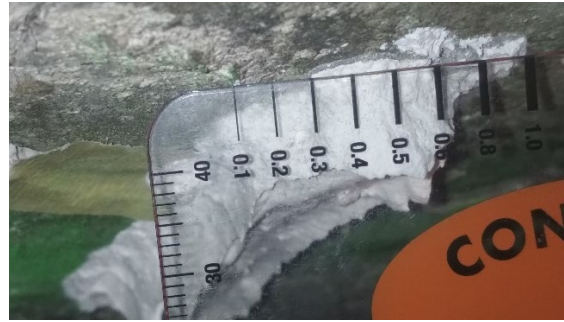
CWM 15 – hairline crack ( $<0.1\text{mm}$ ) (Photo not updated because of quality) – 0.4mm detachment from top/vertical movement detected

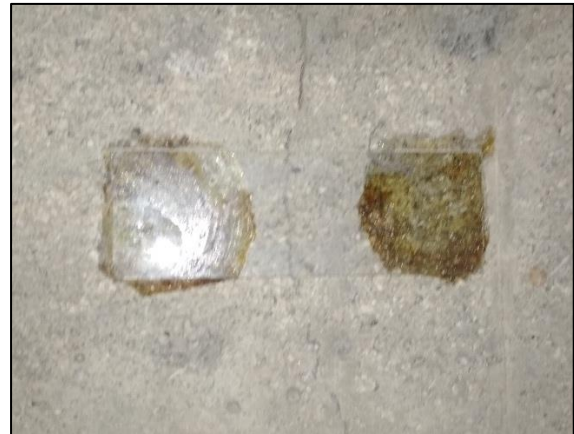
(b) 1 – Not cracked

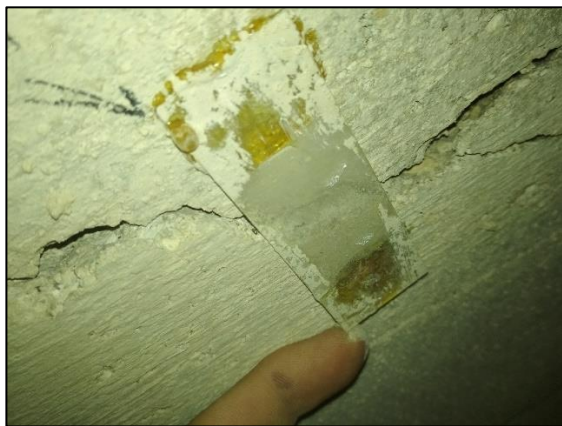
(c) 2 – not cracked (one side detached from wall)

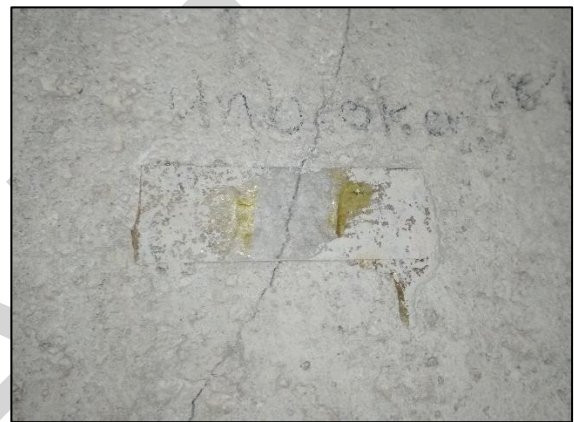
(d) 3 – Not cracked

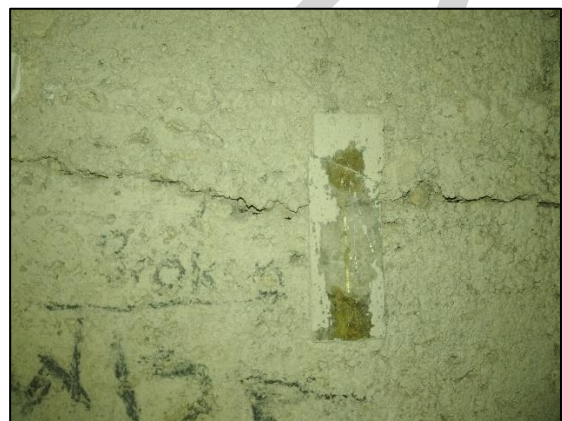
At gauge 4, approx. 2.5mm of relative displacement between the two sides of the crack had occurred, which describes the relative movement that occurred between the southern wall of Zone 2 and the perpendicular wall that the gauge was placed on (see Figure 1-5a).

(e) 4 – Cracked

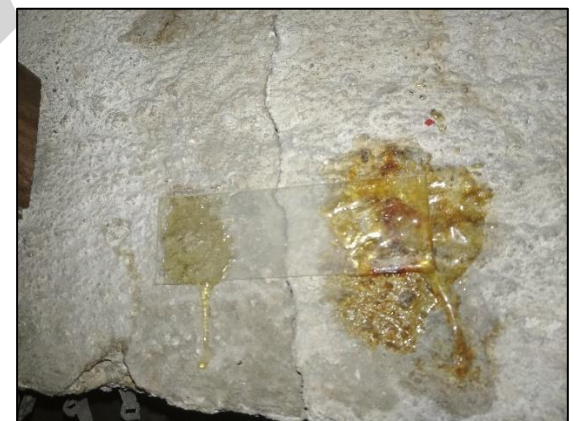
(f) 5 – Not cracked

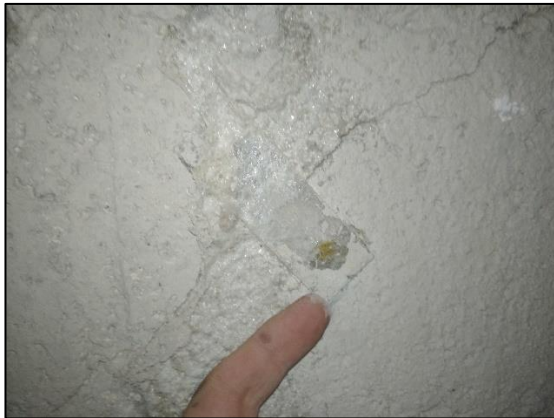
Gauge 6 was placed in the same crack as gauge 4, but on the opposite side of the wall. This gauge had detached from the wall on one side of the crack, however considering the significant relative movement experienced by gauge 4, it is hypothesised that this detachment could have been caused by wall movement. Gauges 1, 3, 5 and 7 did not exhibit any type of failure.

(g) 6 – not cracked (one side detached from wall)

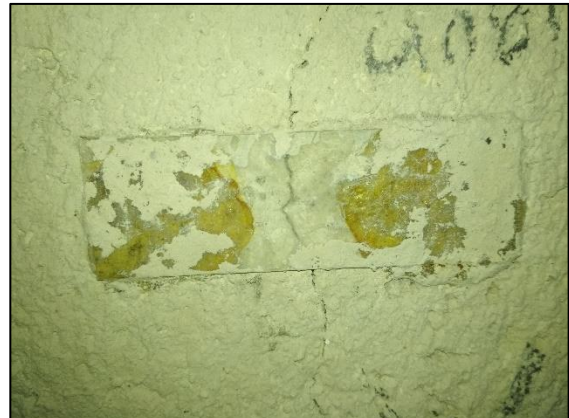
(h) 7 - Not cracked

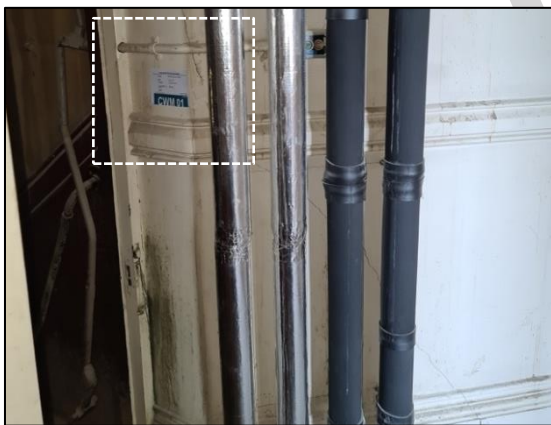
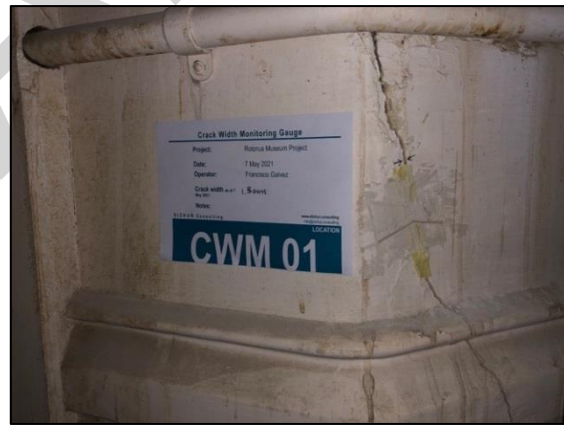
CWM 1 – crack width at time of gauge placement = 1.3mm

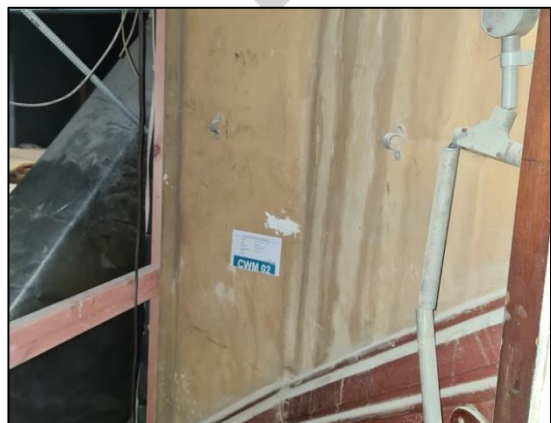
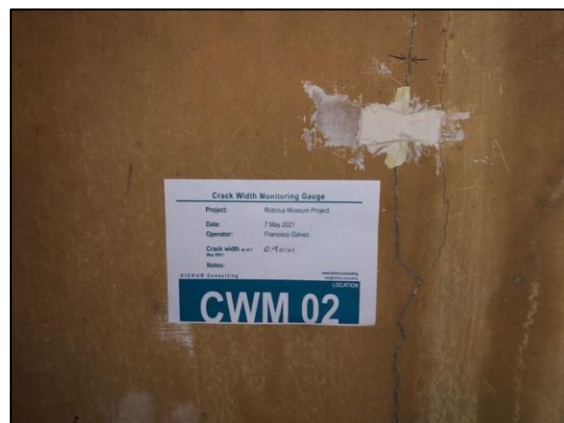
CWM 2 – crack width at time of gauge placement = 0.9mm

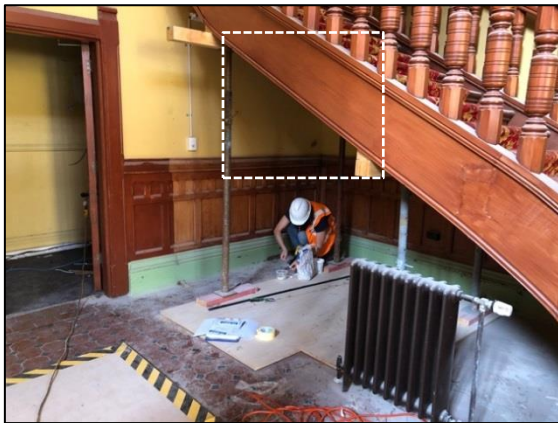
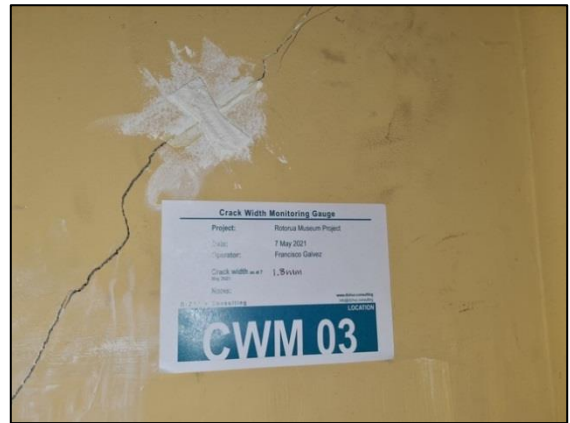
CWM 3 – crack width at time of gauge placement = 1.8mm

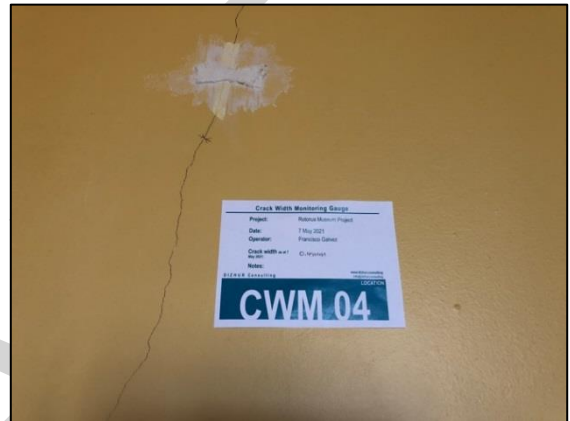
CWM 4 – crack width at time of gauge placement = 0.4mm

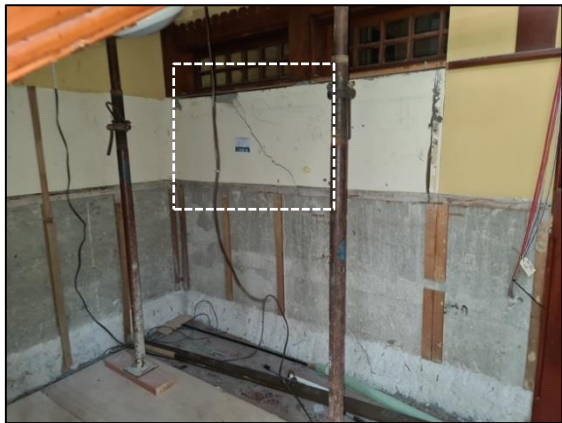
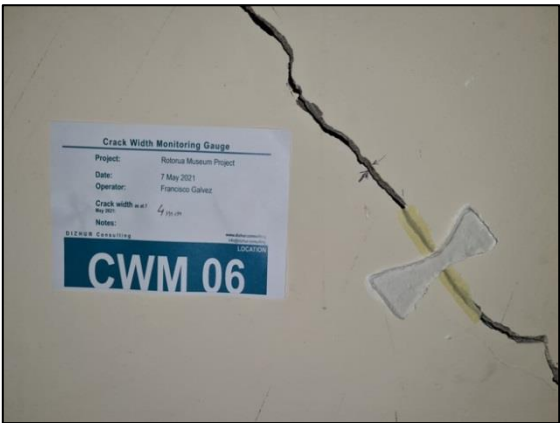
CWM 6 – crack width at time of gauge placement = 4mm

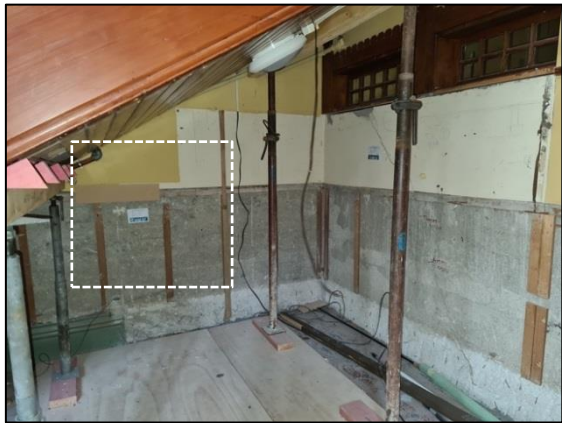
CWM 7 – crack width at time of gauge placement = 1.2mm

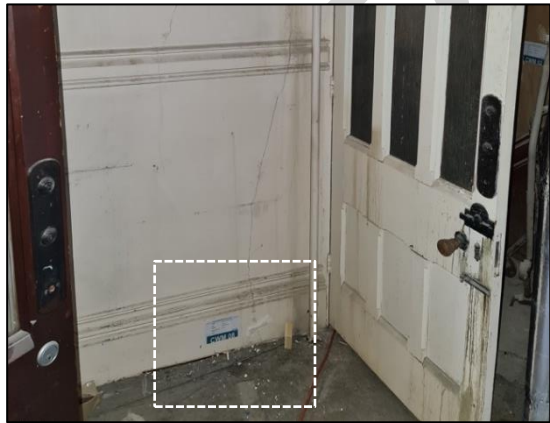
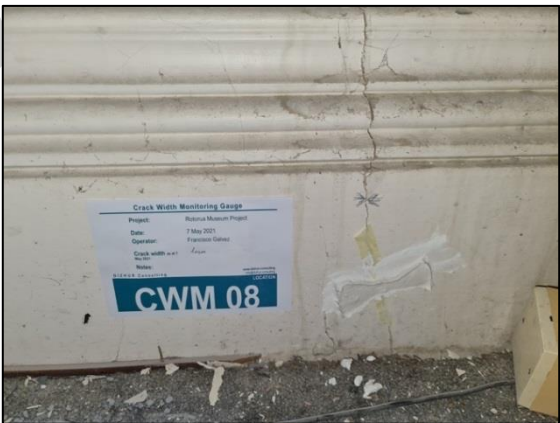
CWM 8 – crack width at time of gauge placement = 1mm

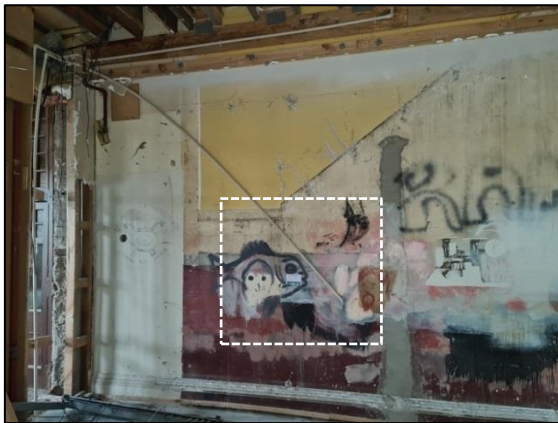
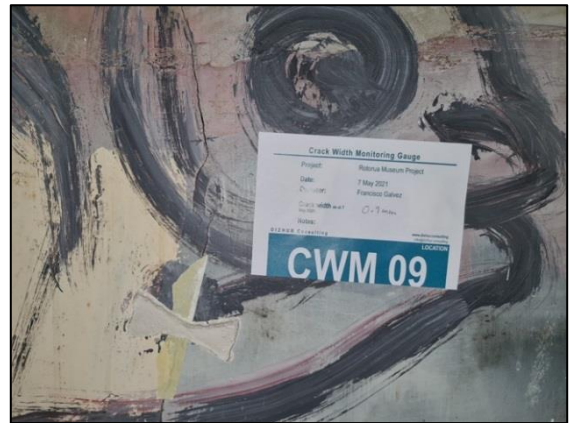
CWM 9 – crack width at time of gauge placement = 0.9mm

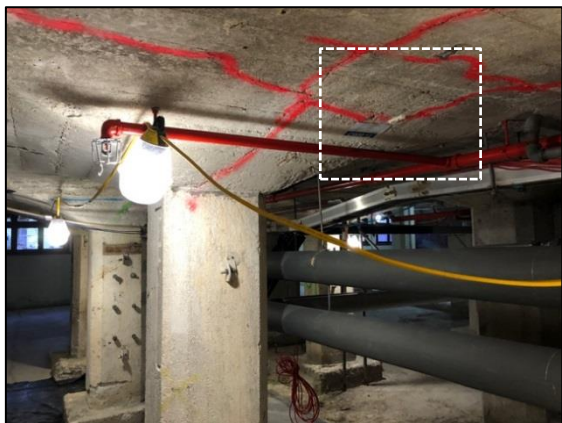
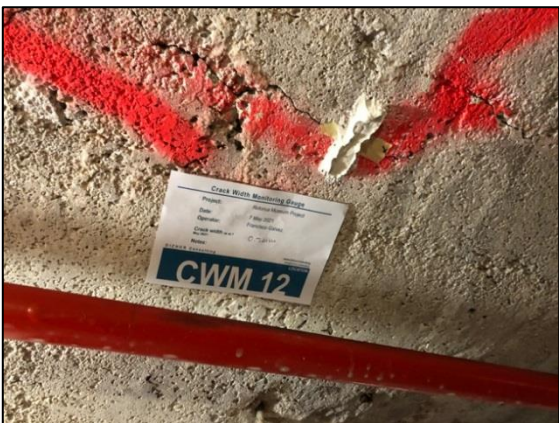
CWM 12 – crack width at time of gauge placement = 0.7mm

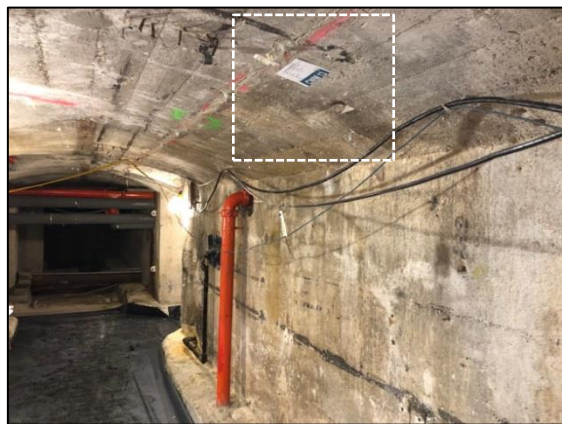
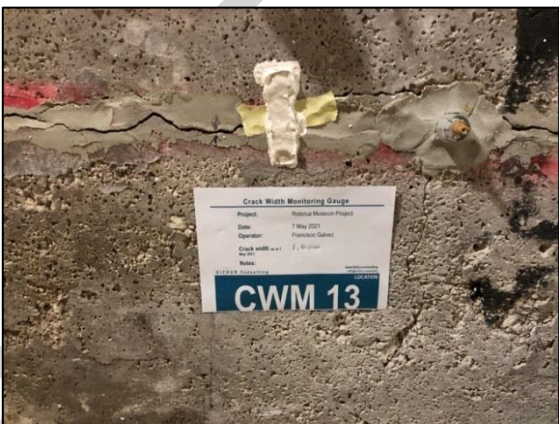
CWM 13 – crack width at time of gauge placement = 1.6mm

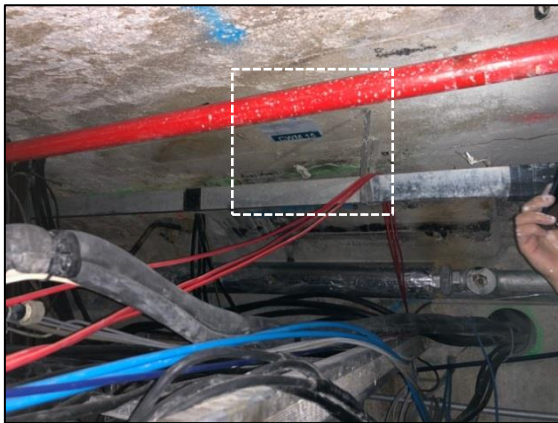
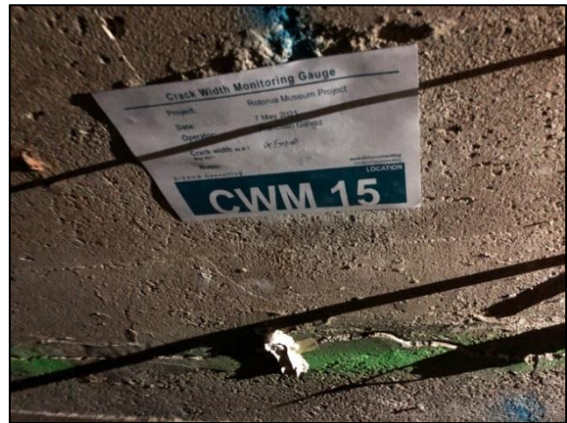
CWM 15 – crack width at time of gauge placement = 4.5mm

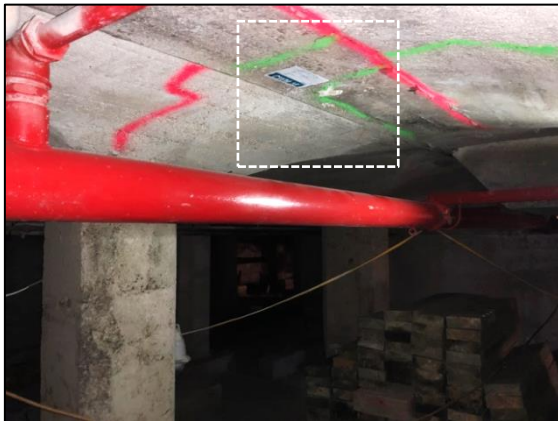
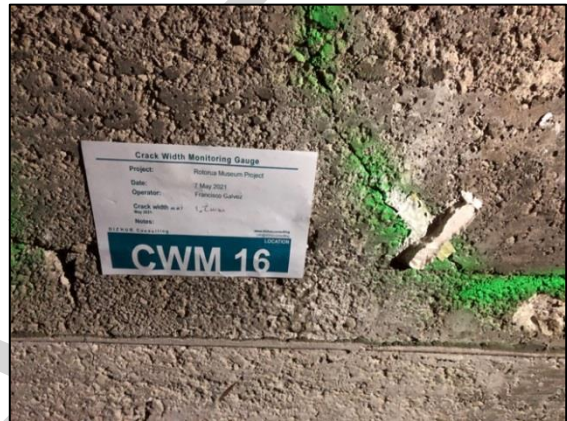
CWM 16 – crack width at time of gauge placement = 1.2mm

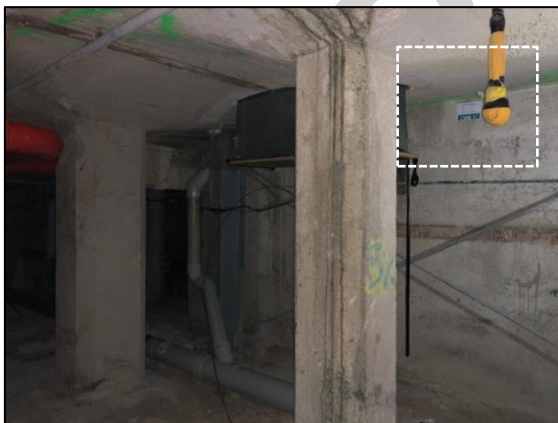
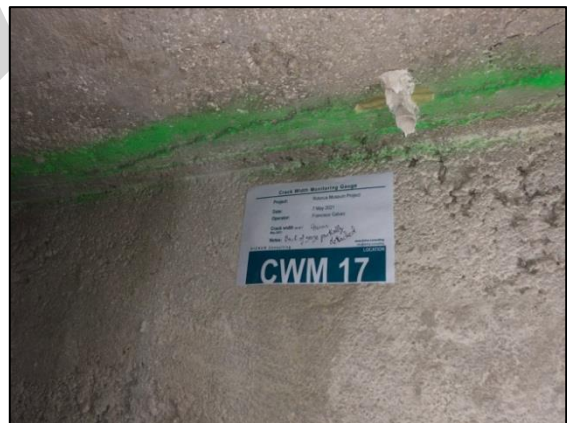
CWM 17 – crack width at time of gauge placement = 4mm [Notes: Back of the gauge partially detached because of difficulty during installation]

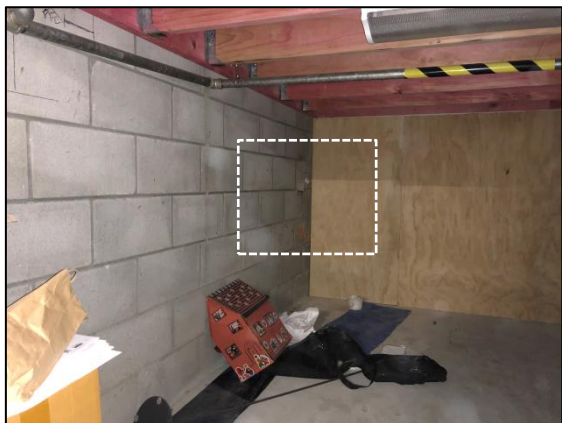
CWM 18 – crack width at time of gauge placement = 0.55mm

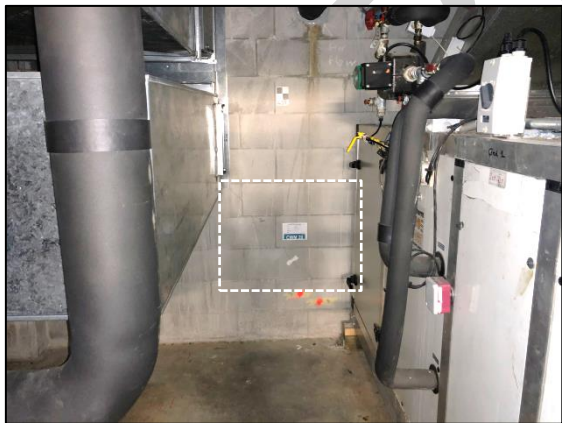
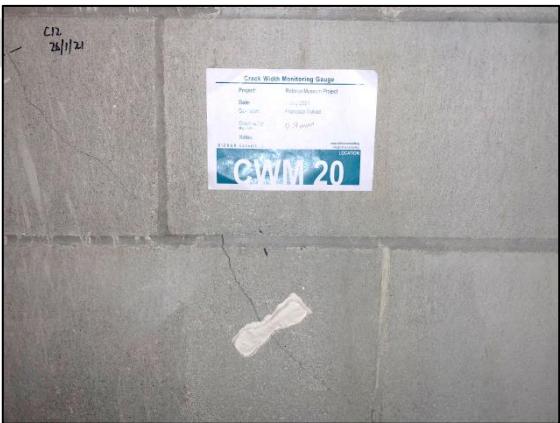
CWM 20 – crack width at time of gauge placement = 0.7mm

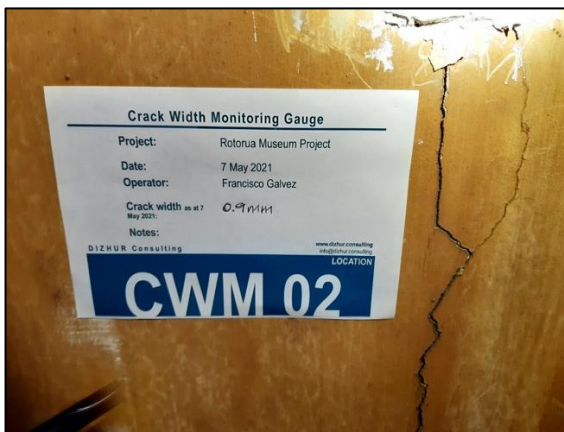
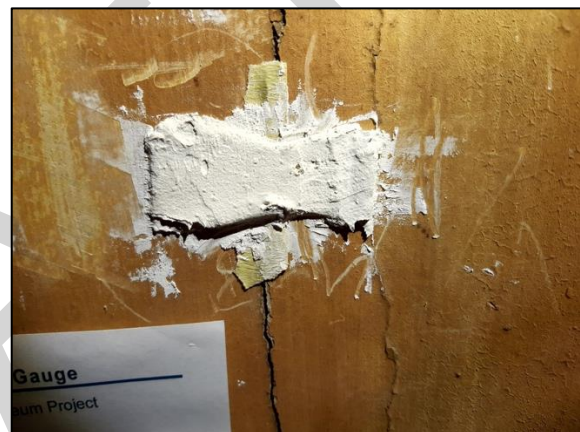
(b) CWM 02 – no movement identified

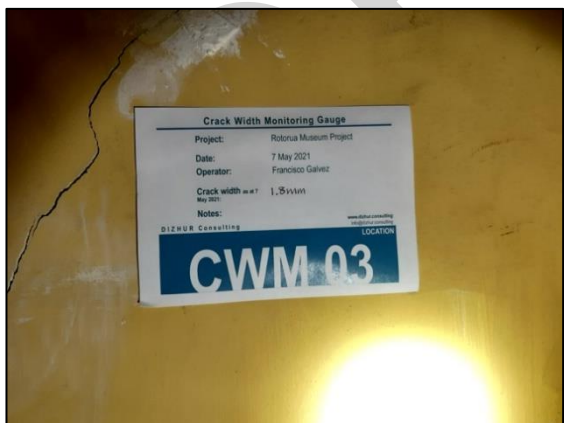
| ID | Zone | Location description | Existing crack width (mm) measured on: 7 May 2021 | Dog-bone crackwidth inspected and measured on: 14 June 2021 | Dog-bone crackwidth inspected and measured on: 17 August 2021 | Dog-bone crack width inspected and measured on: 21 November 2021 |
|---|---|---|---|---|---|---|
| CWM 3 | Zone 3 | GF – Beneath south staircase | 1.8 | No movement | Very small hairline crack | Very small hairline crack |

(c) CWM 03 – no movement identified

CWM 03 – hairline crack (<0.1mm) identified

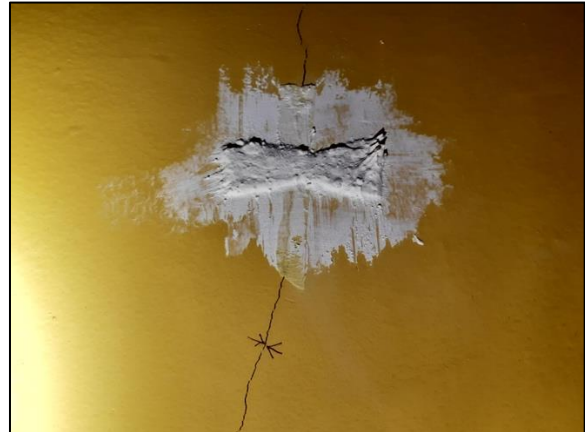
(d) CWM 04 – no movement identified

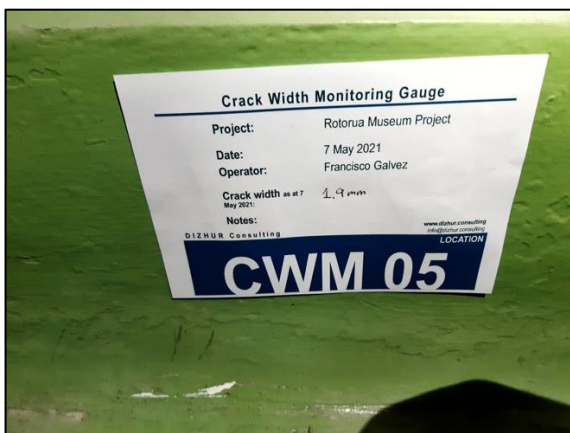
| ID | Zone | Location description | Existing crack width (mm) measured on: 7 May 2021 | Dog-bone crackwidth inspected and measured on: 14 June 2021 | Dog-bone crackwidth inspected and measured on: 17 August 2021 | Dog-bone crack width inspected and measured on: 21 November 2021 |
|---|---|---|---|---|---|---|
| CWM 5 | Zone 3 | GF – floor next to south wall doorway | 1.9 | Crack, +0.1mm = 2.0mm new width | Crack, 0.2mm crack in plaster = 2.1mm new width | Crack, 0.2mm |

(e) CWM 05 – 0.1mm crack identified in plaster, new total crack width = 23pprox.. 2.0mm

CWM 05 – 0.2mm crack, +0.1mm from previous measurement

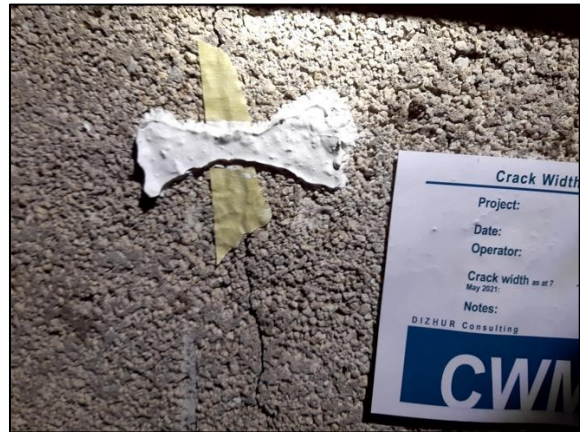
(g) CWM 07 – no movement identified

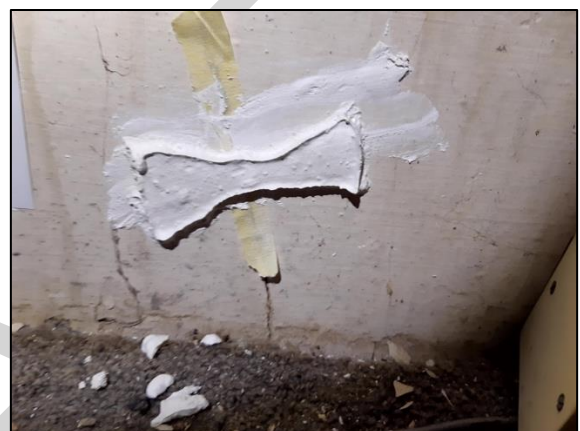
| ID | Zone | Location description | Existing crack width (mm) measured on: 7 May 2021 | Dog-bone crackwidth inspected and measured on: 14 June 2021 | Dog-bone crackwidth inspected and measured on: 17 August 2021 | Dog-bone crack width inspected and measured on: 21 November 2021 |
|---|---|---|---|---|---|---|
| CWM 8 | Zone 3 | GF – south gable wall, southeast corner | 1 | No movement | Hairline crack | Hairline crack |

(h) CWM 08 – no movement identified

CWM 08 – hairline crack ( $<0.1\text{mm}$ ) identified

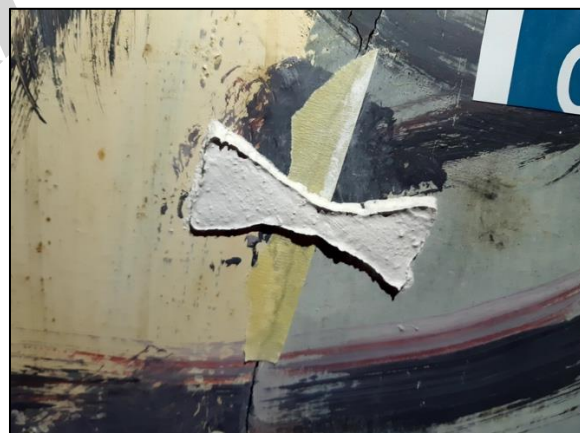
(i) CWM 09 – no movement identified

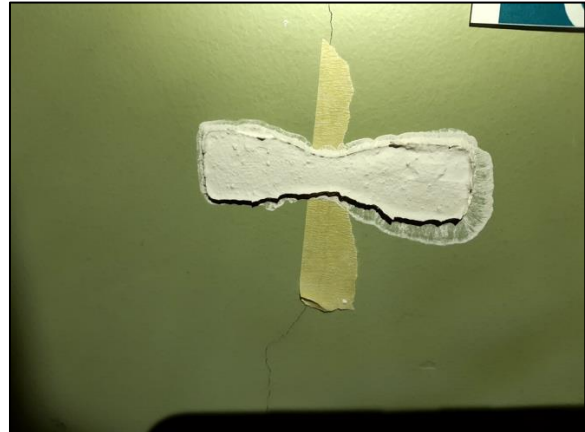
(j) CWM 10 – no movement identified

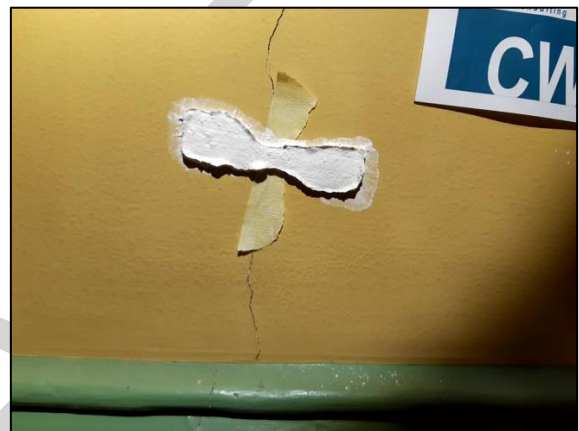
| ID | Zone | Location description | Existing crack width (mm) measured on: 7 May 2021 | Dog-bone crackwidth inspected and measured on: 14 June 2021 | Dog-bone crackwidth inspected and measured on: 17 August 2021 | Dog-bone crack width inspected and measured on: 21 November 2021 |
|---|---|---|---|---|---|---|
| CWM 11 | Zone 5 | GF – corridor south wall | 0.35 | No movement | Hairline crack | Hairline crack |

(k) CWM 11 – no movement identified

CWM 11 – hairline crack (<0.1mm) identified

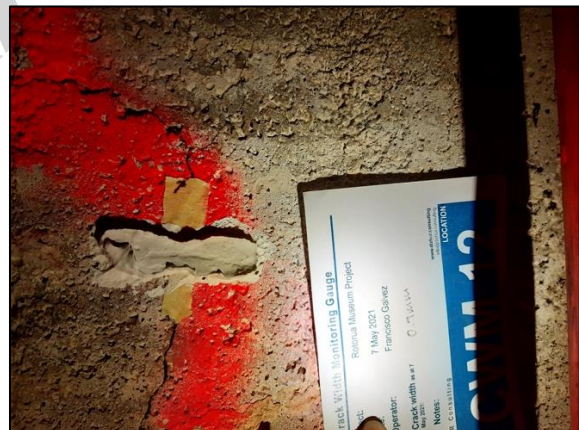
(l) CWM 12 – no movement identified

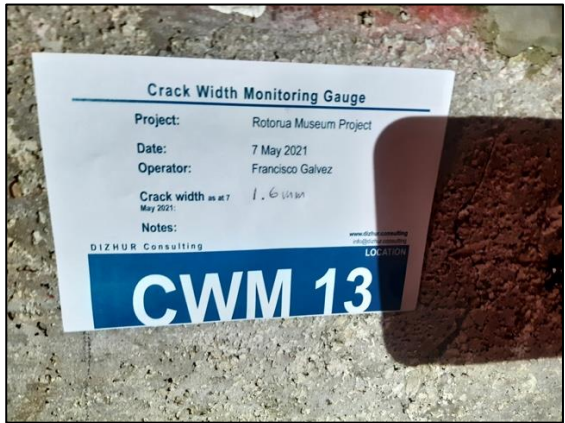
| ID | Zone | Location description | Existing crack width (mm) measured on: 7 May 2021 | Dog-bone crackwidth inspected and measured on: 14 June 2021 | Dog-bone crackwidth inspected and measured on: 17 August 2021 | Dog-bone crack width inspected and measured on: 21 November 2021 |
|---|---|---|---|---|---|---|
| CWM 13 | Zone 3 | Basement – floor slab (overhead) near north gable wall | 1.6 | Hairline crack <0.1mm | Hairline crack + evidence of vertical displacement | Crack 0.2mm (2 <sup>nd</sup> hairline crack parallel) Vertical offset 0.3mm |

(m) CWM 13 – hairline crack (<0.1mm) identified

CWM 13 – hairline crack + vertical displacement – as per previous measurement

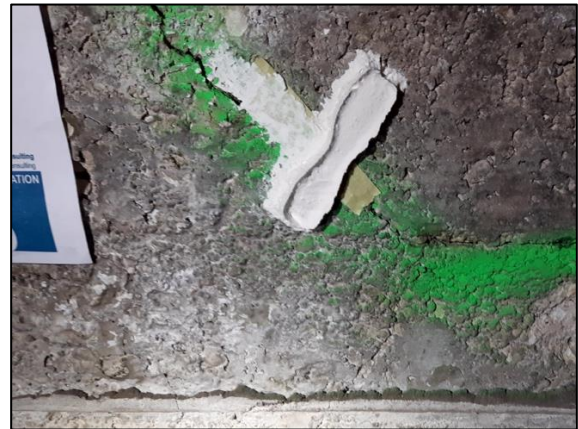
(p) CWM 16 – no movement identified

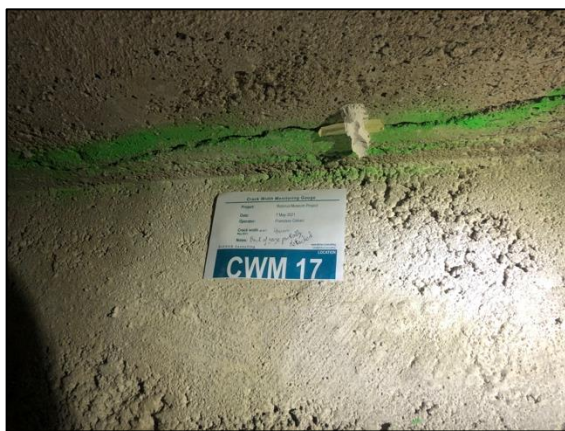
(q) CWM 17 – no movement identified

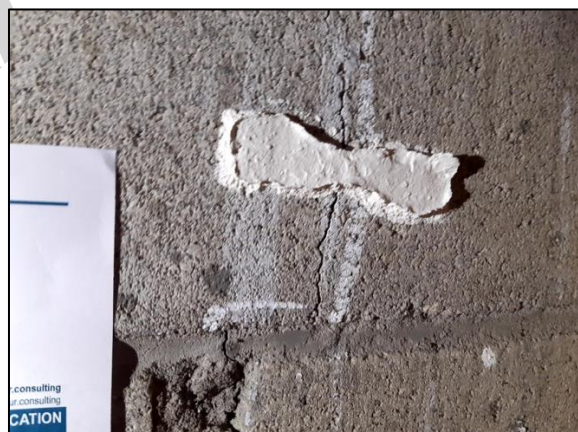
(r) CWM 18 – no movement identified

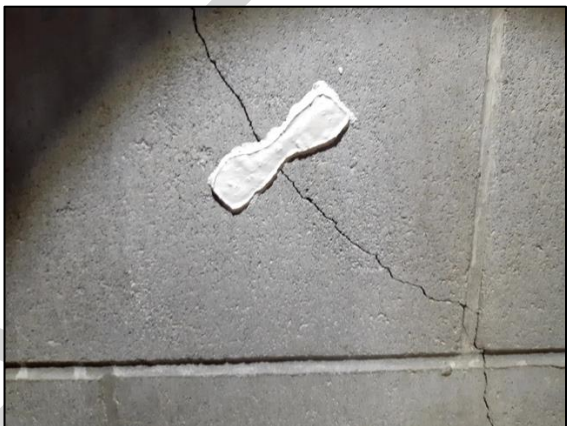
(t) CWM 20 – no movement identified

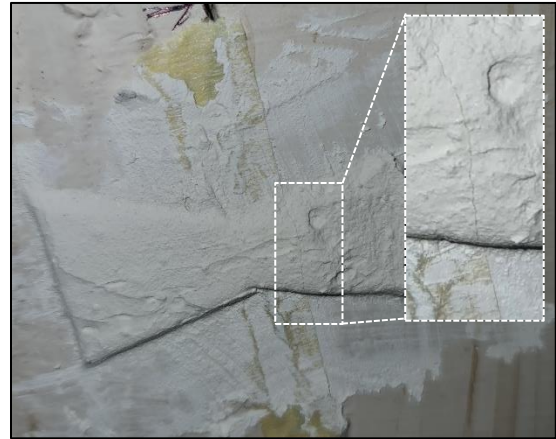
CWM 01 – hairline crack (<0.1mm) as per previous measurement

CWM 01 – hairline crack (<0.1mm) as per previous measurement (Photo not updated because of quality)

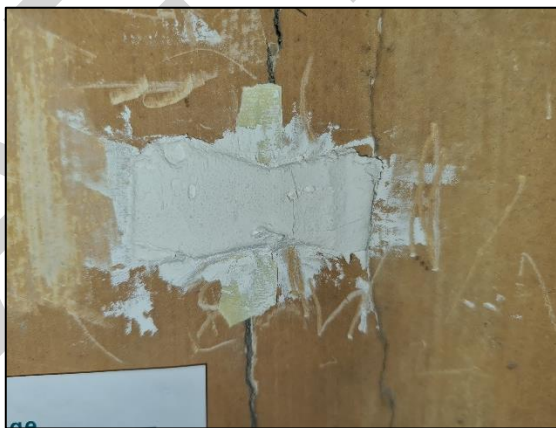
CWM 02 – no movement identified

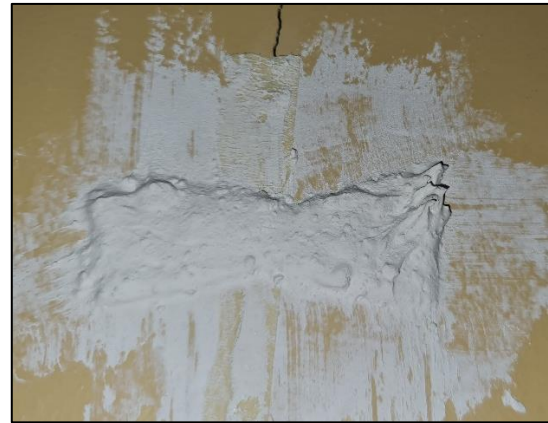
CWM 04 – no movement identified

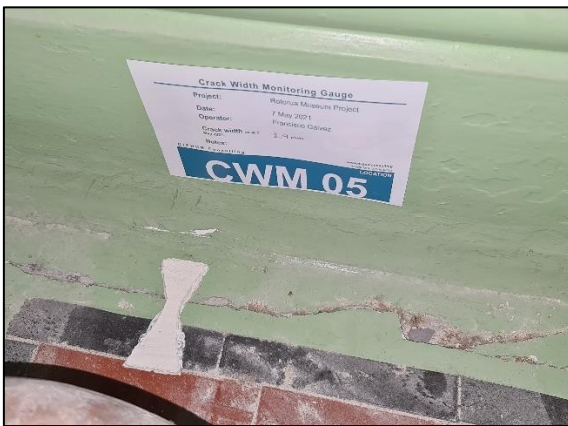
CWM 05 – 0.2mm crack as per previous measurement

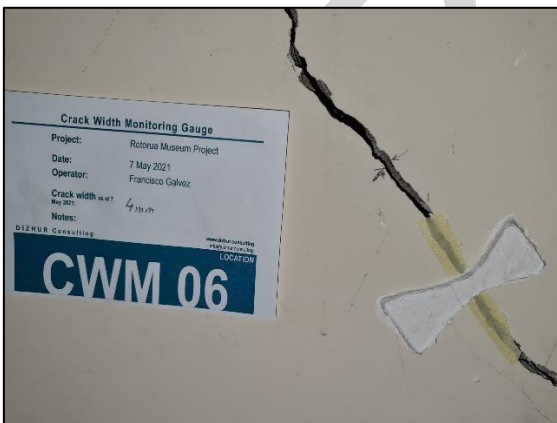
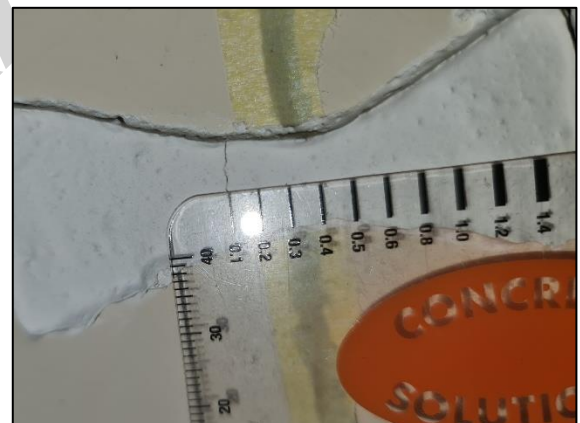
CWM 06 – 0.1mm crack identified, previous measurement = hairline crack (<0.1mm)

CWM 06 – 0.1mm crack as per previous measurement (Photo not updated because of quality)

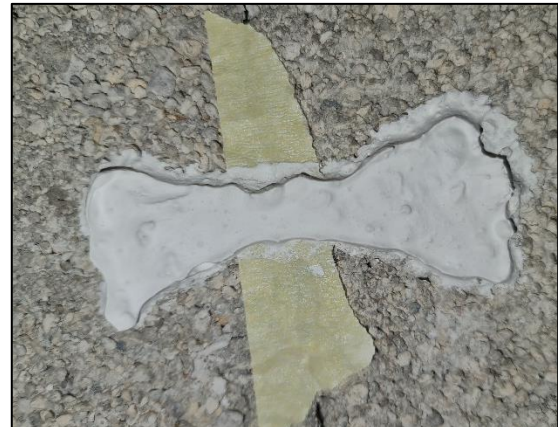
CWM 07 – no movement identified

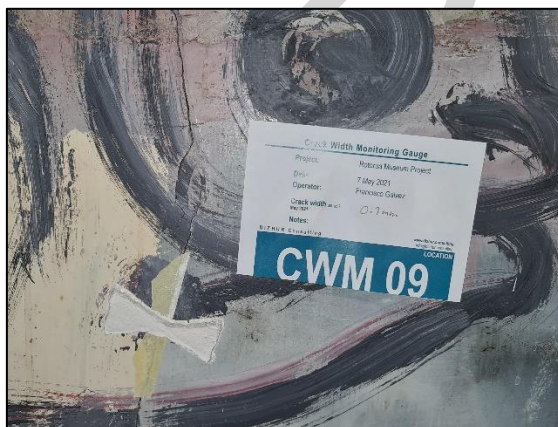
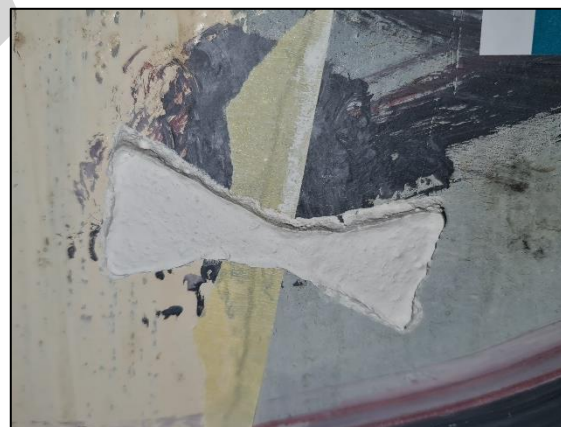
CWM 09 – no movement identified

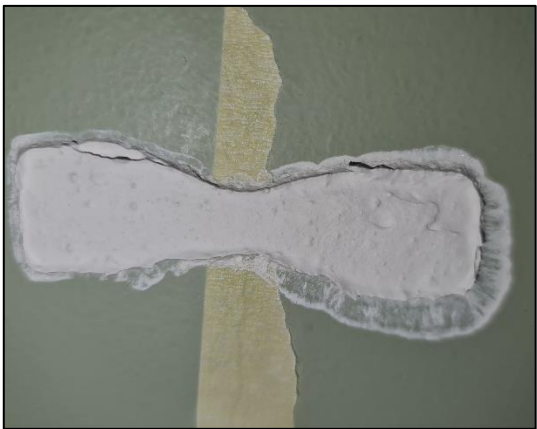
CWM 10 – no movement identified

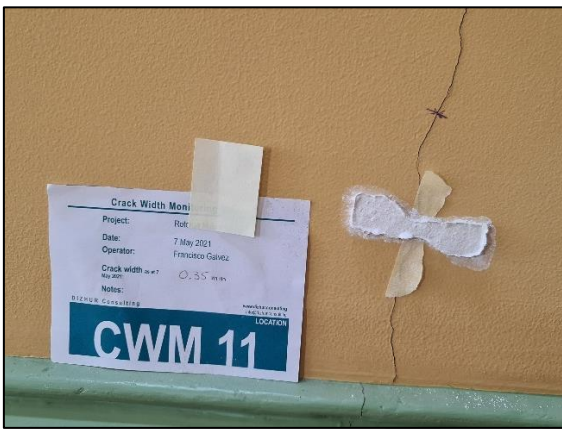
CWM 11 – hairline crack (<0.1mm) as per previous measurement

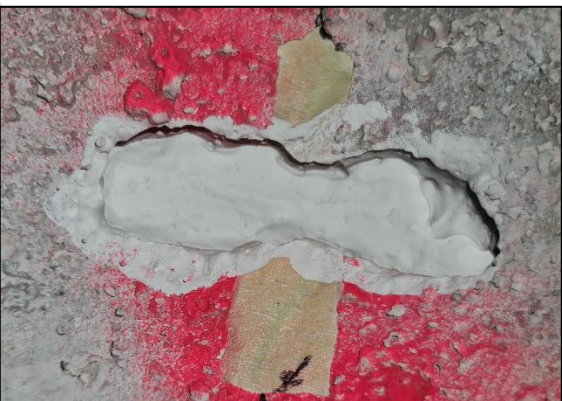
CWM 12 – no movement identified

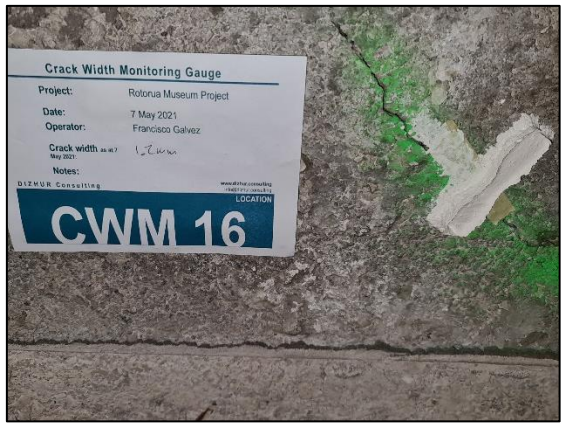
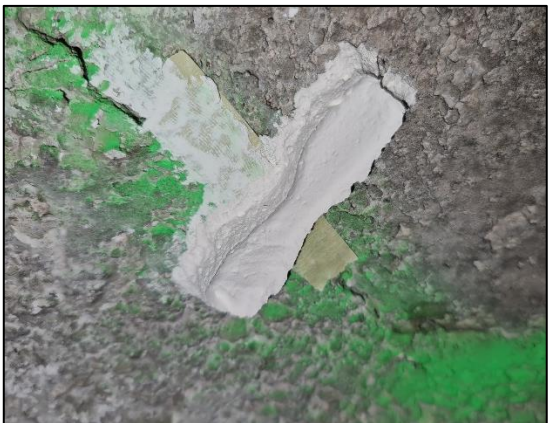
CWM 16 – no movement identified

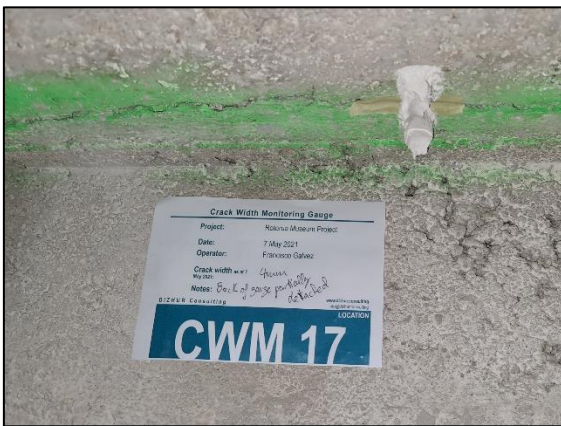
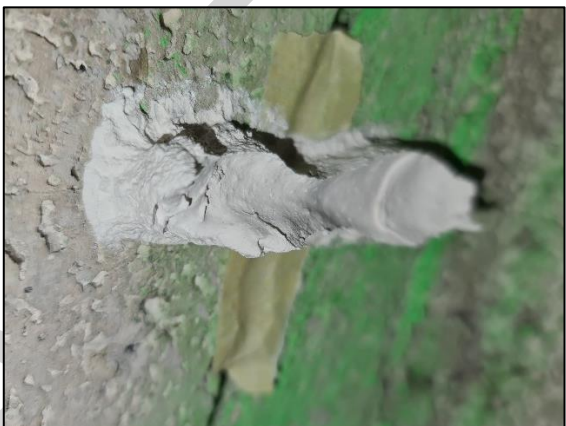
CWM 17 – no movement identified

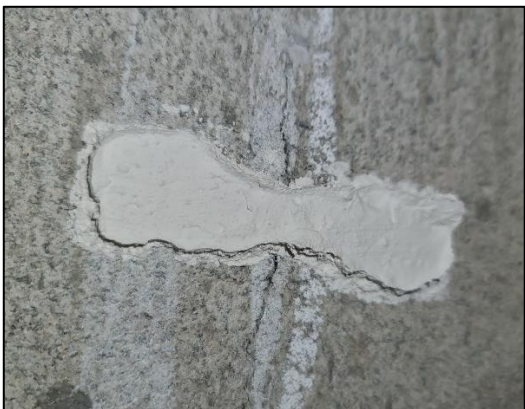
CWM 18 – no movement identified

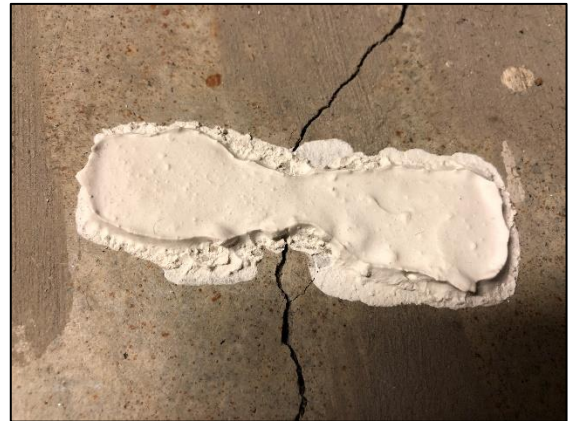
CWM 19 – no movement identified

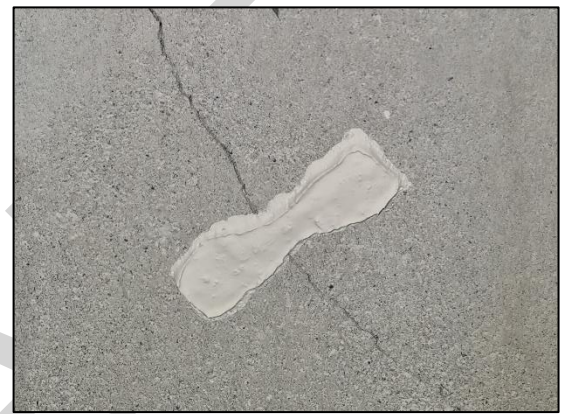
CWM 20 – no movement identified

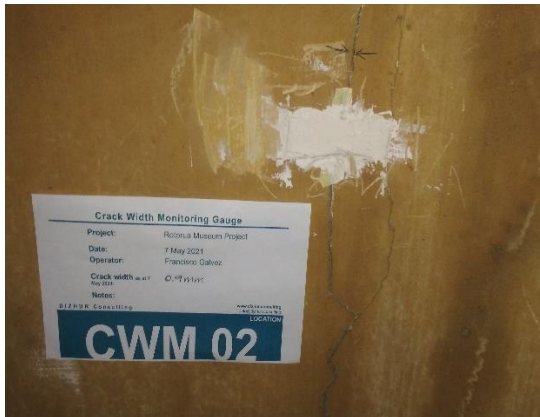
CWM 02 – no movement identified

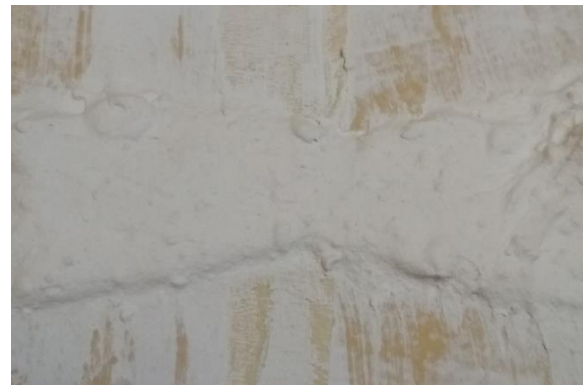
CWM 04 – no movement identified

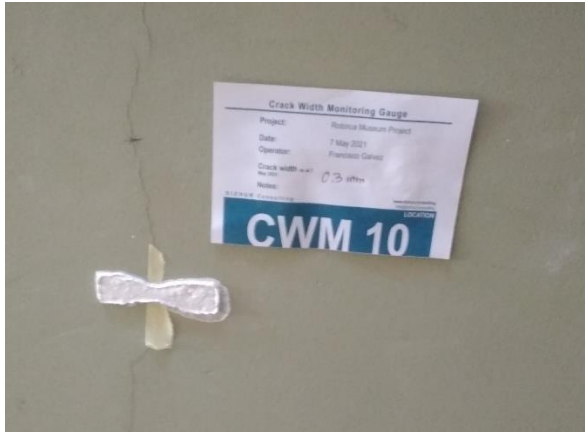
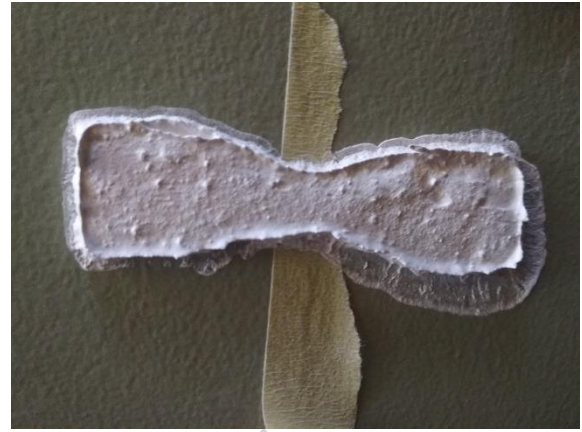
CWM 10 – no movement identified

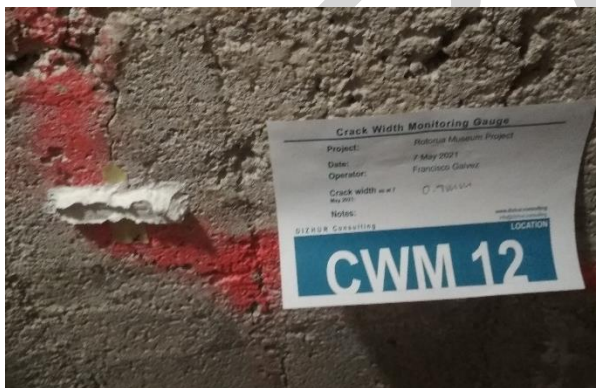
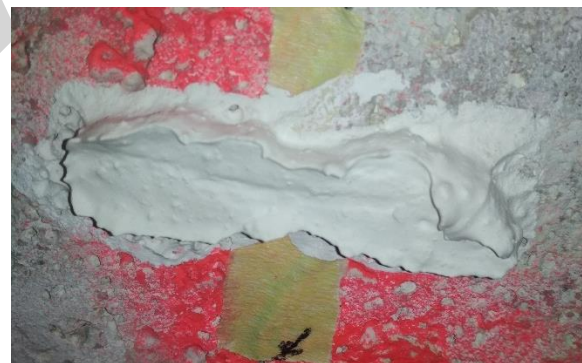
CWM 12 – no movement identified

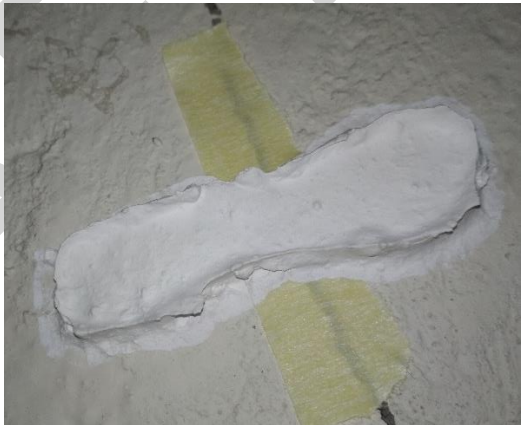
CWM 14 – no movement identified

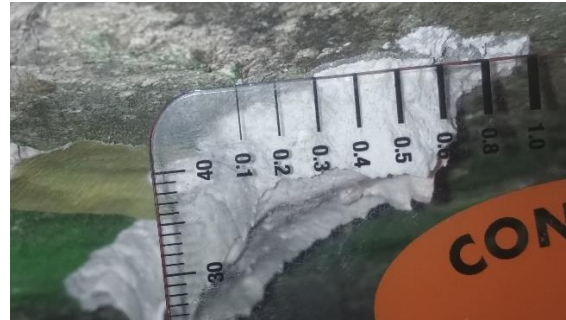
CWM 15 – hairline crack (<0.1mm) (Photo not updated because of quality) – 0.4mm detachment from top/vertical movement detected

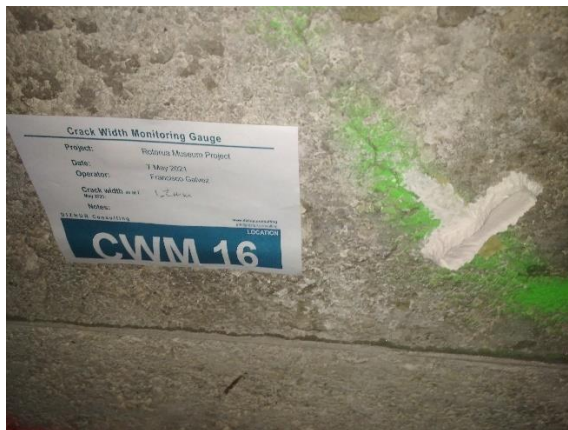
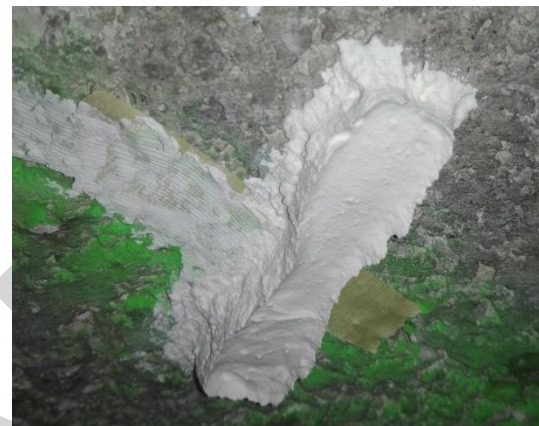
CWM 16 – no movement identified

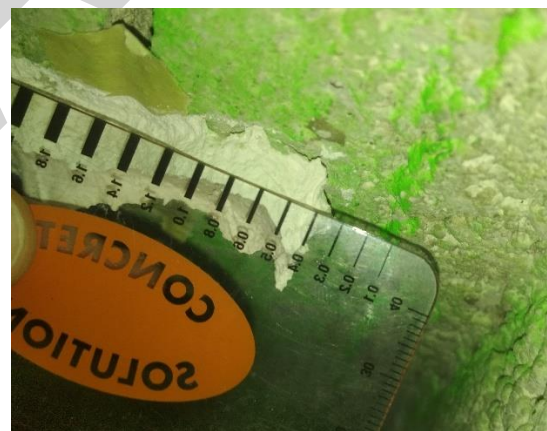
CWM 17 – no movement identified – Back detachment hard to see if movement (new gauge placed)

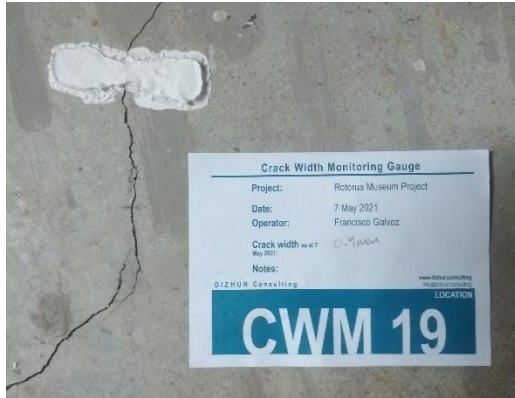
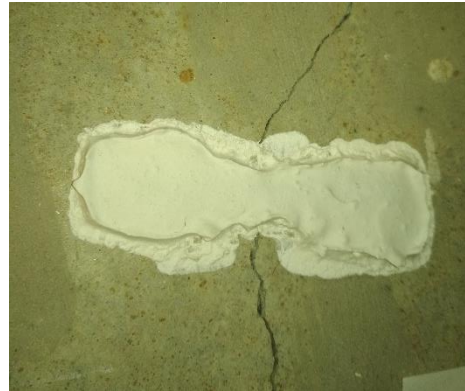
CWM 19 – no movement identified

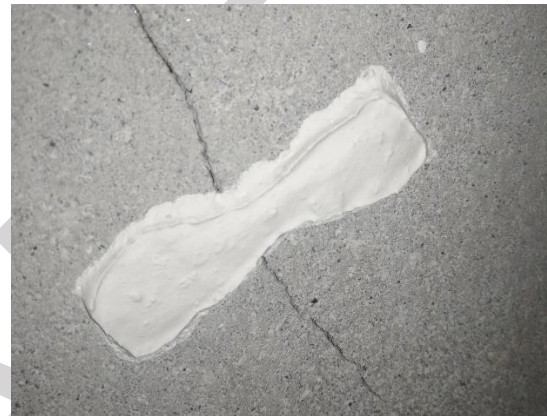
CWM 20 – no movement identified

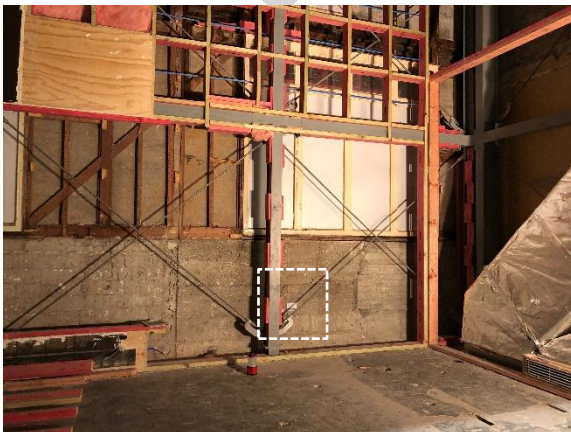
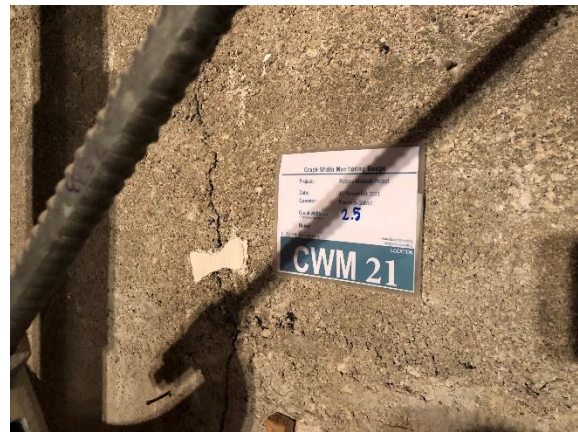
CWM 21 – crack width at time of gauge placement = 2.5mm

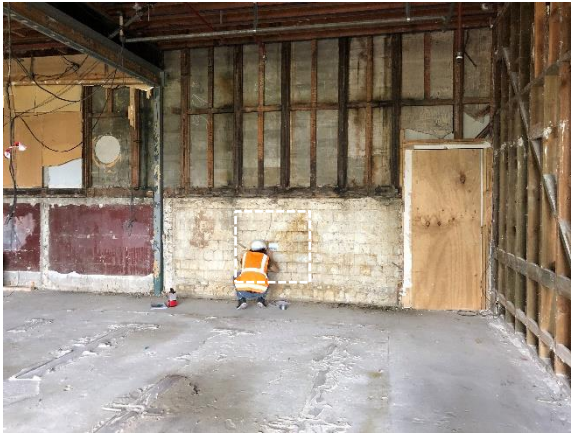
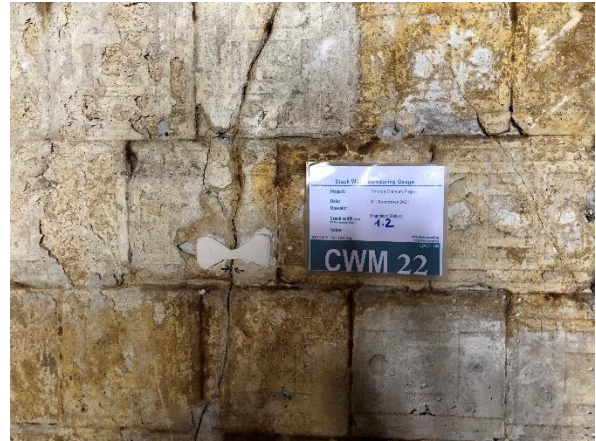
CWM 22 – crack width at time of gauge placement = 1.2mm

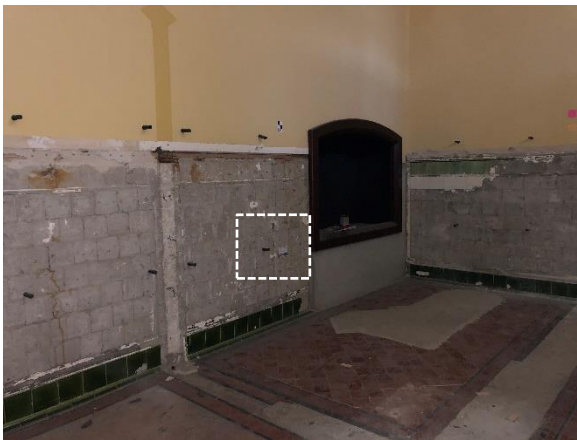
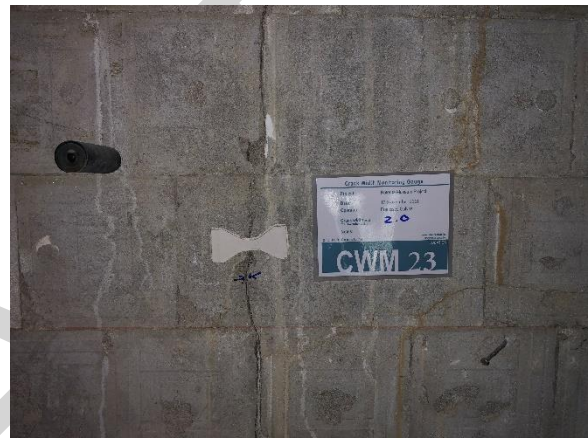
CWM 23 – crack width at time of gauge placement = 2.0mm
