DETAILED SEISMIC ASSESSMENT & CONCEPT RETROFIT REPORT

## ROTORUA MUSEUM

GOVERNMENT GARDENS ORUAWHATA DRIVE, ROTORUA

February 2022

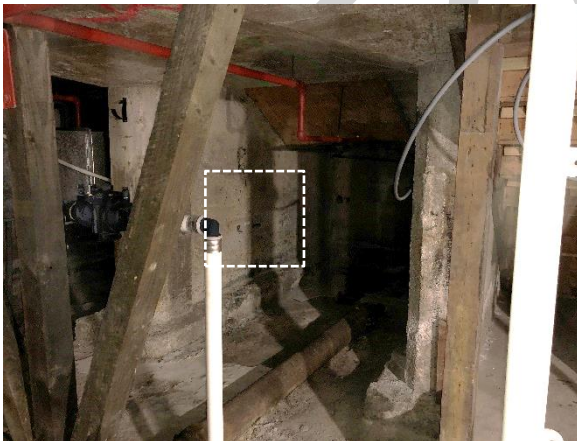
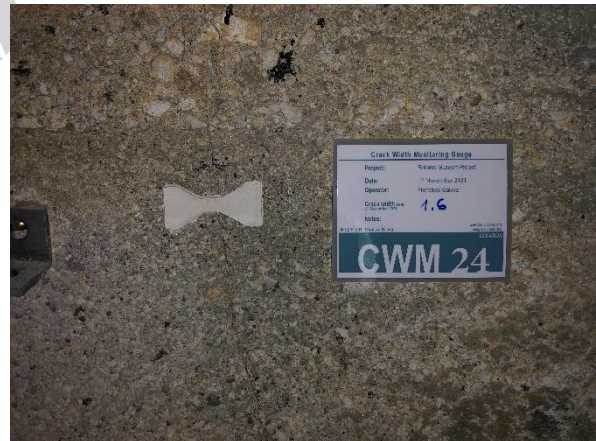
CWM 24 – crack width at time of gauge placement = 1.6mm

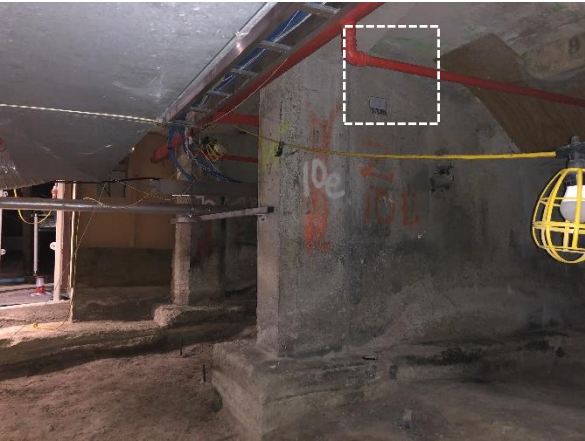
CWM 25 – crack width at time of gauge placement = 1.3mm

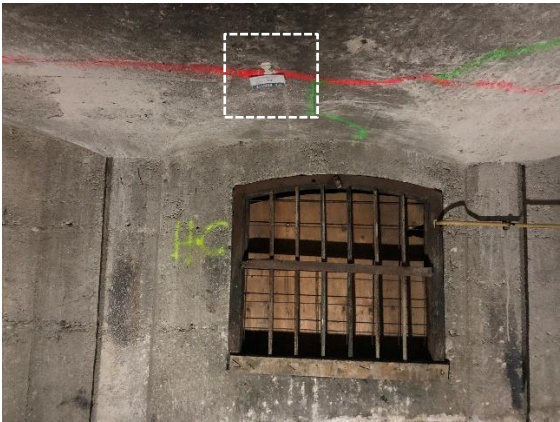
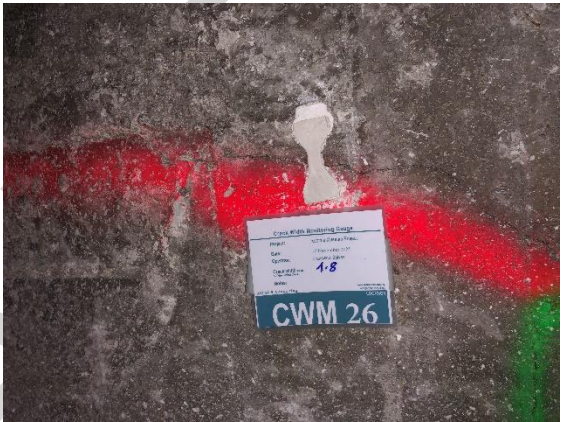
CWM 26 – crack width at time of gauge placement = 1.8mm

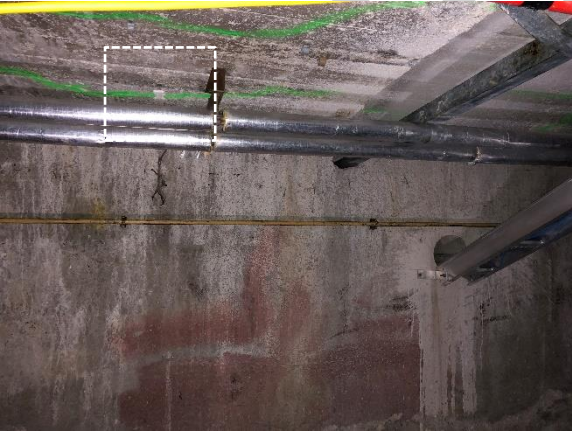
CWM 27 – crack width at time of gauge placement = 1.1mm + vertical movement

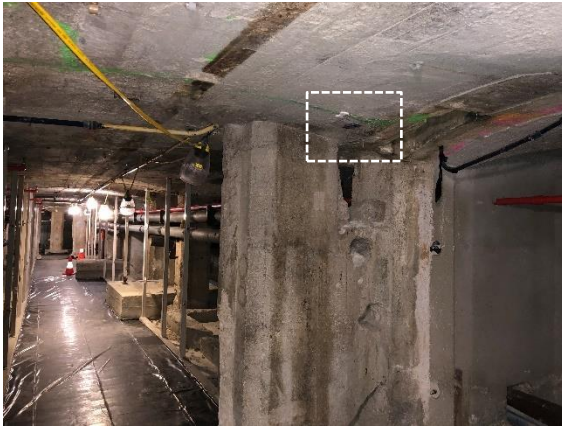
CWM 28 – crack width at time of gauge placement = 2.5mm + vertical movement

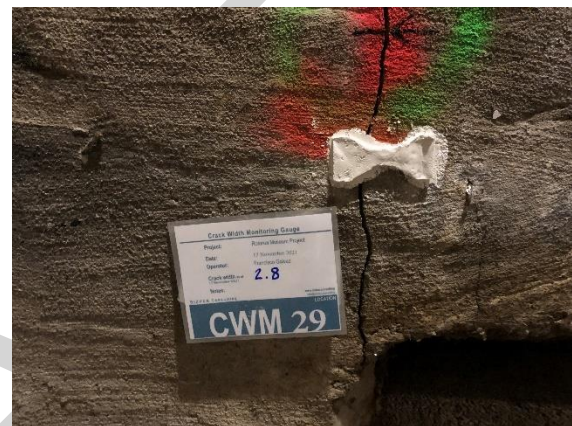
CWM 29 – crack width at time of gauge placement = 2.8mm

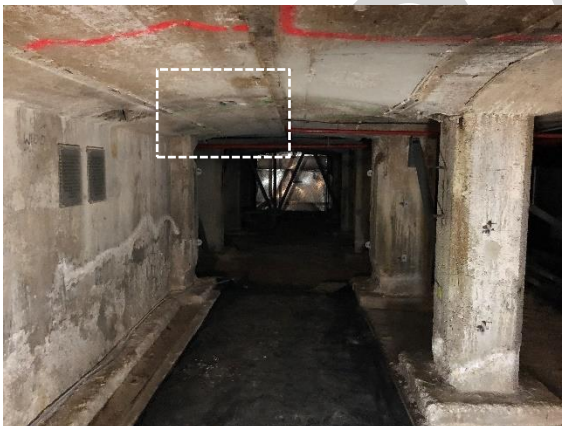
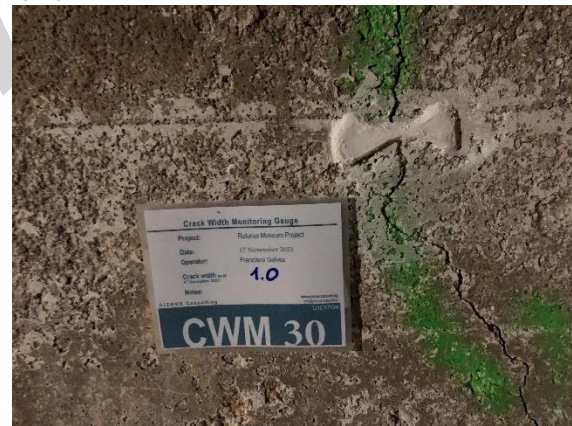
CWM 30 – crack width at time of gauge placement = 1mm

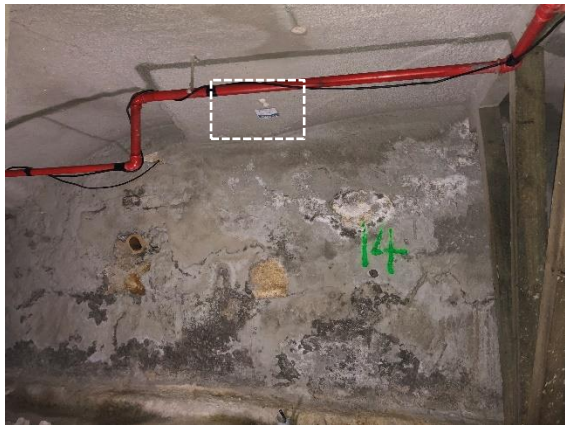
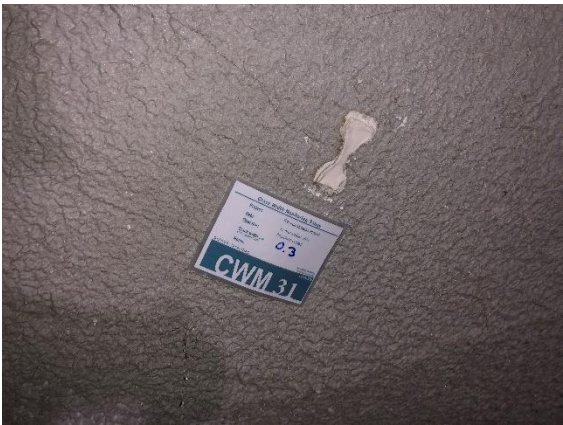
CWM 31 – crack width at time of gauge placement = 0.3mm

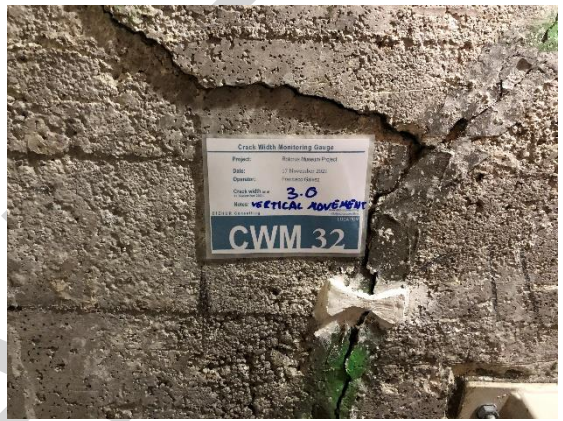
CWM 32 – crack width at time of gauge placement = 3mm + vertical movement

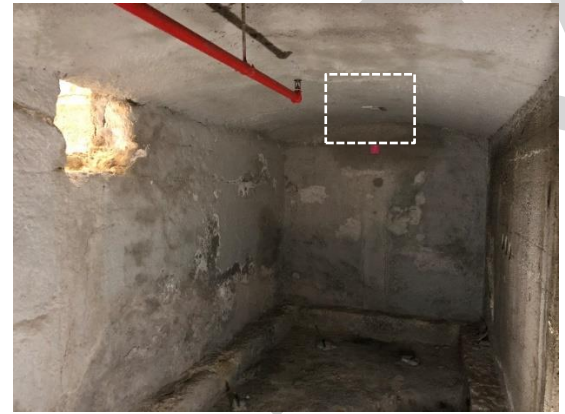
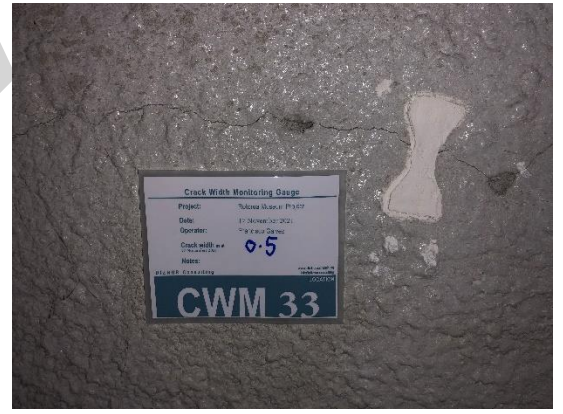
CWM 33 – crack width at time of gauge placement = 0.5mm

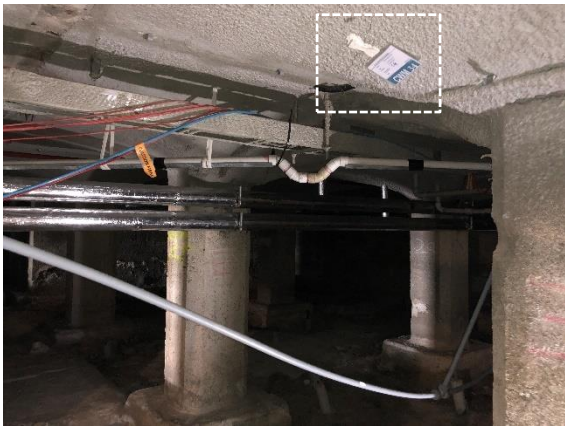
CWM 34 – crack width at time of gauge placement = 1.4mm

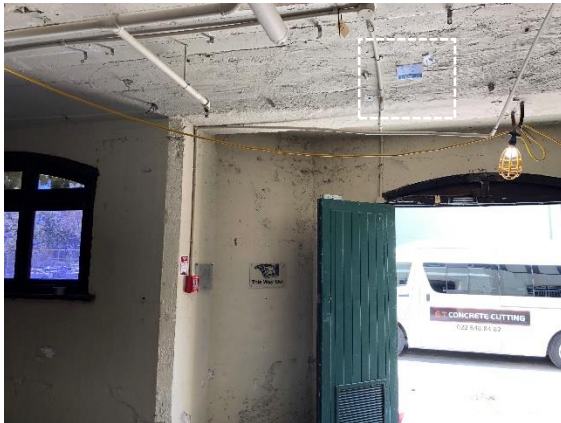
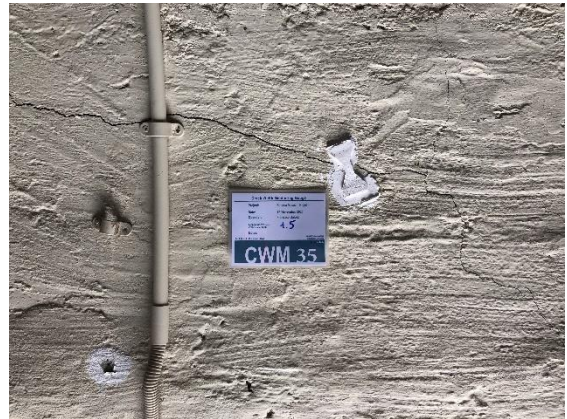
CWM 35 – crack width at time of gauge placement = 1.5mm

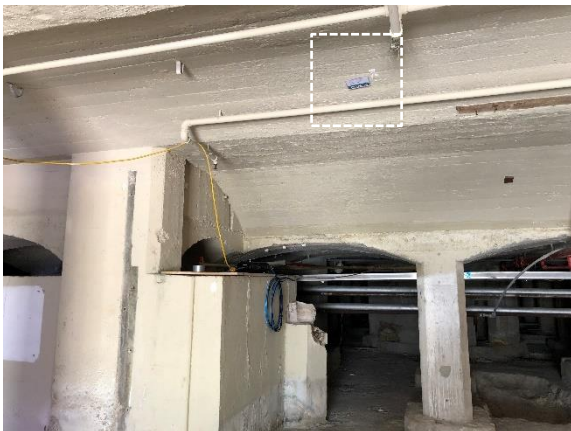
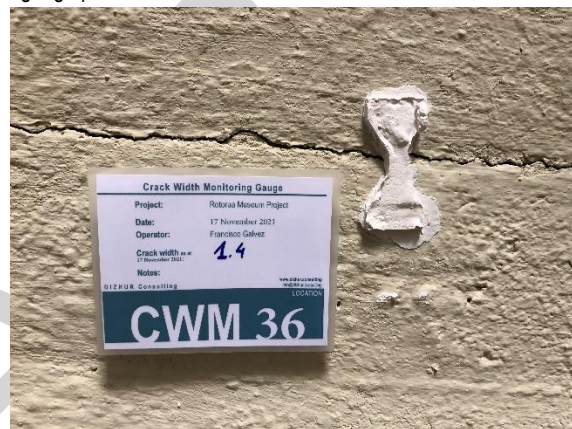
CWM 36 – crack width at time of gauge placement = 1.4mm

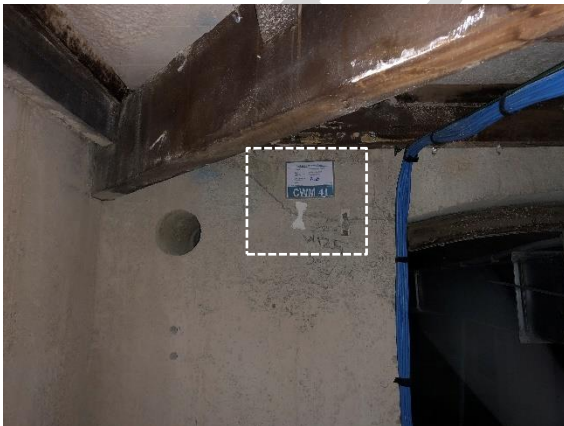
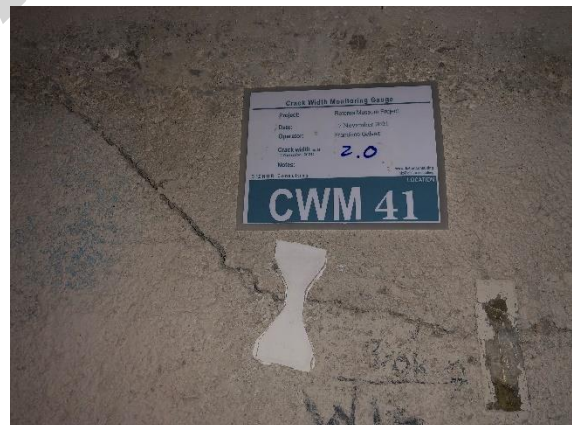
CWM 41 – crack width at time of gauge placement = 2mm

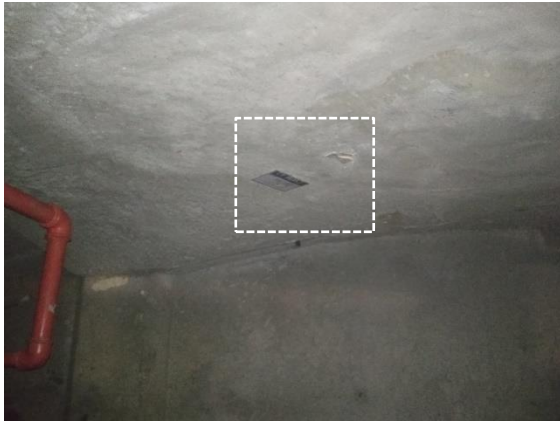
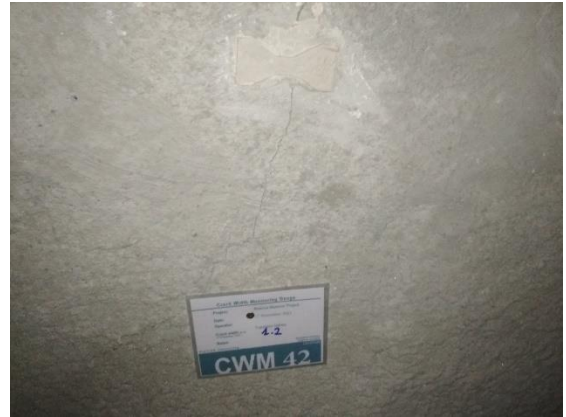
CWM 42 – crack width at time of gauge placement = 1.2mm
